November 12, 2021

**SUBJECT: Report of Asbestos Survey
Former Church and Four Structures
316 Tarboro Street West
Wilson, North Carolina**

**FIGURE 1
 SITE DIAGRAM
 ASBESTOS-CONTAINING MATERIAL (ACM)
 SURVEY
 CITY OF WILSON
 316 TARBORO STREET WEST
 WILSON, NORTH CAROLINA**

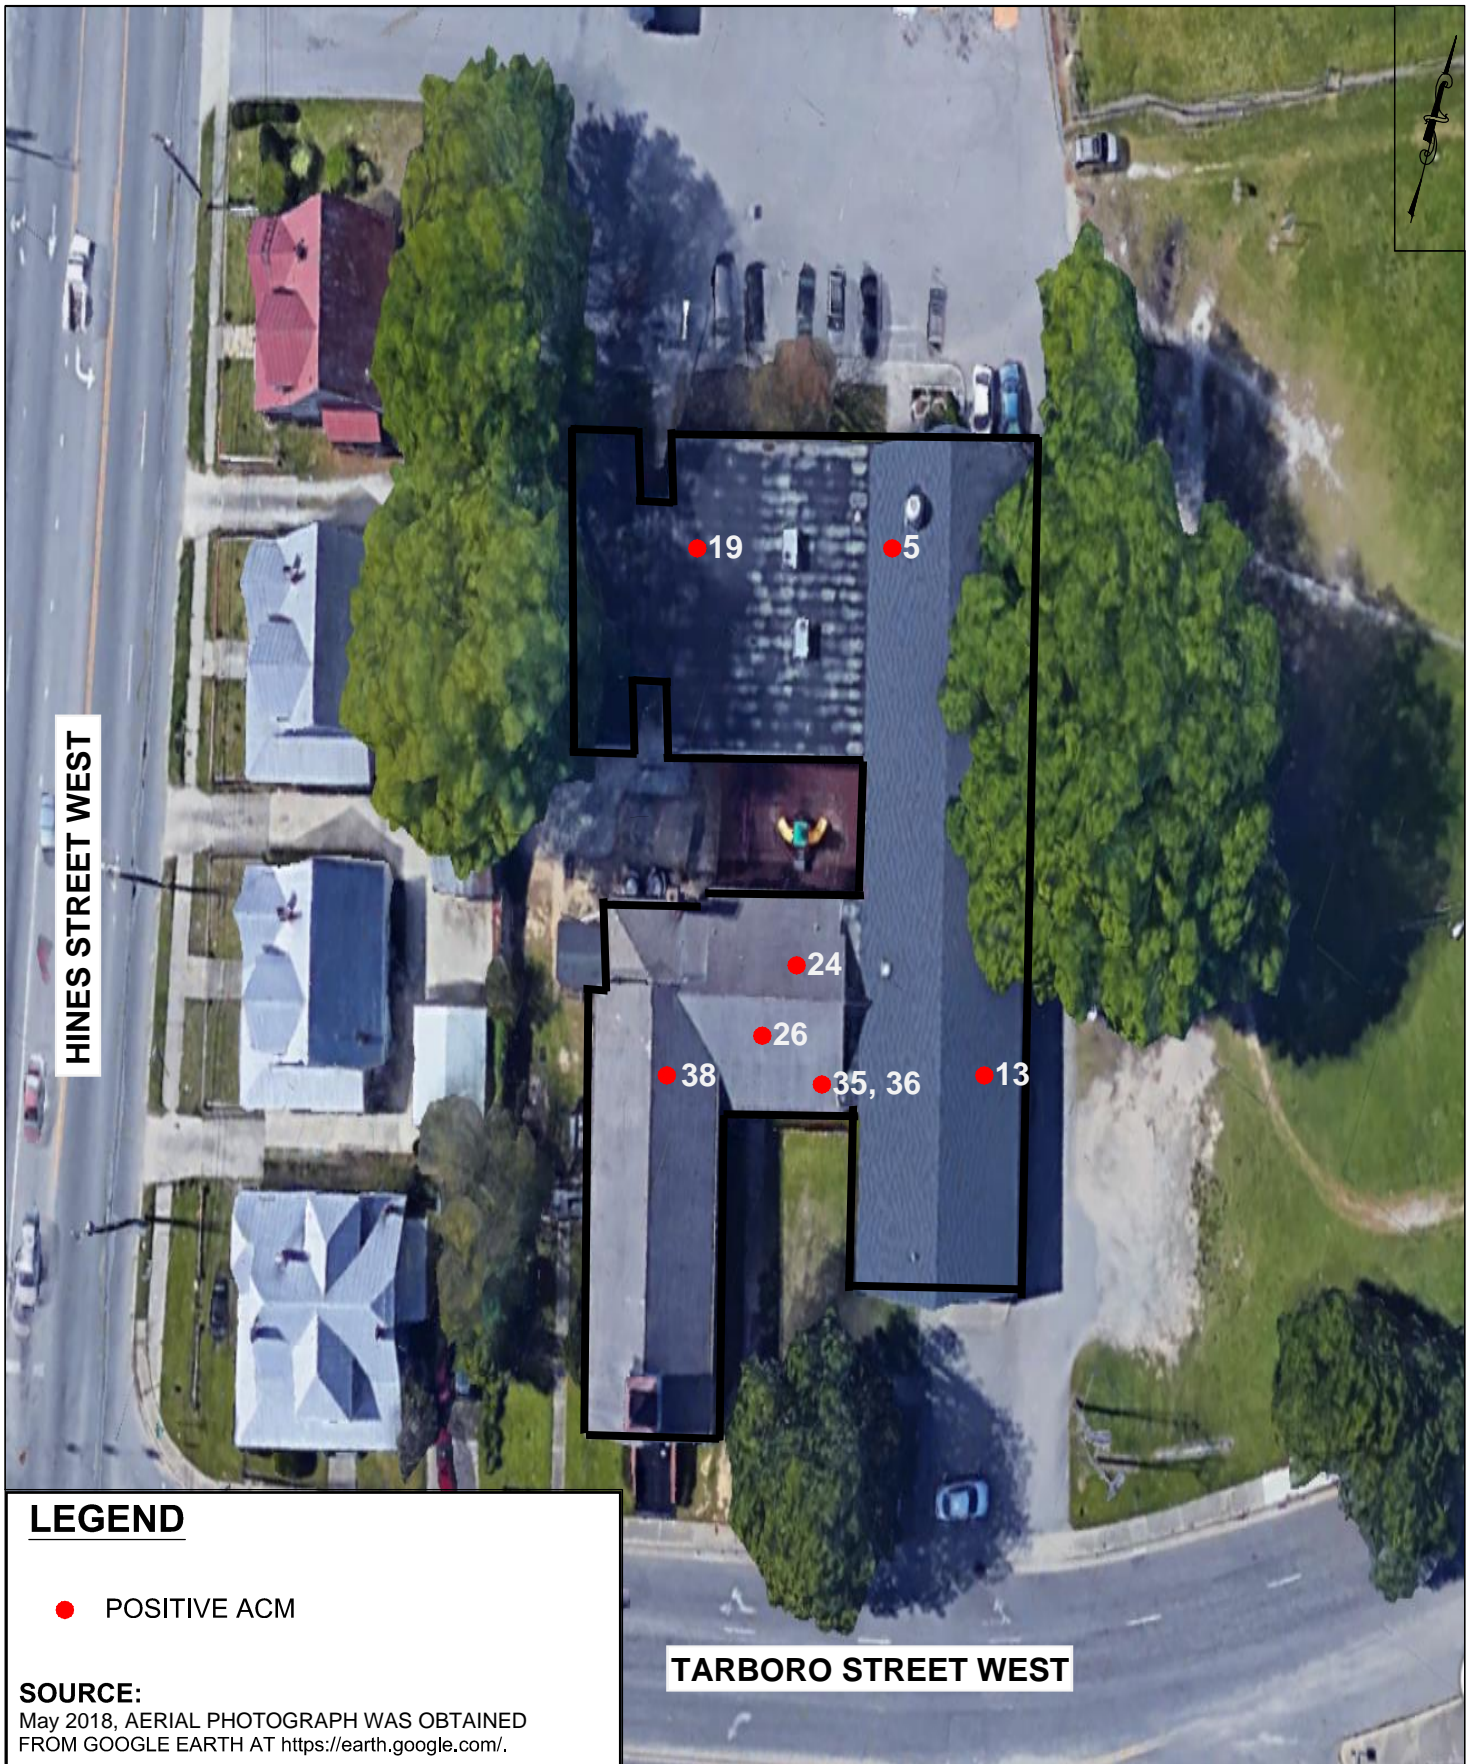
Sample ID	Material Description	Location	Percent / Type Asbestos	Quantity ¹
5	Black mastic	On non-acm fiberglass pipe insulation above the drop ceiling throughout	10% Chrysotile	100 linear feet
13	White popcorn ceiling texture	On non-acm plaster ceiling in the Fellowship Hall	2% Chrysotile	600 square feet
19	Silver light fixture paper	Underneath incandescent light fixtures in restrooms and closets	65% Chrysotile	8 light fixtures
24	Brown 9" x 9" floor tile	In two classrooms in the older section of the building	5% Chrysotile	500 square feet
26	Gray 9" x 9" floor tile	In classrooms and underneath carpet in the hallway of the older section of the building	5% Chrysotile	1,100 square feet
35	Gray pipe elbow	On pipes in the basement and crawl space	65% Chrysotile	20 elbows
36	White corrugated pipe insulation	On pipes in the basement and crawl space	65% Chrysotile	100 linear feet
38	Transite roof shingles	On roof of older section of the building	15% Chrysotile	4,500 square feet

● POSITIVE ACM

SynTerra recommends that the identified ACM be removed by a NC-licensed asbestos-abatement contractor prior to activities including renovation or demolition, which may disturb the materials.
