ATTACHMENT G – CCTV Videos & Reports

Inspection Report

Date 7/15/2019	P/O. No.	Weather Dry	Surveyor's Name Kyle_G	Pipe Segment Reference 2	Section No. 1
Certificate No. U-916-07005449	Survey Customer	System Owner Arlington County	Preset :	Pre-Cleaning Heavy Cleaning	Sewer Category

Street City Loc. details Location Code	Spout Run Arlington County- VA Woods	Use of Sewer Drainage Area Flow Control Length surveyed	Sanitary Not Controlled 498.60 ft	Upstream MH Downstream MH Dir. of Survey Section Length	MH749 MH748 Downstream 498.60 ft
---	---	--	--	--	---

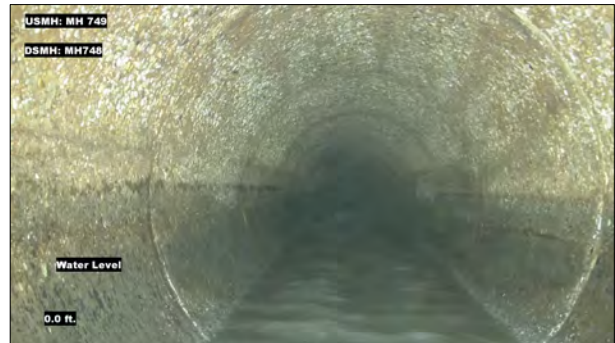
Photo: MH749_D_MH748_MWL_0.jpg, VCR No.: 1
 0FT, Water Level, 10 %of cross sectional area

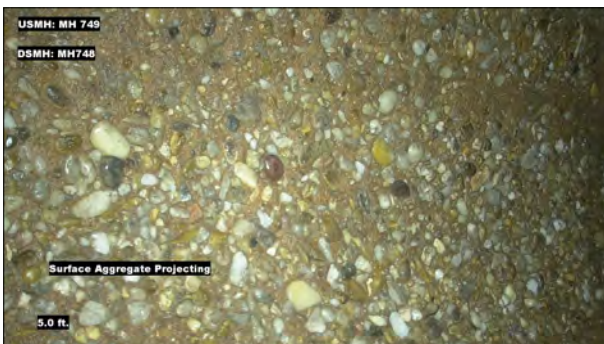
Photo: MH749_D_MH748_SAP_5.jpg, VCR No.: 1
 5FT, Surface Aggregate Projecting, from 07 to 05 o'clock,
 within 8 inches: YES

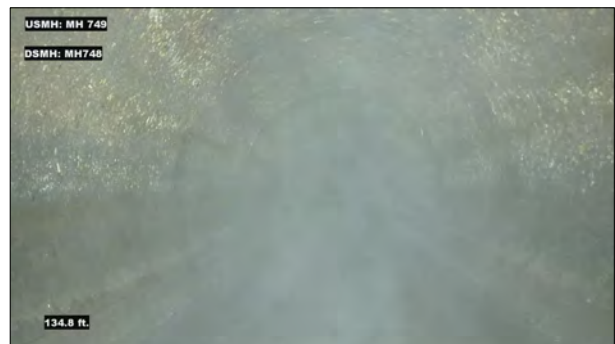
Photo: MH749_D_MH748_SAV_134.jpg, VCR No.: 1
 134FT, Surface Aggregate Visible, from 09 to 03 o'clock,
 within 8 inches of joint: NO, Start

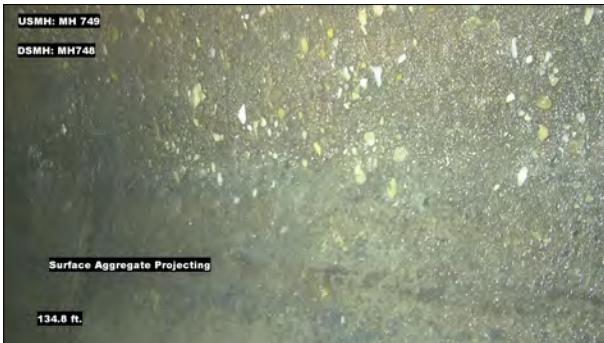
Photo: MH749_D_MH748_SAP_134.8.jpg, VCR No.: 1
134.8FT, Surface Aggregate Projecting, from 07 to 05 o'clock,
within 8 inches: NO

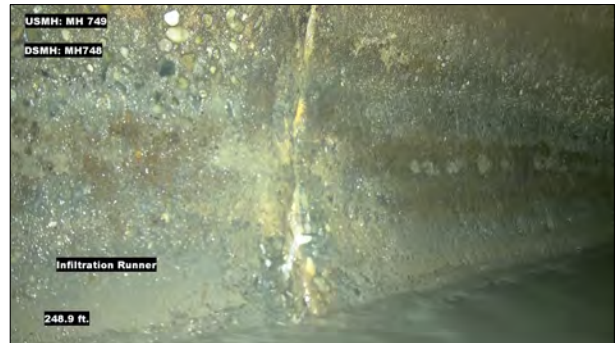
Photo: MH749_D_MH748_IR_248.9.jpg, VCR No.: 1
248.9FT, Infiltration Runner, at 07 o'clock, within 8 inches: YES

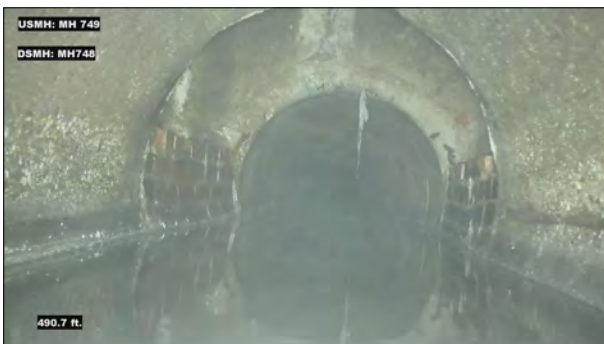
Photo: MH749_D_MH748_SAV_491.jpg, VCR No.: 1
491FT, Surface Aggregate Visible, from 09 to 03 o'clock,
within 8 inches of joint: NO, Finish

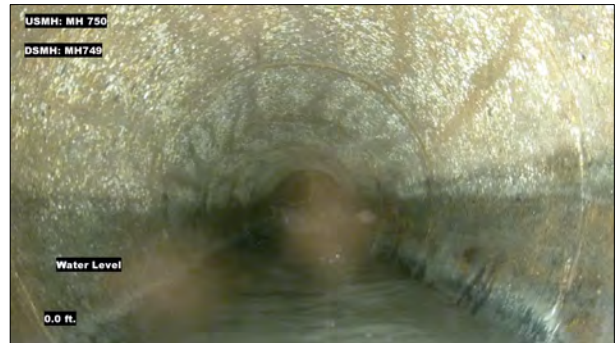
Photo: MH750_U_MH749_MWL_0.jpg, VCR No.: 1
 0FT, Water Level, 10% of cross sectional area

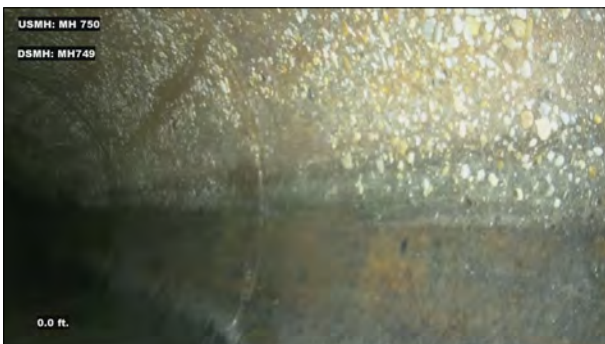
Photo: MH750_U_MH749_SAV_1.jpg, VCR No.: 1
 1FT, Surface Aggregate Visible, from 09 to 03 o'clock, within
 8 inches of joint: YES, Start

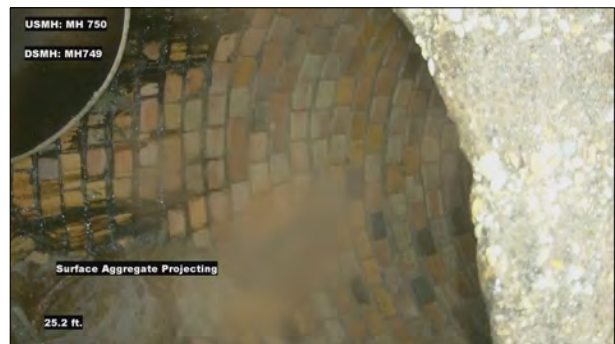
Photo: MH750_U_MH749_SAV_26.jpg, VCR No.: 1
 26FT, Surface Aggregate Visible, from 09 to 03 o'clock, within
 8 inches of joint: YES, Finish

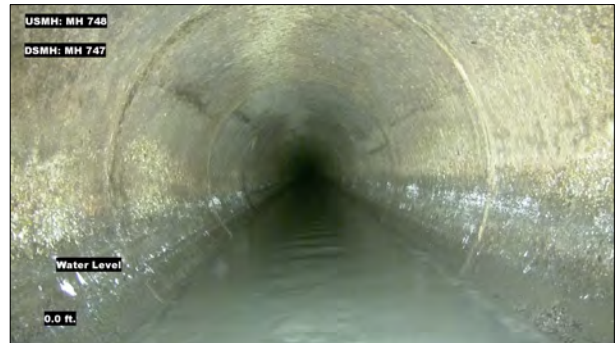
Photo: MH748_D_MH747_MWL_0.jpg, VCR No.: 1
 0FT, Water Level, 10% of cross sectional area

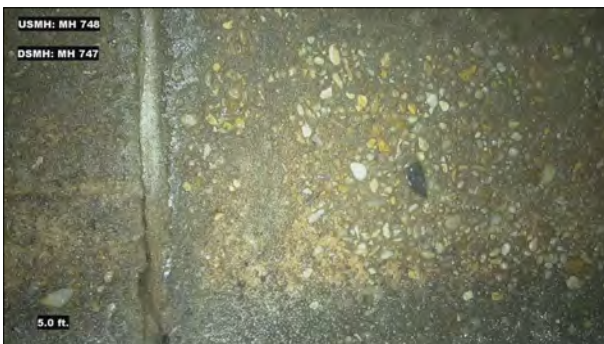
Photo: MH748_D_MH747_SAV_5.jpg, VCR No.: 1
 5FT, Surface Aggregate Visible, from 08 to 04 o'clock, within
 8 inches of joint: YES, Start

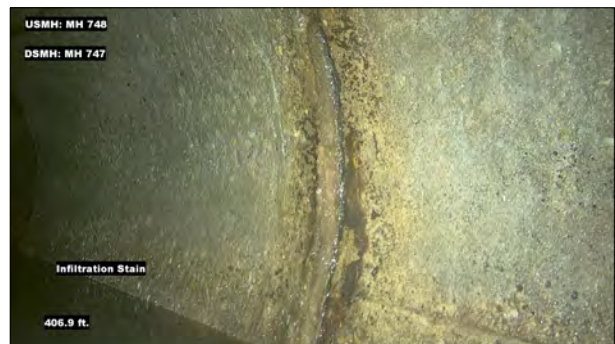
Photo: MH748_D_MH747_IS_406.9.jpg, VCR No.: 1
 406.9FT, Infiltration Stain, from 03 to 05 o'clock, within 8
 inches: NO

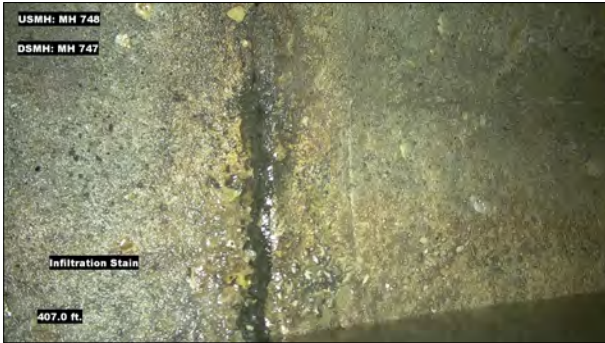
Photo: MH748_D_MH747_IS_407.jpg, VCR No.: 1
407FT, Infiltration Stain, from 07 to 08 o'clock, within 8 inches:
NO

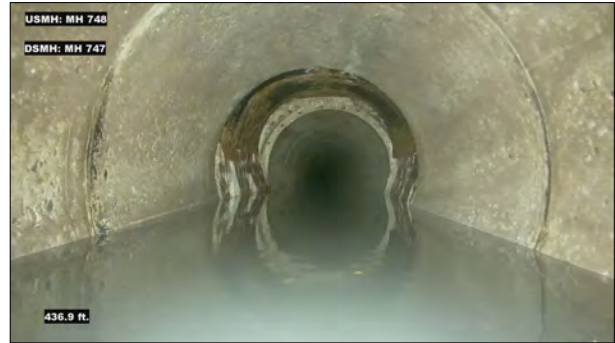
Photo: MH748_D_MH747_SAV_436.jpg, VCR No.: 1
436FT, Surface Aggregate Visible, from 08 to 04 o'clock,
within 8 inches of joint: YES, Finish

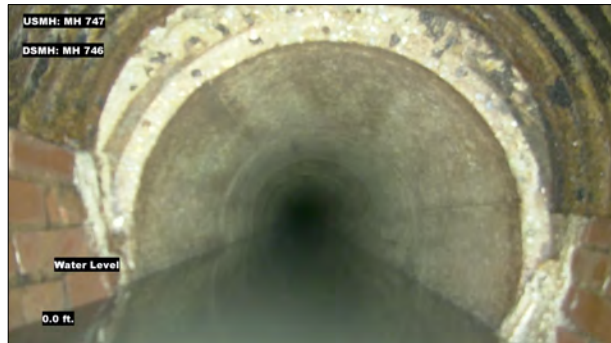
Photo: MH747_D_MH746_MWL_0.jpg, VCR No.: 1
 0FT, Water Level, 15 %of cross sectional area

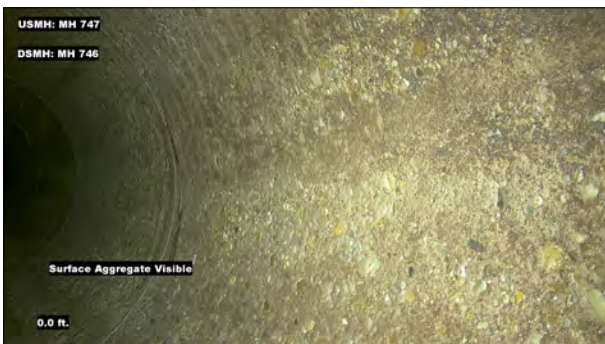
Photo: MH747_D_MH746_SAV_0.jpg, VCR No.: 1
 0FT, Surface Aggregate Visible, from 07 to 05 o'clock, within
 8 inches: YES

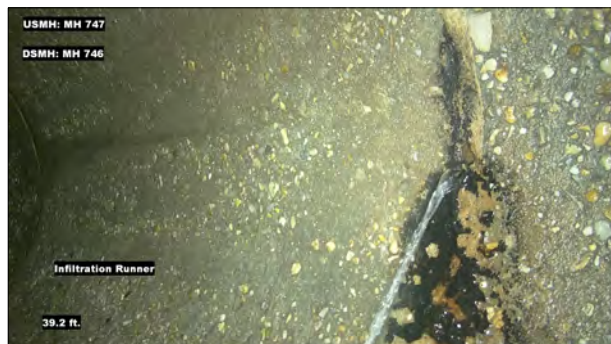
Photo: MH747_D_MH746_IR_39.2.jpg, VCR No.: 1
 39.2FT, Infiltration Runner, at 02 o'clock, within 8 inches: YES

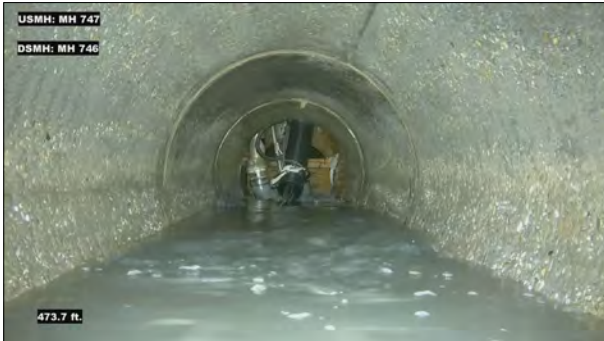
Photo: MH747_D_MH746_SAV_474.jpg, VCR No.: 1
474FT, Surface Aggregate Visible, from 07 to 05 o'clock,
within 8 inches of joint: YES, Finish

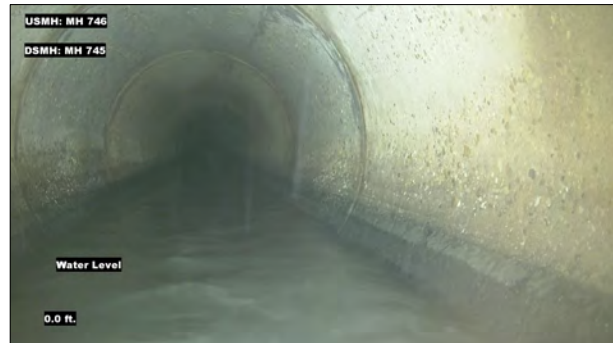
Photo: MH746_D_MH745_MWL_0.jpg, VCR No.: 1
 0FT, Water Level, 5% of cross sectional area

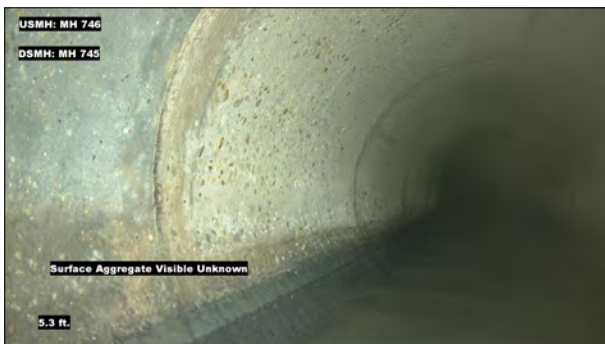
Photo: MH746_D_MH745_SAVZ_5.3.jpg, VCR No.: 1
 5.3FT, Surface Aggregate Visible Unknown, from 07 to 04
 o'clock, within 8 inches: NO

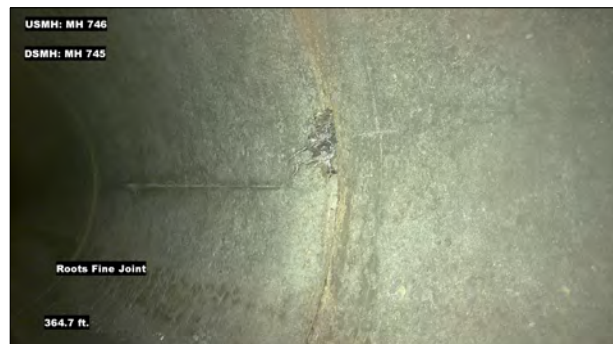
Photo: MH746_D_MH745_RFJ_364.7.jpg, VCR No.: 1
 364.7FT, Roots Fine Joint, at 02 o'clock, within 8 inches: YES

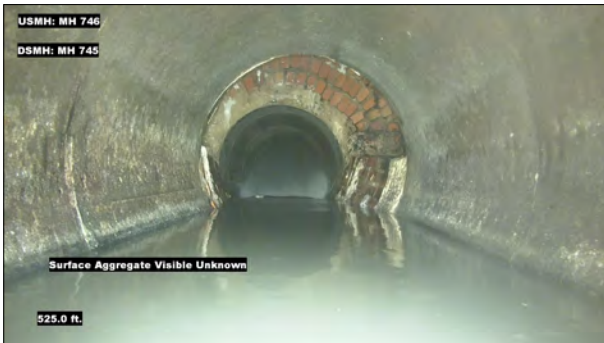
Photo: MH746_D_MH745_SAVZ_525.jpg, VCR No.: 1
525FT, Surface Aggregate Visible Unknown, from 07 to 04
o'clock, within 8 inches: NO

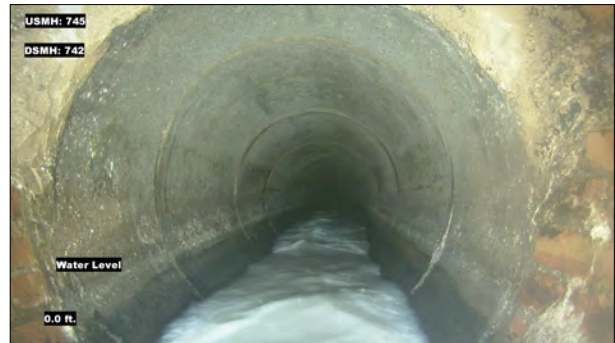
Photo: MH745_D_MH742_MWL_0.jpg, VCR No.: 1
 0FT, Water Level, 5% of cross sectional area

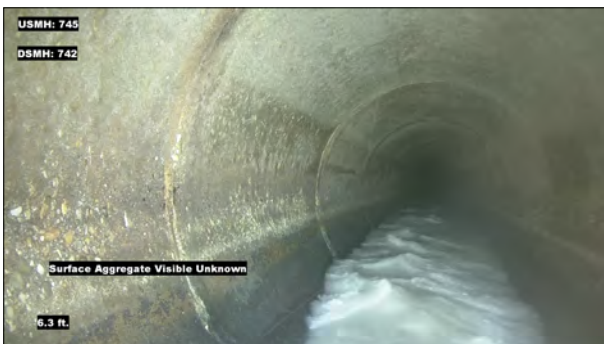
Photo: MH745_D_MH742_SAVZ_6.3.jpg, VCR No.: 1
 6.3FT, Surface Aggregate Visible Unknown, from 09 to 03
 o'clock, within 8 inches: NO

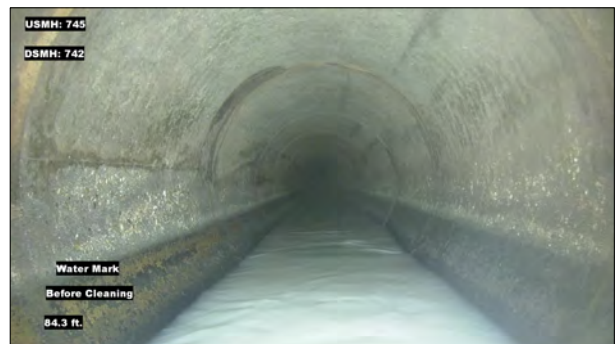
84.30	Water Mark, 25% of cross sectional area	MH745_D_MH742_MWM_84.3.jpg
117.00	Deposits Attached Encrustation, 5% of cross sectional area, at 08 o'clock, within 8 inches: YES	MH745_D_MH742_DAE_117.jpg

Photo: MH745_D_MH742_MWM_84.3.jpg, VCR No.: 1
 84.3FT, Water Mark, 25% of cross sectional area

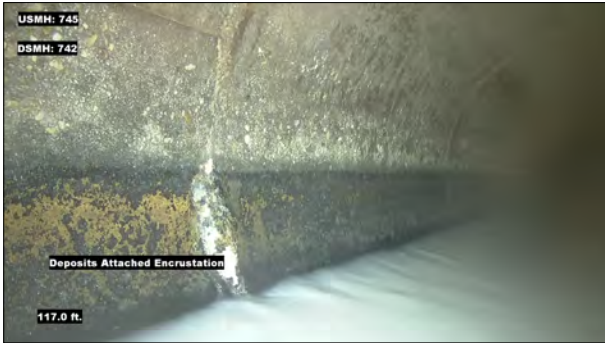
Photo: MH745_D_MH742_DAE_117.jpg, VCR No.: 1
117FT, Deposits Attached Encrustation, 5% of cross sectional
area, at 08 o'clock, within 8 inches: YES

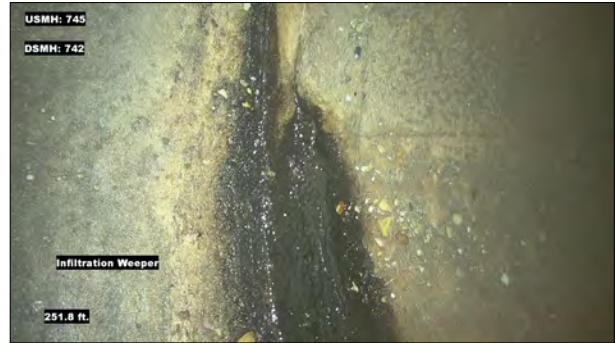
251.80	Infiltration Weeper, at 11 o'clock, within 8 inches: YES	MH745_D_MH742_IW_251.8.jpg
252.30	Infiltration Stain, at 03 o'clock, within 8 inches: YES	MH745_D_MH742_IS_252.3.jpg

Photo: MH745_D_MH742_IW_251.8.jpg, VCR No.: 1
251.8FT, Infiltration Weeper, at 11 o'clock, within 8 inches:
YES

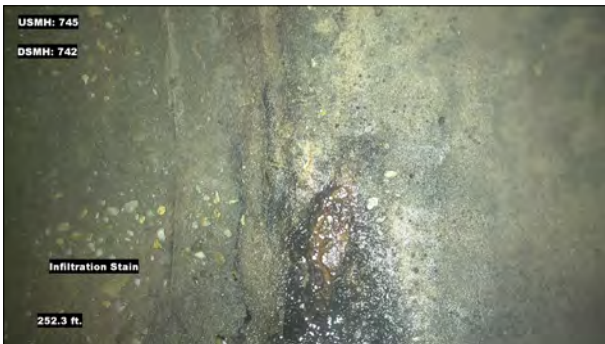
Photo: MH745_D_MH742_IS_252.3.jpg, VCR No.: 1
252.3FT, Infiltration Stain, at 03 o'clock, within 8 inches: YES

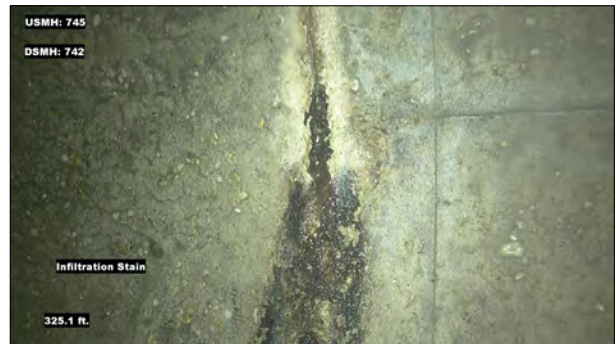
325.10	Infiltration Stain, at 02 o'clock, within 8 inches: YES	MH745_D_MH742_IS_325.1.jpg
365.00	Crack Circumferential, from 08 to 05 o'clock, within 8 inches of joint: NO	MH745_D_MH742_CC_365.jpg

Photo: MH745_D_MH742_IS_325.1.jpg, VCR No.: 1
325.1FT, Infiltration Stain, at 02 o'clock, within 8 inches: YES

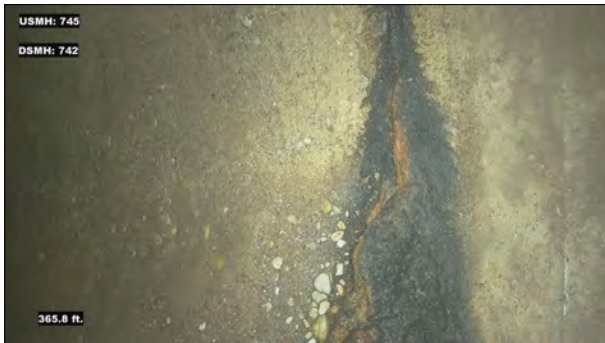
Photo: MH745_D_MH742_CC_365.jpg, VCR No.: 1
 365FT, Crack Circumferential, from 08 to 05 o'clock, within 8 inches of joint: NO

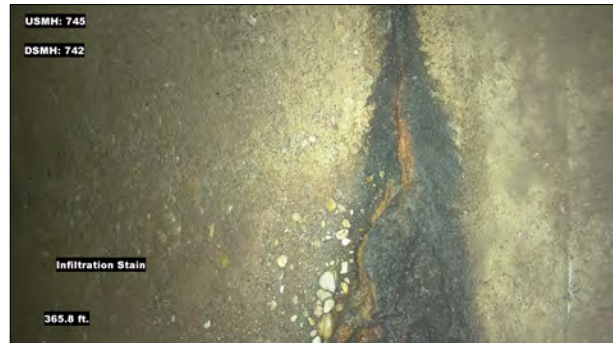
365.80	Infiltration Stain, at 02 o'clock, within 8 inches: YES	MH745_D_MH742_IS_365.8.jpg
365.80	Deposits Attached Encrustation, 5% of cross sectional area, at 03 o'clock, within 8 inches: YES	MH745_D_MH742_DAE_365.8.jpg

Photo: MH745_D_MH742_IS_365.8.jpg, VCR No.: 1
 365.8FT, Infiltration Stain, at 02 o'clock, within 8 inches: YES

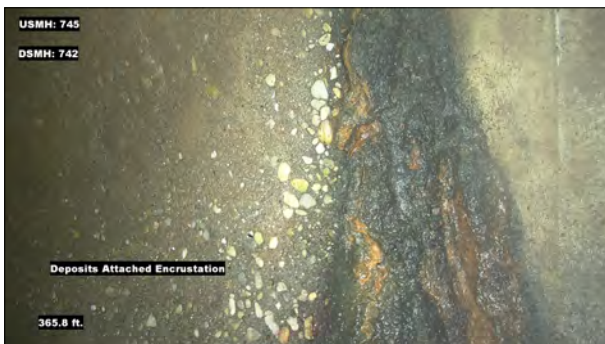
Photo: MH745_D_MH742_DAE_365.8.jpg, VCR No.: 1
 365.8FT, Deposits Attached Encrustation, 5% of cross sectional area, at 03 o'clock, within 8 inches: YES

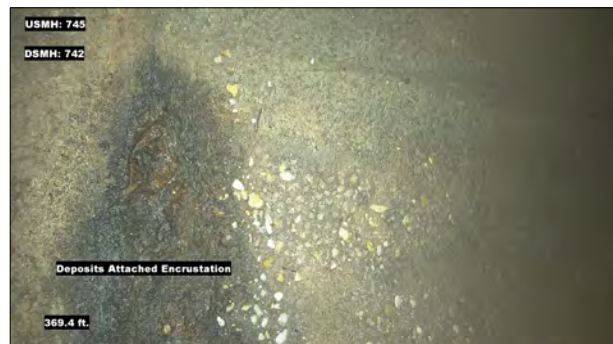
369.40	Deposits Attached Encrustation, 5% of cross sectional area, at 11 o'clock, within 8 inches: YES	MH745_D_MH742_DAE_369.4.jpg
376.70	Deposits Attached Encrustation, 5% of cross sectional area, at 11 o'clock, within 8 inches: YES	MH745_D_MH742_DAE_376.7.jpg

Photo: MH745_D_MH742_DAE_369.4.jpg, VCR No.: 1
 369.4FT, Deposits Attached Encrustation, 5% of cross sectional area, at 11 o'clock, within 8 inches: YES

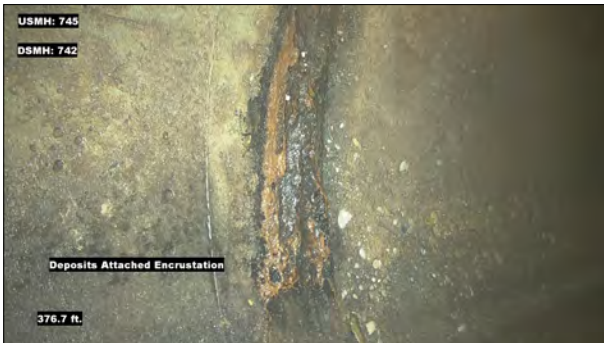
Photo: MH745_D_MH742_DAE_376.7.jpg, VCR No.: 1
376.7FT, Deposits Attached Encrustation, 5% of cross sectional area, at 11 o'clock, within 8 inches: YES

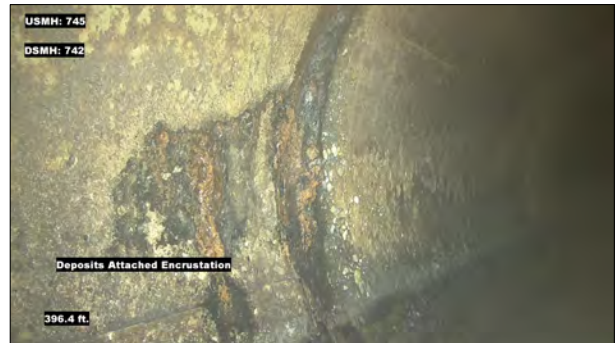
396.40	Deposits Attached Encrustation, 5% of cross sectional area, at 10 o'clock, within 8 inches: YES	MH745_D_MH742_DAE_396.4.jpg
406.60	F1 Surface Aggregate Visible Unknown, from 09 to 03 o'clock, within 8 inches: NO	MH745_D_MH742_SAVZ_406.6.jpg

Photo: MH745_D_MH742_DAE_396.4.jpg, VCR No.: 1
396.4FT, Deposits Attached Encrustation, 5% of cross sectional area, at 10 o'clock, within 8 inches: YES

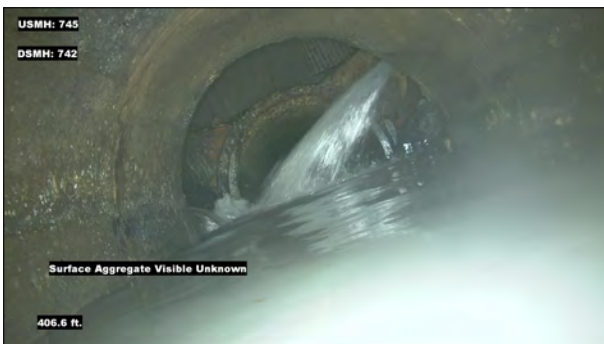
Photo: MH745_D_MH742_SAVZ_406.6.jpg, VCR No.: 1
406.6FT, Surface Aggregate Visible Unknown, from 09 to 03 o'clock, within 8 inches: NO

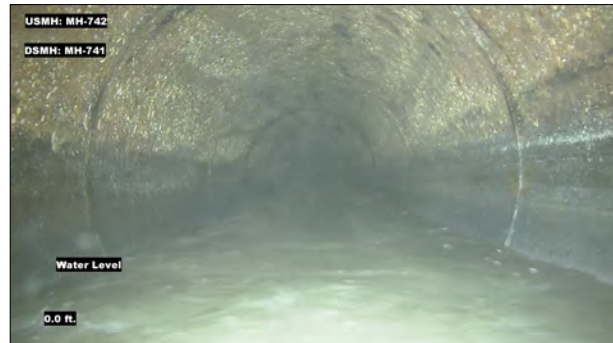
Photo: MH742_D_MH741_MWL_0.jpg, VCR No.: 1
 0FT, Water Level, 10% of cross sectional area

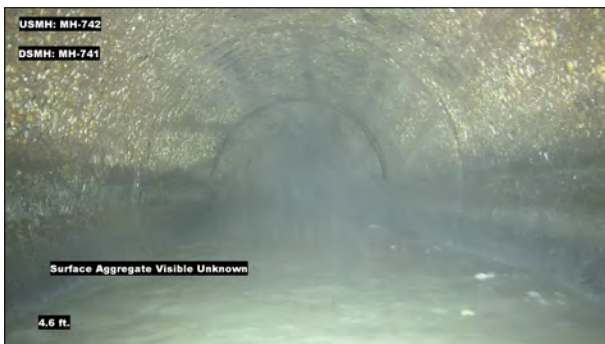
Photo: MH742_D_MH741_SAVZ_4.6.jpg, VCR No.: 1
 4.6FT, Surface Aggregate Visible Unknown, from 09 to 03
 o'clock, within 8 inches: NO

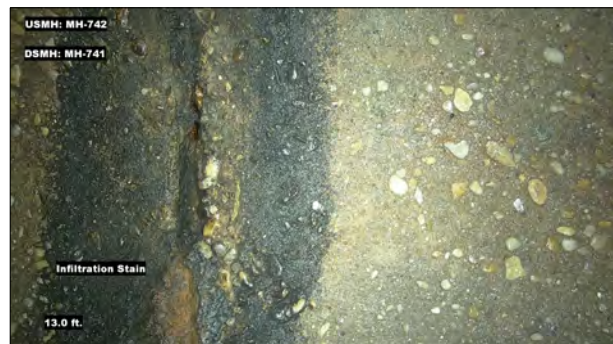
Photo: MH742_D_MH741_IS_13.jpg, VCR No.: 1
 13FT, Infiltration Stain, at 04 o'clock, within 8 inches: YES

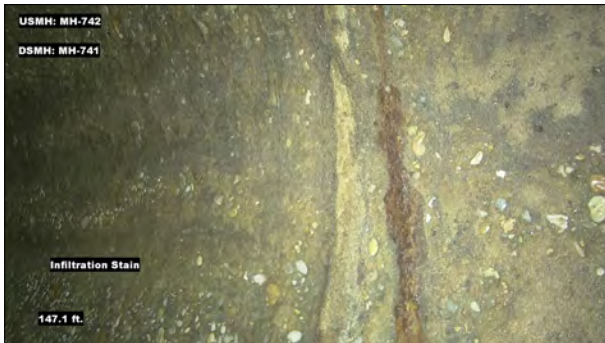
Photo: MH742_D_MH741_IS_147.1.jpg, VCR No.: 1
 147.1FT, Infiltration Stain, at 02 o'clock, within 8 inches: NO

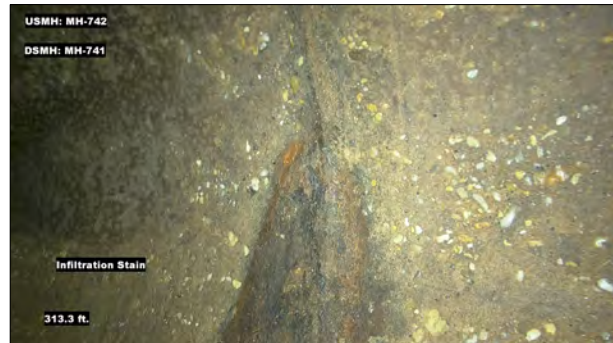
Photo: MH742_D_MH741_IS_313.3.jpg, VCR No.: 1
 313.3FT, Infiltration Stain, at 01 o'clock, within 8 inches: YES

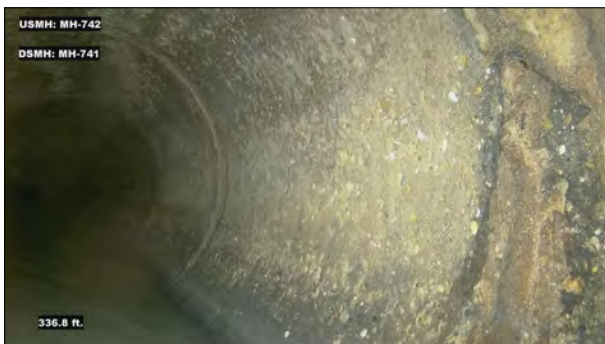
Photo: MH742_D_MH741_DAE_336.jpg, VCR No.: 1
 336FT, Deposits Attached Encrustation, 5 %of cross sectional area, from 07 to 05 o'clock, , within 8 inches of joint: YES

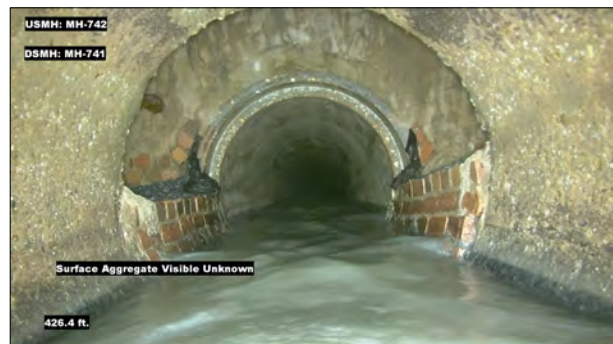
Photo: MH742_D_MH741_SAVZ_426.4.jpg, VCR No.: 1
 426.4FT, Surface Aggregate Visible Unknown, from 09 to 03 o'clock, within 8 inches: NO

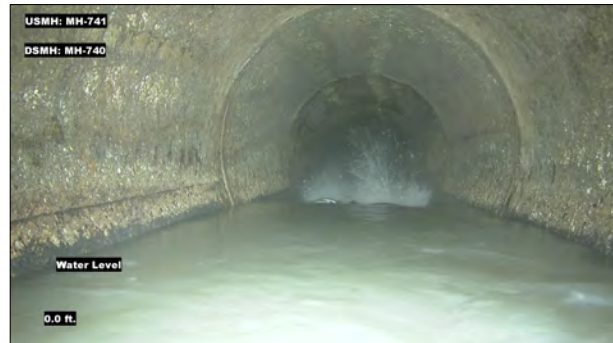
Photo: MH741_D_MH740_MWL_0.jpg, VCR No.: 1
 0FT, Water Level, 10% of cross sectional area

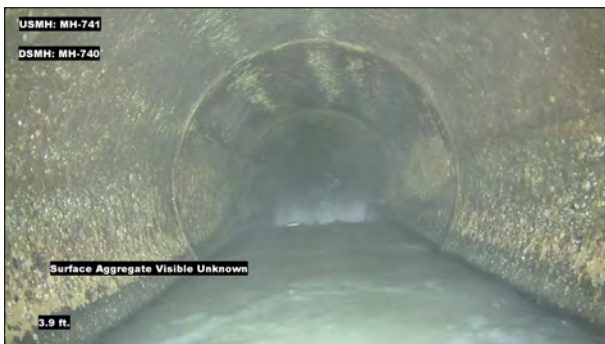
Photo: MH741_D_MH740_SAVZ_3.9.jpg, VCR No.: 1
 3.9FT, Surface Aggregate Visible Unknown, from 08 to 04
 o'clock, within 8 inches: YES

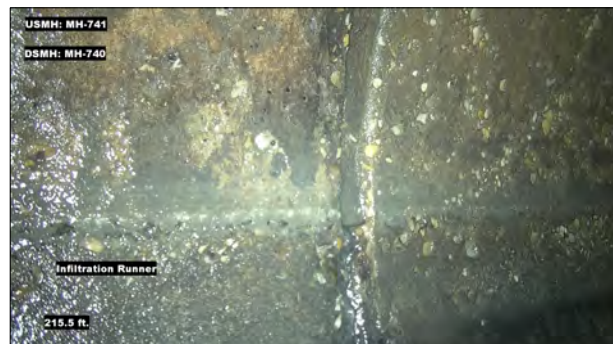
Photo: MH741_D_MH740_IR_215.5.jpg, VCR No.: 1
 215.5FT, Infiltration Runner, at 08 o'clock, within 8 inches: YES

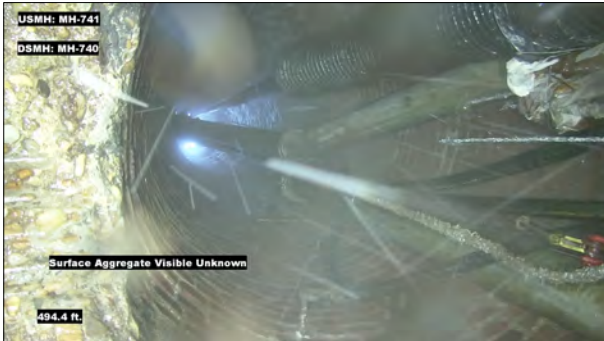
Photo: MH741_D_MH740_SAVZ_494.4.jpg, VCR No.: 1
494.4FT, Surface Aggregate Visible Unknown, from 08 to 04
o'clock, within 8 inches: NO
