## **Asbestos Assessment Update**

City of Spartanburg  
177 West Wood Street  
Spartanburg, South Carolina 29303

Project Number: 0123-01  
May 15, 2023

Reference: Asbestos Assessment Update  
177 West Wood Street  
Spartanburg, South Carolina 29303

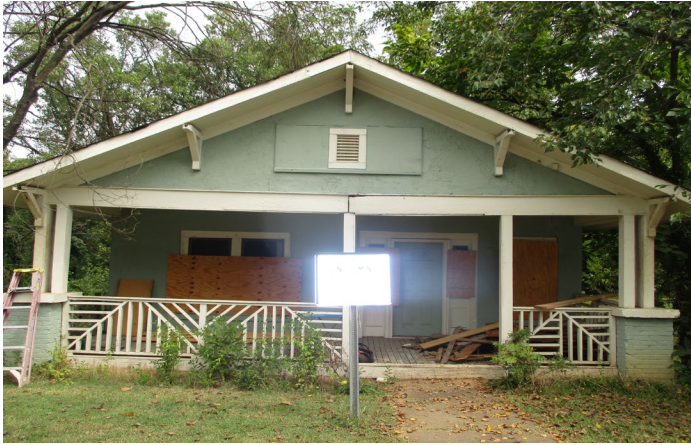
Photo 1 – 177 West Wood Street in Spartanburg, South Carolina 29303

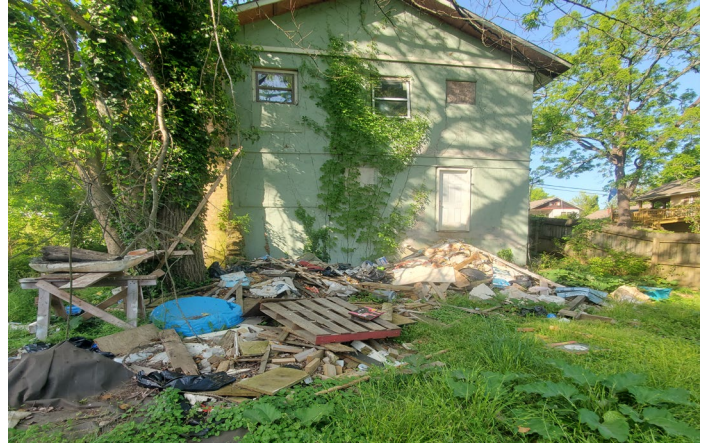
Photo 2 – Building material located at the rear of the residence.

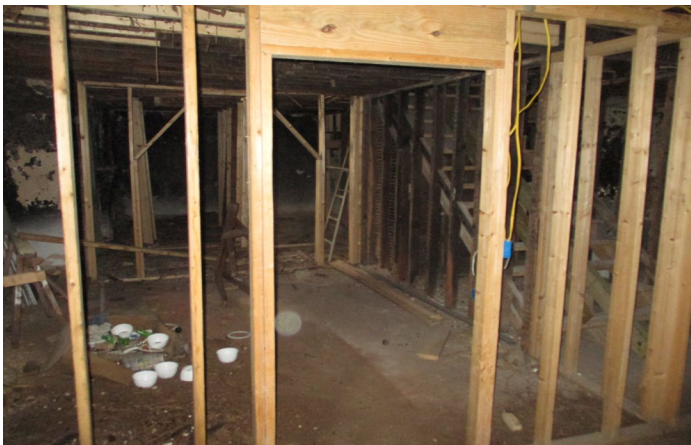
Photo 3 – View of basement from the 2021 assessment.

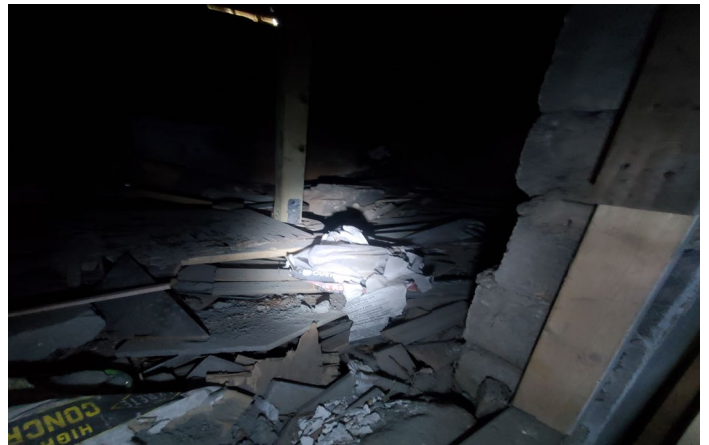
Wood subflooring has been added to the main level of the residence. New building finishes have been stored within the main level as well. The initial assessment in 2021 listed plaster walls throughout the residence. The plaster has been removed from several areas and currently stored within the basement level. Finished drywall walls have been added to the basement since the assessment in 2021. Drywall, joint compound and tape were sampled within the basement on April 25<sup>th</sup>, 2023. The basement drywall installation is evidence that renovations are in process. The building was fully assessed; however, if additional ACM is discovered during demolition activities, Apex recommends that work activities stop until the suspect building materials may be sampled and analyzed.

Photo 4 – Original wall material from walls is in piles on basement floor.

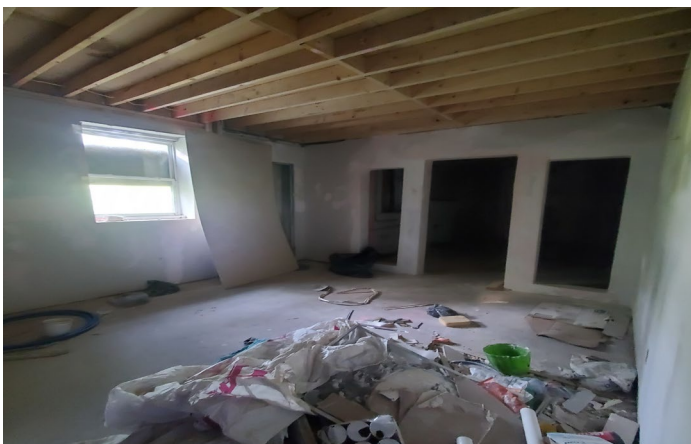
The drywall, joint compound, and tape added to the basement after the initial assessment was sampled on April 25<sup>th</sup>, 2023. The analysis of the material did not detect asbestos from the material sampled.

Photo 5 – New drywall added to basement since initial assessment. View of sampling area.

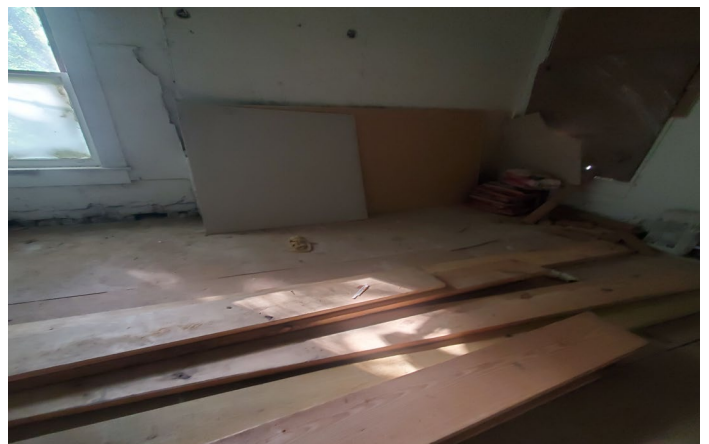
Photo 6 – Typical view of wood flooring stored throughout main level. New subflooring has been added.

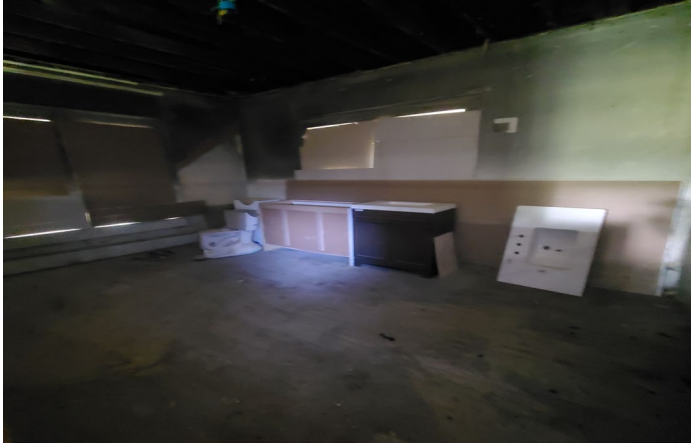
Photo 7 – Newly added wood flooring. Building material stored on main level of residence.

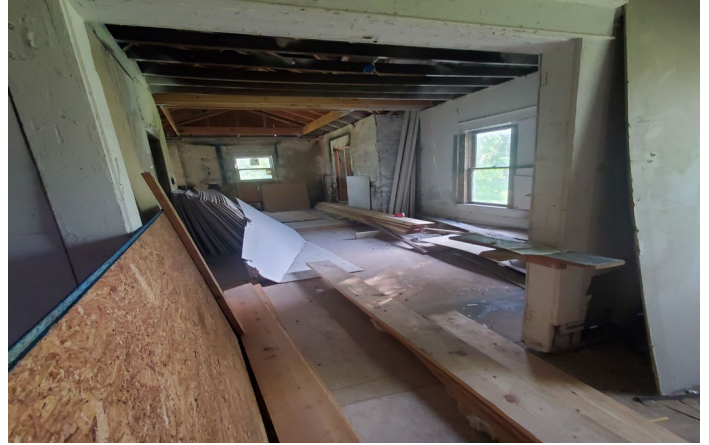
Photo 8 – Stacks of unfinished drywall located sporadically throughout.
