## **Asbestos & Lead Based Paint Assessment**

City of Spartanburg 342 Allen Street Spartanburg, South Carolina 29301

Project Number: 0124-01

January 31, 2024

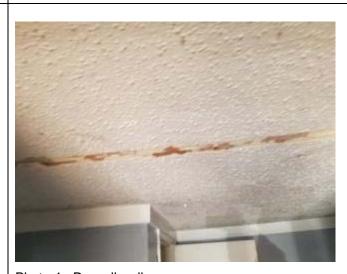
Photo 4 - Drywall walls.
