May 15, 2019

Mr. Adam Dutter, Bond Project Manager  
**Ojai Unified School District**  
414 East Ojai Avenue  
Ojai, CA 93023

**Subject: Exterior Painting Project – Asbestos & Lead Survey**  
Meiners Oaks Elementary School  
400 South Lomita Avenue  
Ojai, CA 93023  
*FCG Project Code: Ojai USD-49*

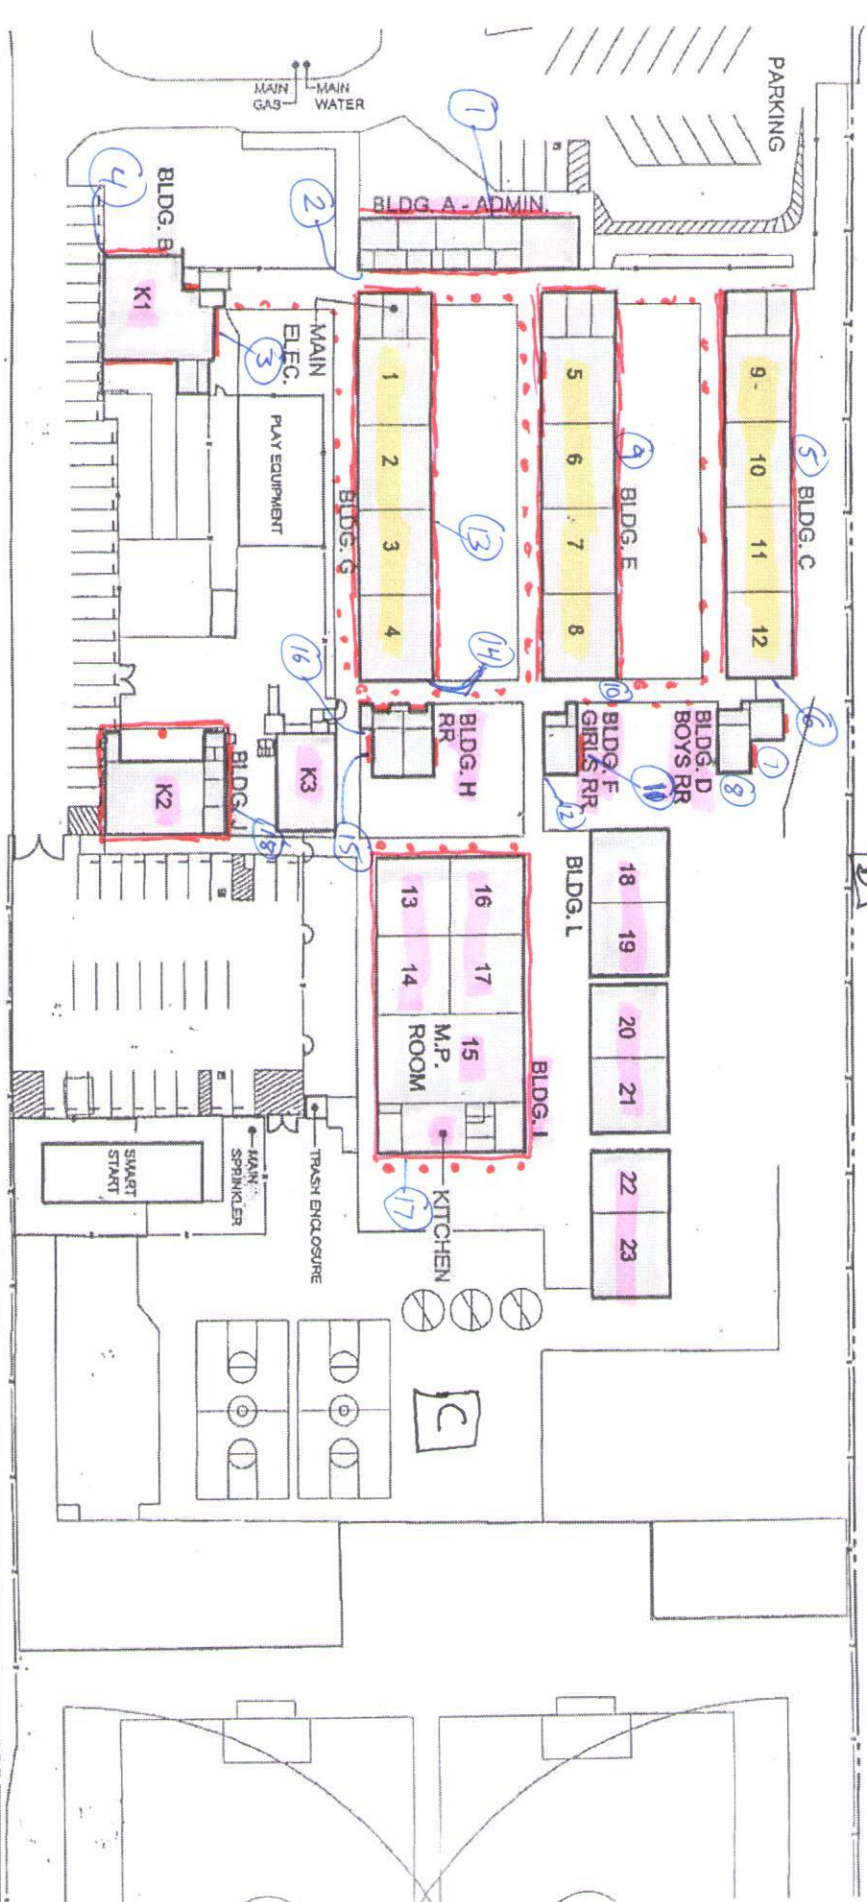
Site Plan with Sample Locations & LBP Noted

Bldg. F/Girls RR - Same as Bldg. D/Boys RR

\* Bldg. I  
 - White wood rafter Beams A + C sides  
 - Green Metal posts A + C sides  
 - White wood eaves All sides  
 - Green Wood Fascia All sides

- Bldg L Portables  
 - Bldg J-K3 Portable  
 \* NO LRP  
 \* NO window Putty  
 \* NO Plaster, etc.
