Node Inspection - 8/9/2023 - 1828

Date 8/9/2023	Time 12:03	Manhole Number 1828	Access Type Manhole	City Georgetown	Street Front Street and
Surveyed By Matthew Headrick	Certificate Number U-0419-07030528	PO Number	Work Order	Pre-Cleaning No Pre-Cleaning	Sheet Number

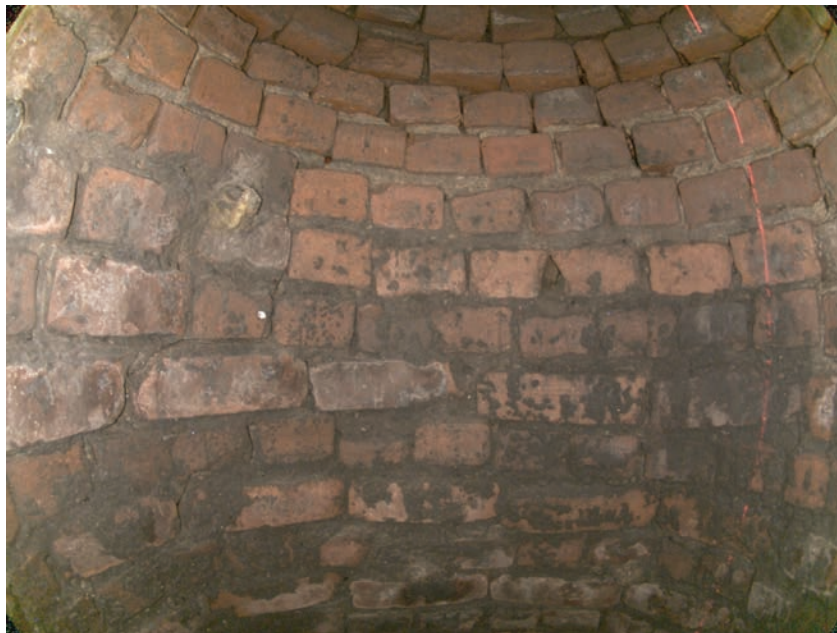
Nr.	Distance	MACP Code	Observation	Remark				
1	3.0'	MML	Missing Mortar Large from 12 o'clock to 12 o'clock	Fully exposed bricks with gaps				
2	6.6'	MML	Missing Mortar Large from 12 o'clock to 12 o'clock	Fully exposed bricks with gaps				
QSR	QMR	QOR	SPR	MPR	OPR	SPRI	MPRI	OPRI
4332	3114	4333	21.0	7.0	28.0	2.6	1.4	2.2

1828b_5154b3dc-7153-4625-bad4-be8d5b792f69_af14e9ce-43e7-4d78-b89c-bf5f5b97d8ee_P11.jpg,
, 3.02
Missing Mortar Large from 12 o'clock to 12 o'clock

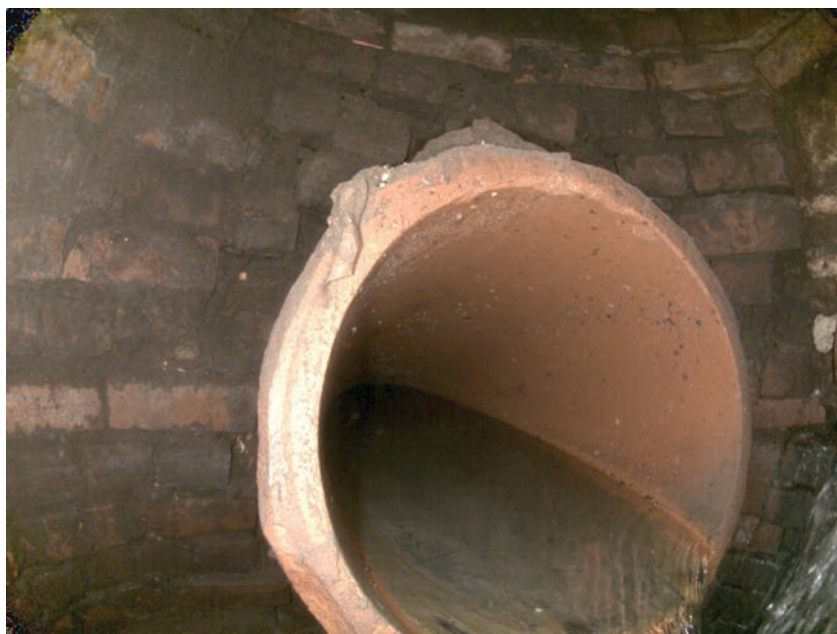
1828b_5154b3dc-7153-4625-bad4-be8d5b792f69_edb4c192-5e6a-4281-8e16-ea99f963de5c_P11.jpg,
00:00:32, 6.58
Missing Mortar Large from 12 o'clock to 12 o'clock

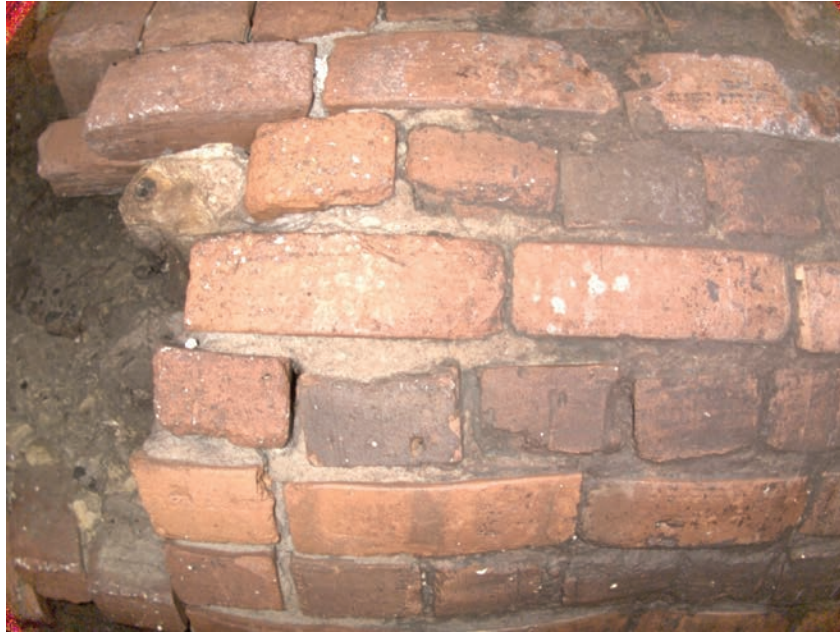
Nr.	Distance	MACP Code	Observation	Remark
3	6.9'	BSV	Broken Soil Visible, 18inch defective, 18inch intrusion at 1 o'clock, within 8 inch, Start	soil visible
4	8.2'	DB	Displaced Brick from 8 o'clock to 11 o'clock	displaced bricks
5	9.5'	MML	Missing Mortar Large from 12 o'clock to 12 o'clock	Fully exposed bricks with gaps

1828b_5154b3dc-7153-4625-bad4-be8d5b792f69_3173cf7b-f6db-4944-a0d7-c17632622fc9_P11.jpg,
00:00:33, 6.91
Broken Soil Visible, 18inch defective, 18inch intrusion at 1 o'clock, within 8 inch, Start

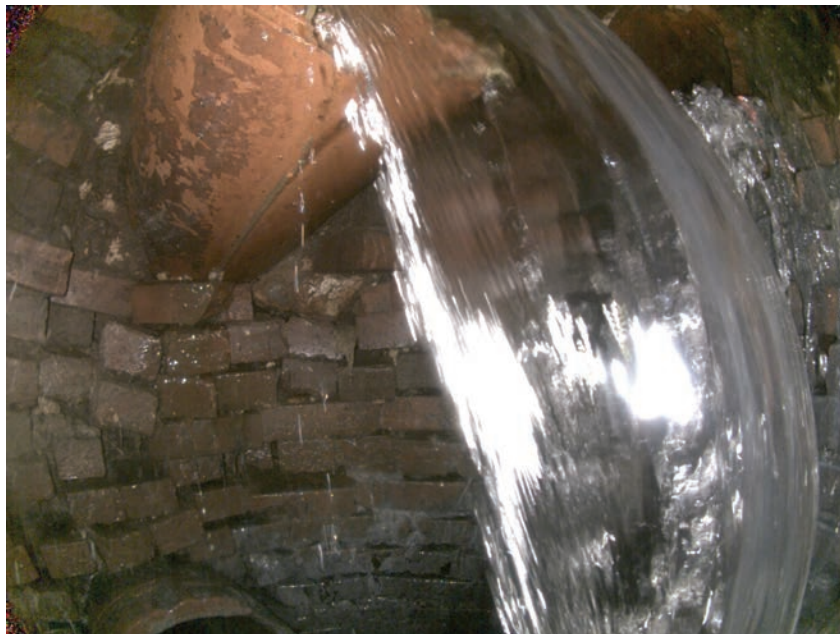
1828b_5154b3dc-7153-4625-bad4-be8d5b792f69_a9eef5b8-2357-475d-a879-3b8cd9676573_P11.jpg,
00:00:39, 8.18
Displaced Brick from 8 o'clock to 11 o'clock

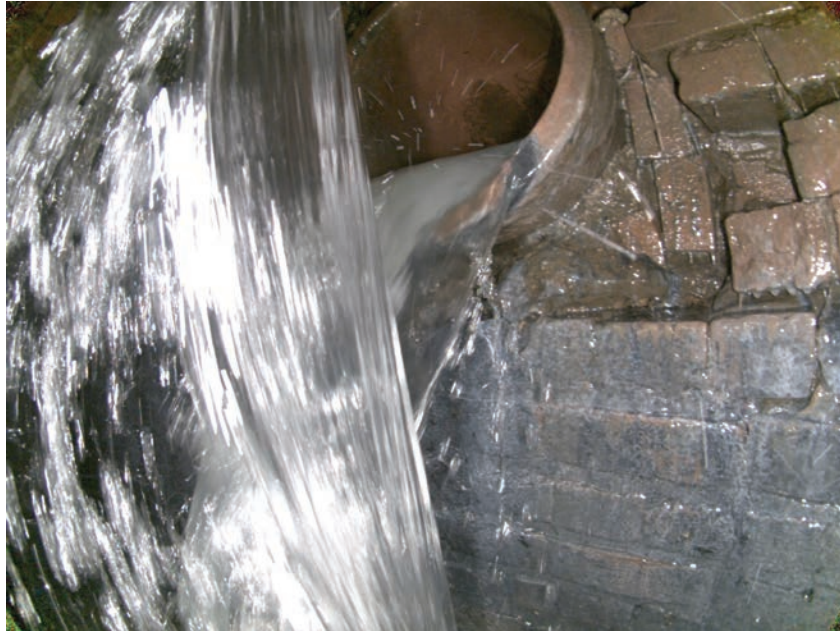
1828b_5154b3dc-7153-4625-bad4-be8d5b792f69_bcfea9bc-7934-4eb7-bd36-91ffe877c936_P11.jpg,
00:00:44, 9.50
Missing Mortar Large from 12 o'clock to 12 o'clock
