FIELD REPORT

FIELD NOTES

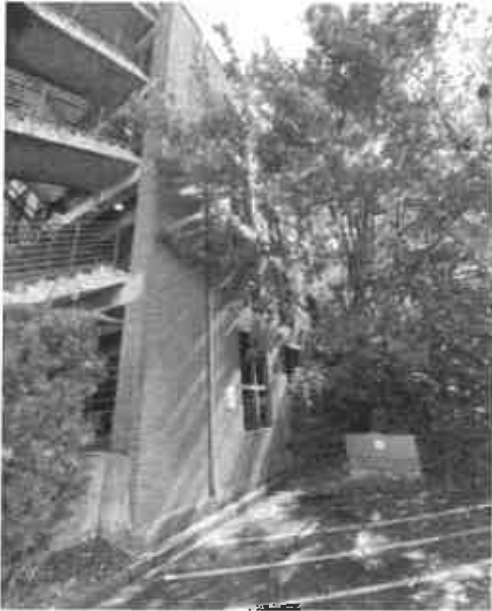
PHOTO 1: VEGETATION AGAINST THE SOUTH EXTERIOR WALL

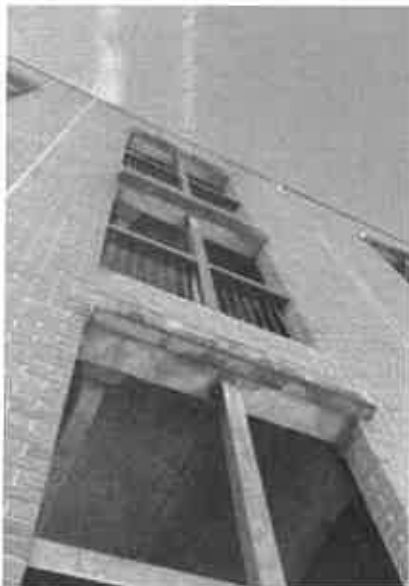
PHOTO 3: MOISTURE AND ORGANIC GROWTH ON CAST STONE PIECES

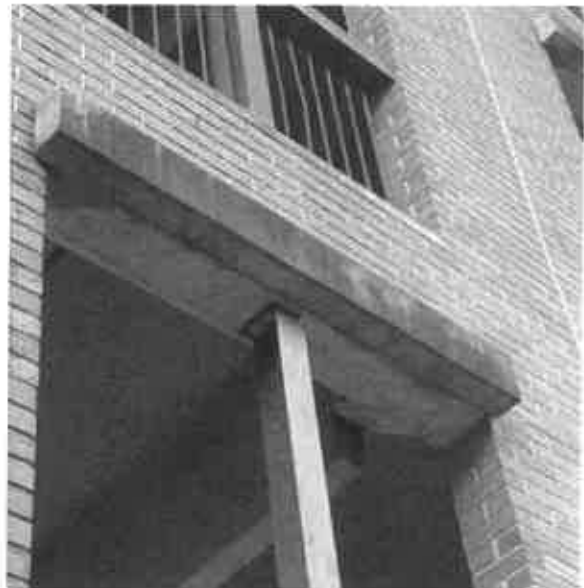
PHOTO 4: MOISTURE AND ORGANIC GROWTH ON CAST STONE PIECES

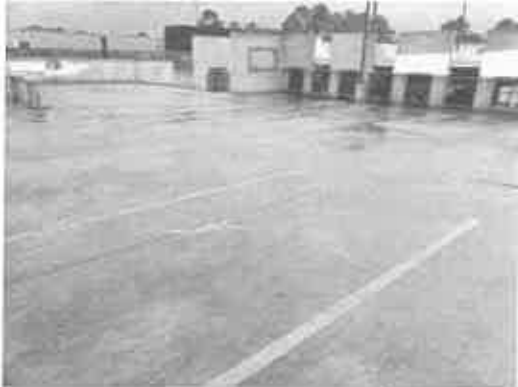
PHOTO 5: OVERVIEW OF UPPER LEVEL DECK

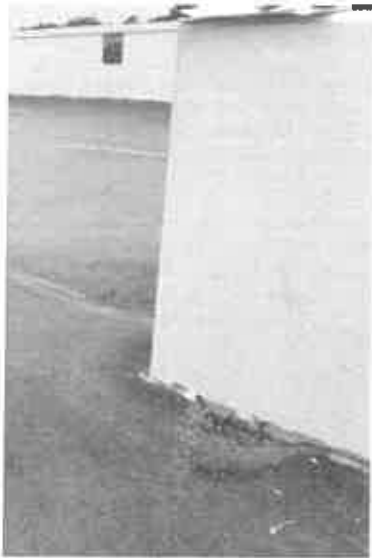
PHOTO 9: CONCRETE TOPPING DAMAGE AT UPPER LEVEL

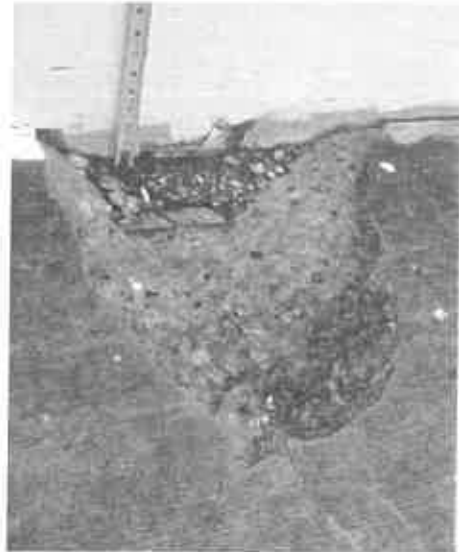
PHOTO 10: CLOSE UP OF CONCRETE TOPPING DAMAGE AT UPPER LEVEL

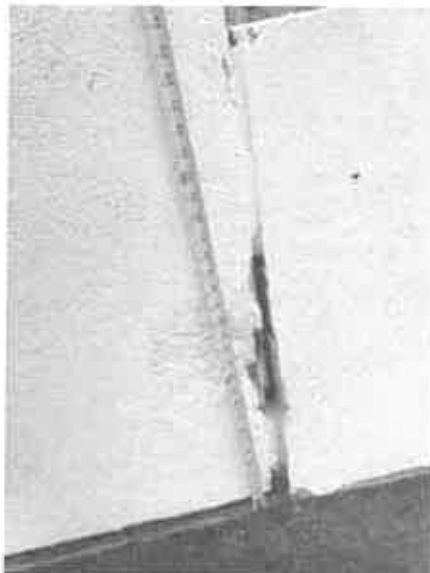
PHOTO 11: SPALLED UPPER LEVEL PANEL CONNECTION

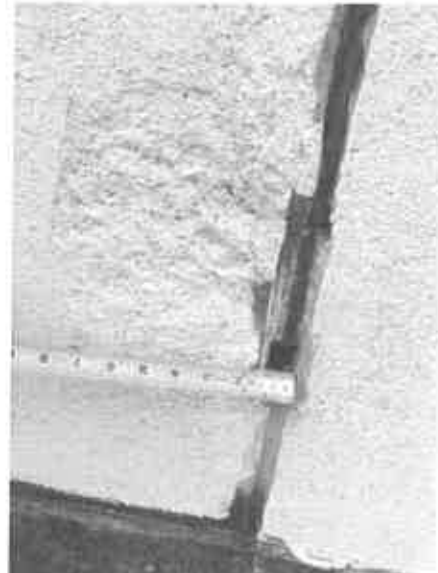
PHOTO 12: SPALLED UPPER LEVEL PANEL CONNECTION

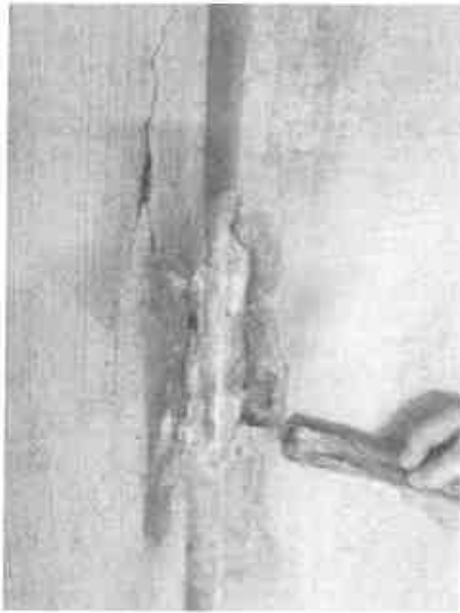
PHOTO 13: SPALLED INTERMEDIATE LEVEL PANEL CONNECTION

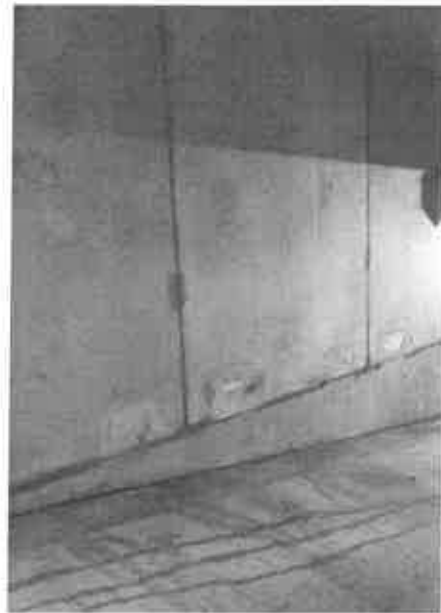
PHOTO 14: LOWER LEVEL PANEL CONNECTIONS (NOTE DARKER GROUT)

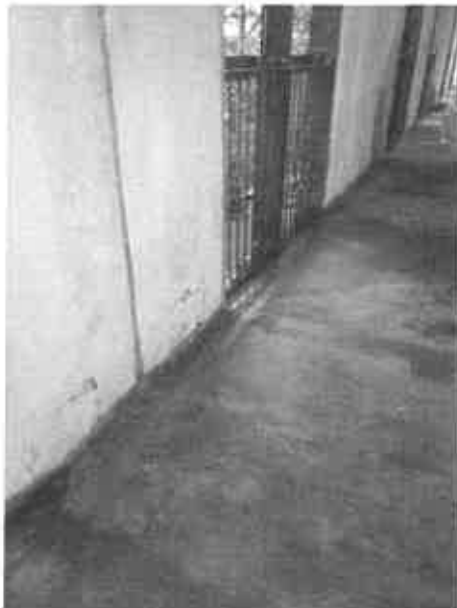
PHOTO 15: EXPANSIVE SPALLING GROUT AT WALL PANEL BASE CONNECTION

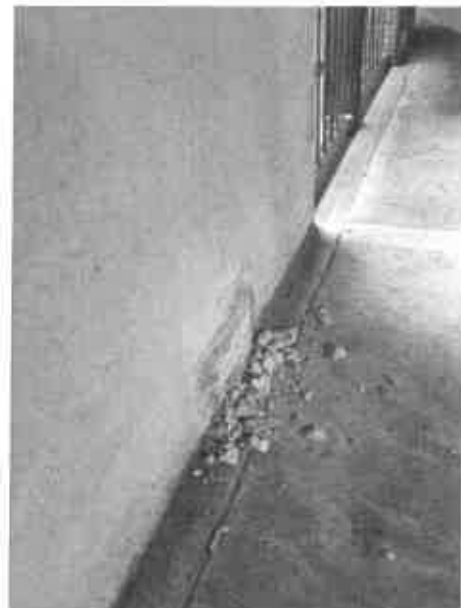
PHOTO 16: DISLODGED GROUT AT WALL PANEL BASE CONNECTION

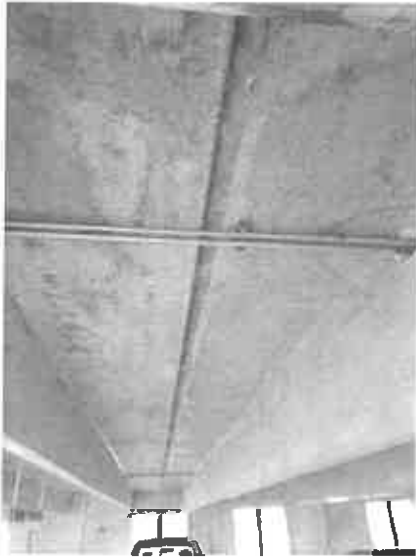
PHOTO 17: TAPERED JOINT BETWEEN PRECAST DOUBLE-TEE MEMBERS

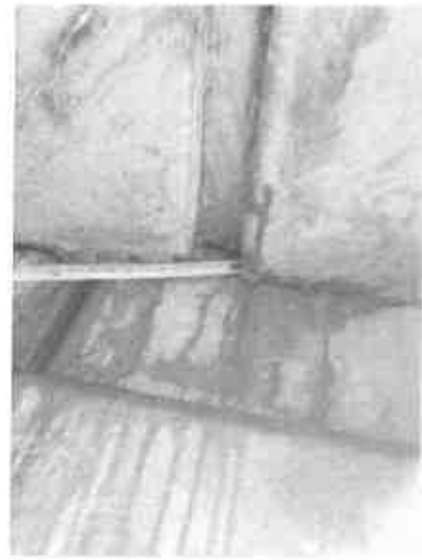
PHOTO 18: NORTH END OF TAPERED JOINT BETWEEN PRECAST DOUBLE-TEE MEMBERS

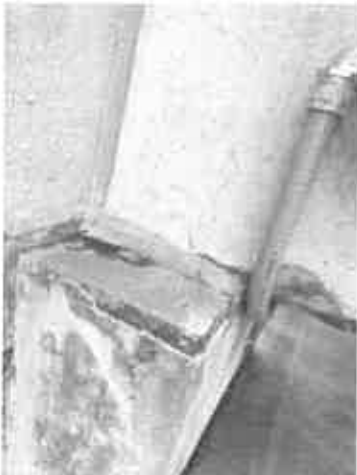
PHOTO 19: CORRODED BEAM BEARING PLATE

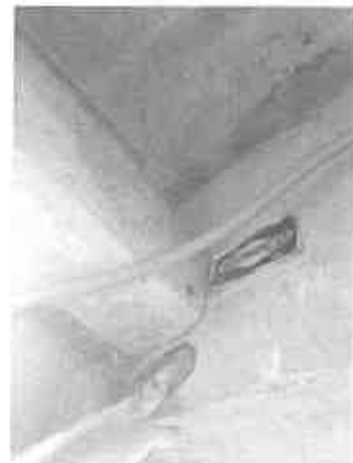
PHOTO 20: LOOSE PIECE FROM CORRODED BEAM BEARING PLATE

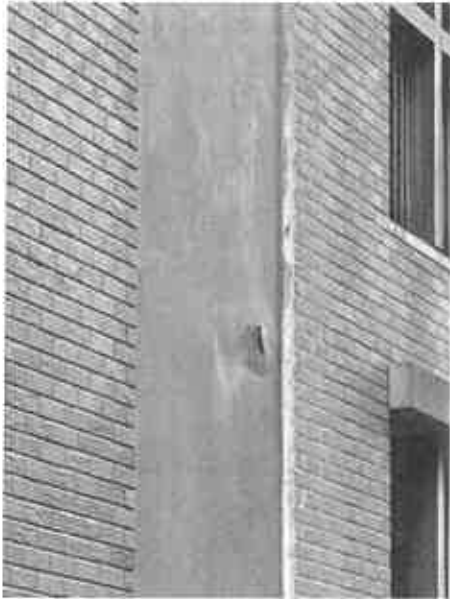
PHOTO 20: ISOLATED SPALLING ON EAST WALL

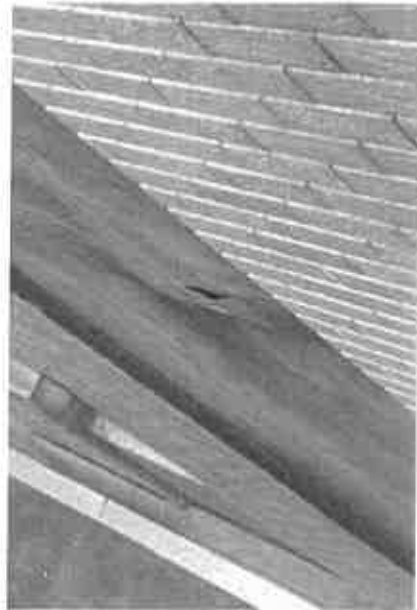
PHOTO 21: ISOLATED SPALLING ON EAST WALL (FROM ABOVE)

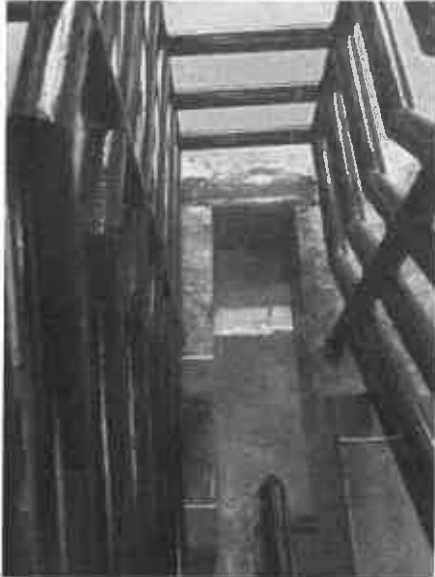
PHOTO 22: RAINWATER RUNOFF BETWEEN STAIR FLIGHTS

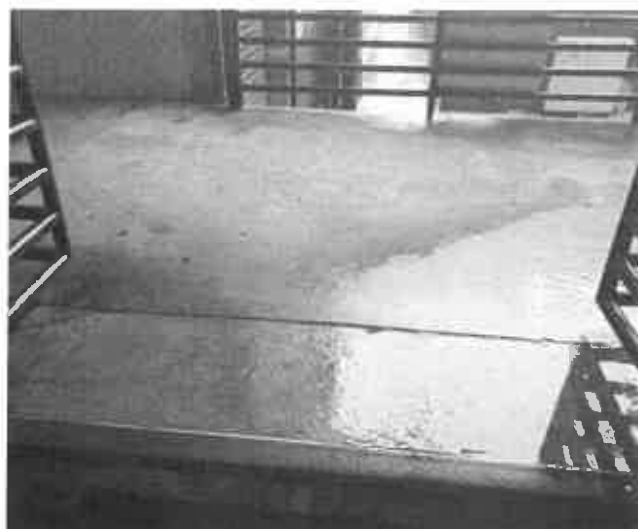
PHOTO 25: RAINWATER PONDING ON STAIR LANDING

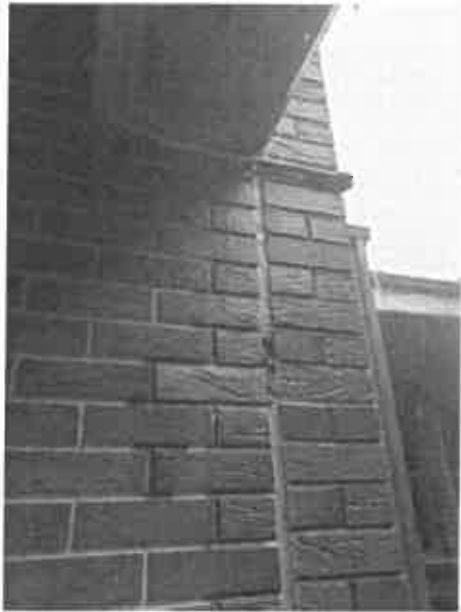
PHOTO 26: DETERIORATED CAULK IN WALL PANEL JOINTS

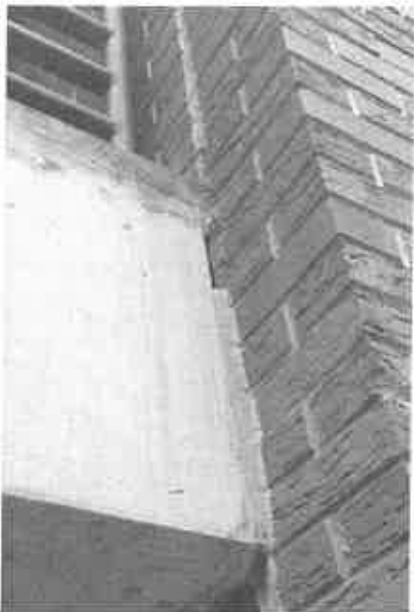
PHOTO 27: MISSING CAULK AT THE WALL PANEL AND BEAM JOINT

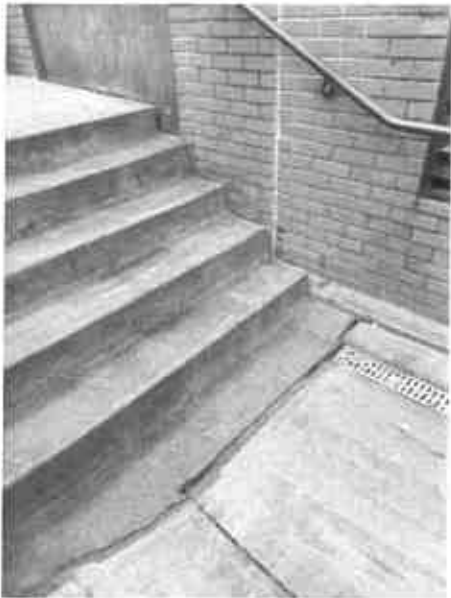
PHOTO 28: DAMAGED BRICK VENEER

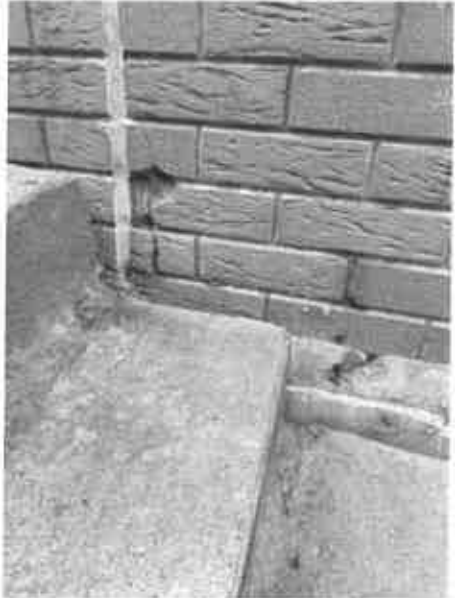
PHOTO 29: CLOSEUP OF DAMAGED BRICK VENEER

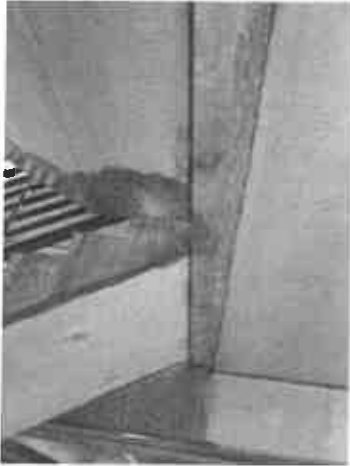
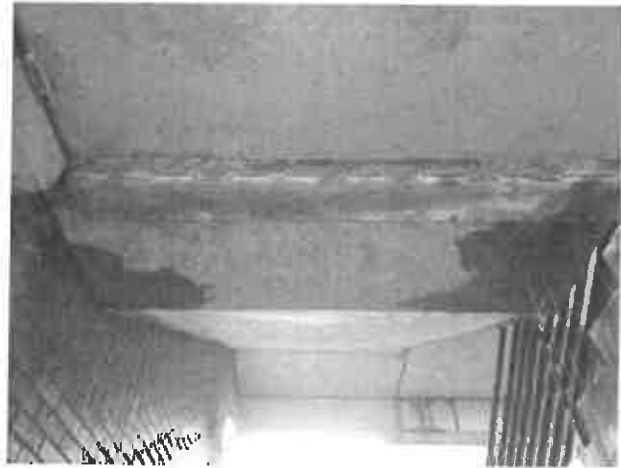
PHOTO 30: CORROSION AT STAIR FLIGHT CONNECTIONS TO LANDING BEAM
PHOTO 31: CORROSION AT STAIR FLIGHT CONNECTIONS TO LANDING BEAM

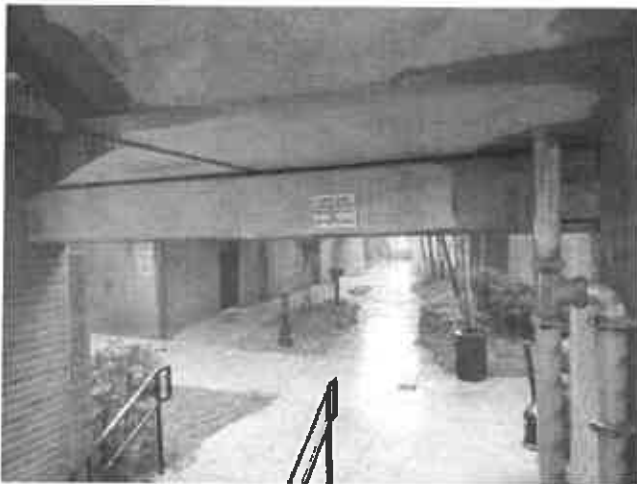
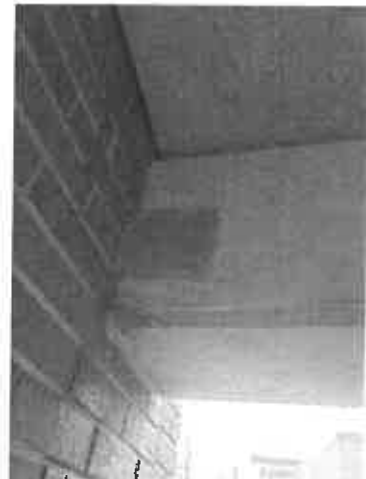
PHOTO 32: STAIR LANDING BEAM ABOVE ENTRANCE AT EAST END OF STAIRS
PHOTO 33: MINOR CRACKING AT NORTH END CONNECTION OF LANDING BEAM

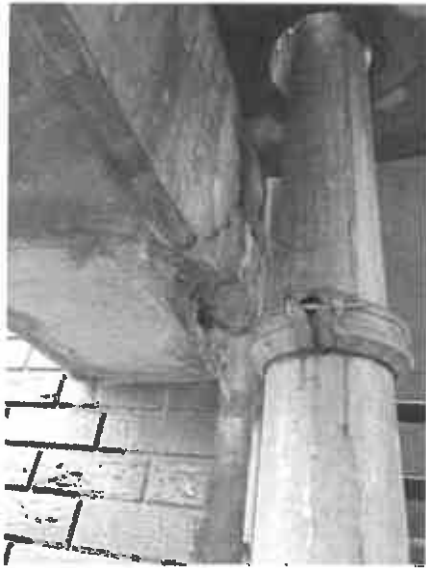
PHOTO 34: CRACKING AND SPALLING AT SOUTH END OF LANDING BEAM

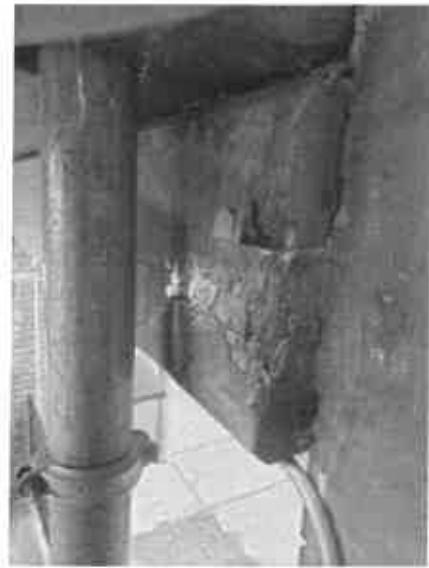
PHOTO 35: CRACKING AND SPALLING AT SOUTH END OF LANDING BEAM

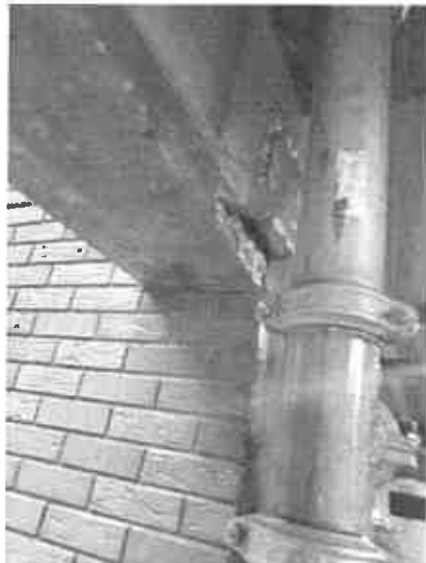
PHOTO 36: CRACKING AND SPALLING AT SOUTH END OF LANDING BEAM

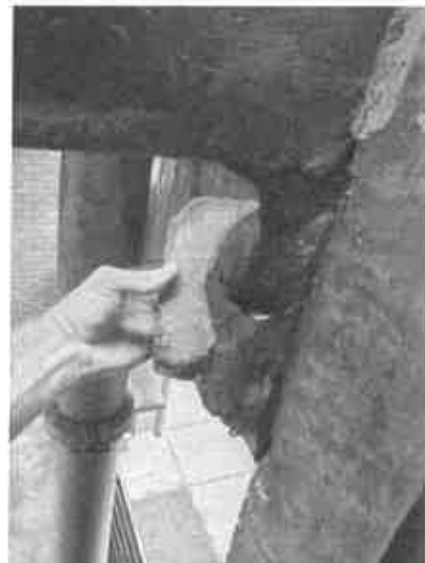
PHOTO 37: LOOSE PIECE OF CONCRETE AT SOUTH END OF LANDING BEAM

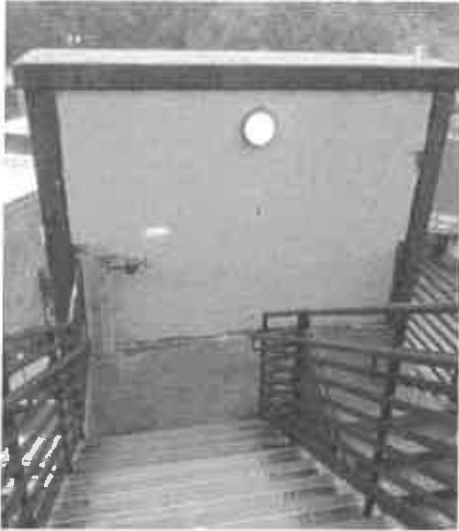
PHOTO 38: SPALLED CONCRETE COVER OVER PANEL JOINT

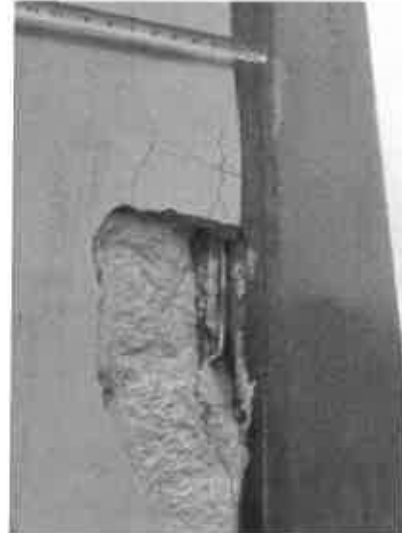
PHOTO 39: CLOSE UP OF SPALLED CONCRETE AND CORRODED REINFORCING

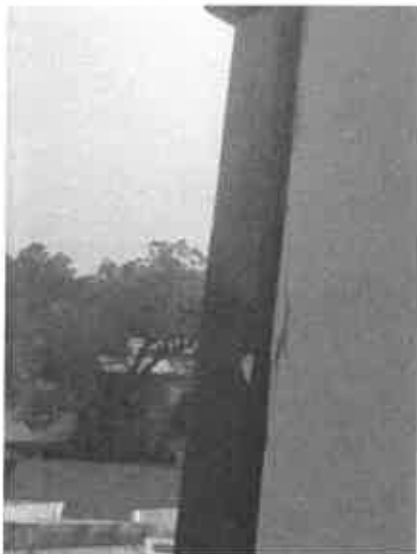
PHOTO 40: SPALLED CONCRETE COVER OVER PANEL JOINT

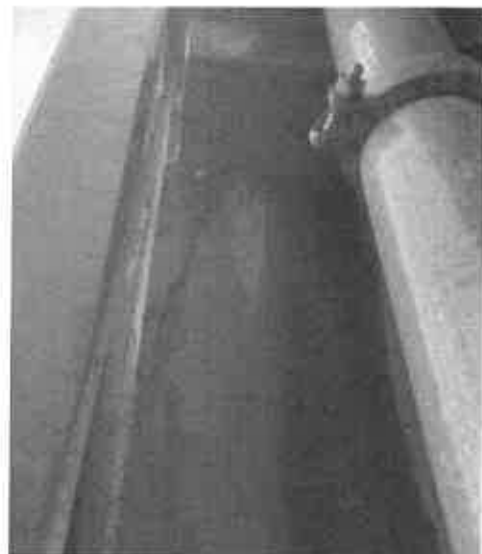
PHOTO 41: SPALLED CONCRETE COVER OVER PANEL JOINT BELOW UPPER LANDING

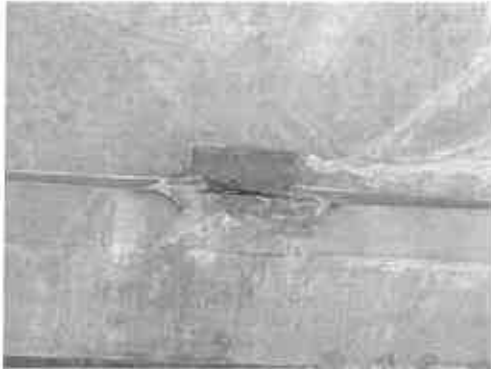
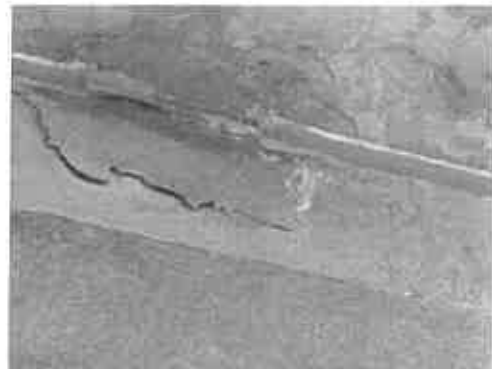
PHOTO 42: SPALLED AND CORRODED LANDING SLAB CONNECTION TO CORBEL

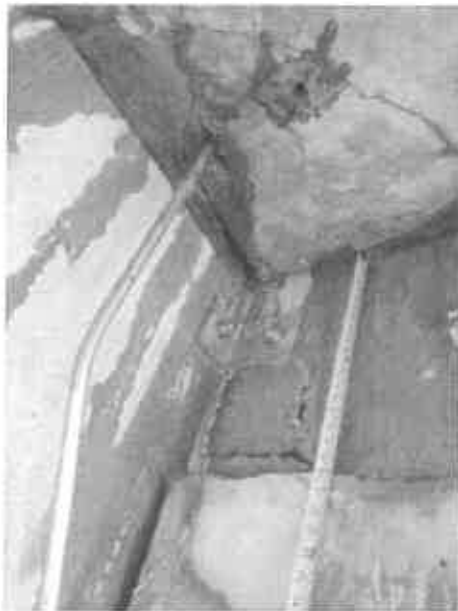
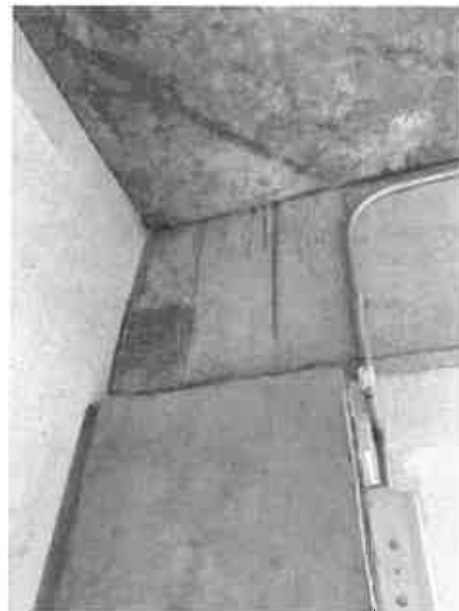
PHOTO 44: CRACKED AND SPALLED CONNECTION AT SOUTH END OF LANDING BEAM

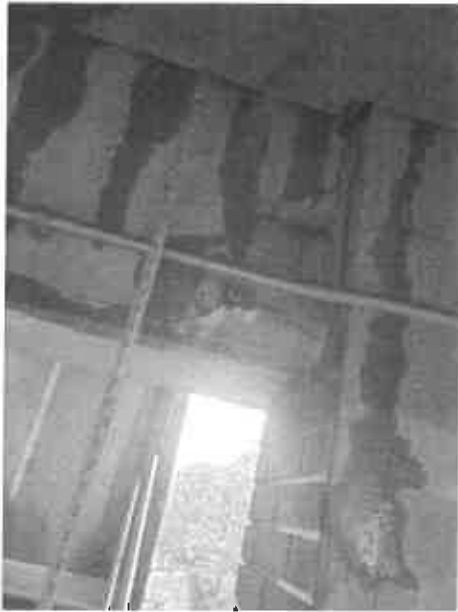
PHOTO 46: CRACKED AND SPALLED CONNECTION AT NORTH END OF LANDING BEAM

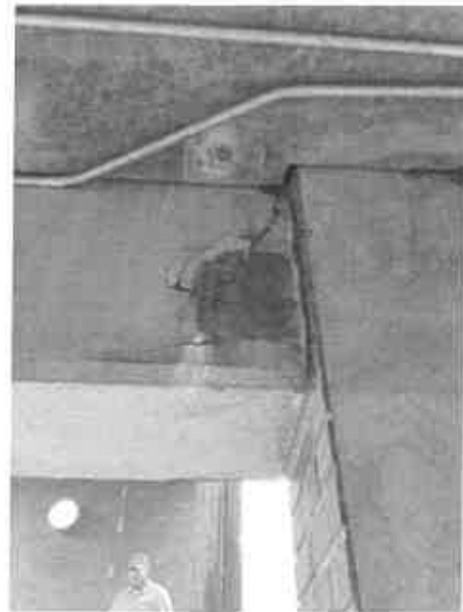
PHOTO 47: CRACKED AND SPALLED CONNECTION AT NORTH END OF LANDING BEAM

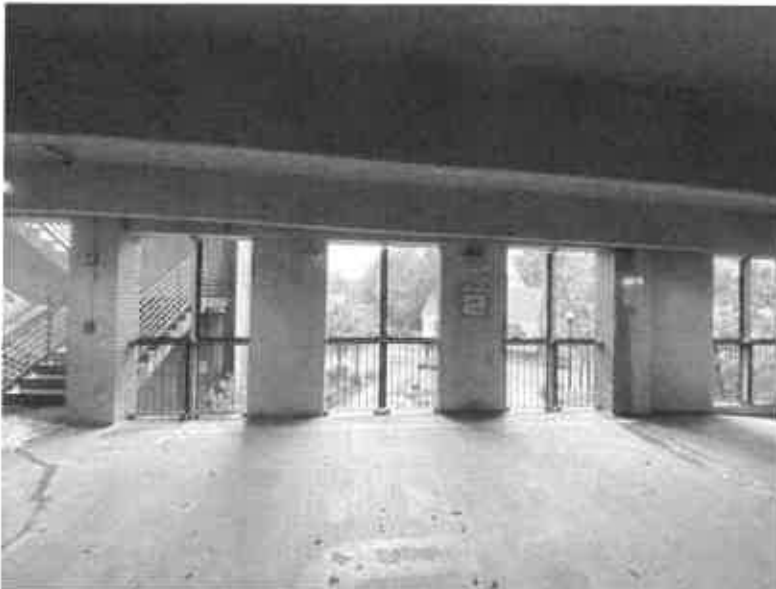
PHOTO 48: BEAM LINE ADJACENT TO STAIRS

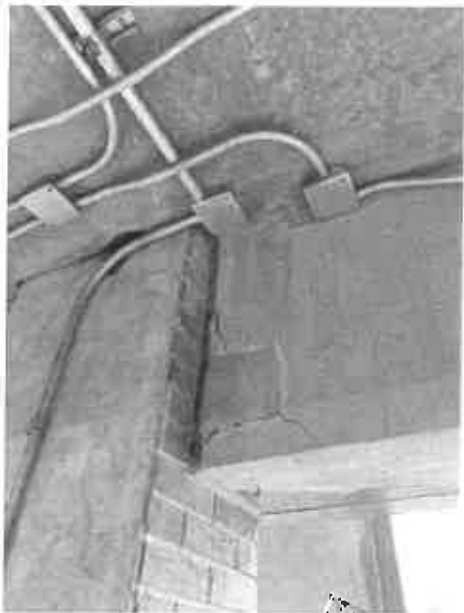
PHOTO 49: CRACKING AT SOUTH END OF BEAM ADJACENT TO STAIRS

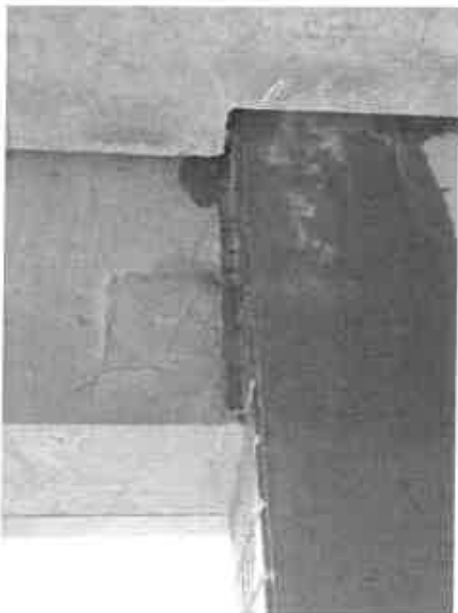
PHOTO 50: CRACKING AT NORTH END OF BEAM ADJACENT TO STAIRS

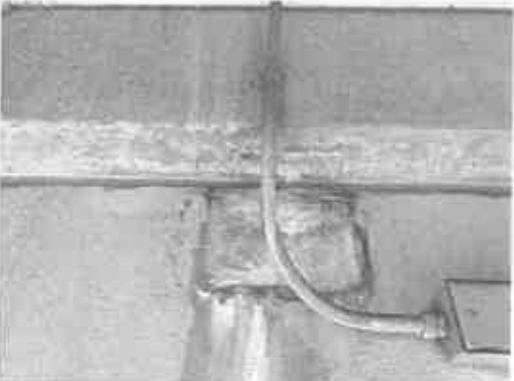
PHOTO 51: SPALLED CONNECTION AT INT. SUPPORT OF BEAM ADJACENT TO STAIRS

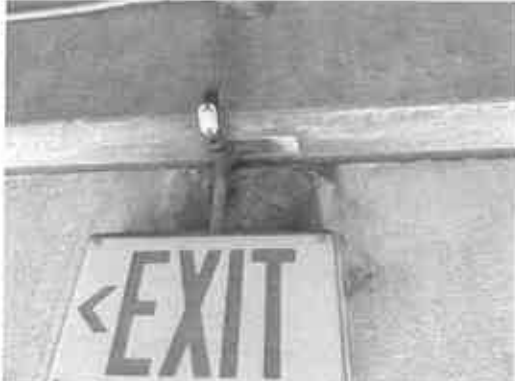
PHOTO 52: SPALLED CONNECTION AT INT. SUPPORT OF BEAM ADJACENT TO STAIRS

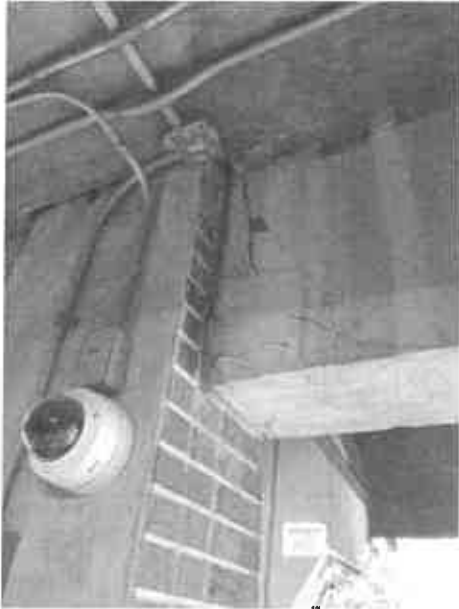
PHOTO 53: CRACKING AT SOUTH END OF BEAM OVER MAIN GARAGE ENTRANCE

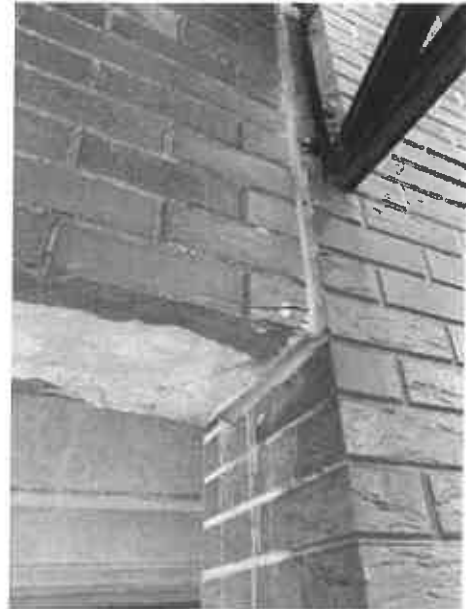
PHOTO 54: CRACK THROUGH EXTERIOR BRICK VENEER

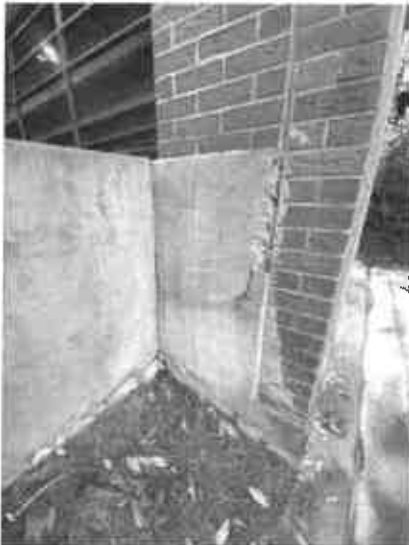
PHOTO 55: CRACK THROUGH EXTERIOR BRICK VENEER
