MEMORANDUM

SUBJECT: City of Aztec Reservoir No. 1 Rehabilitation Project

I. Part I: Project Overview

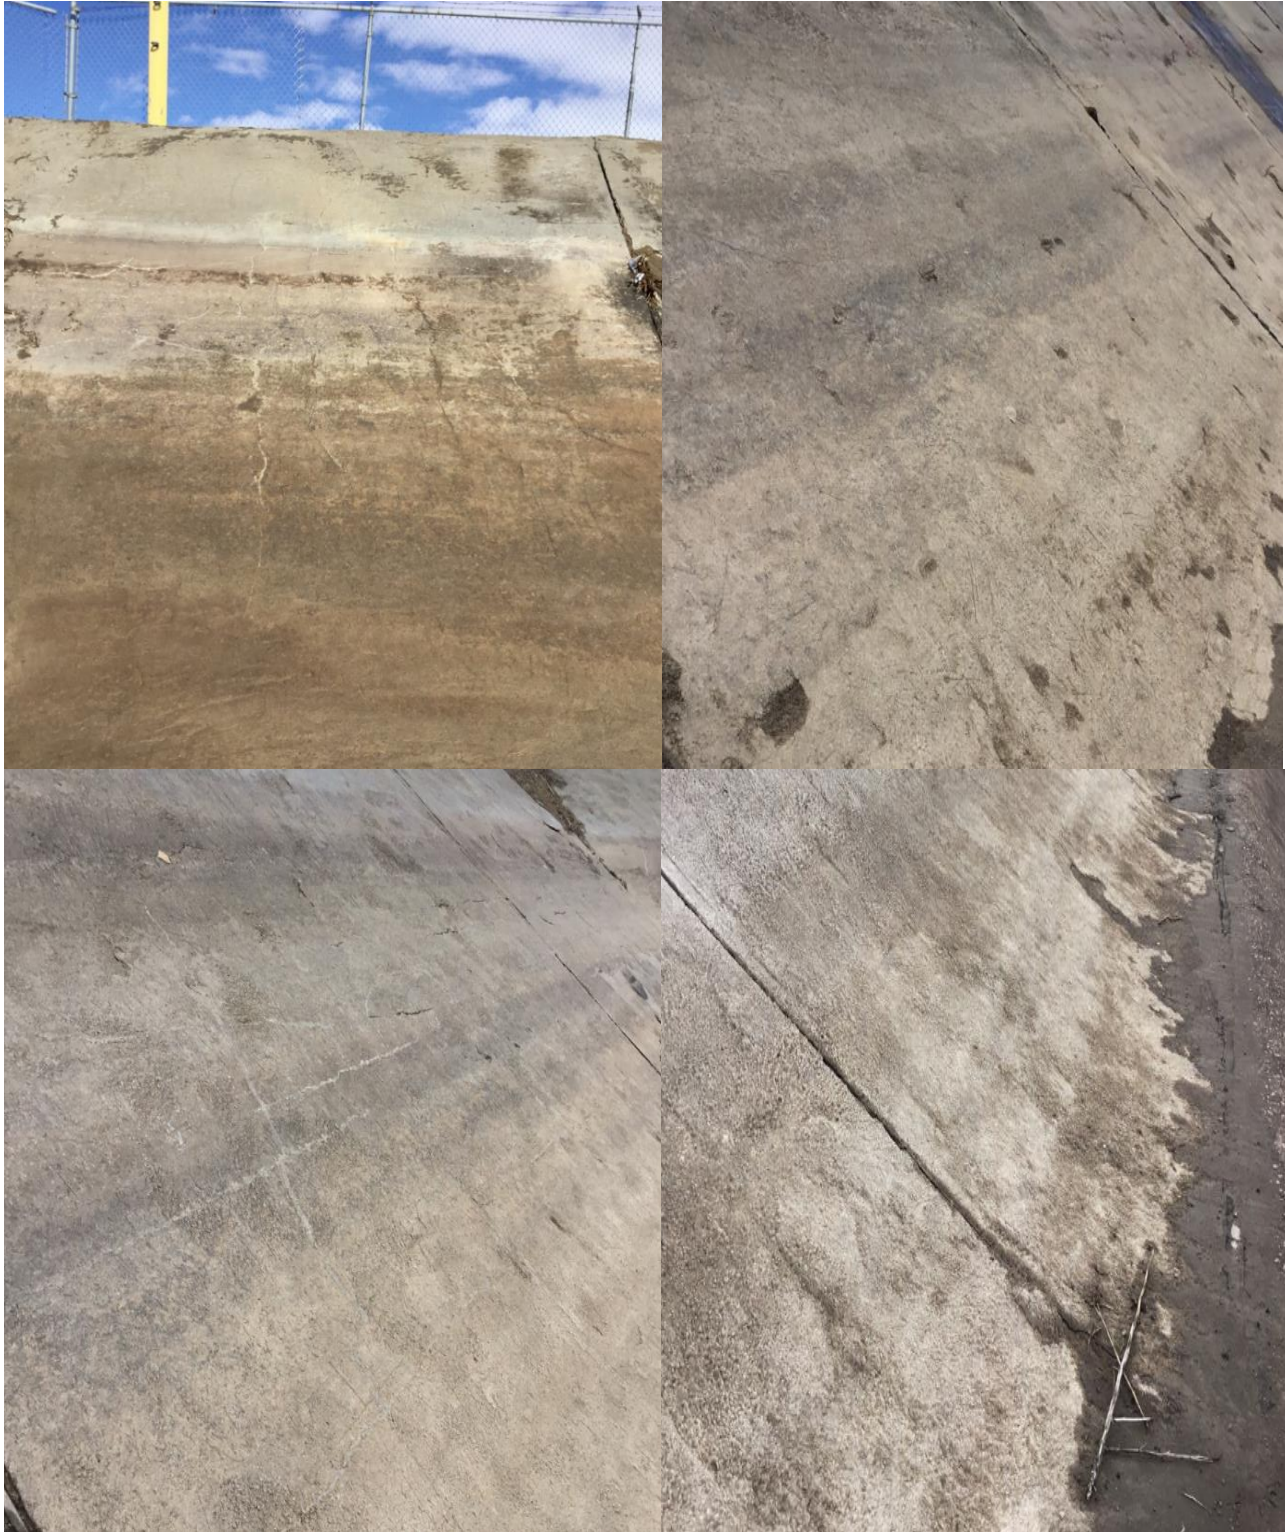
Figure 1 – Rating 5 Example

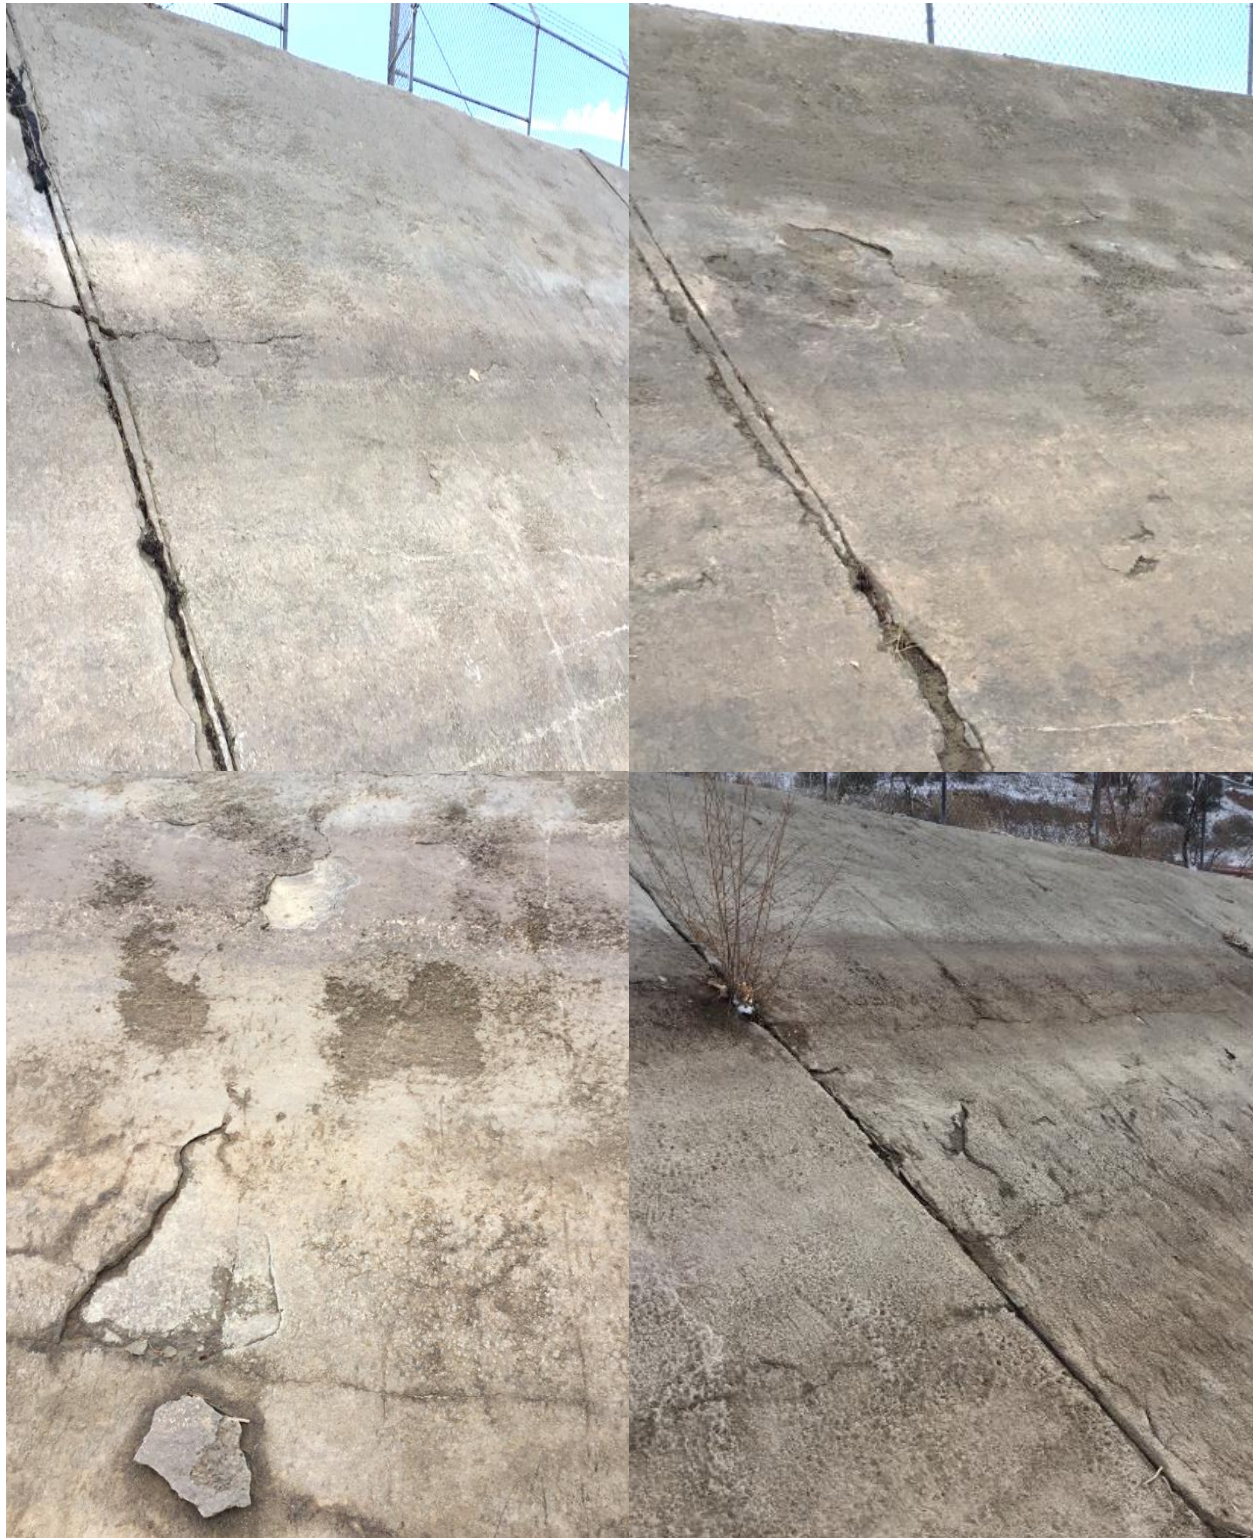
Figure 2 – Rating 4 Example

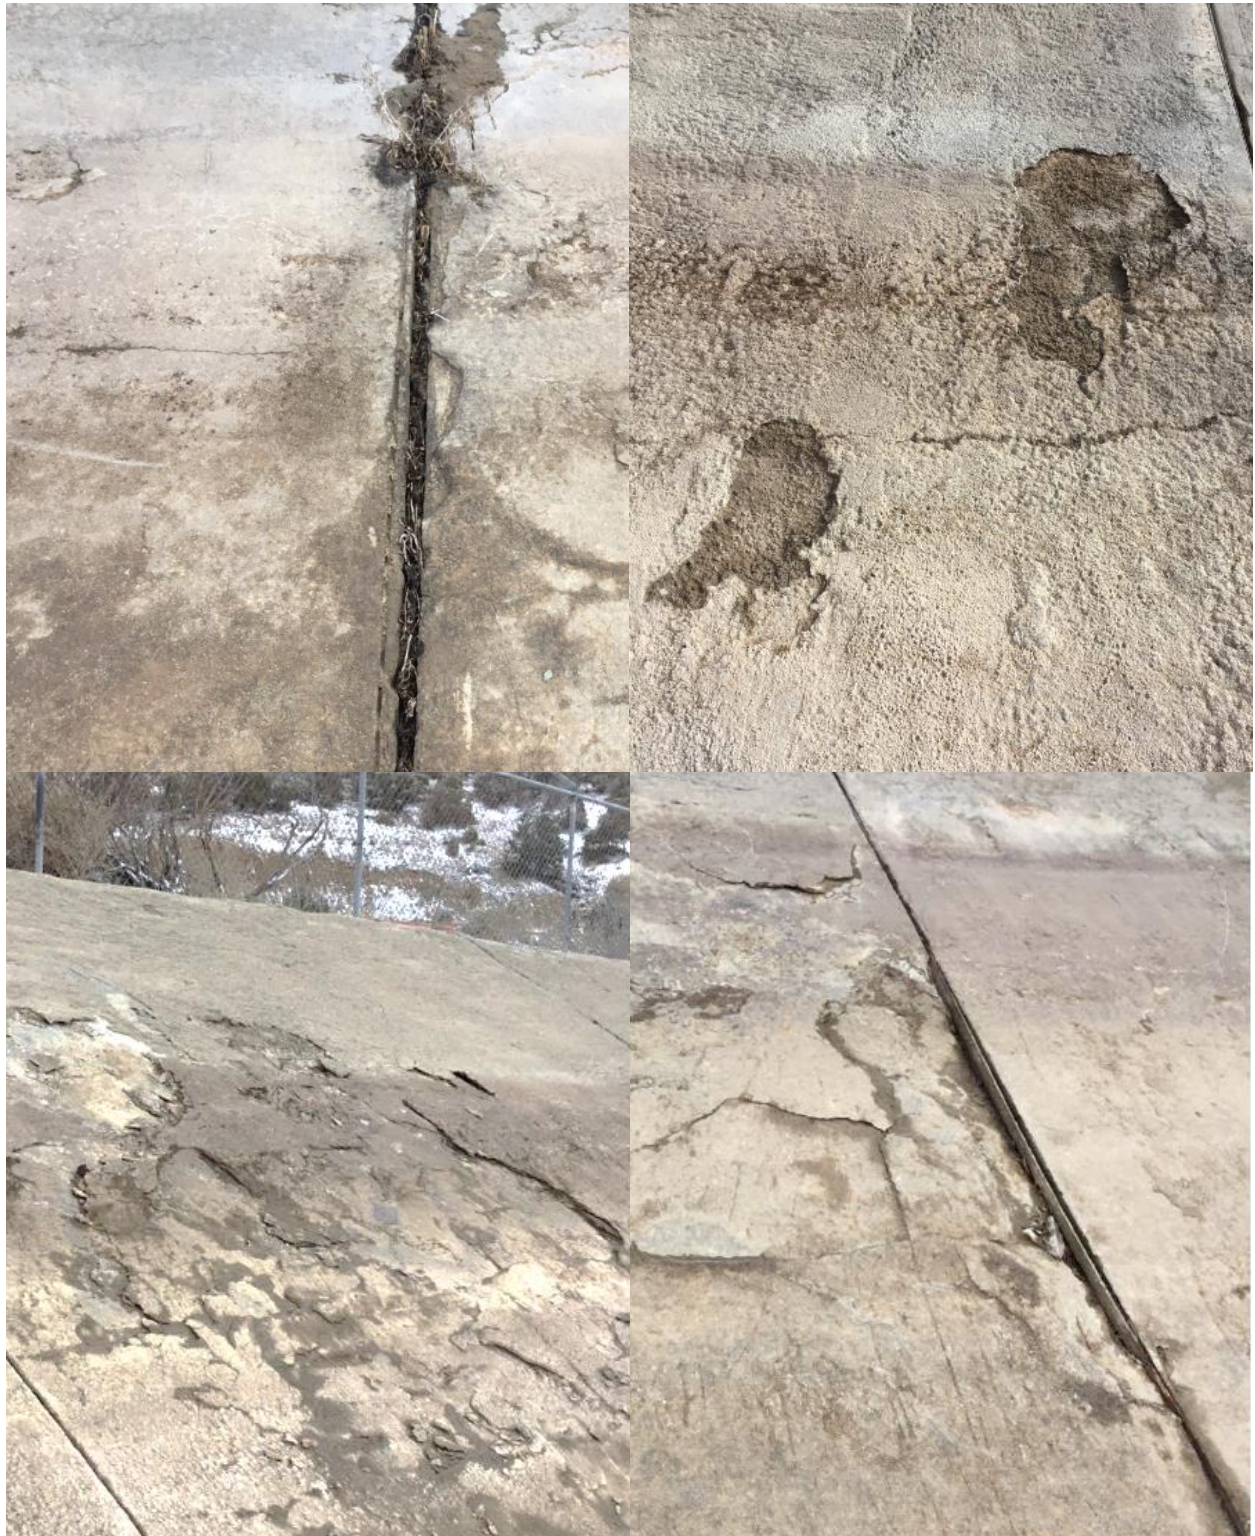
Figure 3 – Rating 3 Example

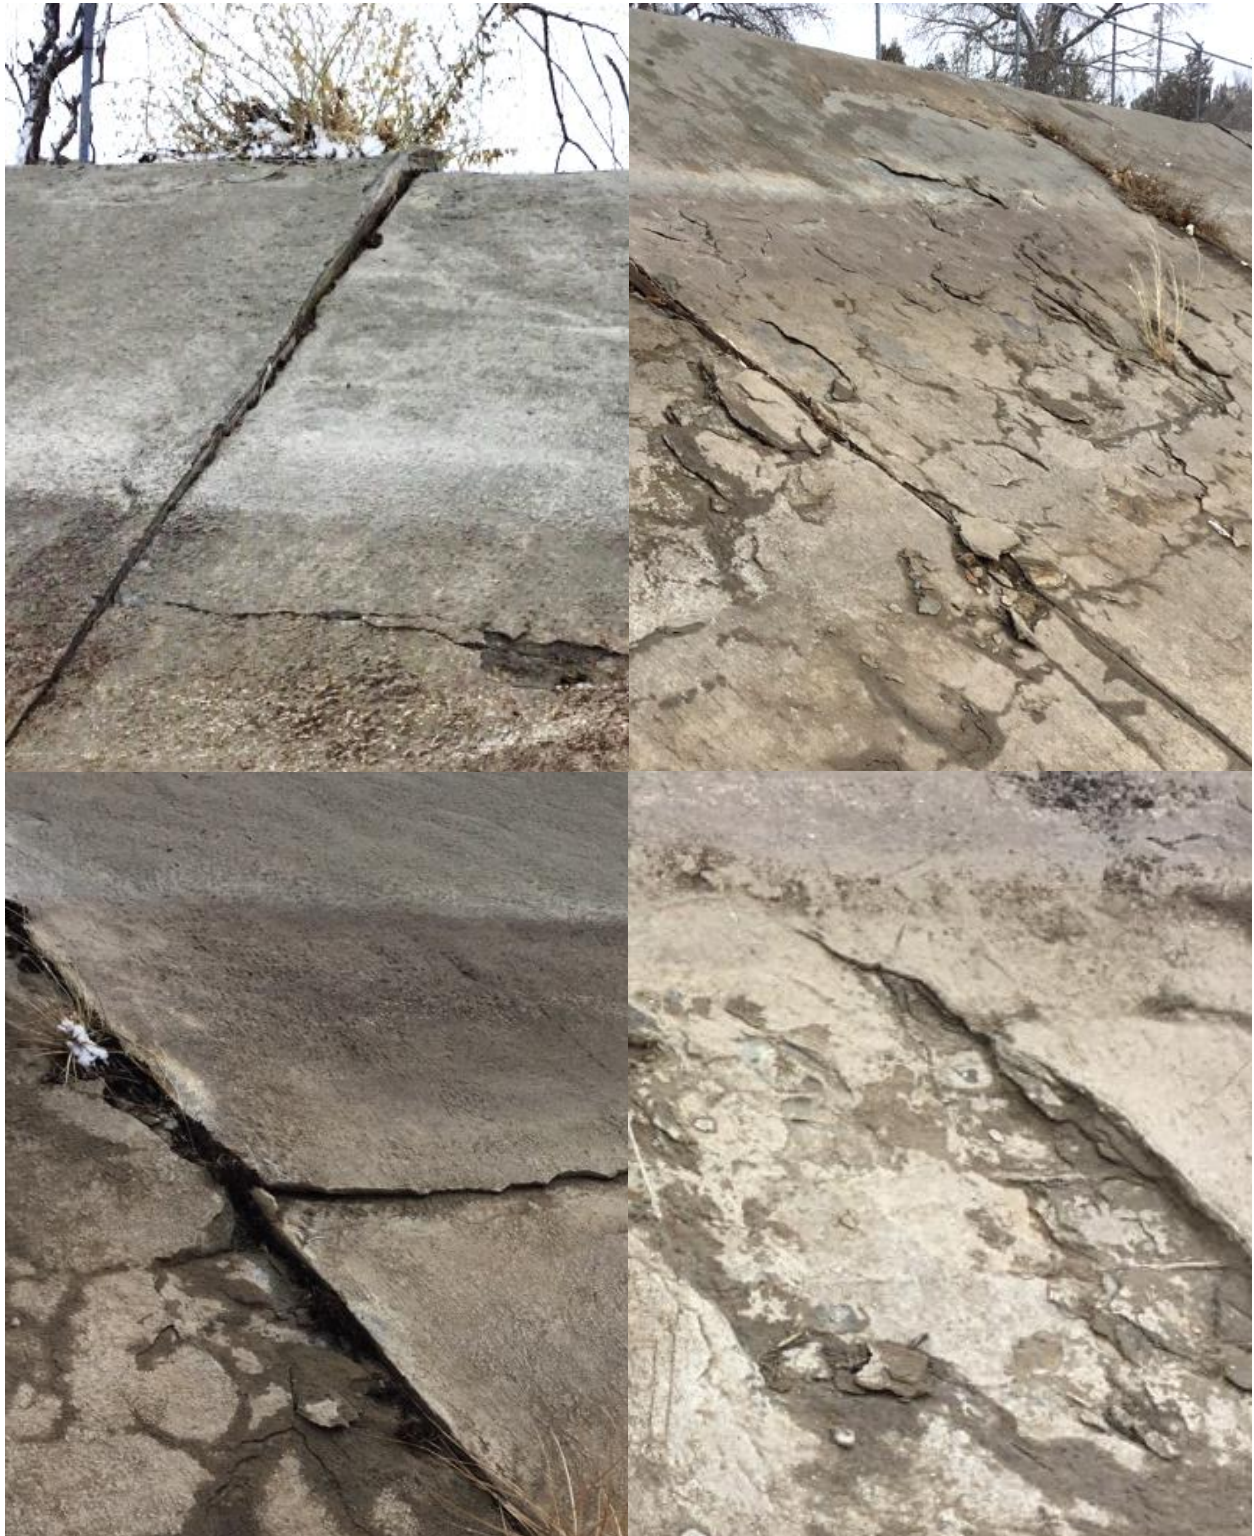
Figure 4 – Rating 2 Example

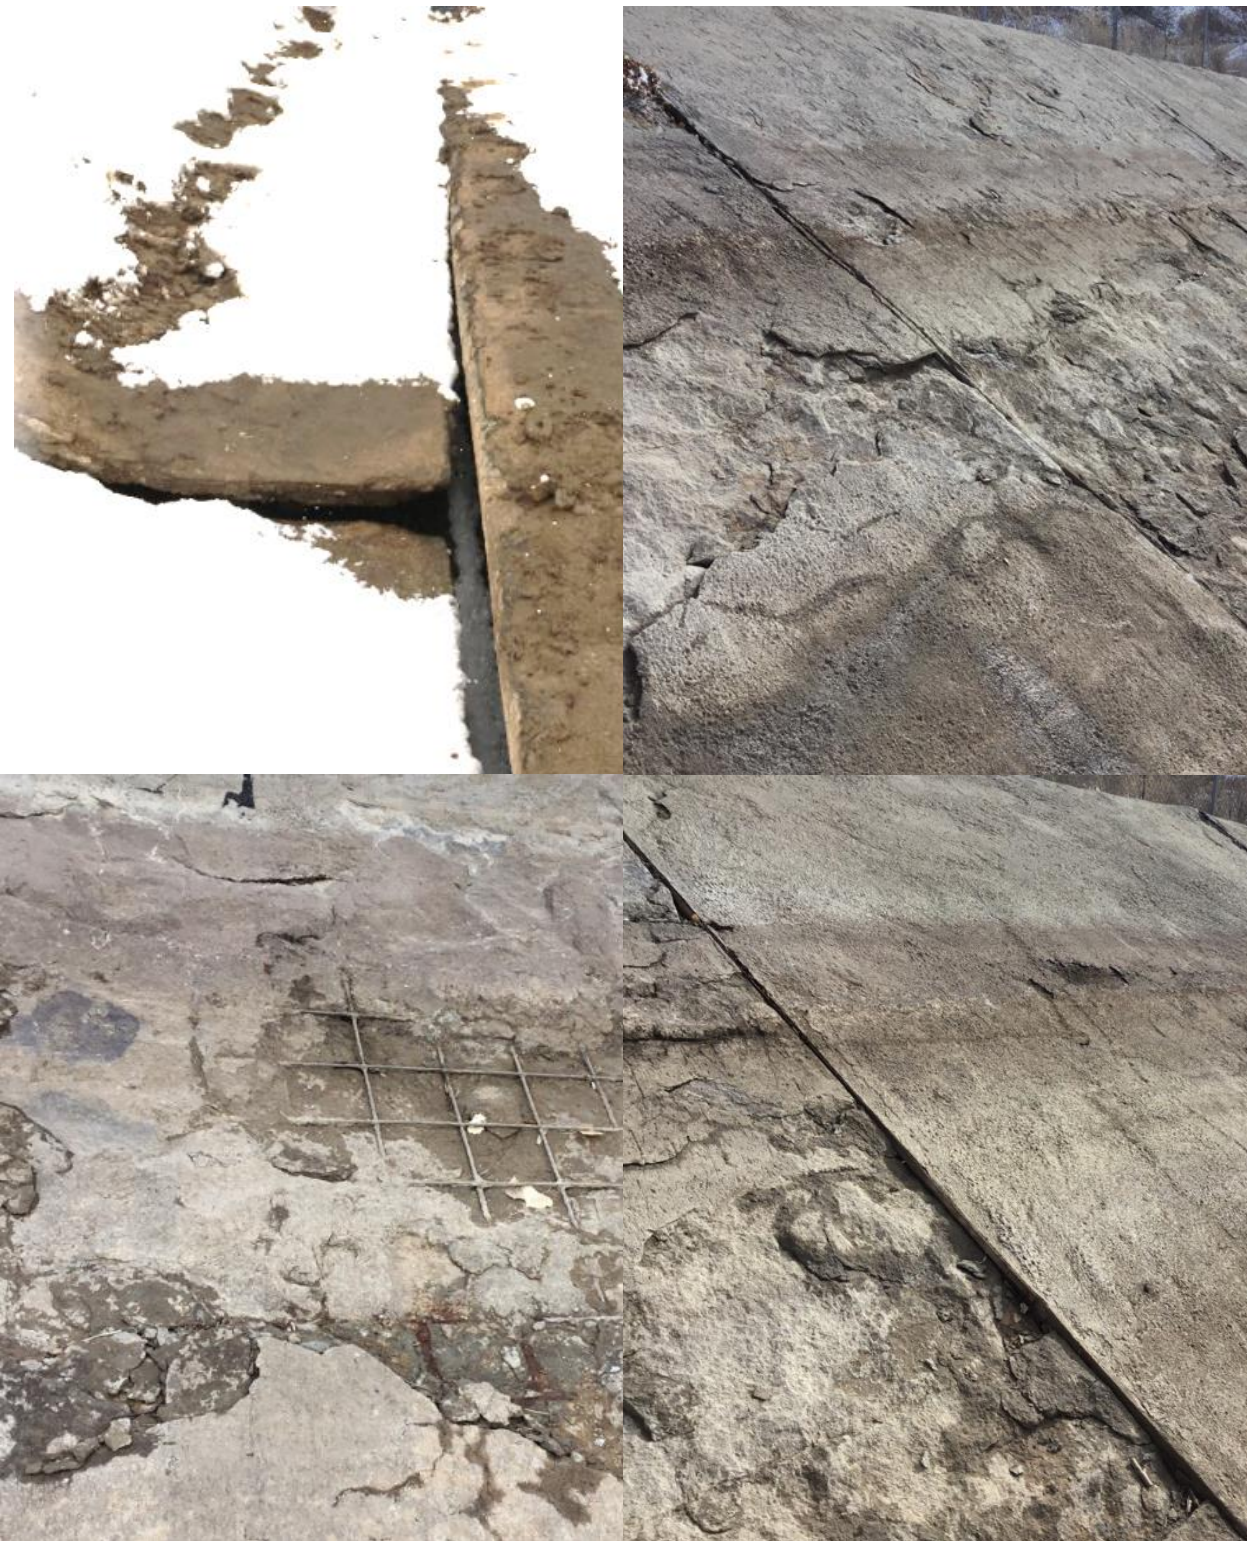
Figure 5 – Rating 1 Example

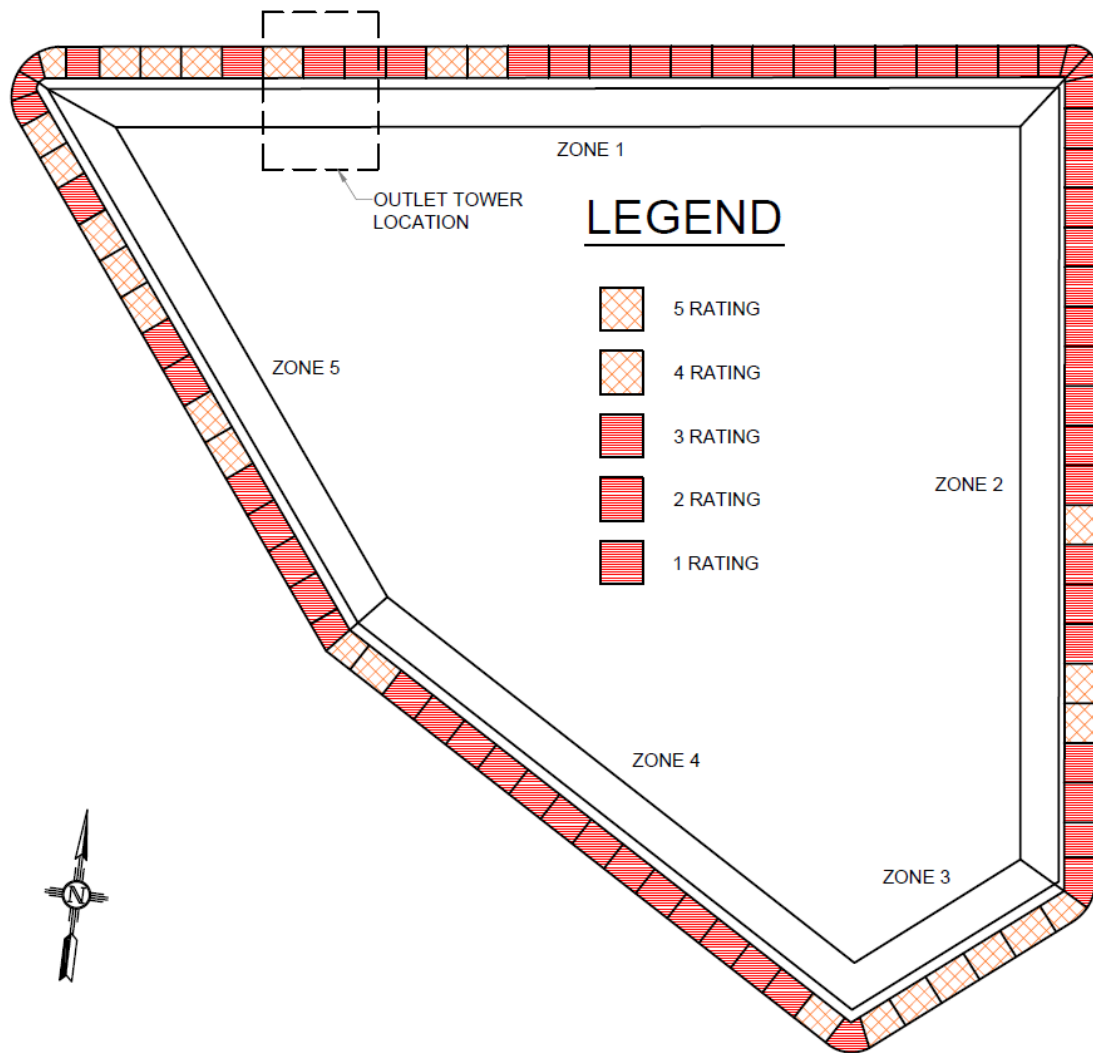
Figure 6 – Top 3” Gunite concrete lining (1981)

In general, panels receiving a rating of 3 or lower (shown in red in Figure 6) are considered to be in poor to bad condition. Chain drag test results on panels receiving a rating of 4 or 5 (see orange hatch in Figure 6) in the visual inspection showed signs of delamination but are considered to be in fair condition.

Based on the field evaluation of the existing conditions of Reservoir 1, 71 percent of the upper 3-inch Gunit concrete lining (built in 1981) and 20 percent of the lower 3-inch concrete lining (built in 1954) is currently in poor to bad condition. This is due to joint failure, settlement, longitudinal cracking, delamination, and spalling conditions making Reservoir 1 not optimal for water storage. It is also necessary to understand where the current leakage is originating, the magnitude of water intrusion from Reservoir 2, and how settlement is affecting the embankment on Zone 4 to prevent future failure at this location.

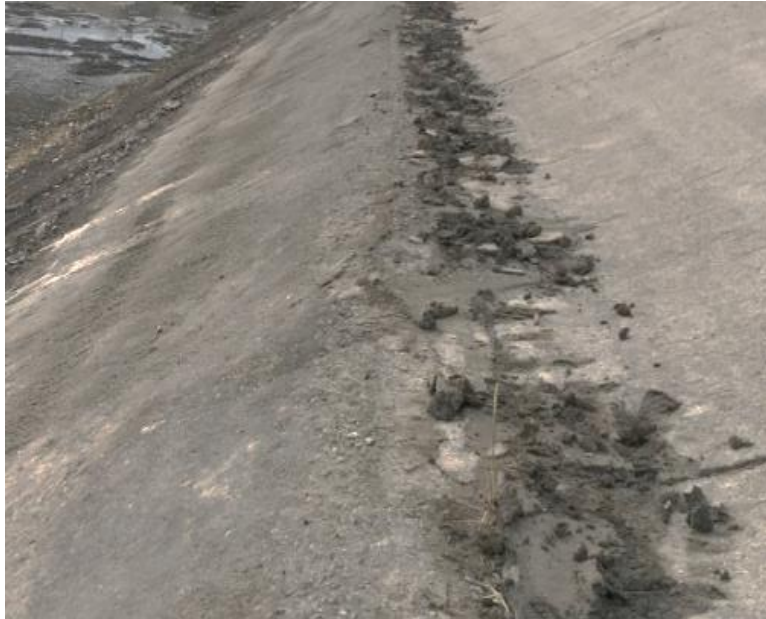
Figure 7 – Signs of Spalling

In general, Zone 1 presented signs of spalling covering approximately 4 ft below the horizontal ledge (See Figure 7). Zone 2 presented longitudinal cracks of 1/8 inch up to 1/4 inch (see Figure 8 and Figure 9) and had significant signs of delamination and spalling (see Figure 10 and Figure 11).

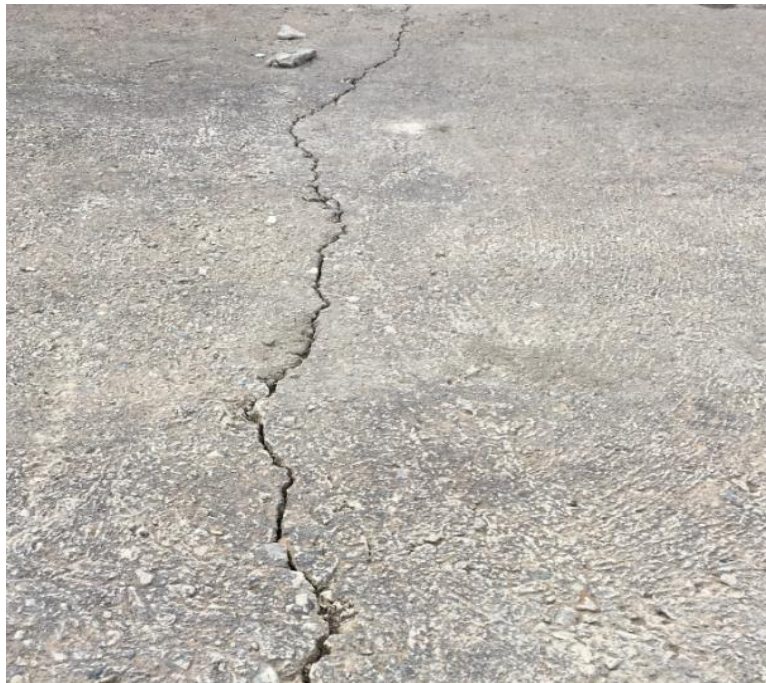
Figure 8 – Longitudinal Crack

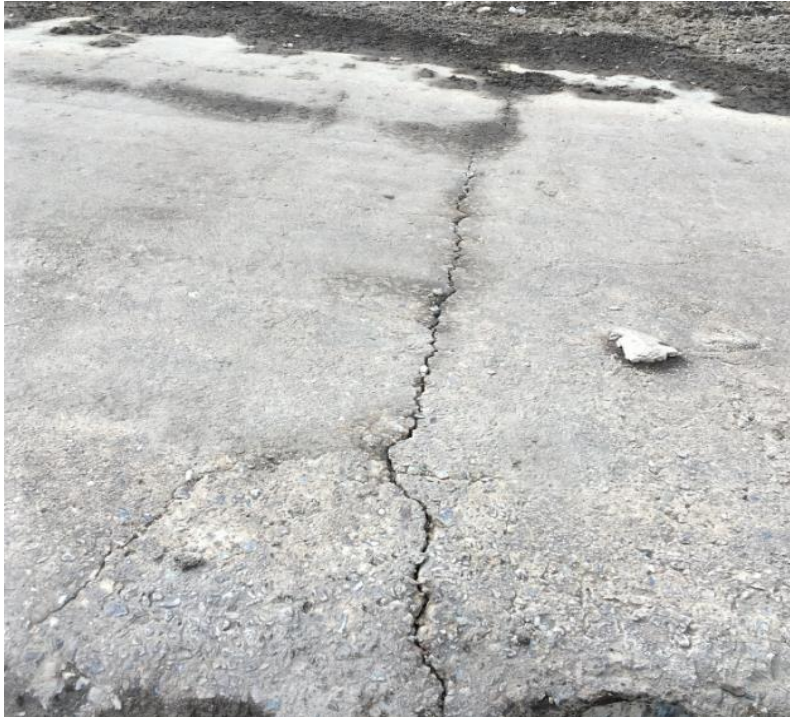
Figure 9 – Longitudinal Crack

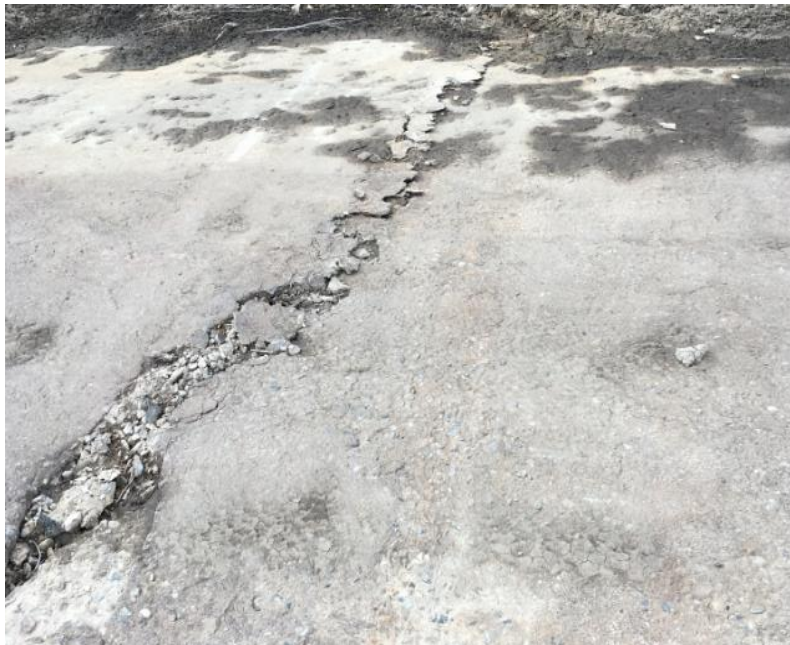
Figure 10 – Longitudinal Crack with Delamination

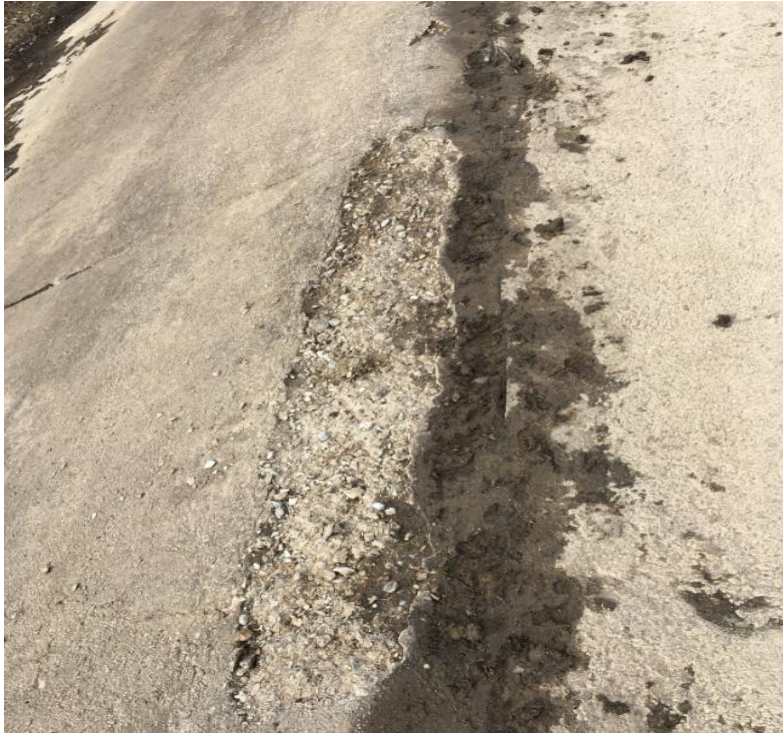
Figure 11 – Signs of Spalling

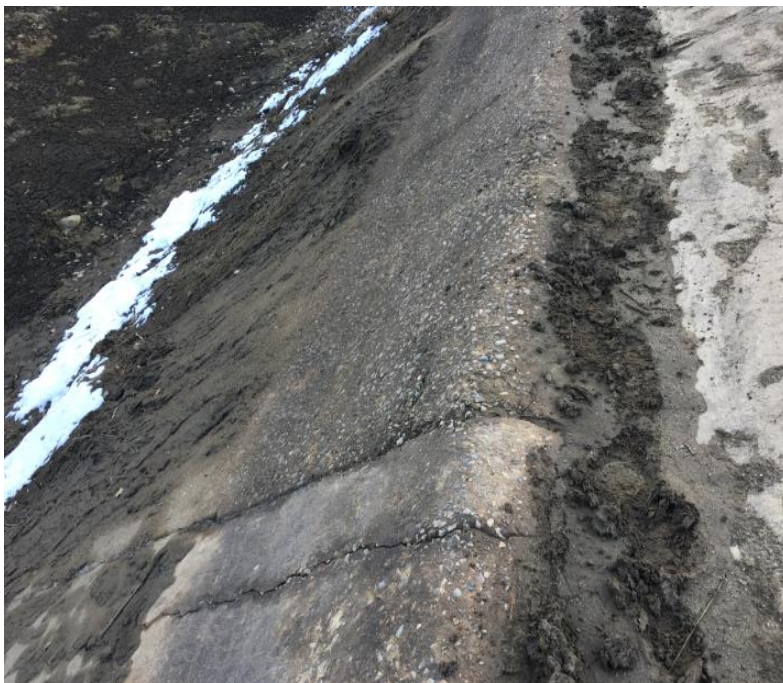
Figure 12 – Signs of Spalling and Longitudinal Crack

Zones 3, 4, and 5 presented similar conditions throughout. Most of the upper portion of the layer is undergoing spalling surrounded with longitudinal cracks in some locations (see Figure 12, Figure 13, and Figure 14). Major embankment failure surrounding the inlet pipe that transports water from Reservoir 2 to Reservoir 1 suggests underground water seepage is causing the bottom layer on Zone 4 to bulge out (see Figure 15 and Figure 16).

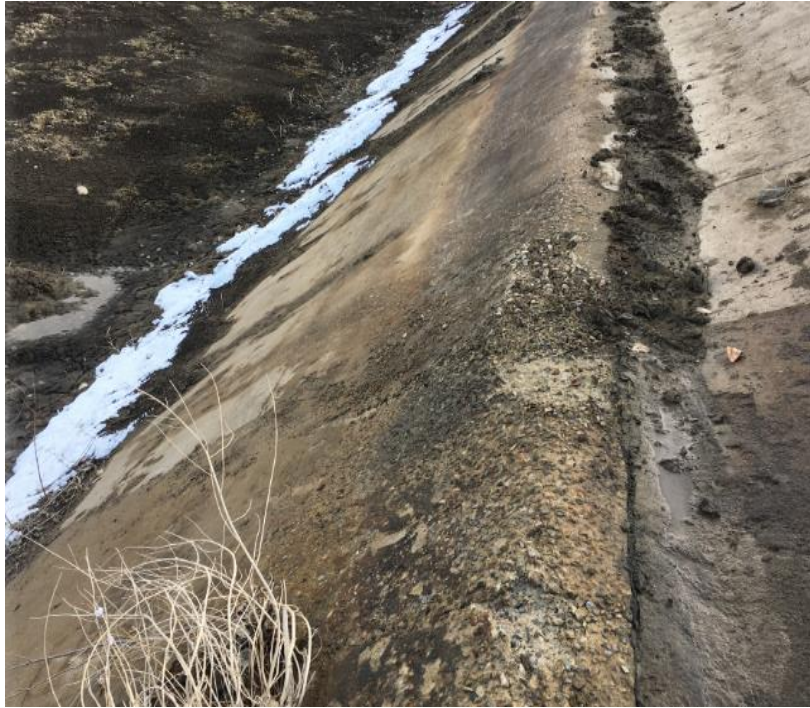
Figure 13 - Signs of Spalling with Longitudinal Crack

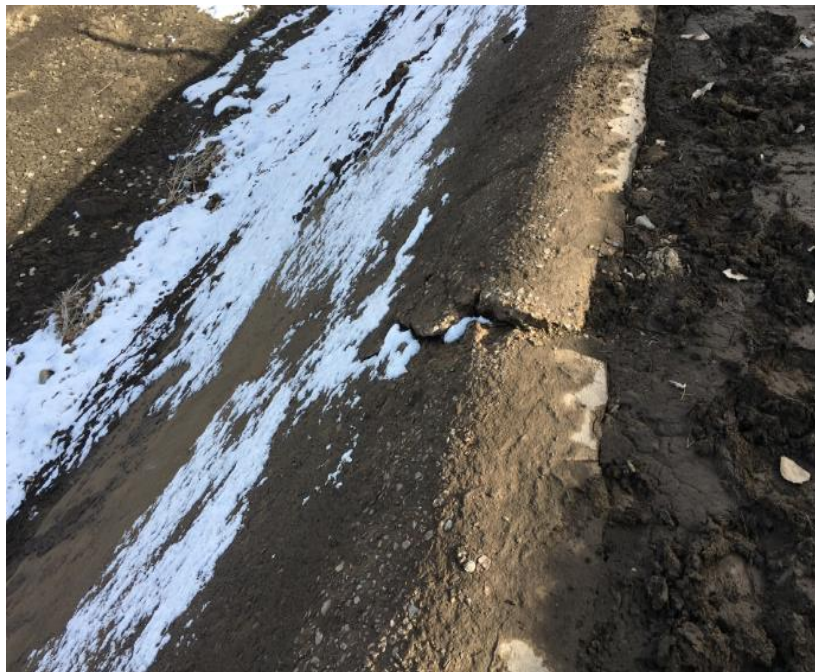
Figure 14 – Longitudinal Crack

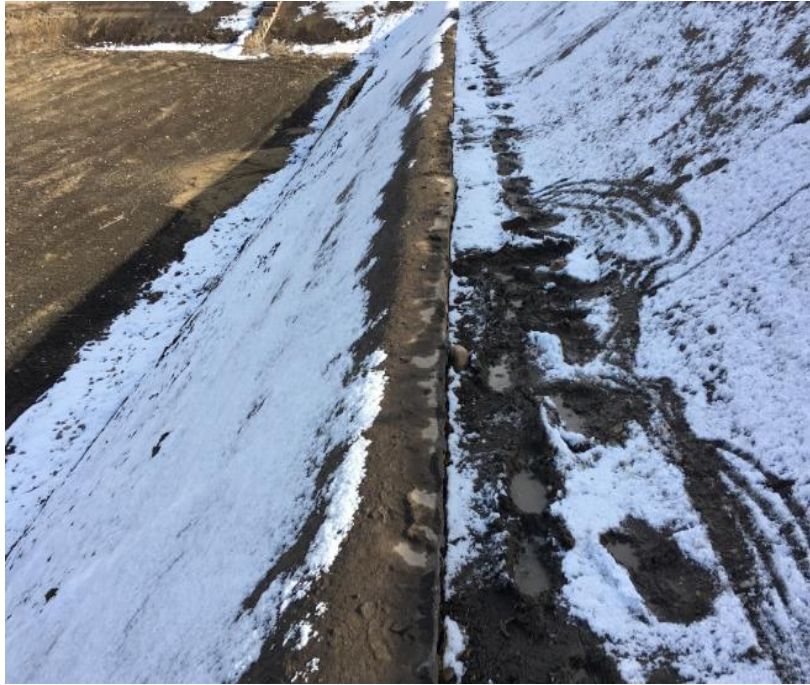
Figure 15 – Lower Lining Bulging Out (Sideview)

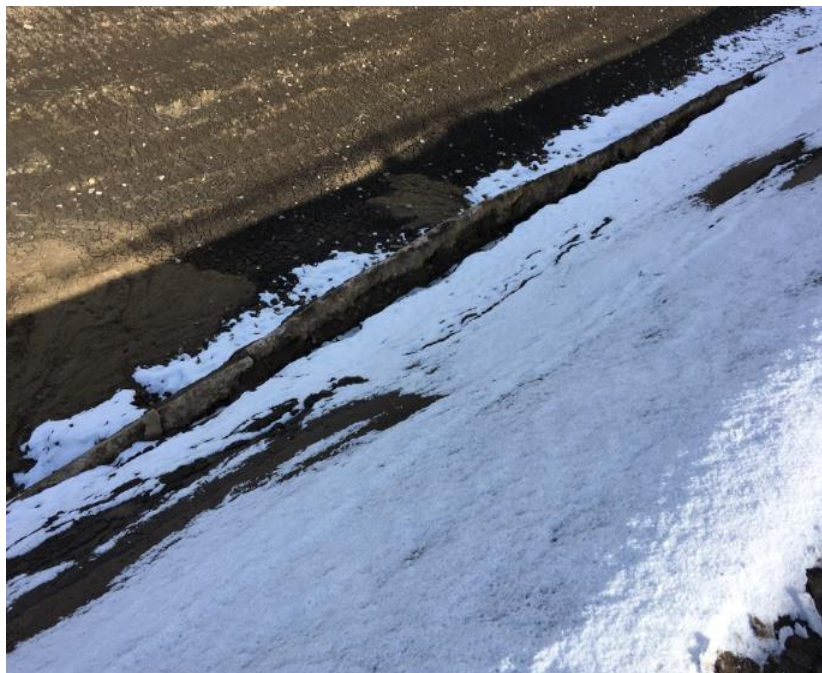
Figure 16 – Lower Lining Bulging Out

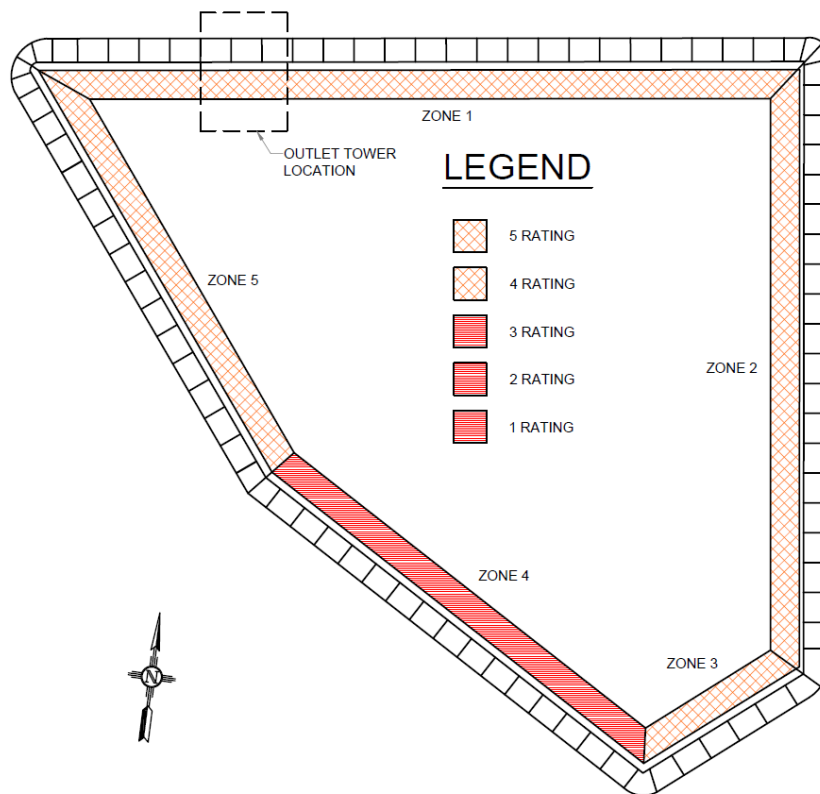
Figure 17 – Bottom 3” concrete lining (1954)

In general, zones receiving a rating of 3 or lower (shown in red in Figure 17) are considered to be in poor to bad condition. Zones 1, 2, 3, and 5 received ratings of 4 or higher (see orange hatch in Figure 17) in the visual inspection and are considered to be in fair condition.

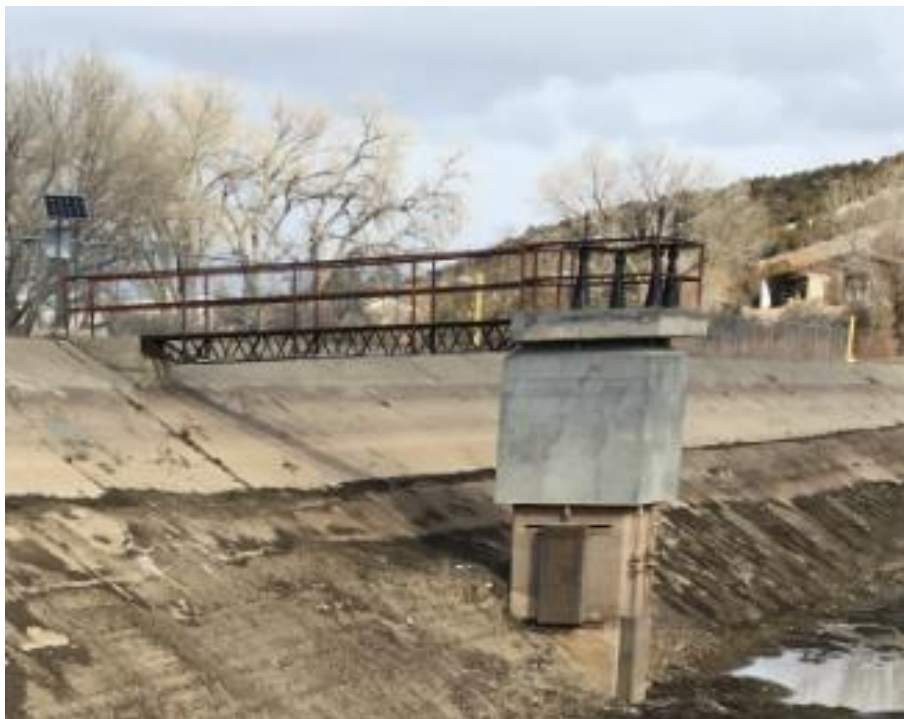
Figure 18 – Outlet Tower

The outlet tower located at the northern side of Reservoir 1 was also evaluated (see Figure 18). As expected with concrete exposed to water, a leaching process starts to develop when water enters cracks in the concrete and dissolves compounds inside the mixture. In general, leaching tends to increase porosity in the concrete and degradation is enhanced. Figure 19 and Figure 20

Based on the information gathered in the evaluation of the outlet tower, the team concluded that the structure is in fair condition. That is, no major signs of structural failure were visually observed. However, the extent of rebar damage underneath the concrete placed in 2018 is a concern and will be considered when evaluating future repair.

Outlet Structure Tower- During the site evaluation, it was noted that there are underlying problems beneath the most recent layer of concrete. There is concern that the exposure to water and freeze-thaw over time has compromised the structural integrity of the tower. Regardless of which option is chosen, we recommend that a new outlet structure be built at the location of the existing structure. Although the steel bridge used to access the structure was found to be in decent condition and could be reused after rehab and recoating of the steel members, it is also recommended that the catwalk be replaced with the tower.

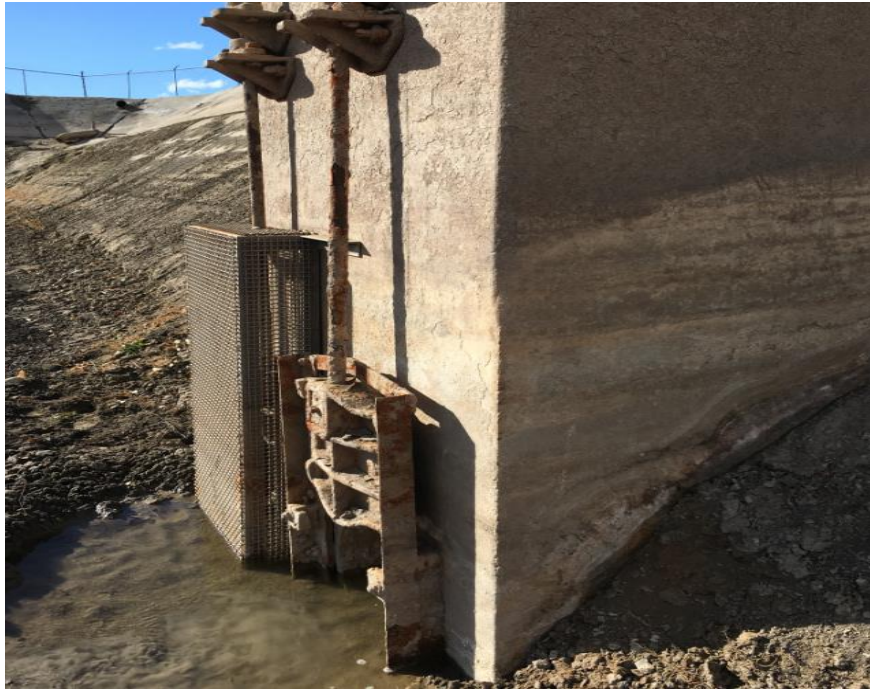
show instances of leaching at the lower and middle layers of the tower. Above these layers, the concrete tower was rehabilitated with the 2018 project (see Figure 21) and appears to be in good condition with some minor spalling on the underside of the platform. Nominal cracking due to temperature and shrinkage forces in the concrete are present (see Figure 22). Inside the tower, the concrete showed signs of spalling, causing loss of surface material (see Figure 23).

Figure 19 – Leaching at lower right corner of figure

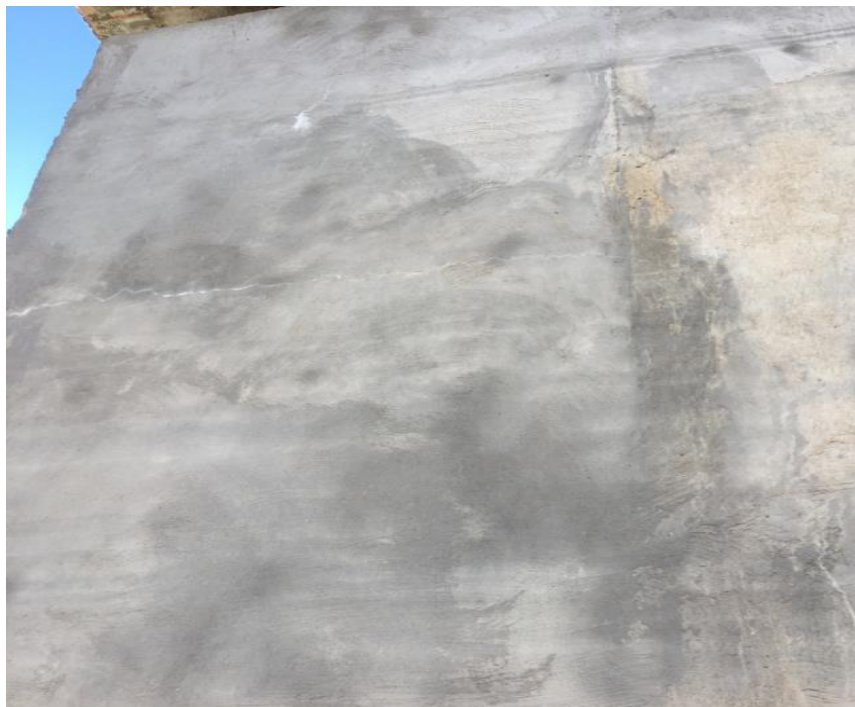
Figure 20 – Leaching in the Middle Cap of the Outlet Tower

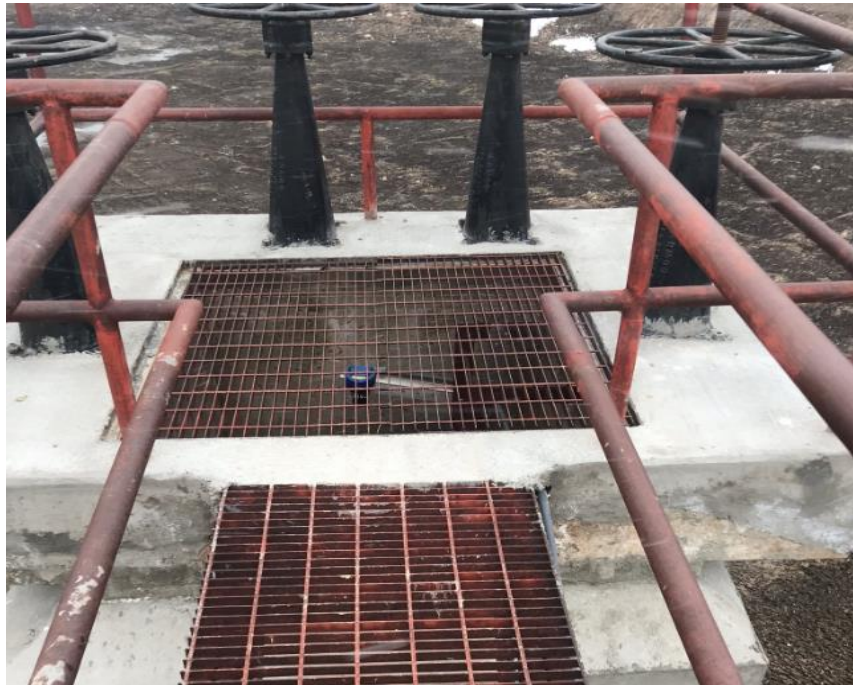
Figure 21 – Concrete Platform

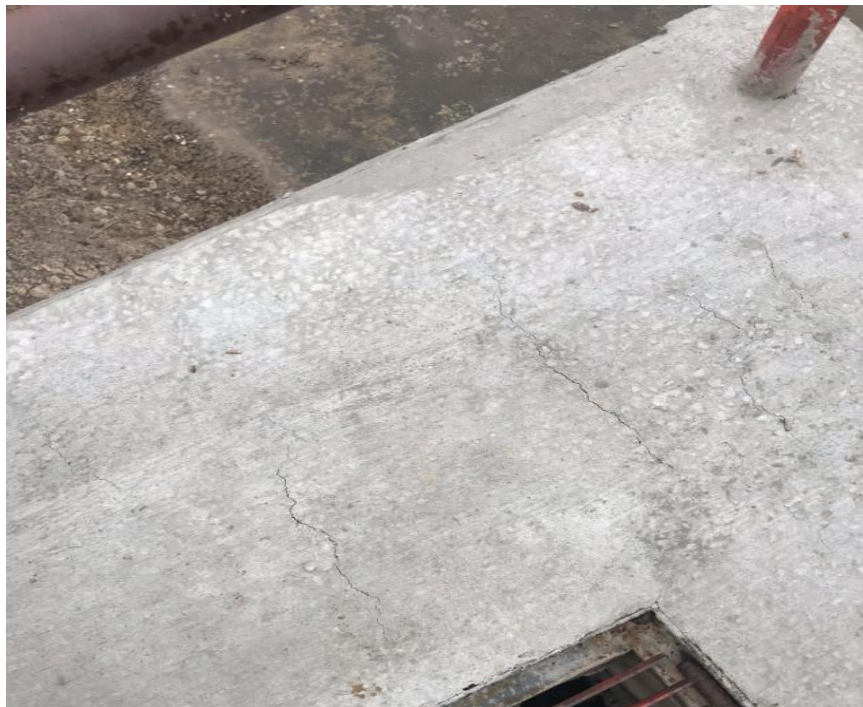
Figure 22 – Nominal Cracking

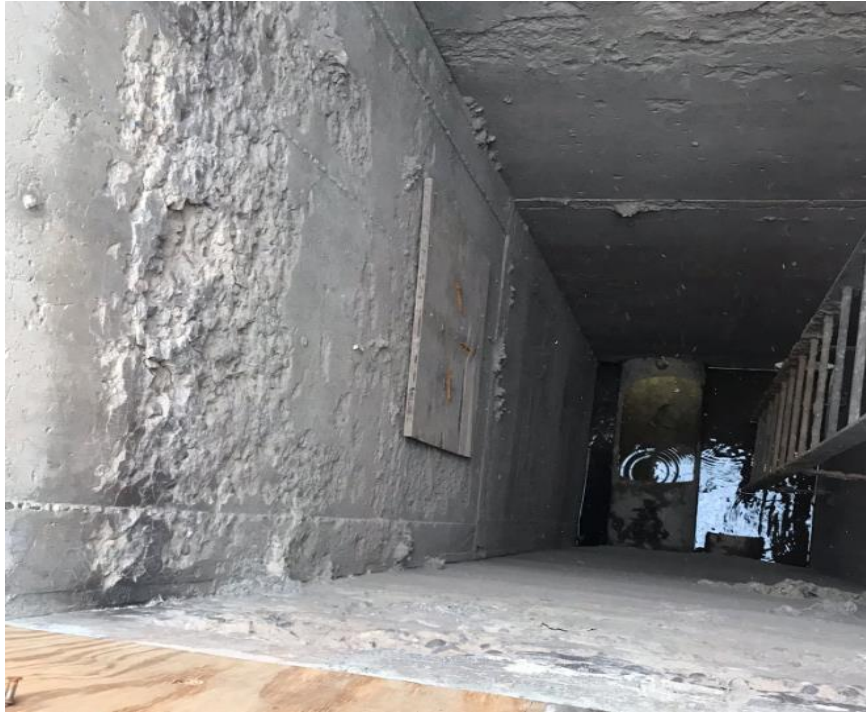
Figure 23 – Signs of Spalling

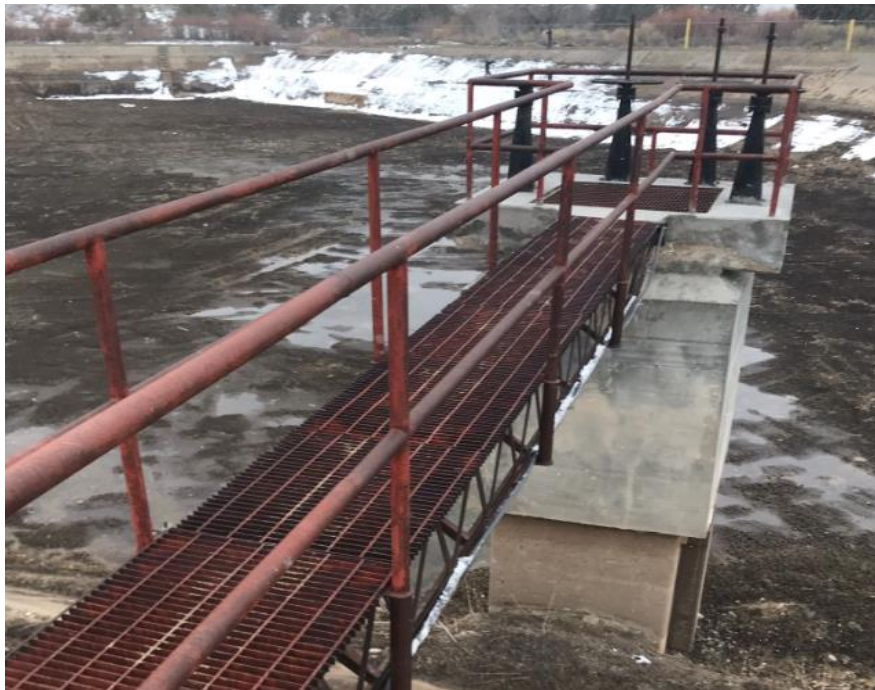
The service bridge structure used to provide to the outlet tower is composed of a steel open-grid deck and pipe railings that appear to be in good condition. Minimal rust and deterioration of the surface coating was evident throughout (see Figure 24).

Figure 24 – Minimal Rust of Surface Coating
