Existing Condition Assessment Report

DEMOLITION OF CENTRAL BOOKING FACILITY

Escambia County Central Booking and Detention Facility
Condition Assessment Report - June 11, 2015

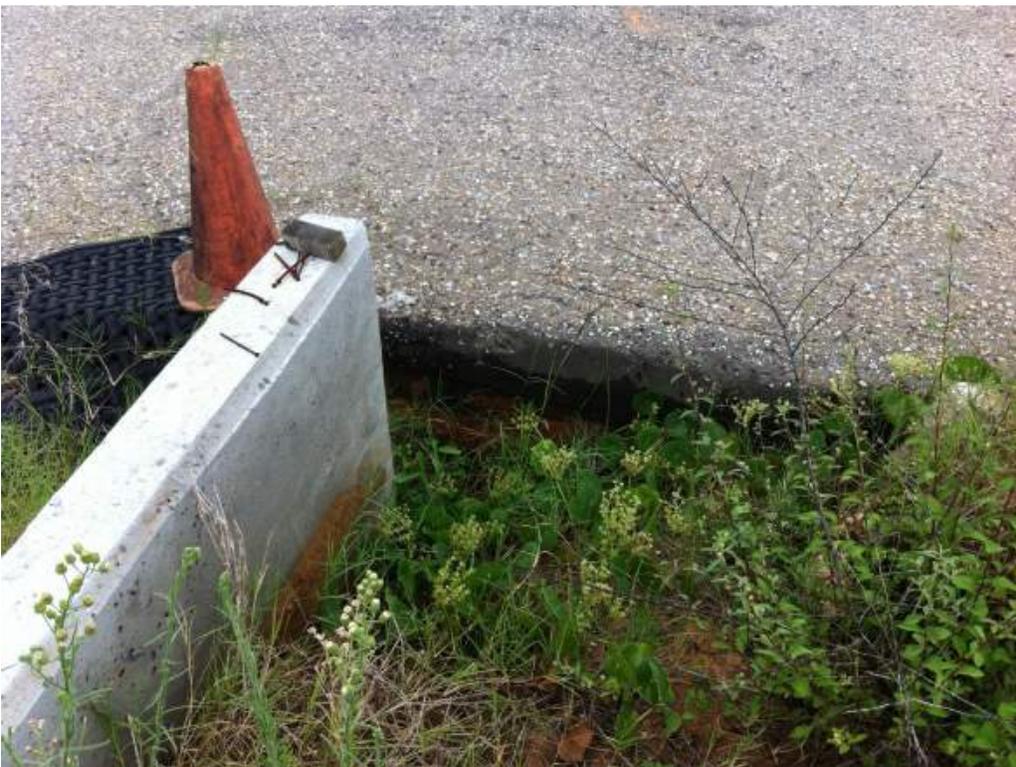
Photo 15: Curb at East Edge of Northwest Access Road Ditching- Looking East

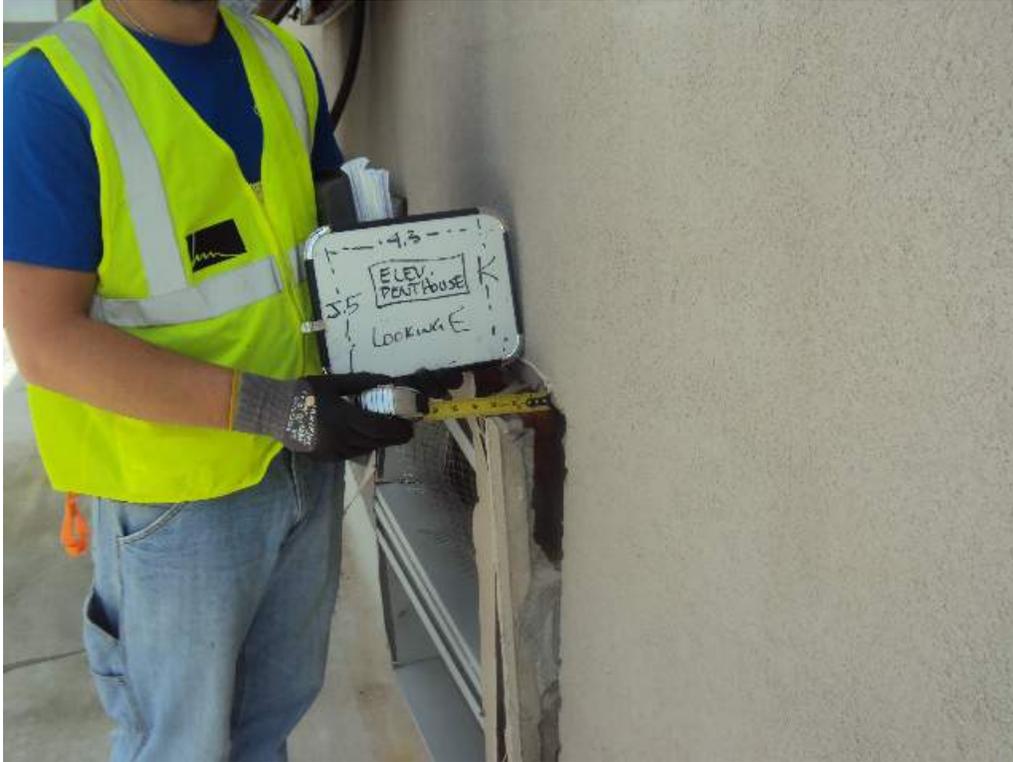
Photo 11: Elevator Penthouse –Along col line 4.3 between col lines J.5 and K – Looking East - Damaged exhaust vent and wall section at the elevator shaft

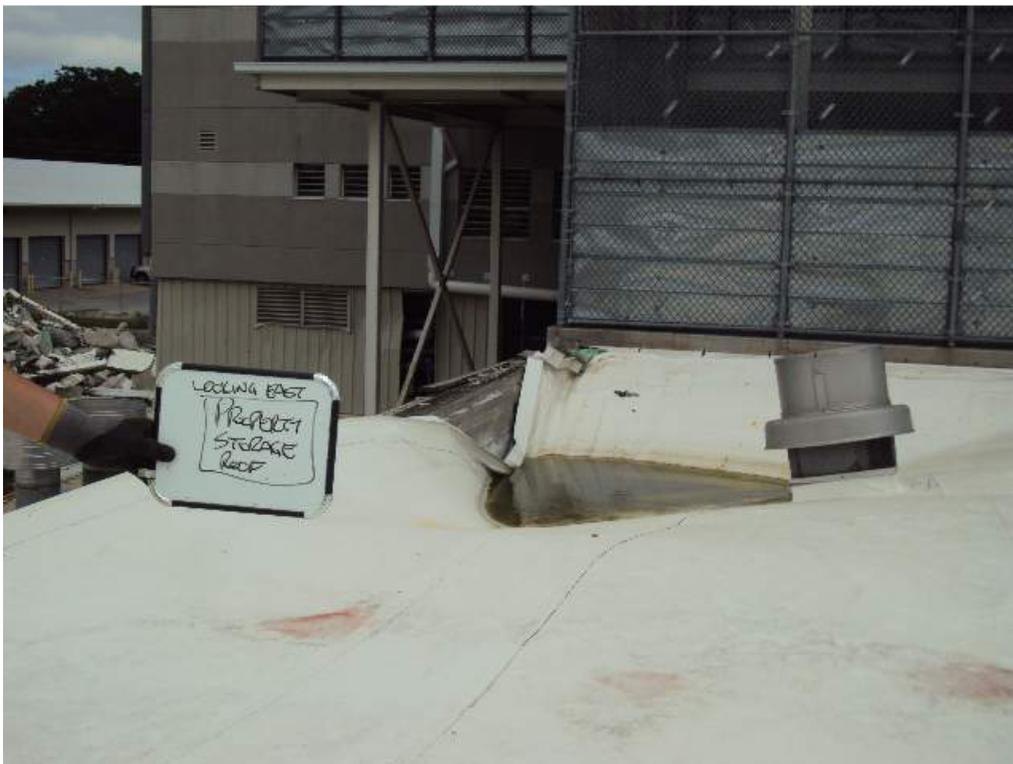
Photo 12: 1st Floor Roof –Between col lines D and E & 7 and 8 – Looking East - Collapsed portion of roof

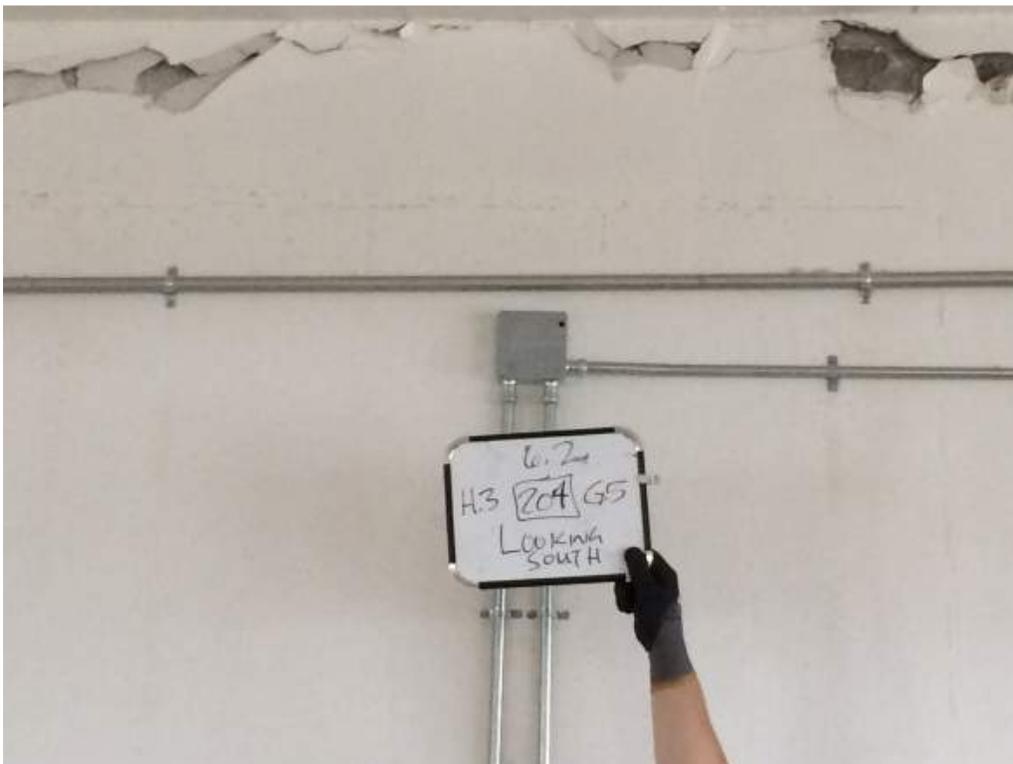
Photo 14: 4th Floor – Room 204 –Along col Line 6.2 between G.5 & H.3 – Looking South – Horizontal crack @ top of CMU wall

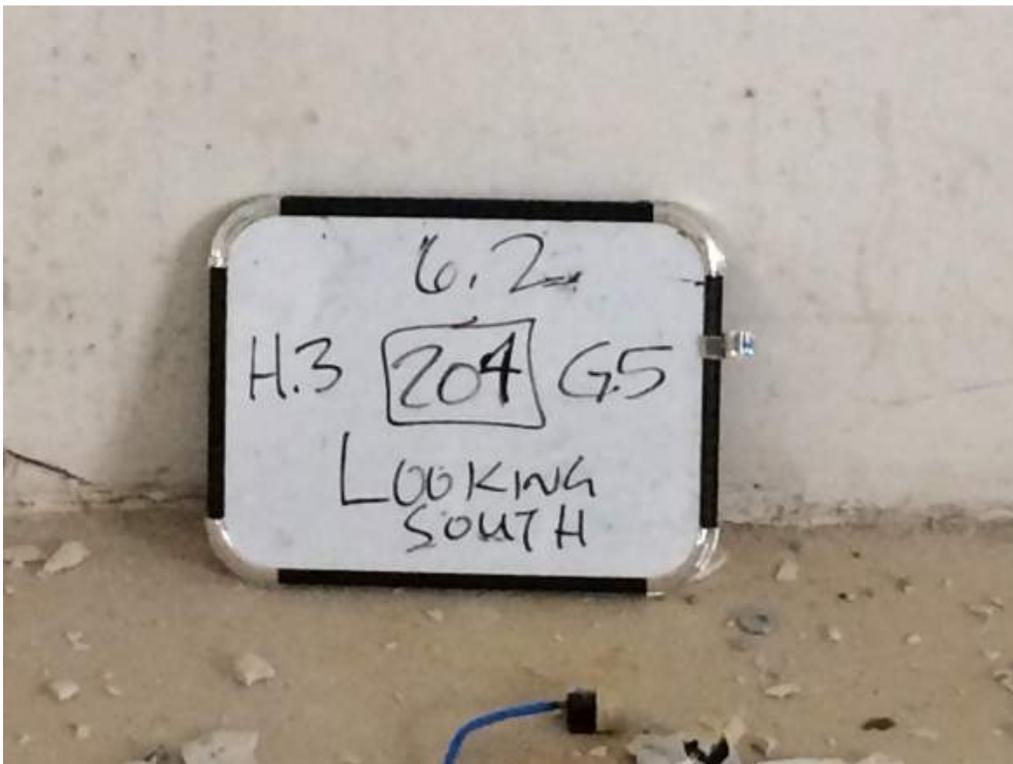
Photo 16: 4th Floor – Room 204 –Along col Line 6.2 between G.5 & H.3 – Looking South –Crack @ bottom of CMU wall

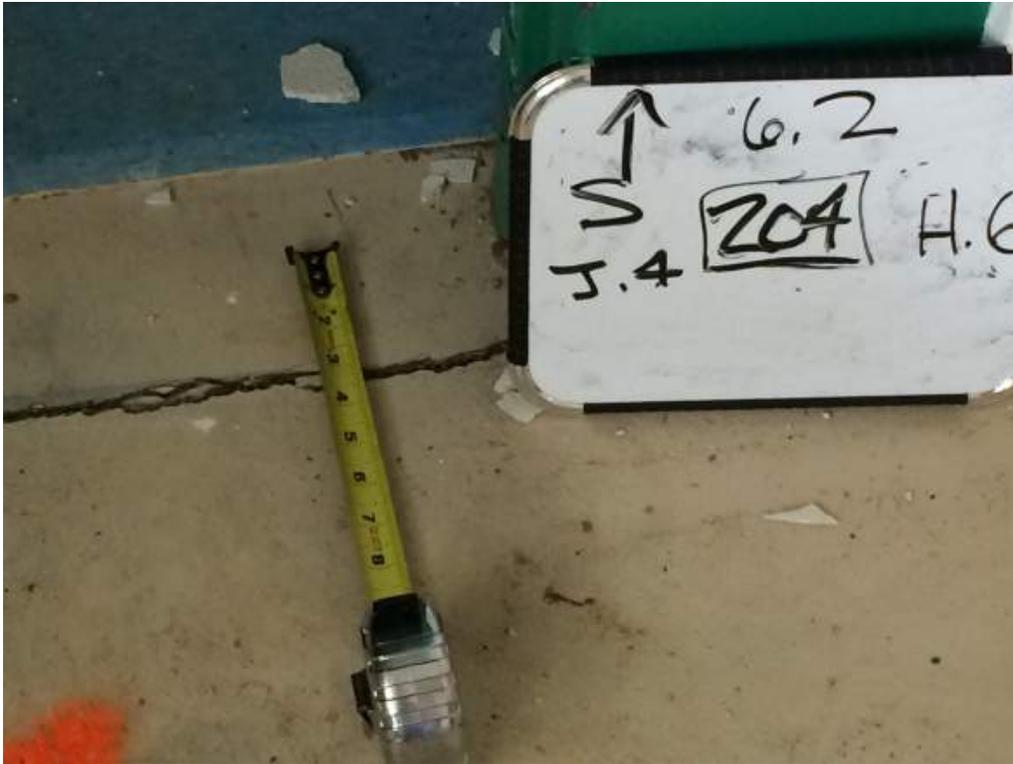
Photo 17: 4th Floor – Room 204 –Along col Line 6.2 between H.6 & J.4 –Crack in floor slab

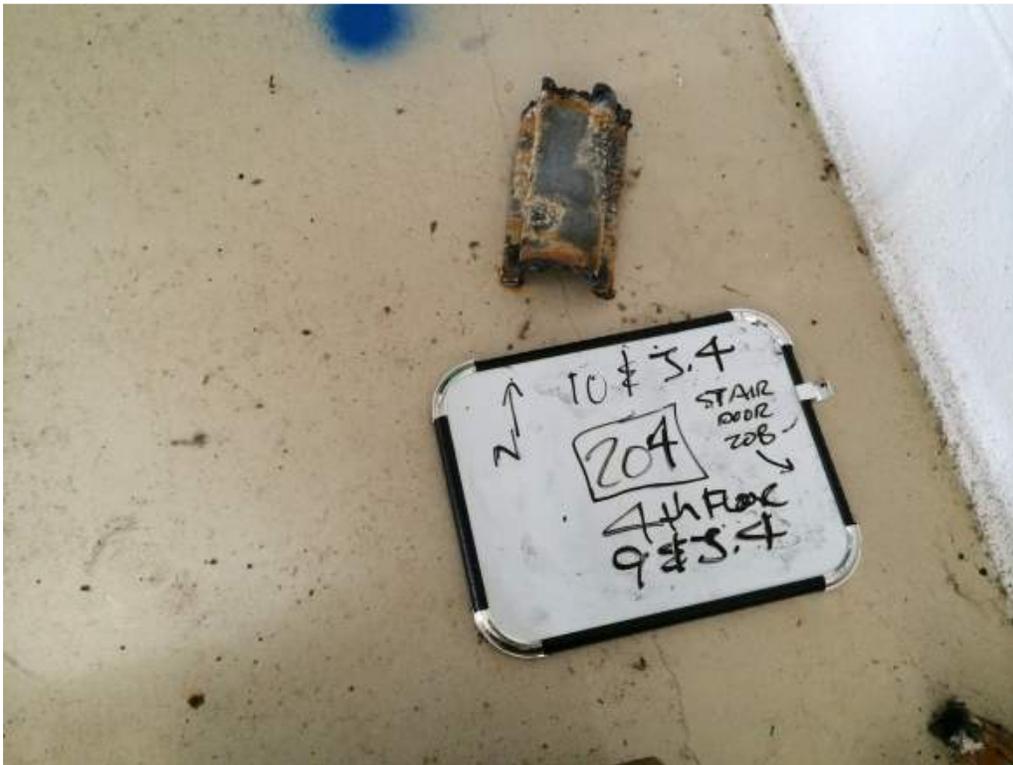
Photo 18: 4th Floor – Room 204 –Along col Line J.4 Between 9 and 10 –Crack in floor slab

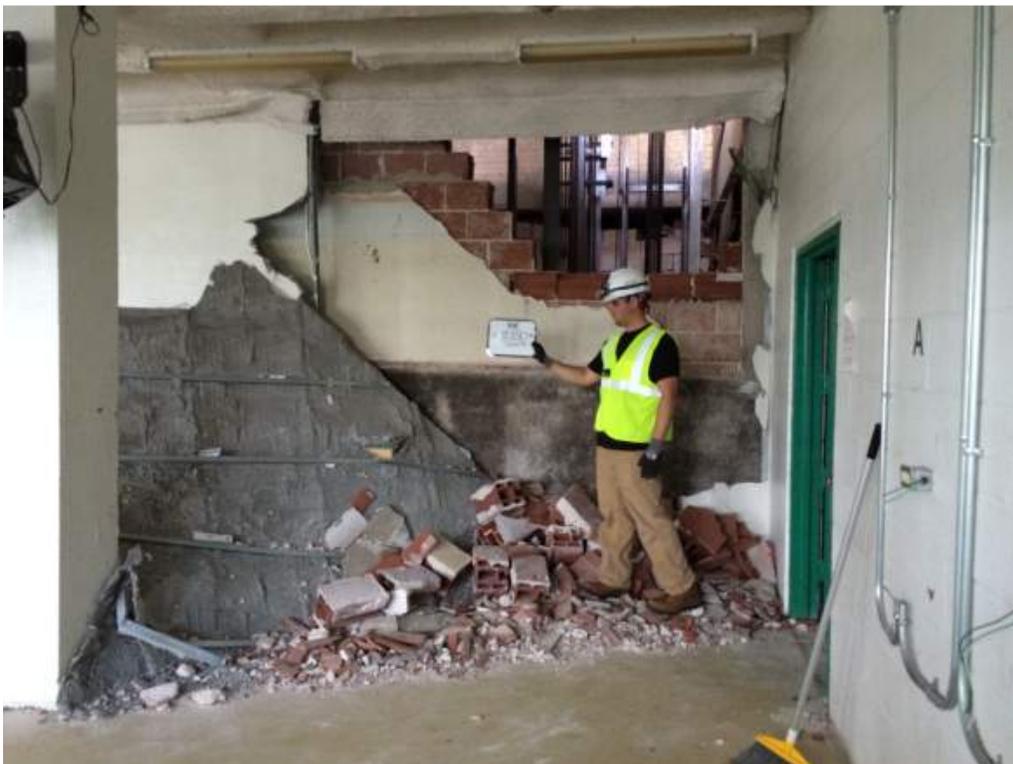
Photo 20: 4th Floor – Room 4201 – Along col line 4.5 between J.4 and K – Looking South – Demolished elevator CMU wall

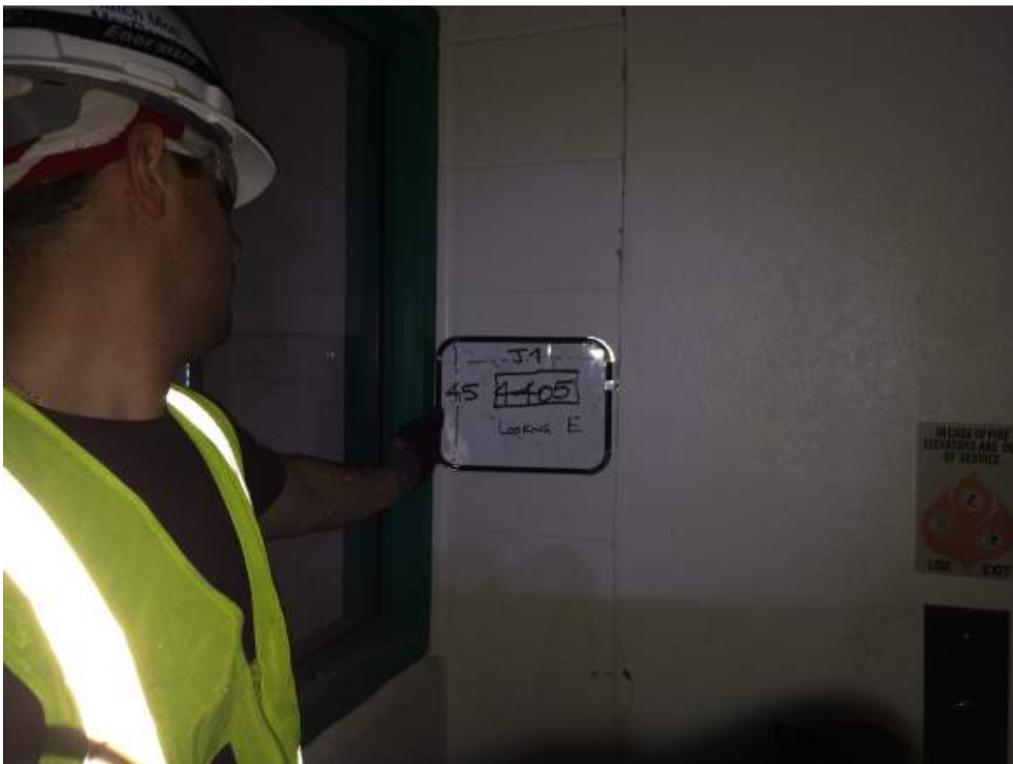
Photo 22: 4th Floor- Room 4405 – Along col line J.4 and 4.5 – Looking East – Vertical crack between concrete column and CMU wall

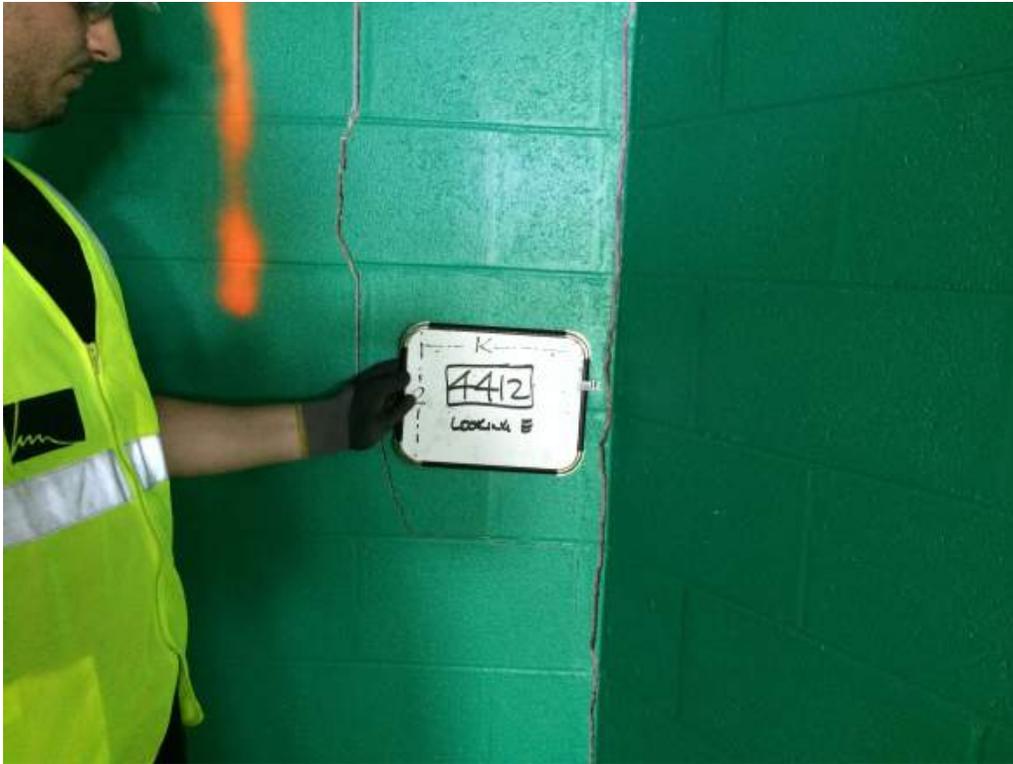
Photo 25: 4TH Floor-Room 4412-Adjacent to col line 2 and behind col line K – Looking East – Vertical cracks in CMU wall

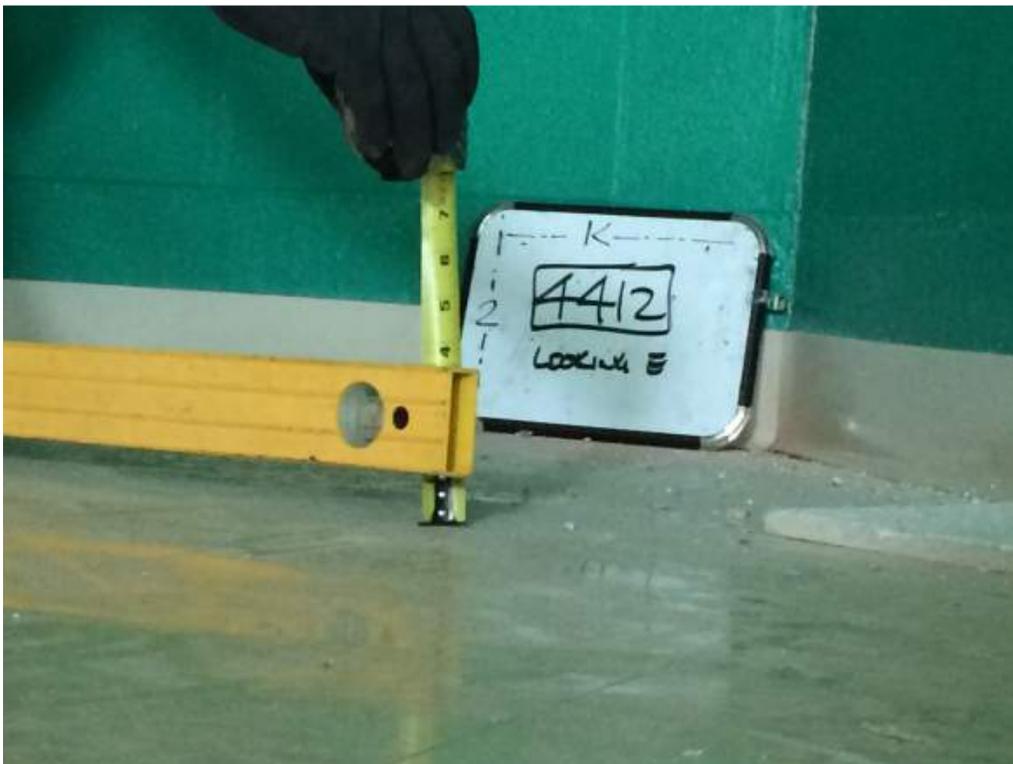
Photo 26: 4TH Floor-Room 4412-Adjacent to col line 2 and behind col line K – Looking East – Settlement of the concrete floor

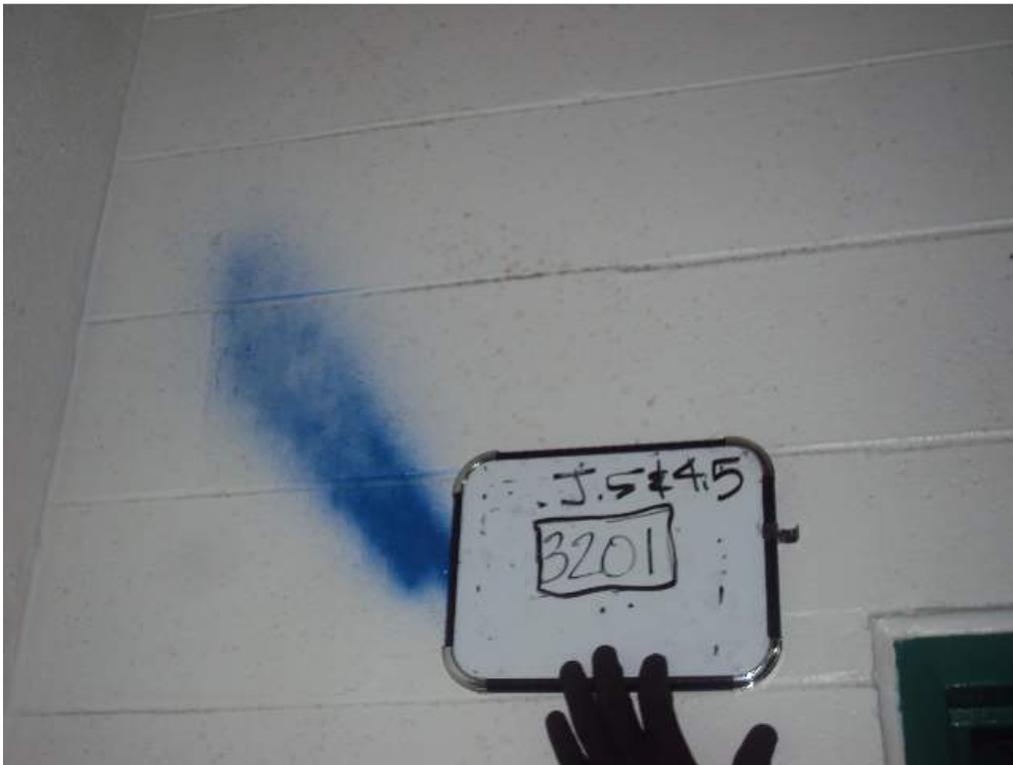
Photo 28: 3rd Floor – Room 3201 – Adjacent to J.5 and 4.5 – Looking West - Diagonal cracking in CMU walls

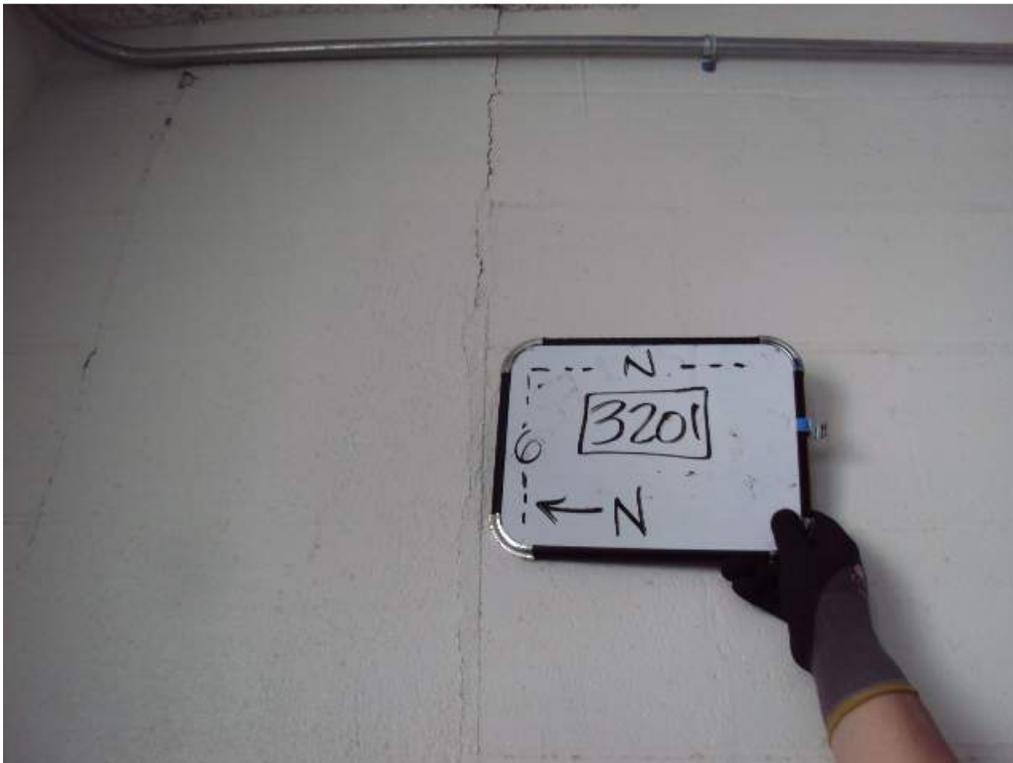
Photo 34: 3rd Floor – Room 3201 – At col line N6 – Looking East – Vertical cracks between the concrete column and the CMU wall

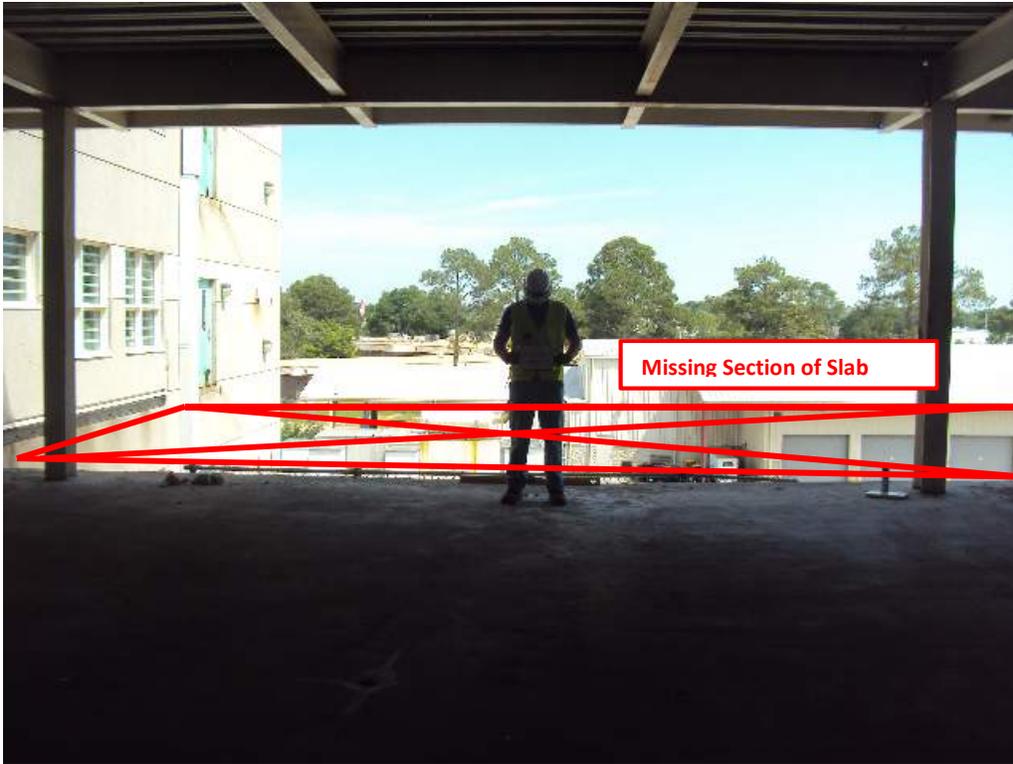
Photo 37: 3rd Floor – Room 3206 – Looking North – Missing section of exercise concrete floor

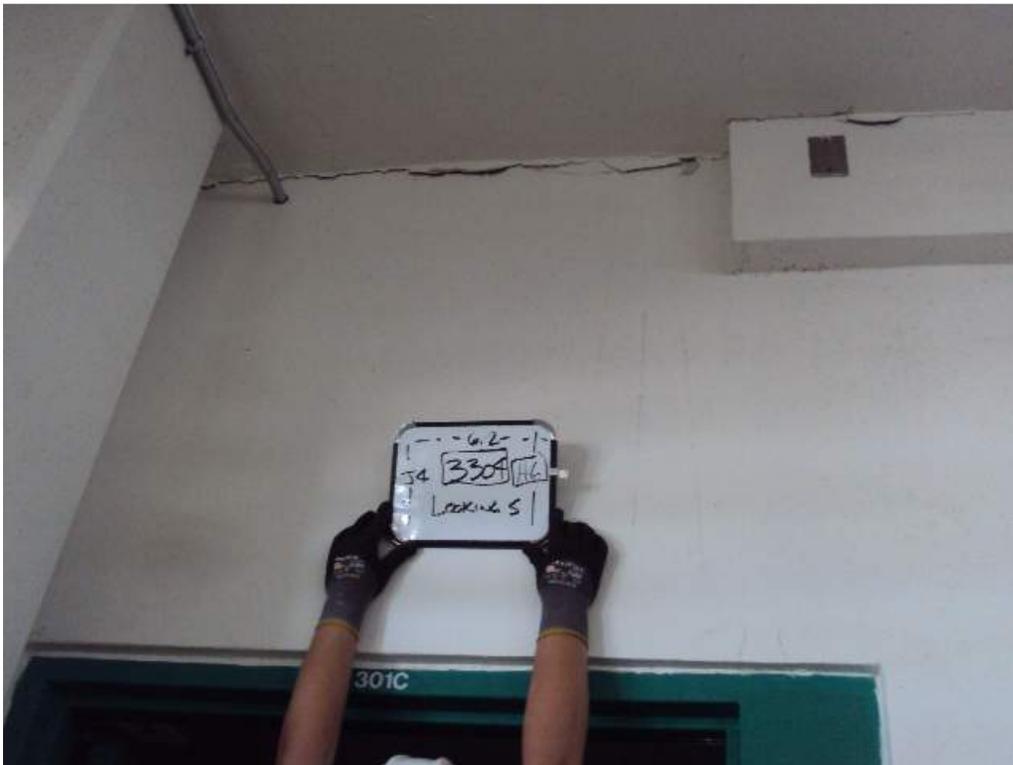
Photo 38: 3rd Floor – Room 3304 – Along col line 6.2 between col lines H.6 and J.4 – Looking South – Horizontal crack at top of CMU wall

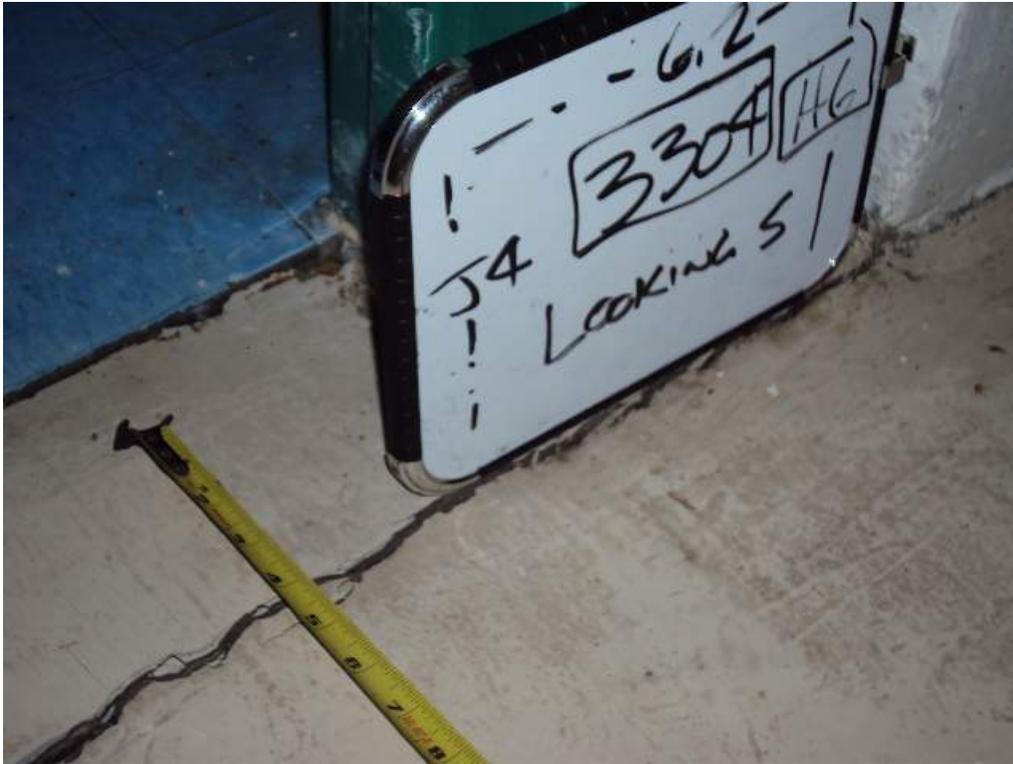
Photo 39: 3rd Floor – Room 3304 – Along col line 6.2 between col lines H.6 and J.4 –Crack in floor slab

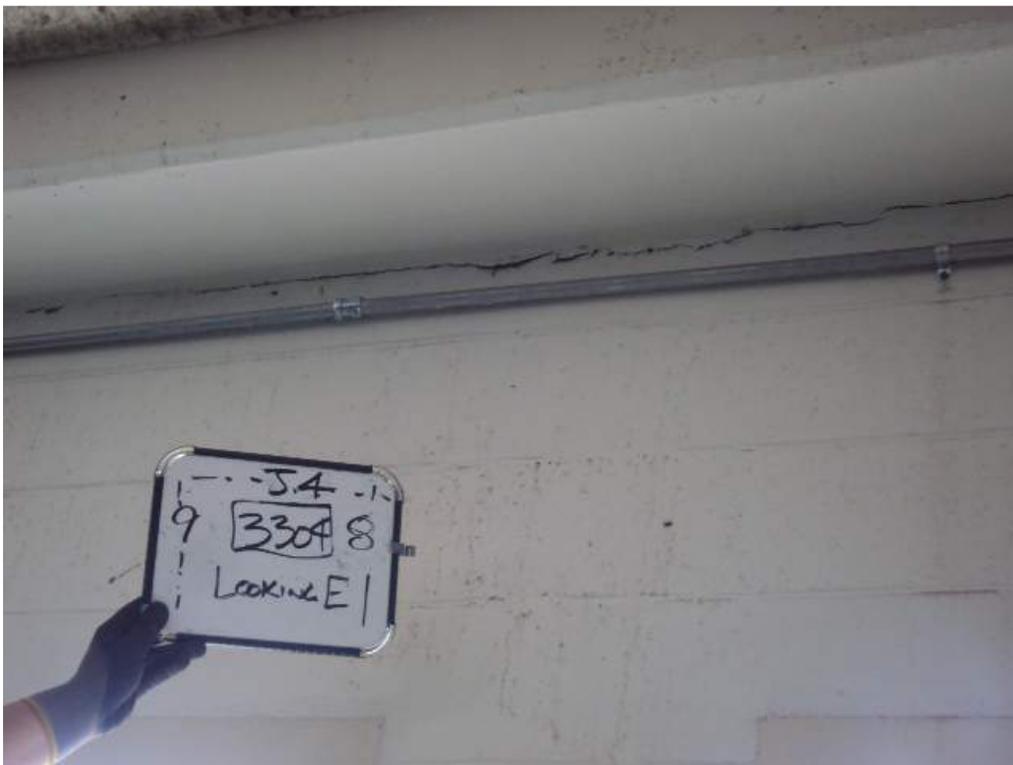
Photo 40: 3rd Floor – Room 3304 – Along col line J.4 between col lines 8 and 9 –Looking East – Horizontal crack between the concrete beam and CMU wall

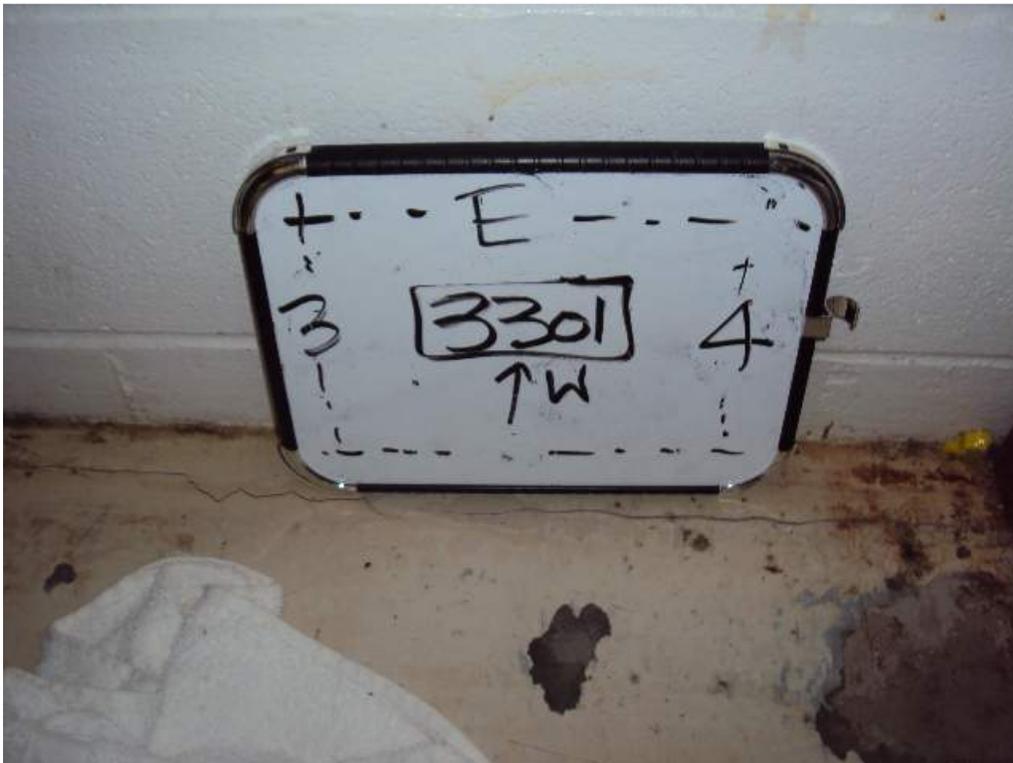
Photo 42: 3rd Floor – Room 3301 – Along col line E between col lines 3 and 4 –Cracks in floor slab

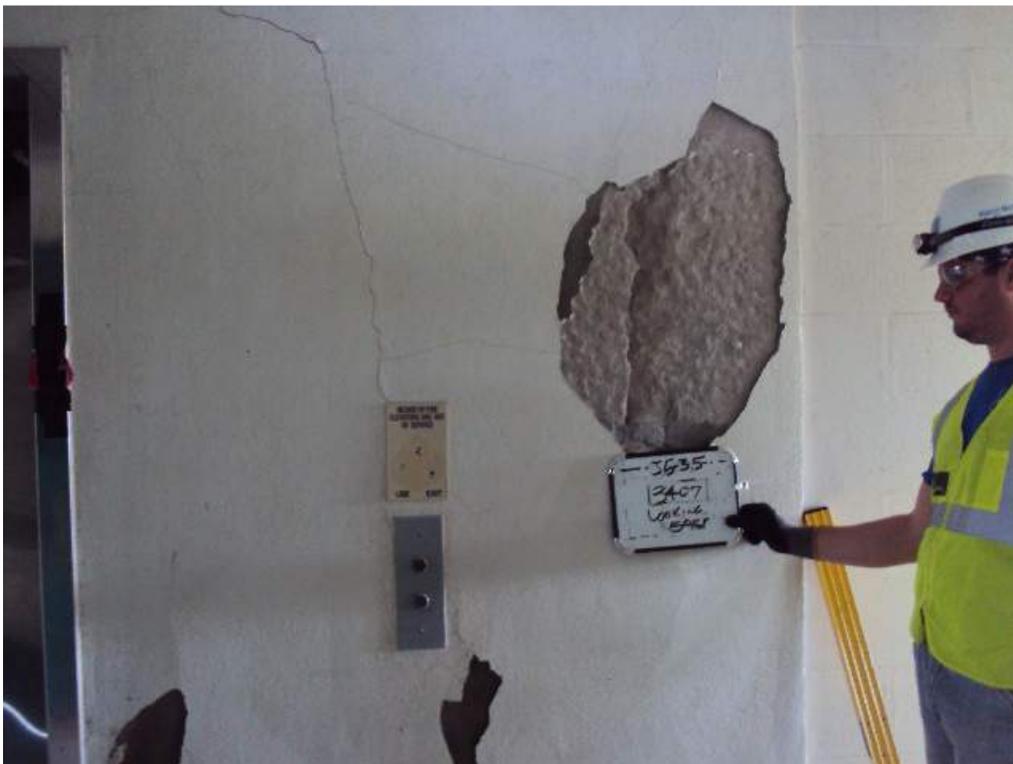
Photo 46: 3rd Floor – Room 3407 – Adjacent to col line J.5 and 3.5 – Looking East – Map cracking in elevator CMU wall

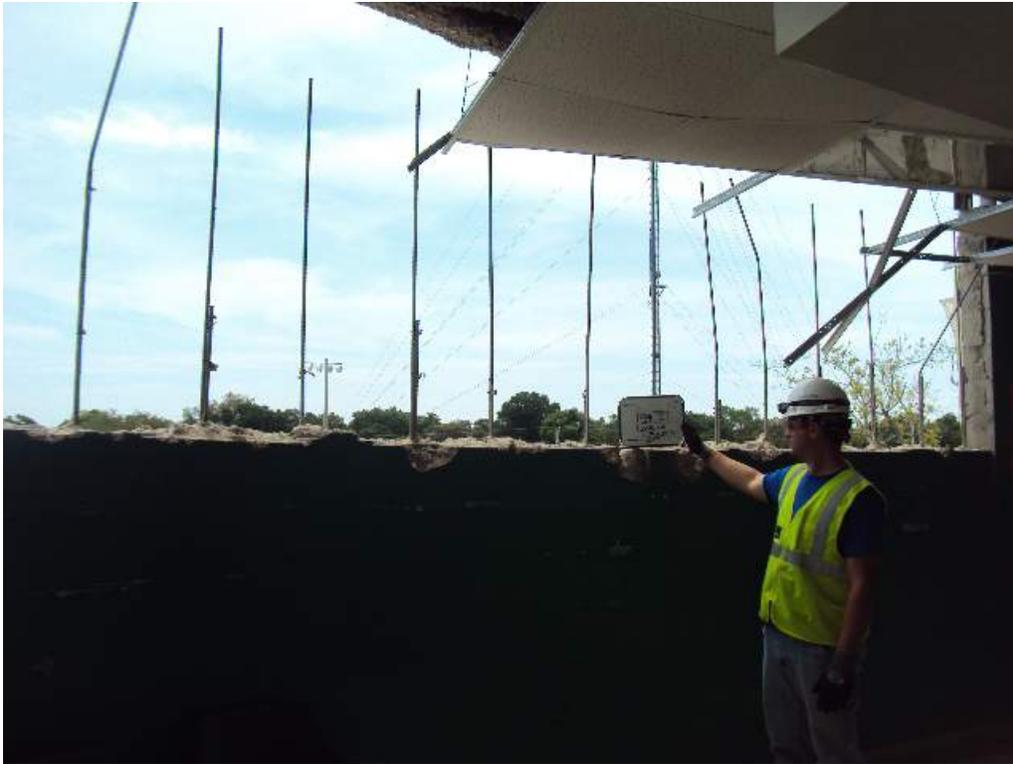
Photo 47: 3rd Floor – Room 3412 – Col line 1.8 north of photo – Looking South – Missing portions of CMU wall with exposed reinforcement

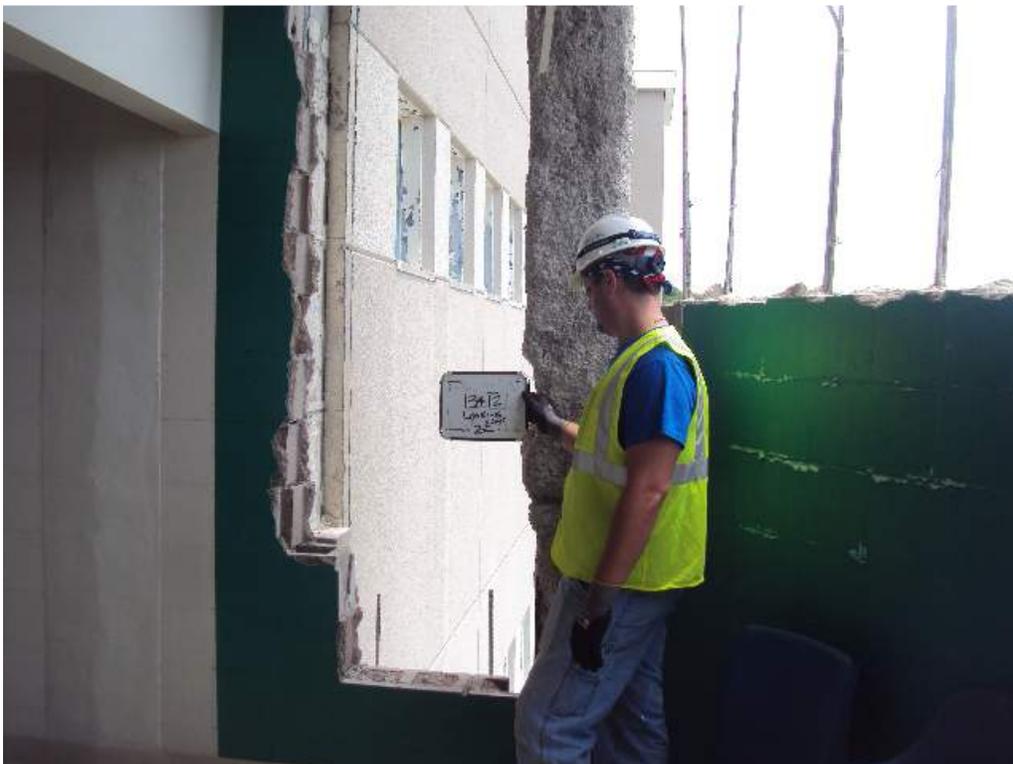
Photo 48: 3rd Floor – Room 3412 – At col line K1.8 – Looking East – Missing portions of CMU wall with exposed reinforcement

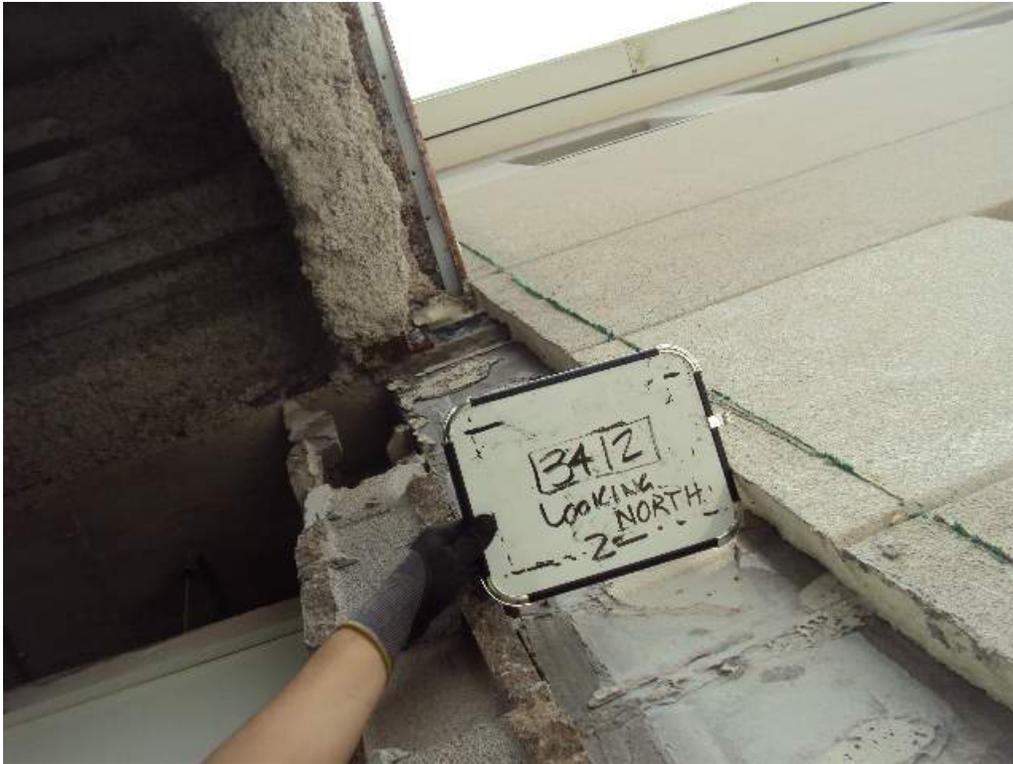
Photo 49: 3rd Floor – Room 3412 – At col line K2 – Damaged bolt connecting beam to col

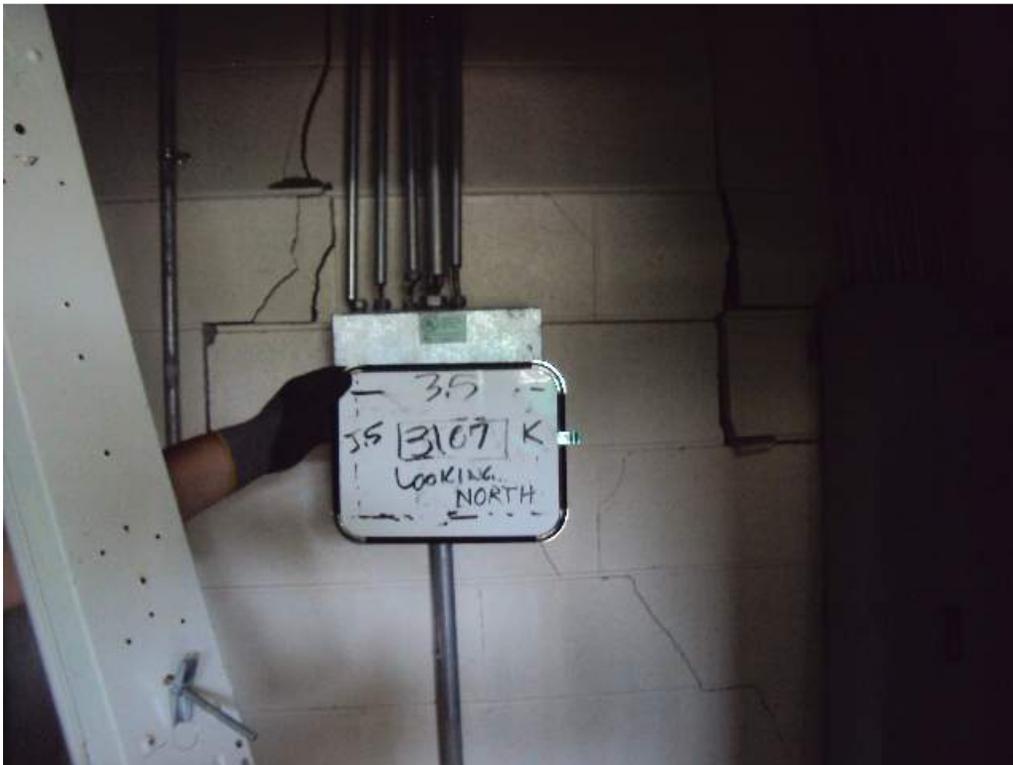
Photo 50: 3rd Floor – Room 3107 – Along col line 3.5 between col lines J.5 and K – Looking North - Collapsed elevator CMU wall

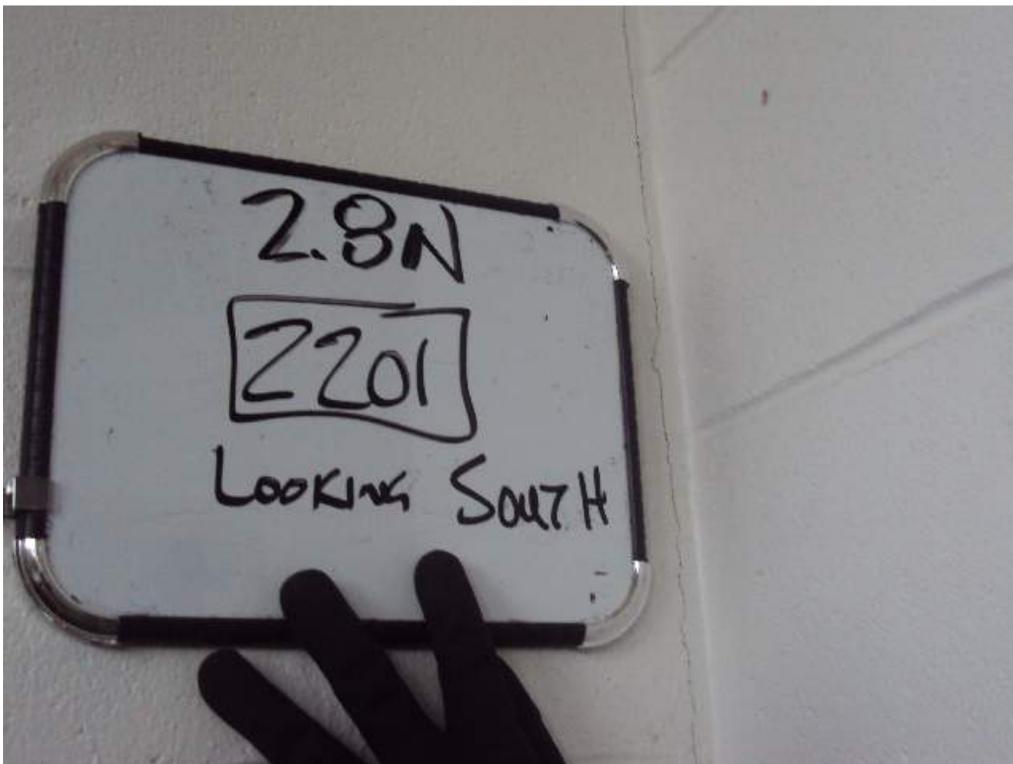
Photo 61: 2nd Floor – Room 2201-East Dormitory –At col line 2.8N - Looking South – Vertical cracks at corner of CMU walls

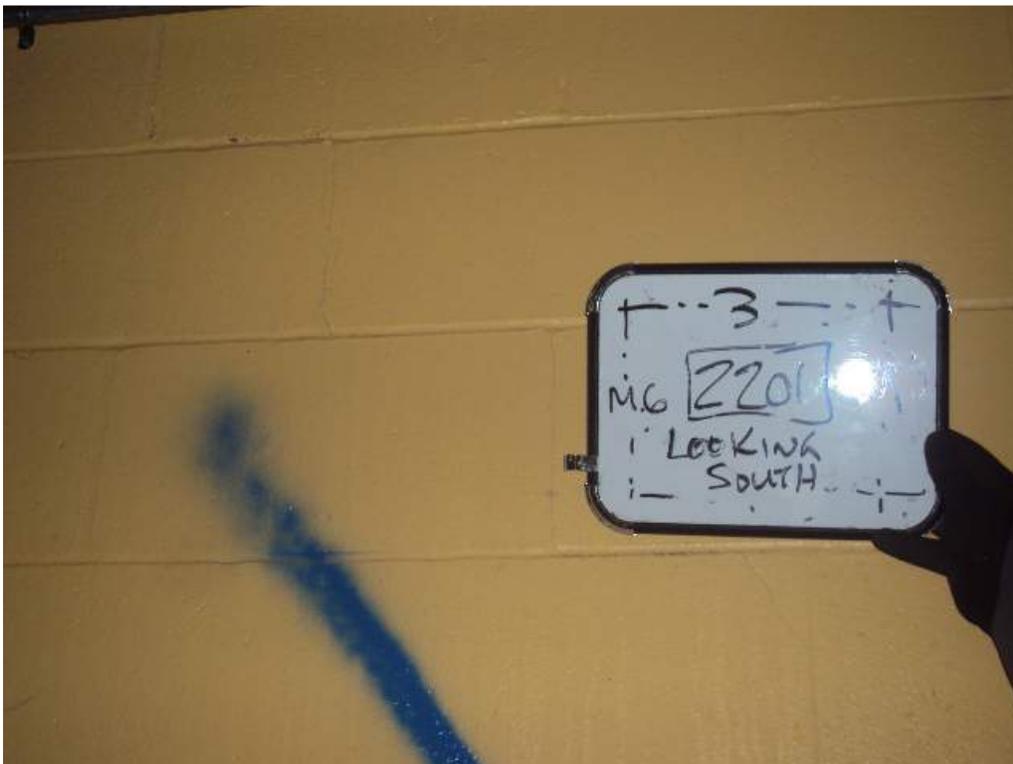
Photo 63: 2nd Floor – Room 2201 – East Dormitory – Along col line 3 between M.6 and M-Looking South -Stair step crack in CMU walls

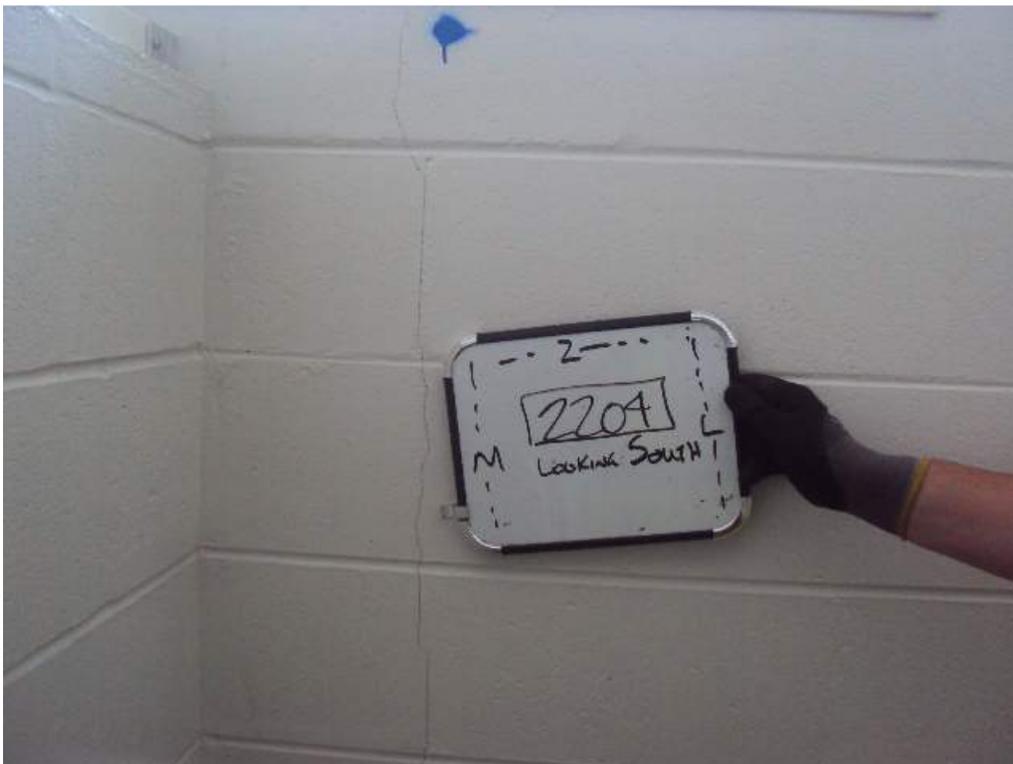
Photo 67: 2nd Floor – Room 2204 – Along col line 2 between col lines L and M -ooking South –Vertical crack in CMU wall

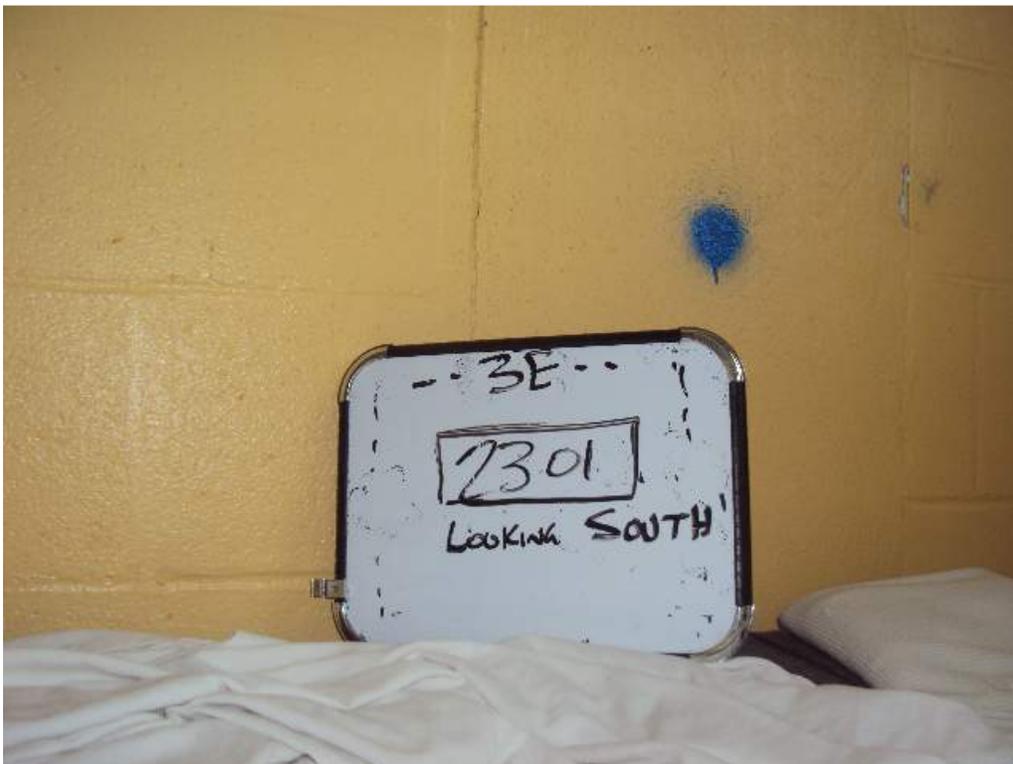
Photo 71: 2nd Floor – Room 2301 – At col line 3E-Looking South –Vertical crack between concrete col and CMU wall

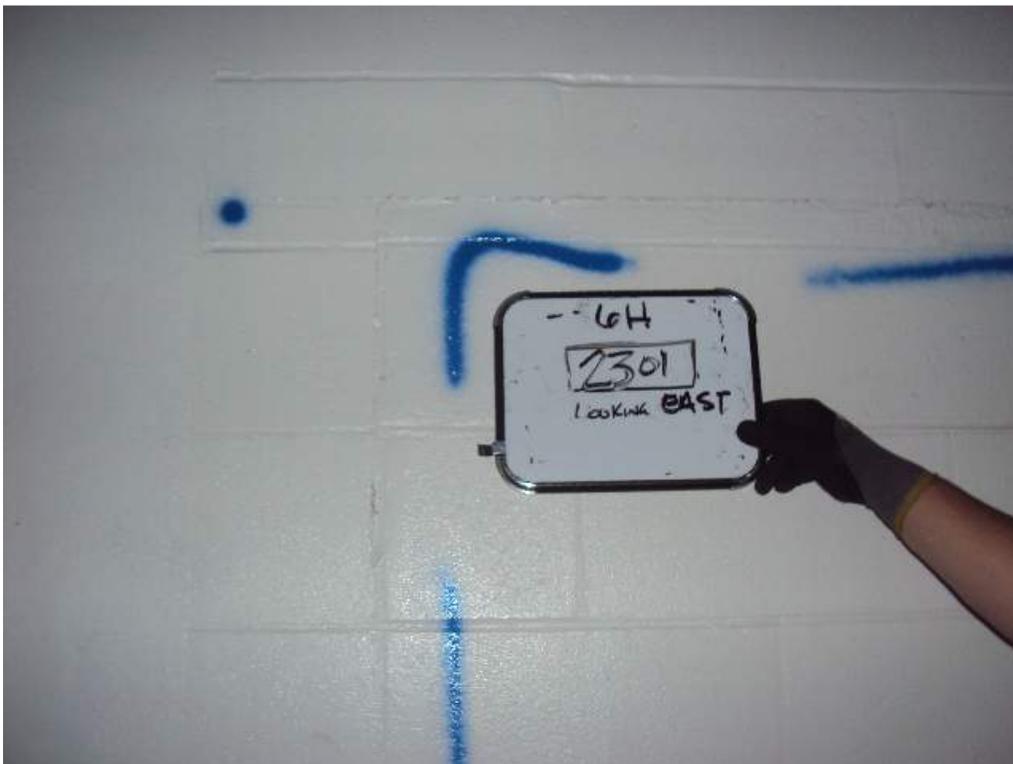
Photo 73: 2nd Floor – Room 2301 – At col line 6H-Looking East –Stair step cracks in CMU wall
