Existing Condition Assessment Report

DEMOLITION OF CENTRAL BOOKING FACILITY

Escambia County Central Booking and Detention Facility
Condition Assessment Report - June 11, 2015

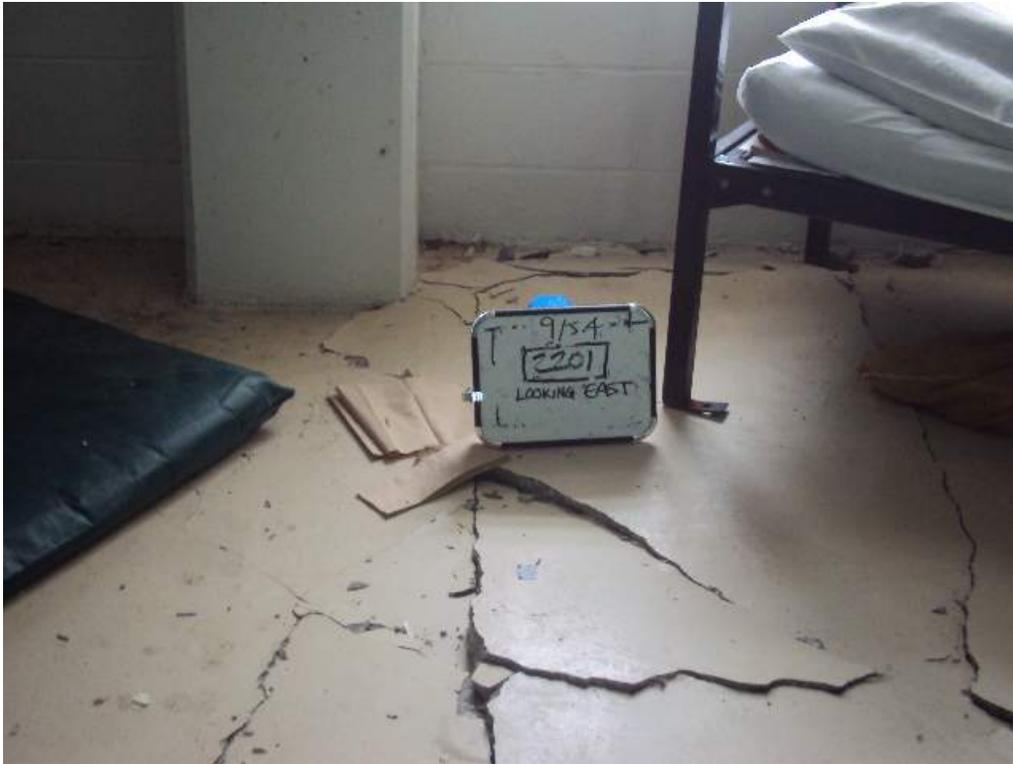
Photo 84: 2nd Floor – Room 2201 North Dormitory – At col line 9 and J4 – Looking East –Buckled, Cracked and Shear floor slabs

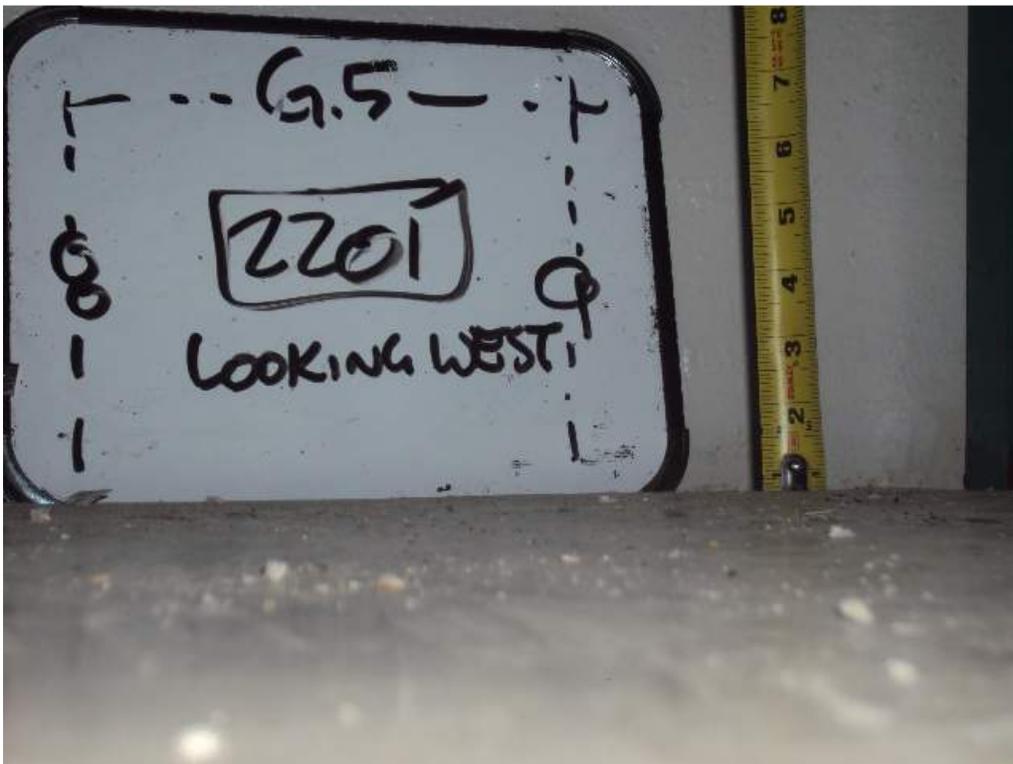
Photo 85: 2nd Floor – Room 2201 North Dormitory – Along col line G.5 between col lines 8 and 9 – Looking East –Buckled, Cracked and Shear floor slabs

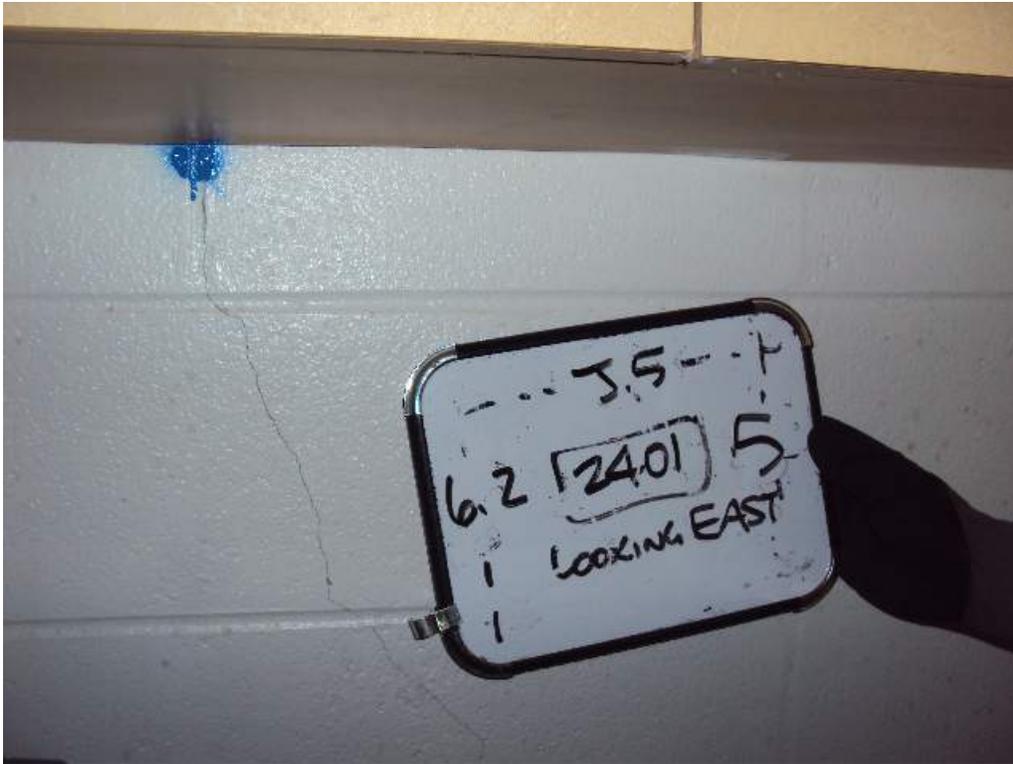
Photo 86: 2nd Floor – Room 2401– Along col line J.5 between col lines 5 and 6.2 – Looking East –Stair step/vertical crack in CMU wall

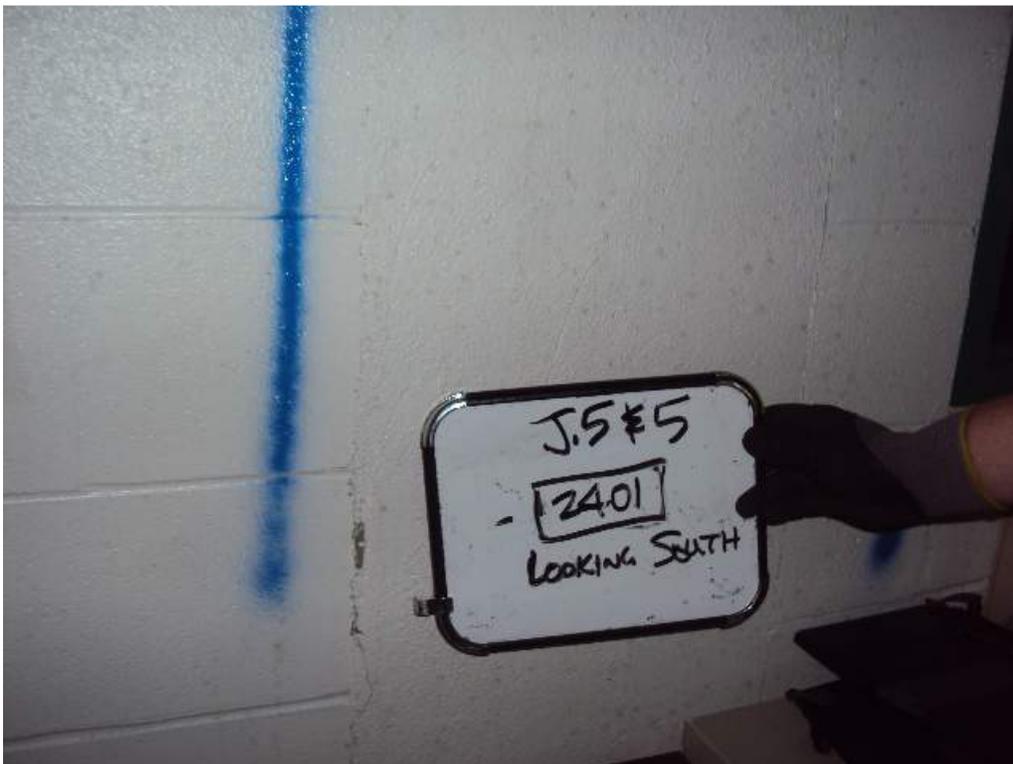
Photo 87: 2nd Floor – Room 2401– At col lines J.5 and 5 – Looking South –Vertical crack between conc col and CMU wall

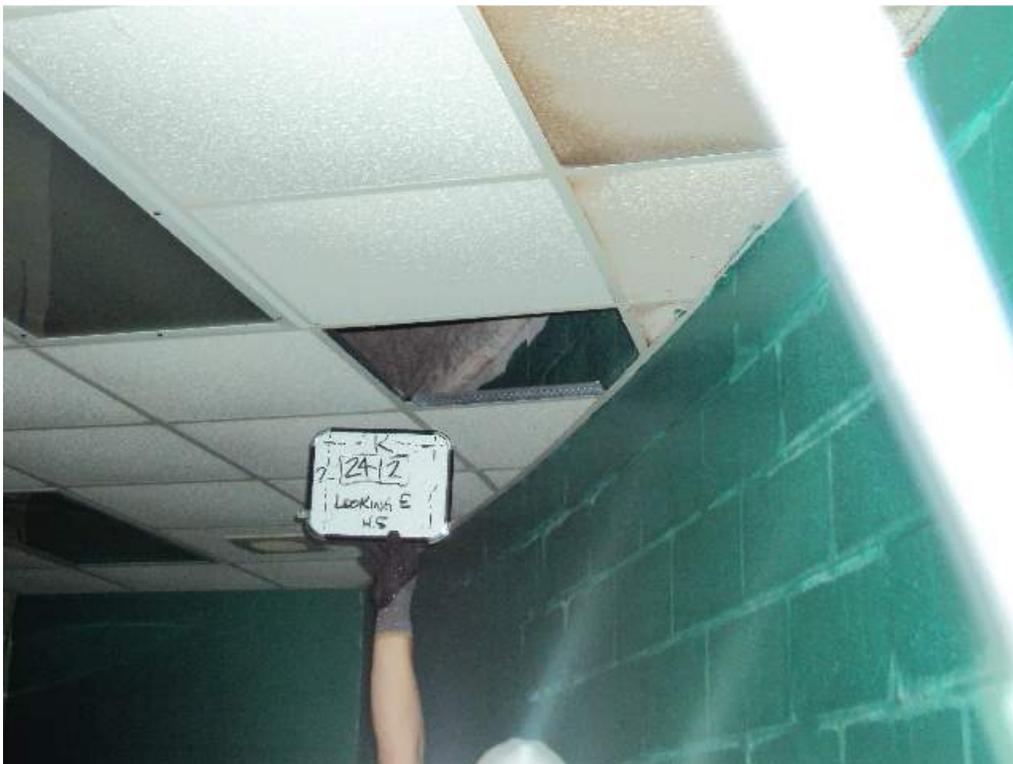
Photo 91: 2nd Floor – Room 2412– Adjacent to col line 2K – Looking East –Collapsed portion of CMU wall below 3rd floor slab

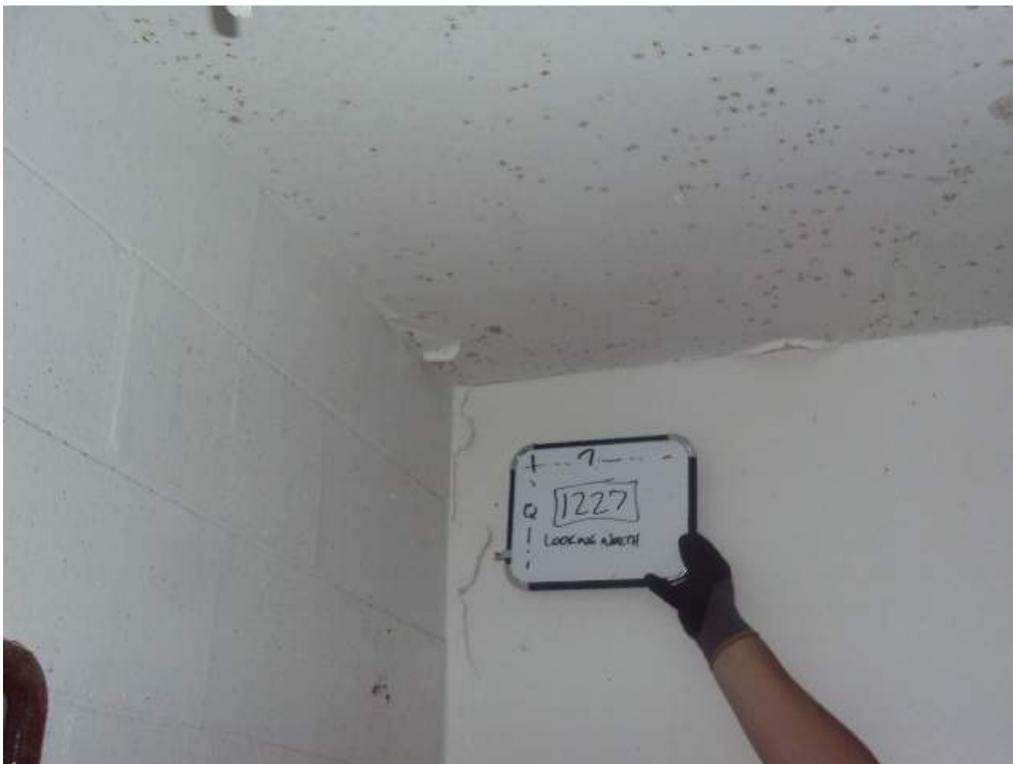
Photo 93: 1st Floor – Room 1227– Adjacent to col line 7Q– Looking North–Vertical cracks at CMU wall corner

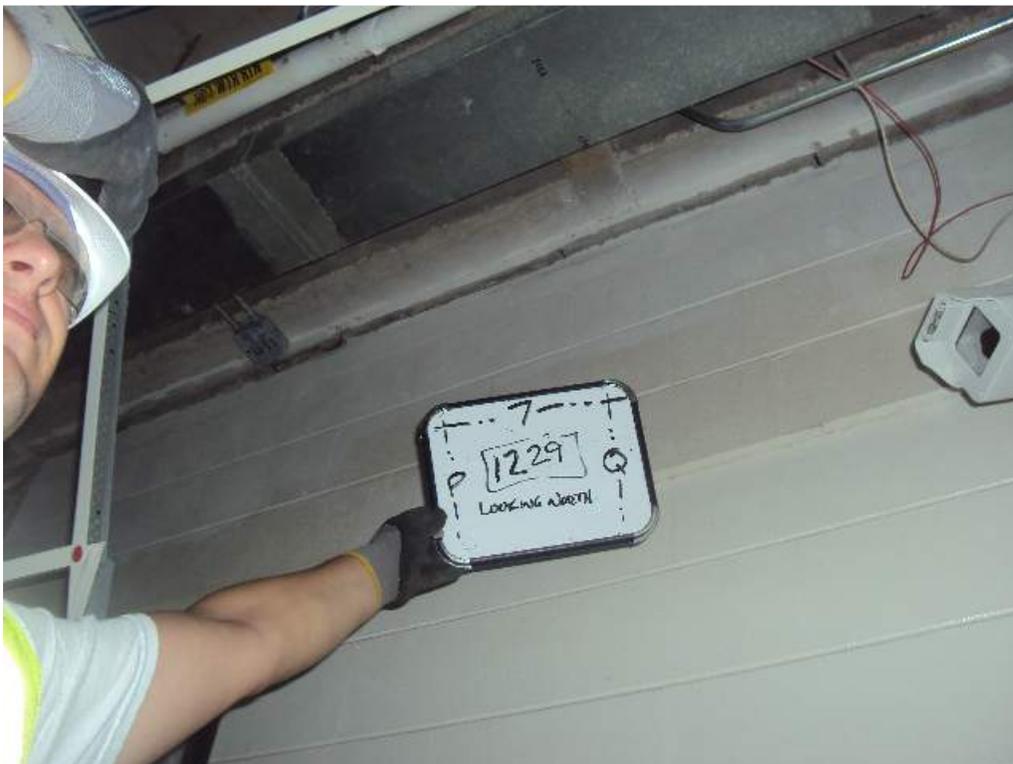
Photo 95: 1st Floor – Room 1229– Along col line 7 between col lines P and Q– Looking North–Displaced CMU wall between col lines P and Q

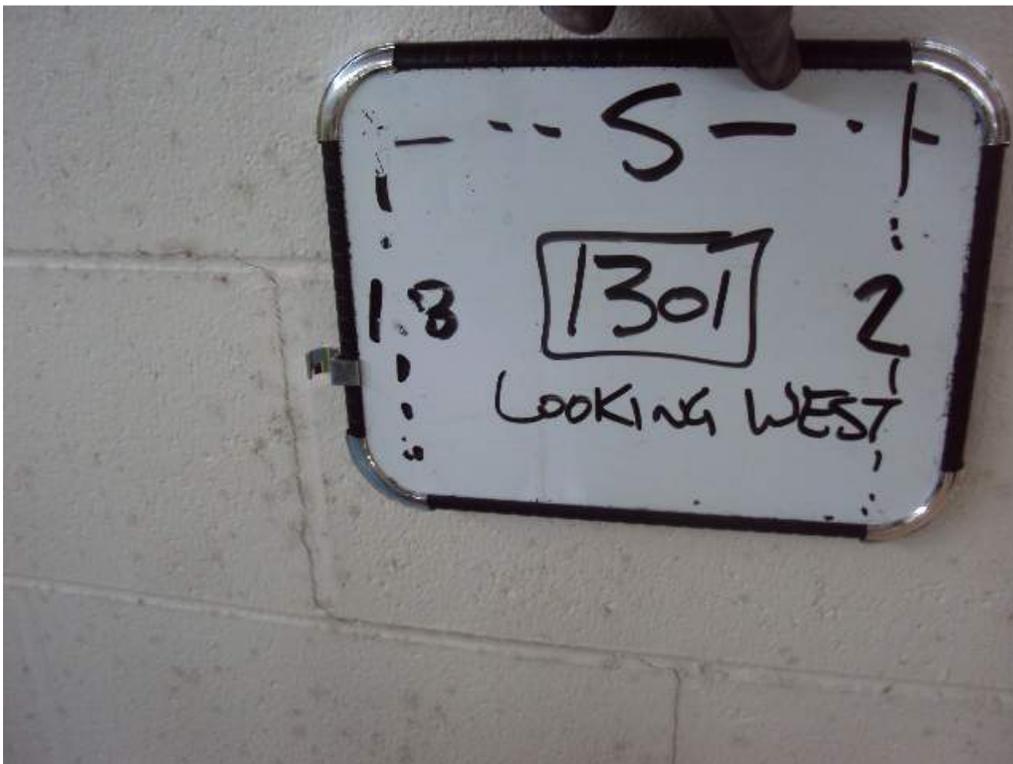
Photo 99: 1st Floor – Room 1301– Along col line S between col lines 1.8 and 2– Looking West-Stair step crack in CMU wall

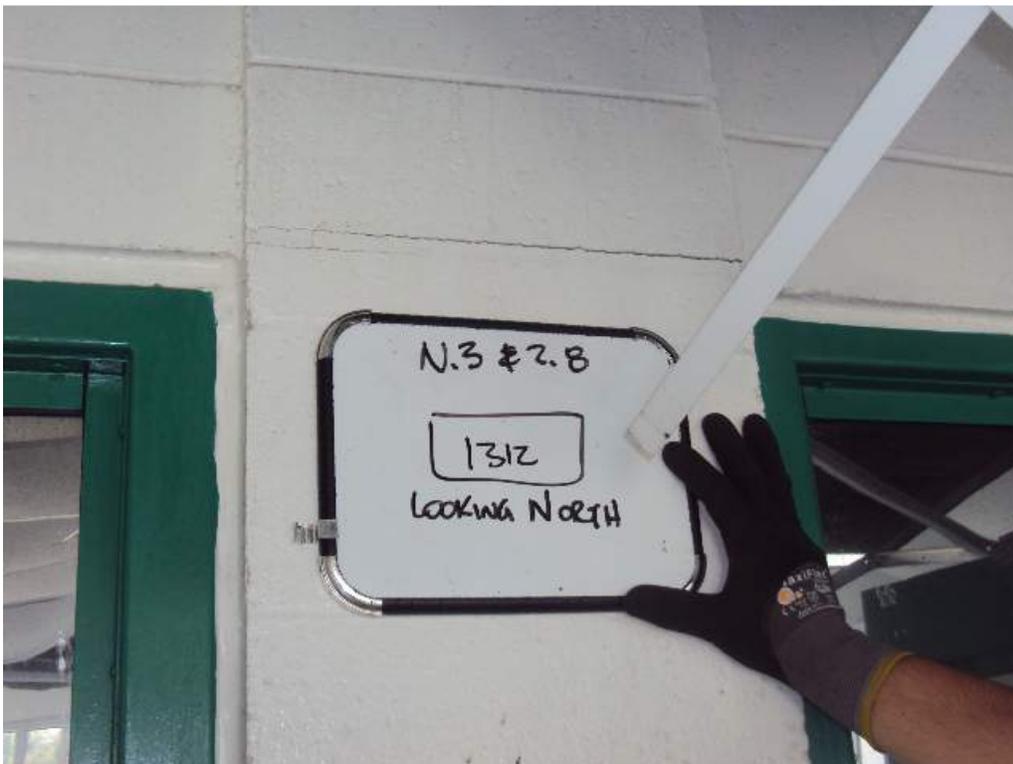
Photo 101: 1st Floor – Room 1312– Col lines N.3 and 2.8 – Looking North – Horizontal crack in CMU column and wall

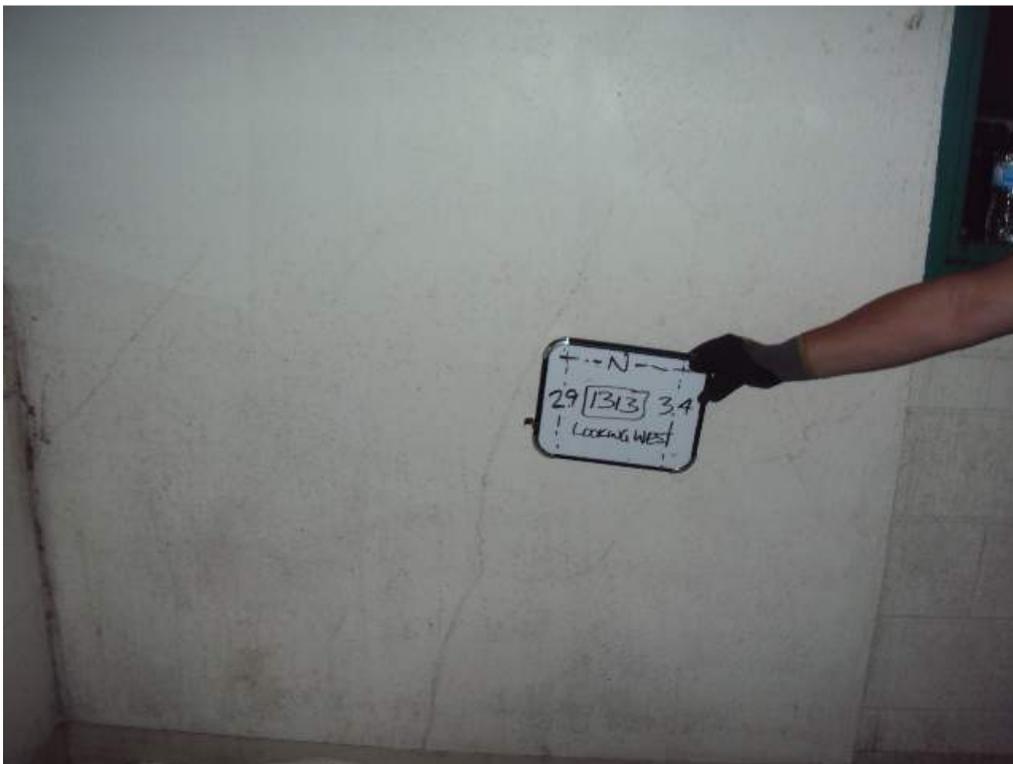
Photo 103: 1st Floor – Room 1313– Adjacent to col lines N and 2.9 and 3.4 – Looking West – Map cracking in wall

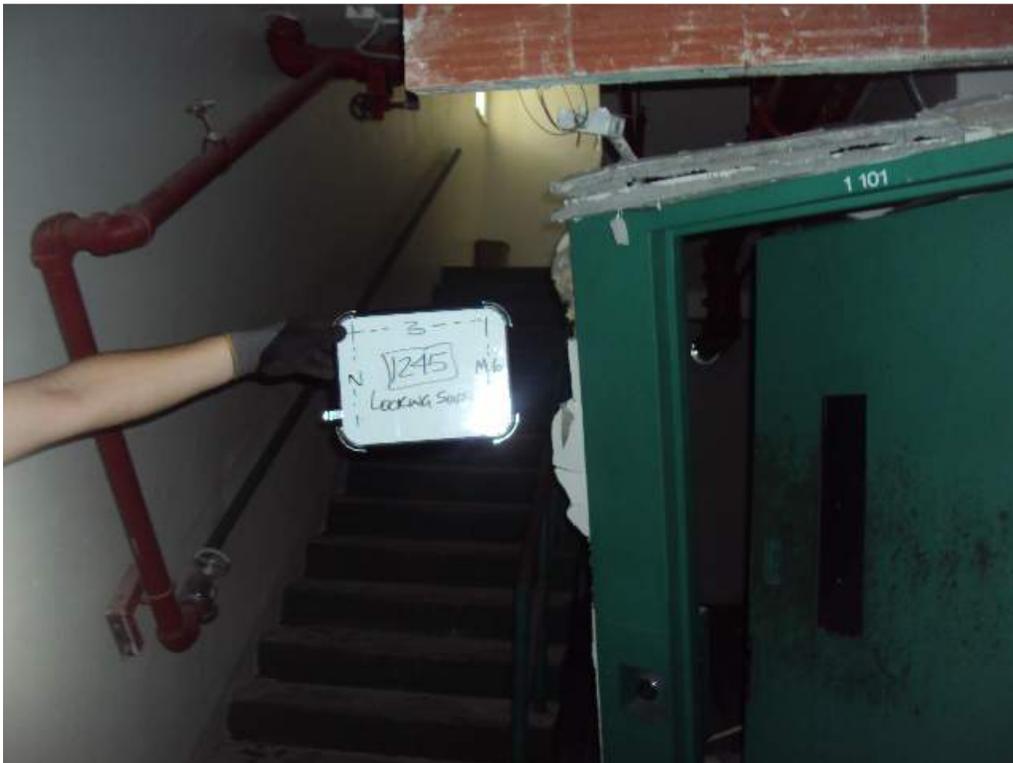
Photo 105: 1st Floor – Room 1245– Along col line 3 between M.6 and N – Looking South – Collapsed CMU wall

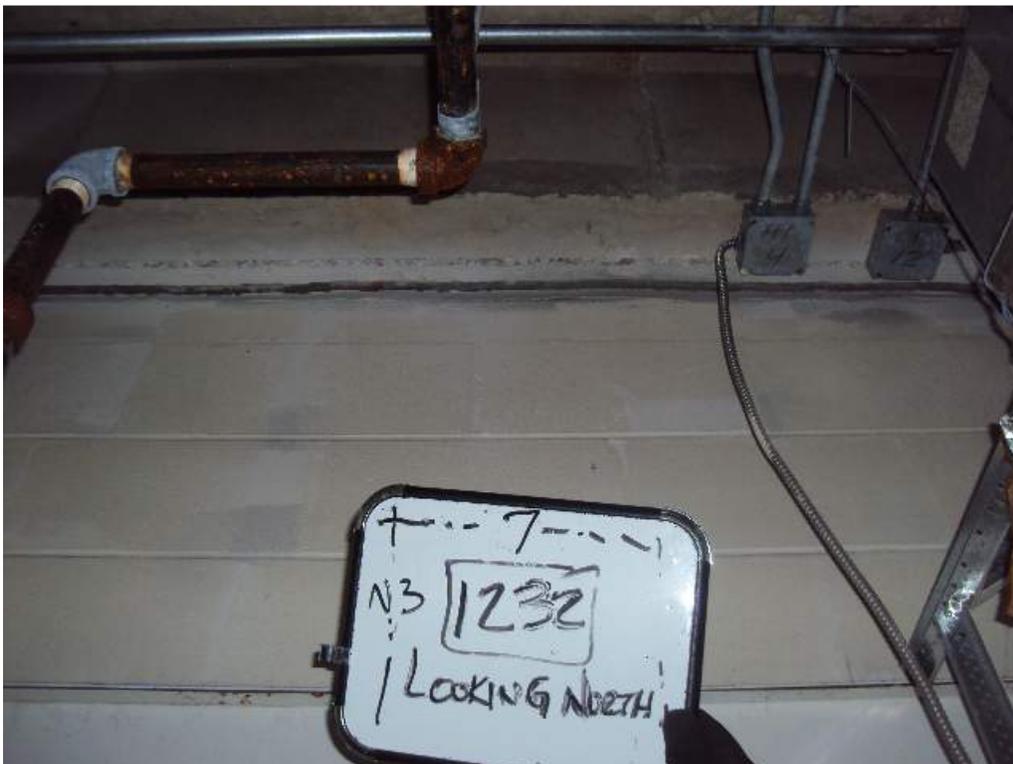
Photo 107: 1st Floor – Room 1232– Along col line 7 adjacent to N3 – Looking North – Displaced CMU wall

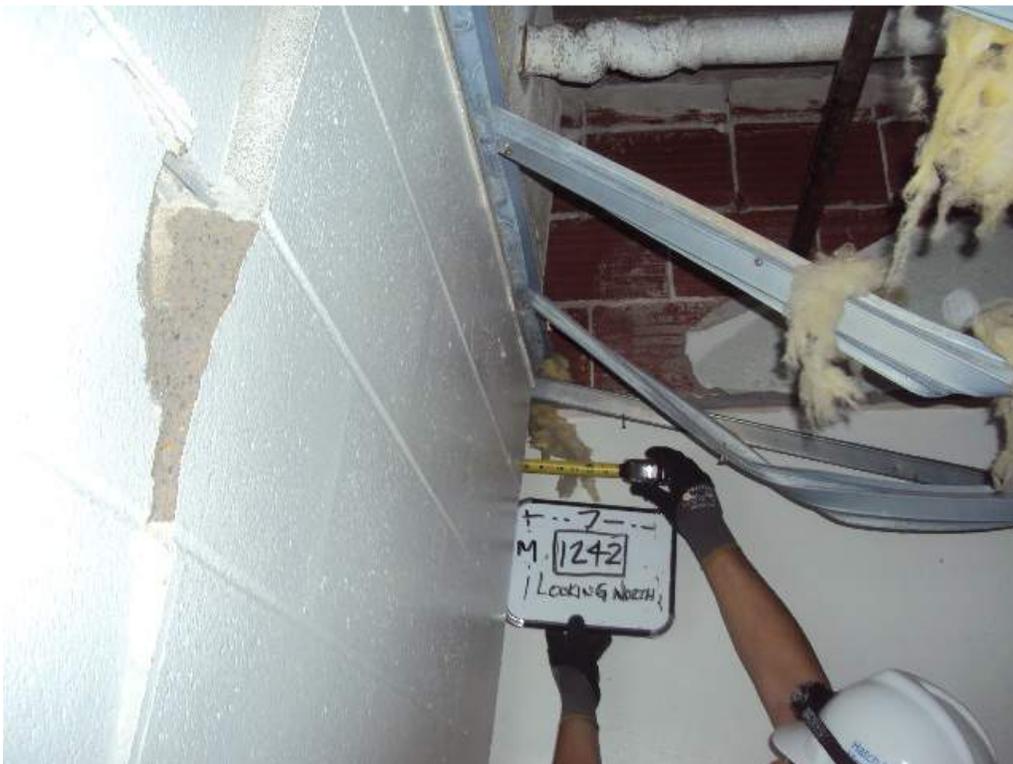
Photo 109: 1st Floor – Room 1242– Along col line 7 and M – Looking North – Sheared, displaced and partially collapsed CMU wall

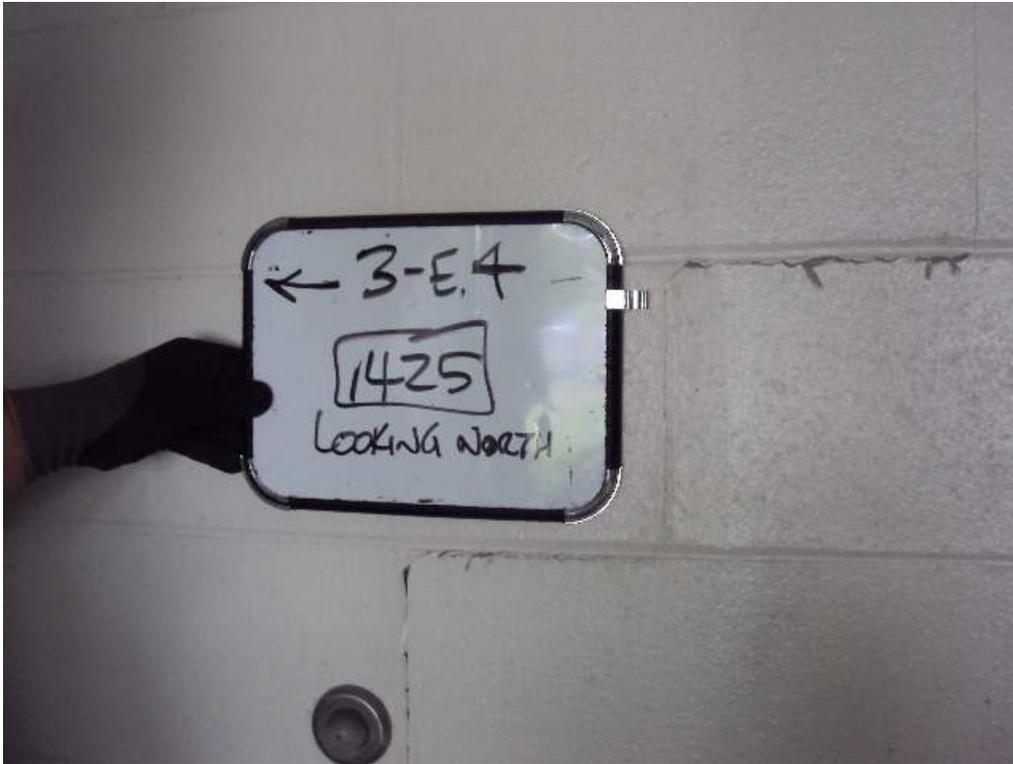
Photo 112: 1st Floor – Room 1425– Adjacent to col line 3/E.4 – Looking North – Stair step crack in CMU wall

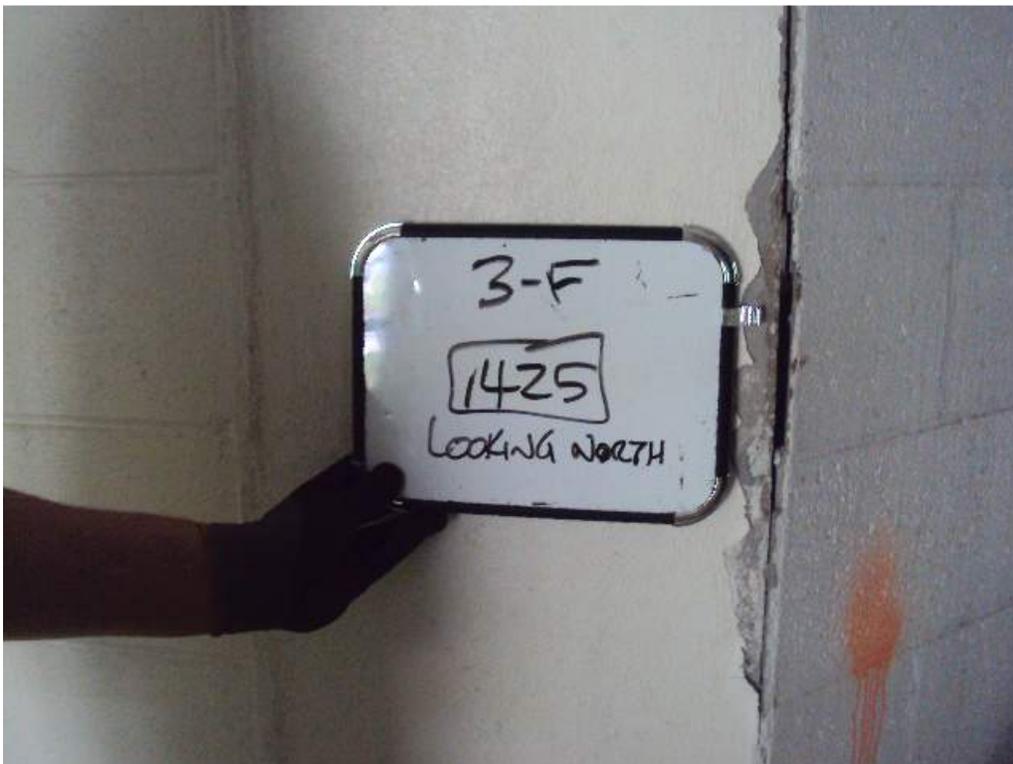
Photo 113: 1st Floor – Room 1425– At col line 3-F – Looking North – Vertical crack between concrete col and CMU wall along with CMU displacement

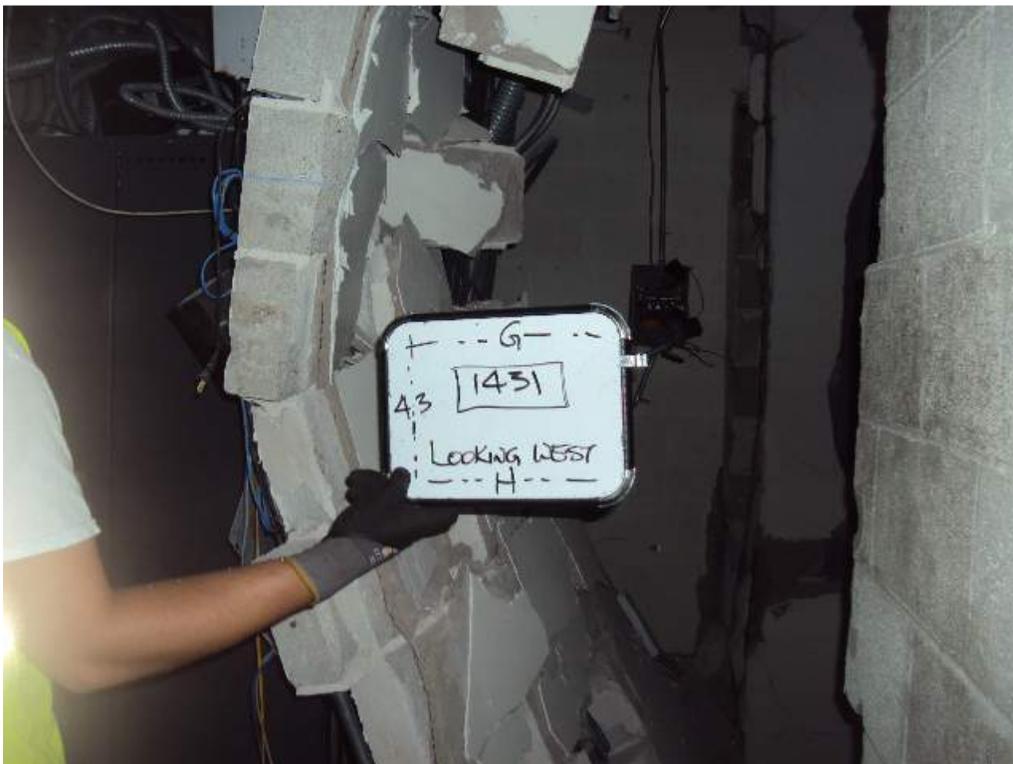
Photo 115: 1st Floor – Room 1431– Along col line 4.3 between col lines G and H – Looking West – Collapsed CMU wall

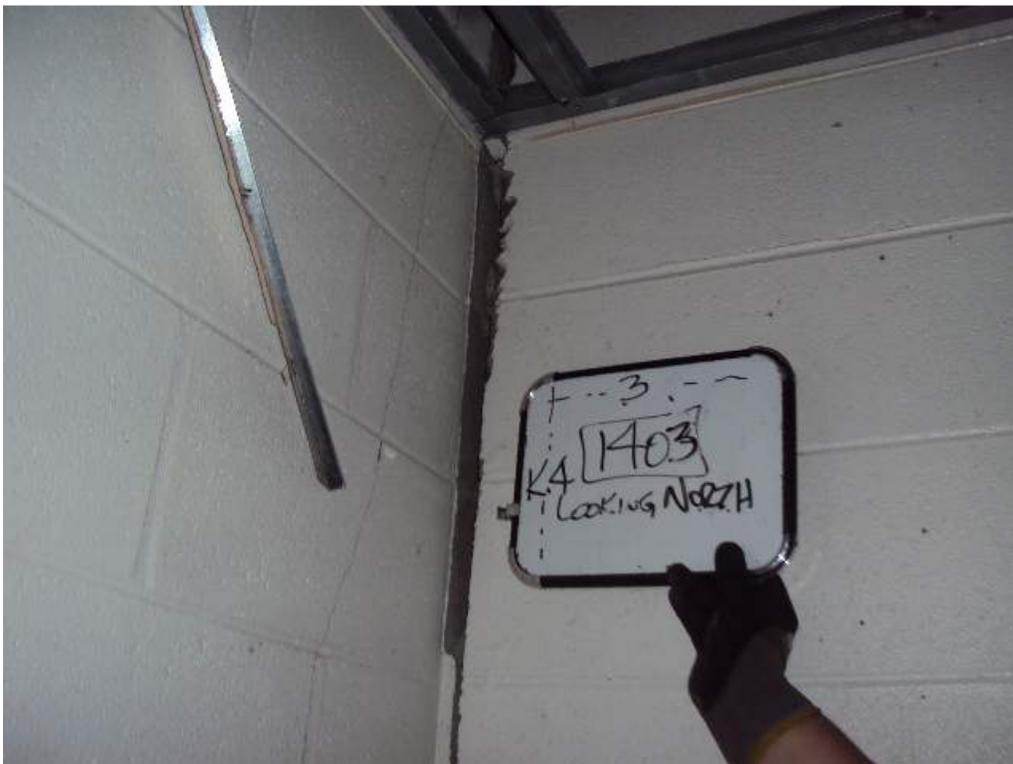
Photo 117: 1st Floor – Room 1403– Along col line K4 adjacent to col line 3 – Looking North– Vertical crack at CMU wall corner along with wall displacement

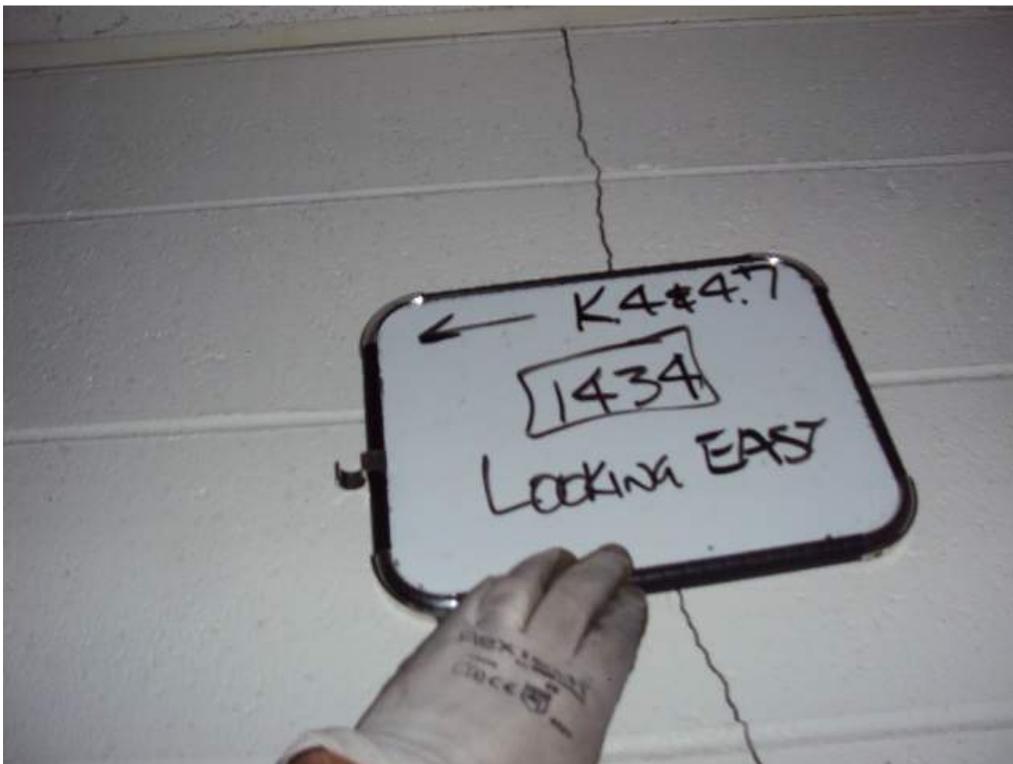
Photo 119: 1st Floor – Room 1434– Adjacent to col line K4 and 4.7 – Looking East– Vertical crack in CMU wall

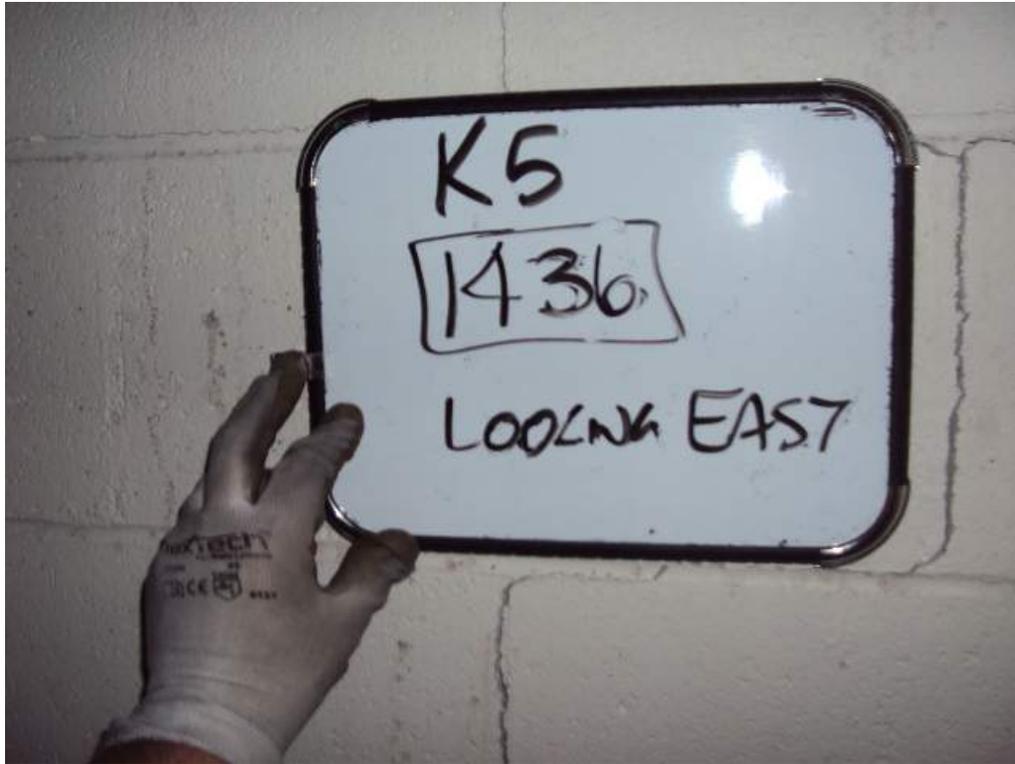
Photo 120: 1st Floor – Room 1436– At col line K5 – Looking East– Stair step crack in CMU wall

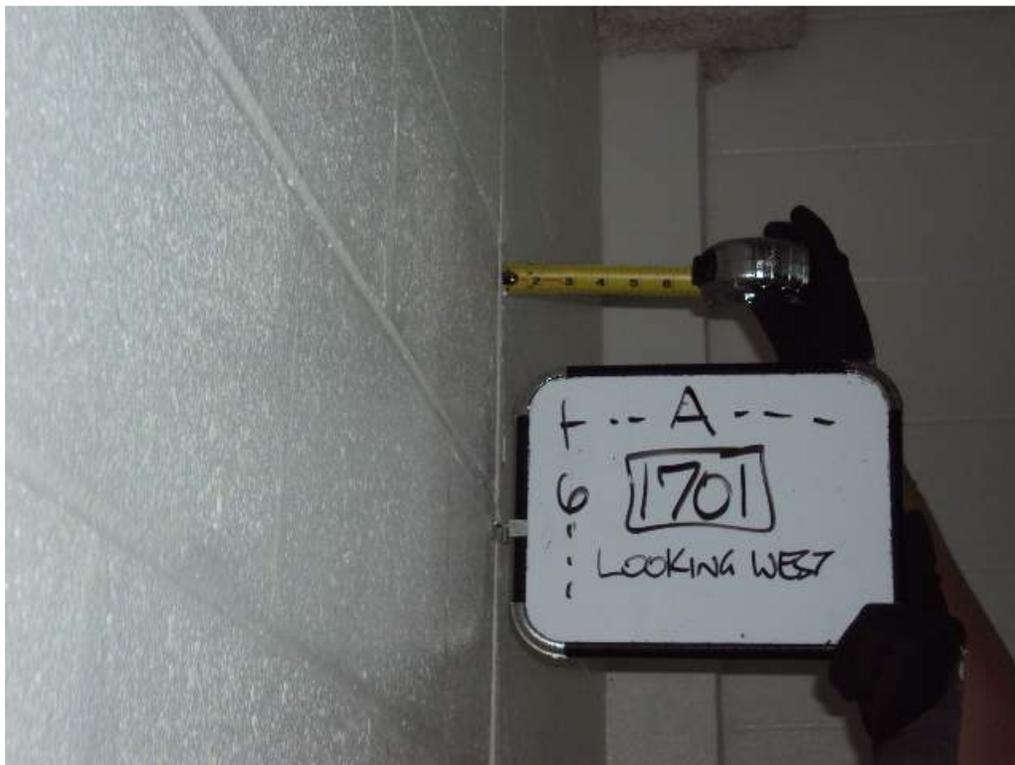
Photo 121: 1st Floor – Room 1701– Along col line 6 adjacent to A – Looking West– Displaced CMU wall

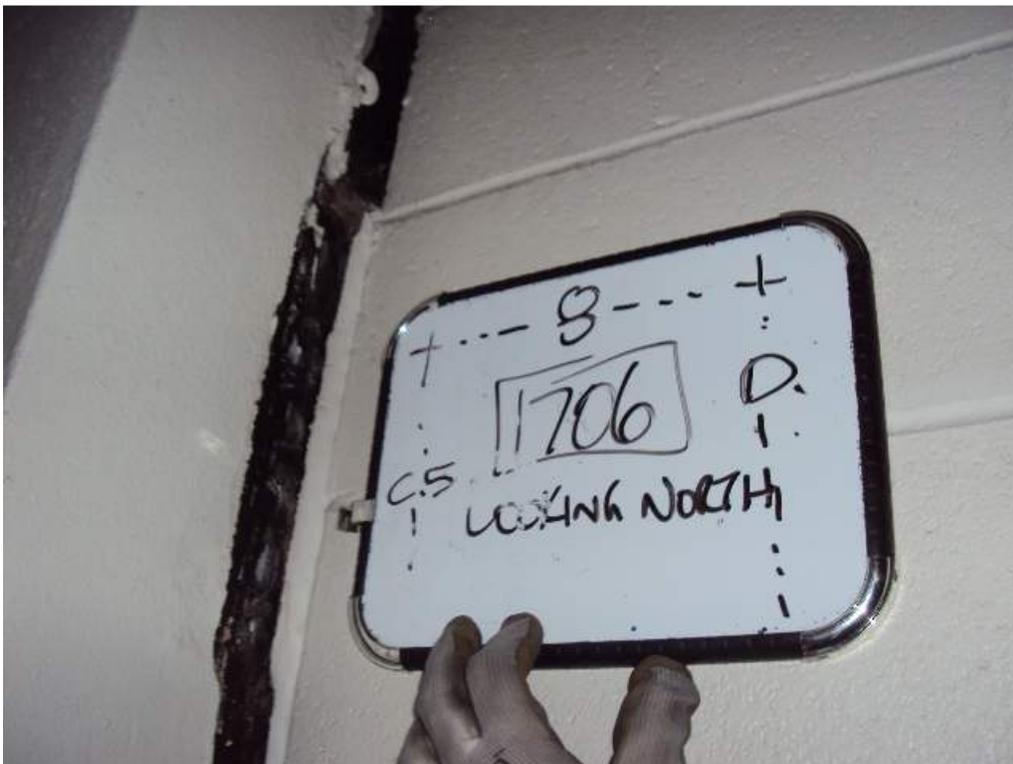
Photo 123: 1st Floor – Room 1706– Along col line 8 between C and D– Looking North– Displaced CMU wall

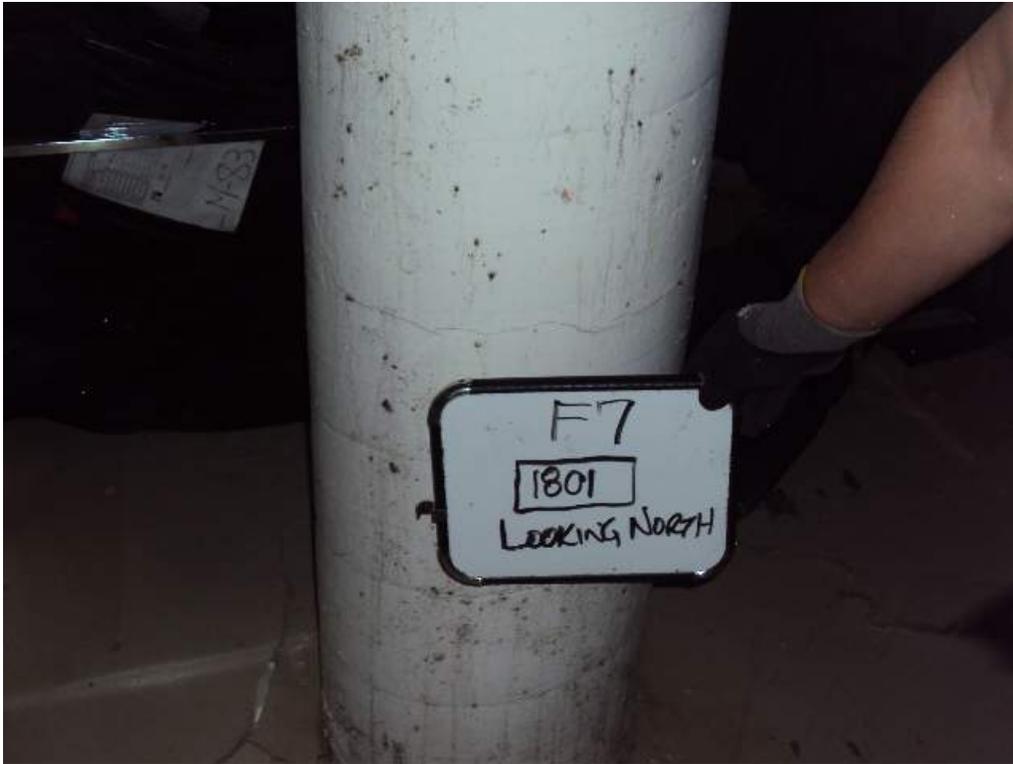
Photo 130: 1st Floor –Room 1801 – At col line F7 – Looking North – Cracked columns

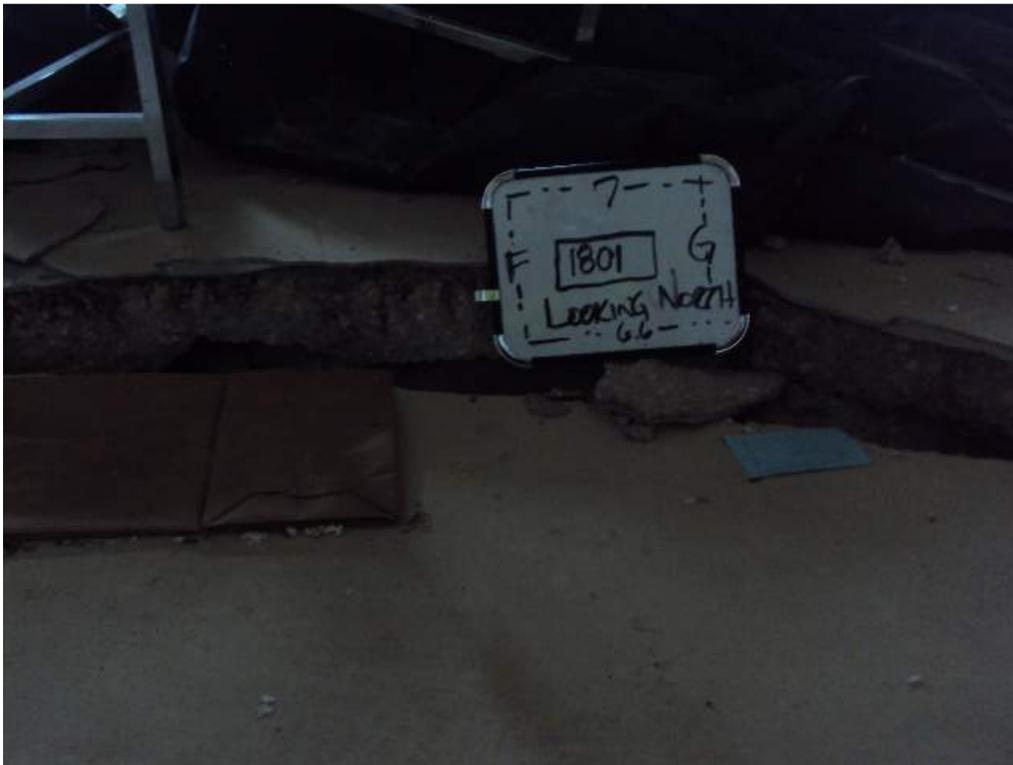
Photo 131: 1st Floor –Room 1801 – Between column lines 6.6 and 7 & F and G – Looking North – Sheared concrete slab

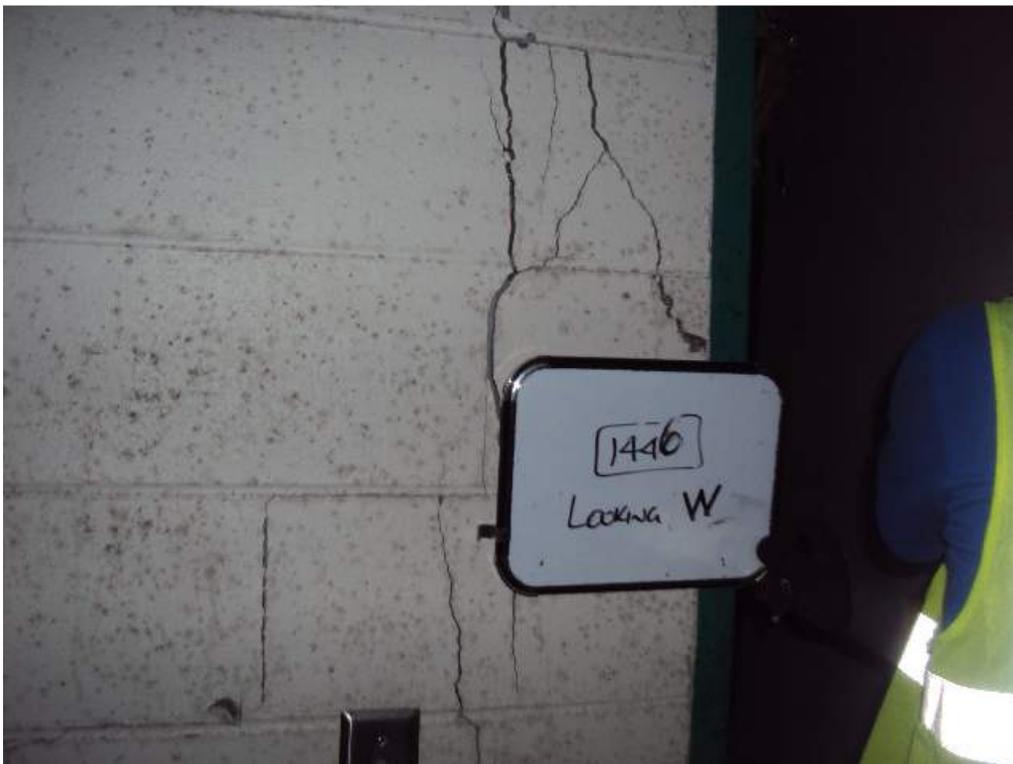
Photo 139: 1st Floor -Room 1446 - Between column lines G and H & 5 and 5.5 - Looking West- Severe map cracking in CMU wall

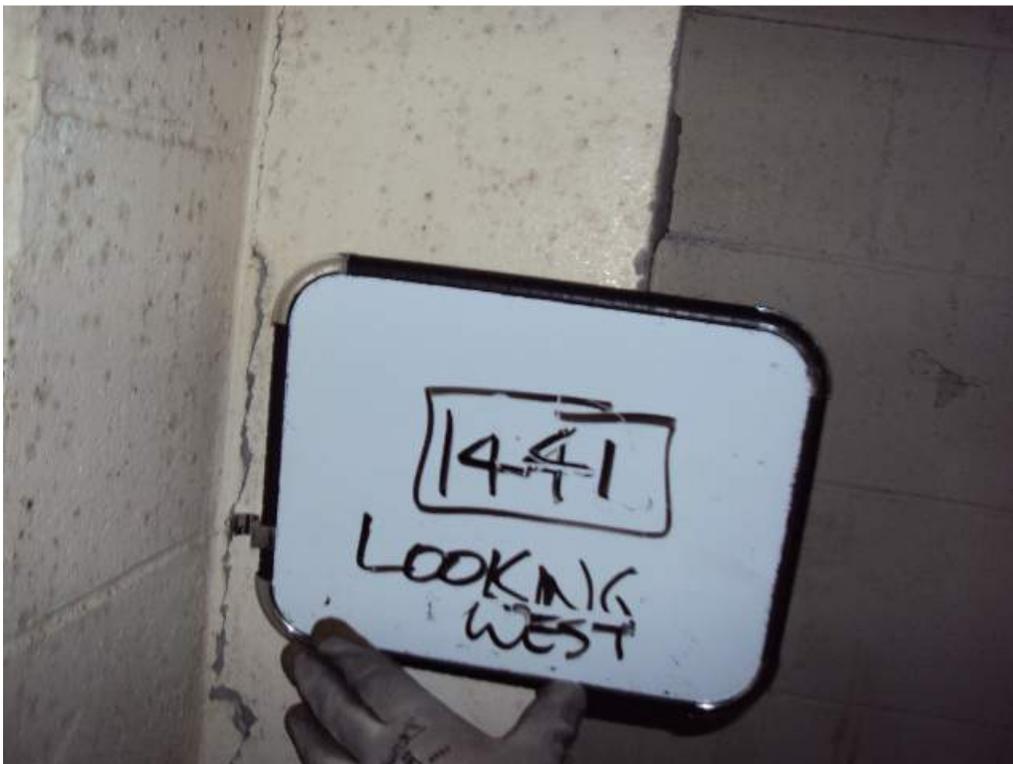
Photo 141: 1st Floor –Room 1441 – At column lines K.4 and 6.6 – Looking West– Vertical crack between concrete column and CMU wall

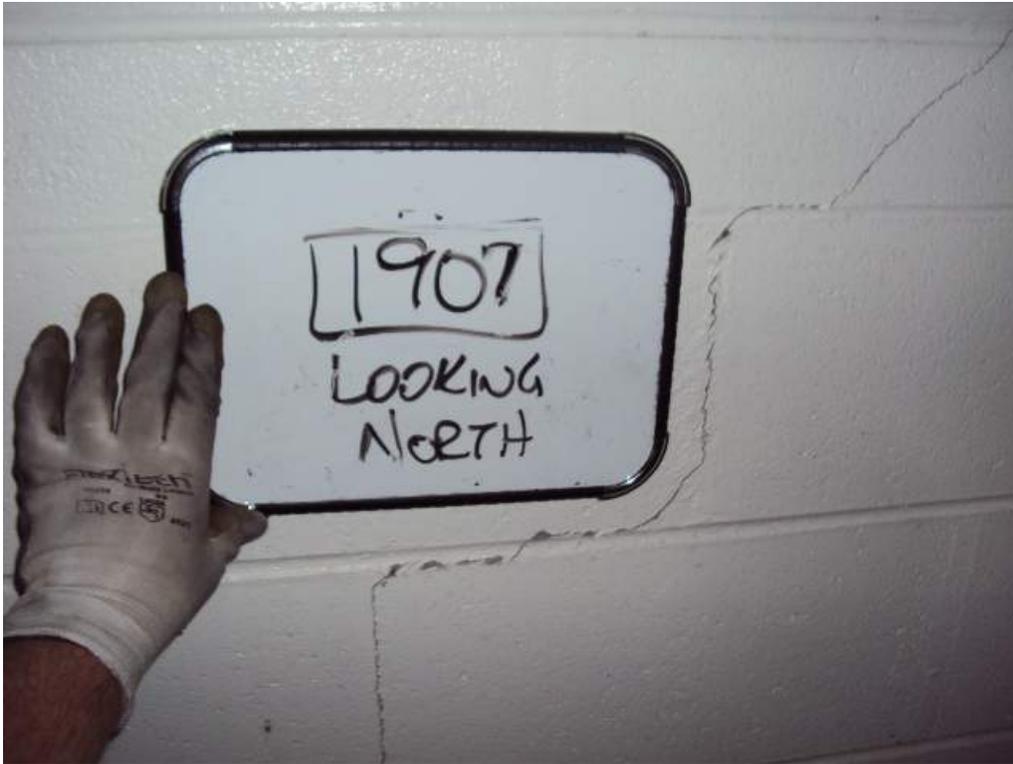
Photo 146: 1st Floor –Room 1907 – Along col line 8 between col lines H.5 and J.5 – Looking North– Stair step crack in CMU wall

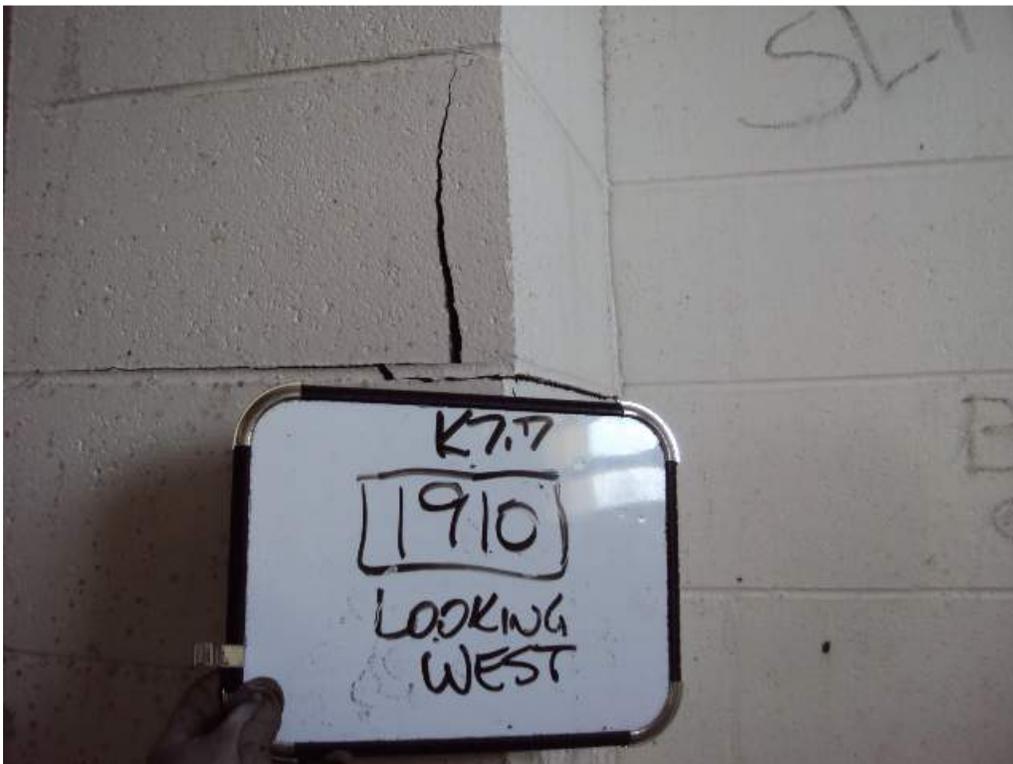
Photo 147: 1st Floor –Room 1910 – At col line K.7 and 7 – Looking West– Vertical and horizontal cracks CMU wall

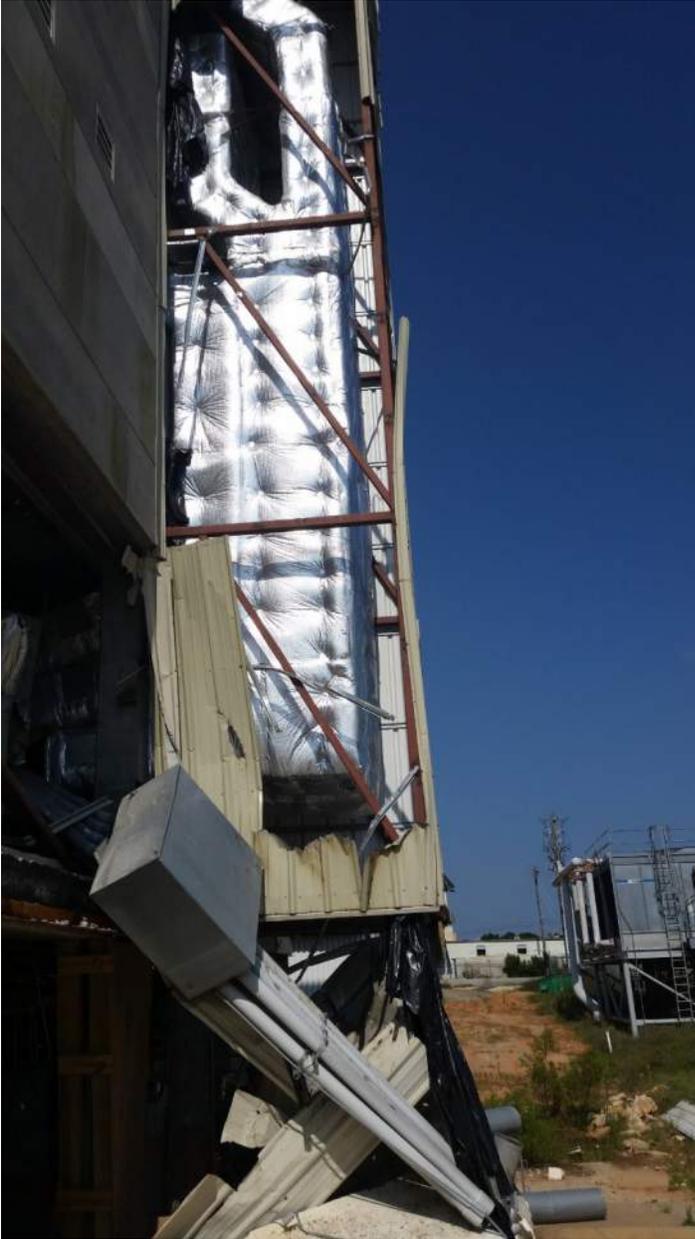
Ductwork on north side of building exposed to weather to be replaced.
