Asbestos & Lead Based Paint Assessment

City of Spartanburg
772 Howard Street
Spartanburg, South Carolina 29303

Project Number: 0118-14

August 14, 2018

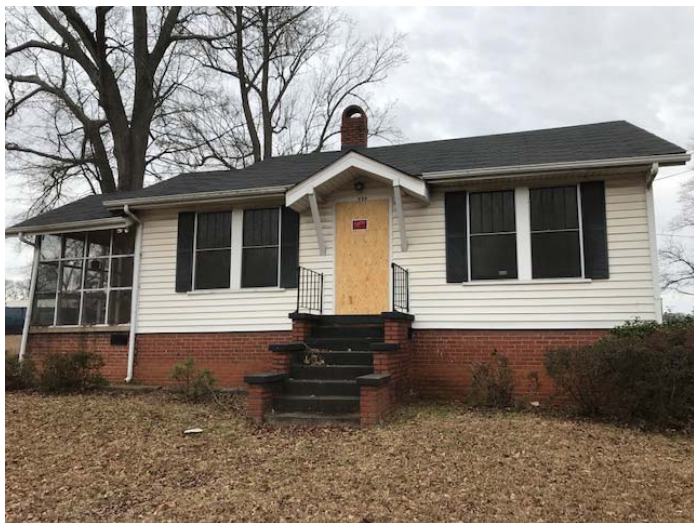
Photo 1 – 772 Howard Street in Spartanburg, South Carolina

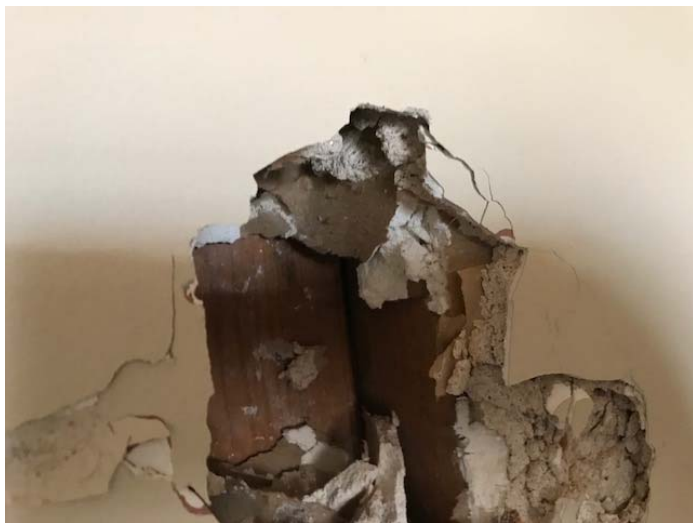
Photo 2 – Plaster with finish over unfinished drywall throughout

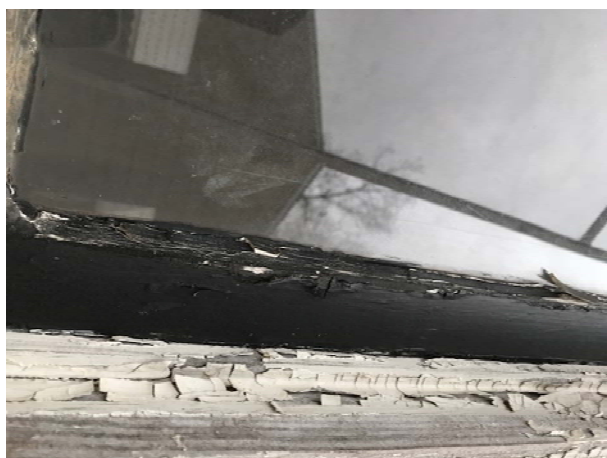
Photo 3 – Wooden window glazing

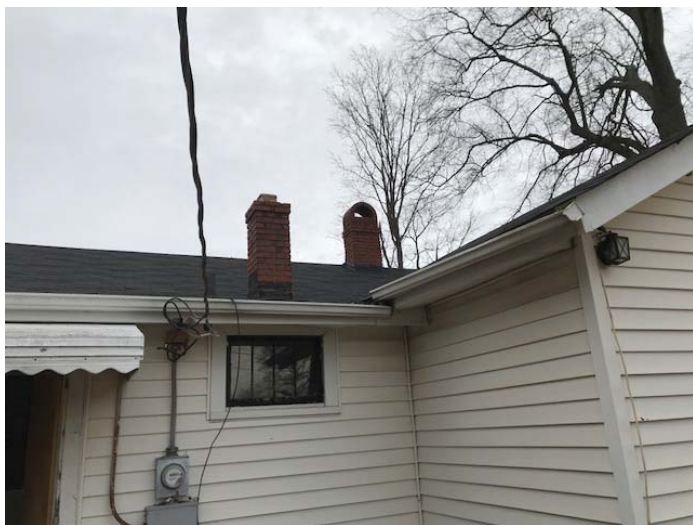
- Approximately 175 SF of brick pattern vinyl floor & mastic in the kitchen (floor tile exists under the brick pattern vinyl floor and mastic).
- Approximately 12 LF of mastic/tar on 2 chimneys – assumed positive.

Photo 4 – 2 chimneys with mastic/tar – assumed positive & roof shingles & felt

1. Abate the asbestos containing materials in the structure prior to renovation or demolition.
2. Follow applicable asbestos regulations during renovation or demolition of the structure. You should be aware that stringent requirements are imposed upon anyone renovating or demolishing a structure in which ACM will be disturbed. This work must be performed in accordance with OSHA asbestos regulations, 29 CFR 1910 & 1926, and NESHAP asbestos regulations 40 CFR 61, subpart M. South Carolina regulations require the accreditation of personnel who work in the asbestos field and notification and permitting fees for asbestos removal projects. There is a 10 working day notification period required prior to abatement of asbestos in a facility. Failure to take proper precautions and actions to protect human health and the environment can result in penalties, danger to personnel, and construction delays.

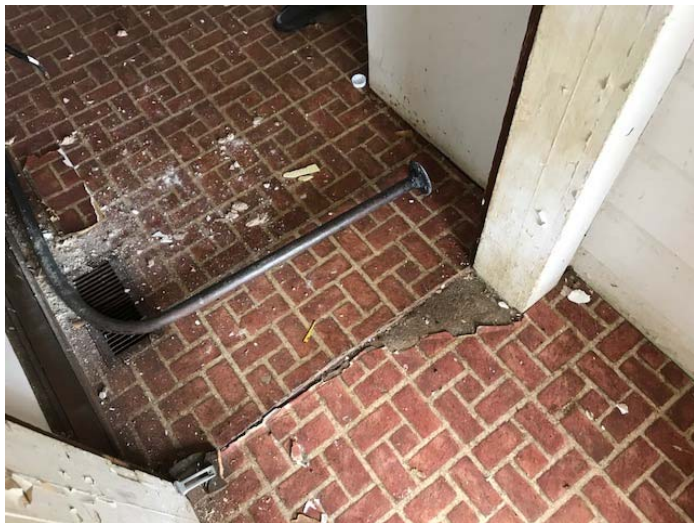
Photo 5 – Brick pattern roll vinyl & mastic over 9" x 9" tan floor tile & mastic in the kitchen

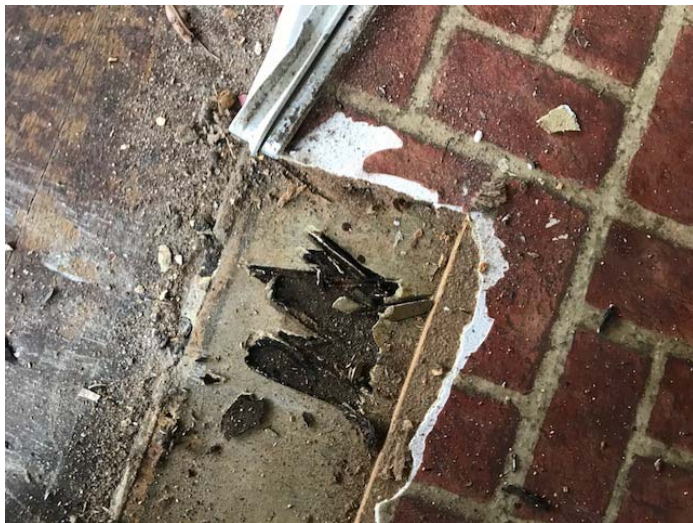
Photo 6 – Brick pattern roll vinyl & mastic over 9" x 9" tan floor tile & mastic in the kitchen

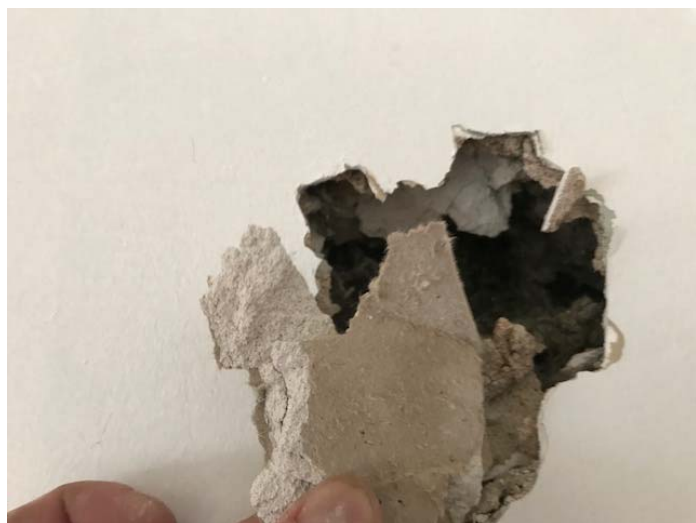
Photo 7 – Plaster with finish over unfinished drywall throughout

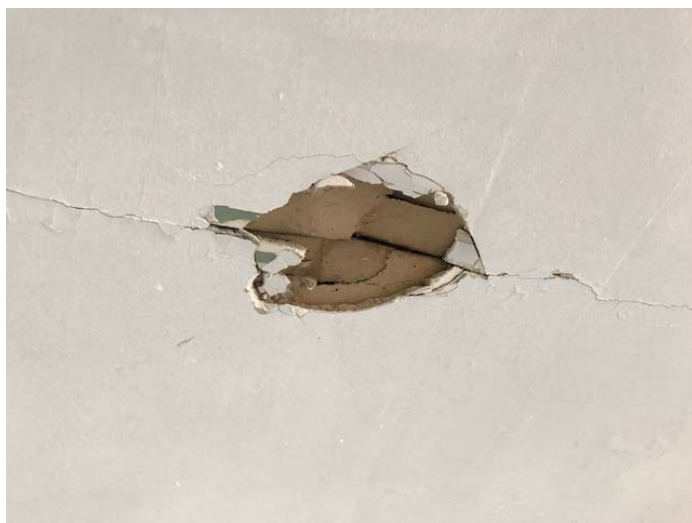
Photo 8 – Plaster with finish over unfinished drywall throughout

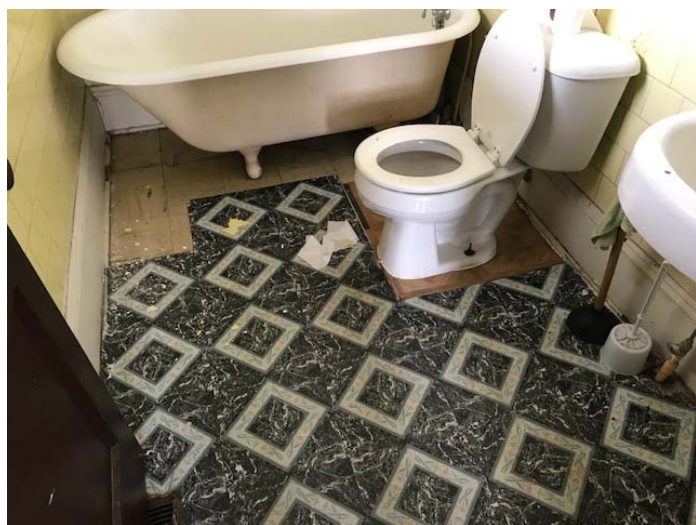
Photo 9 – Black/grey self-stick floor tile & mastic over 9" x 9" yellow floor tile & mastic & wooden pattern self-stick floor tile & mastic in the bathroom

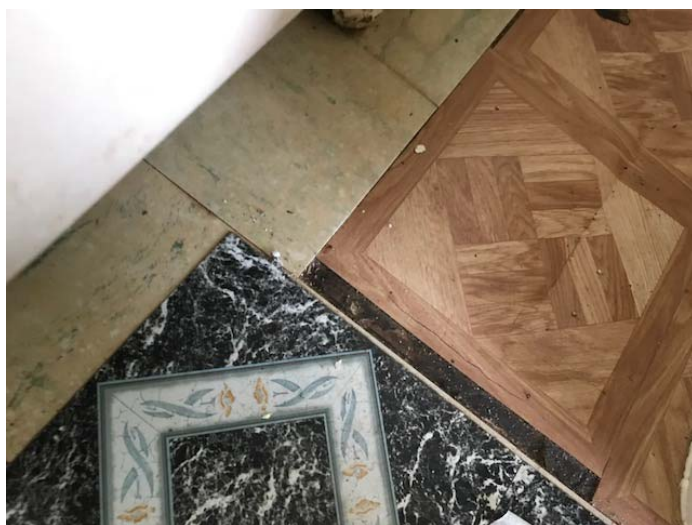
Photo 10 – Black/grey self-stick floor tile & mastic over 9" x 9" yellow floor tile & mastic & wooden pattern self-stick floor tile & mastic in the bathroom
