Asbestos & Lead Based Paint Assessment

City of Spartanburg
780 Howard Street
Spartanburg, South Carolina 29303

Project Number: 0118-14

August 14, 2018

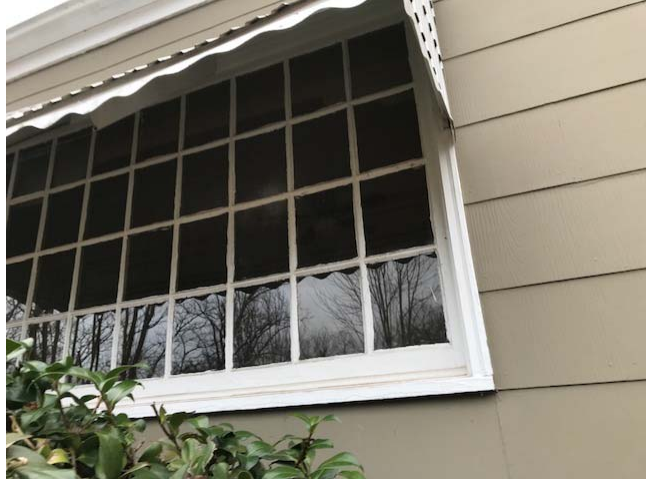
Photo 2 – Transite siding and window glaze.

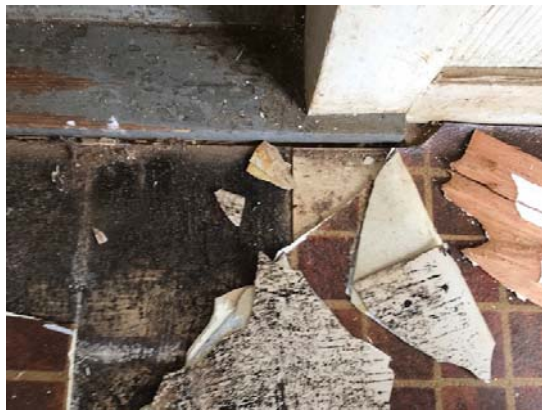
Photo 3 – Two layers of flooring and mastic in utility room.

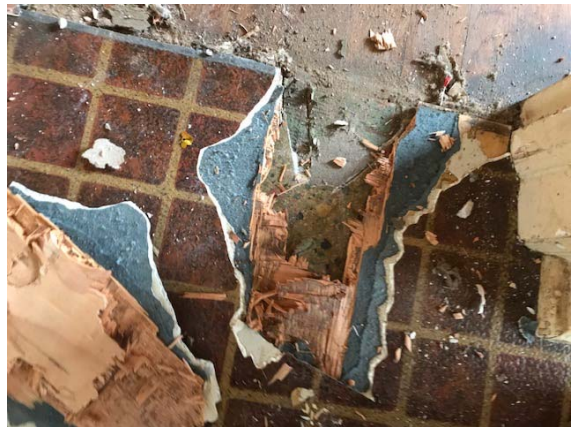
Photo 4 – Kitchen 3 layers of flooring, 3rd under layer of wood.

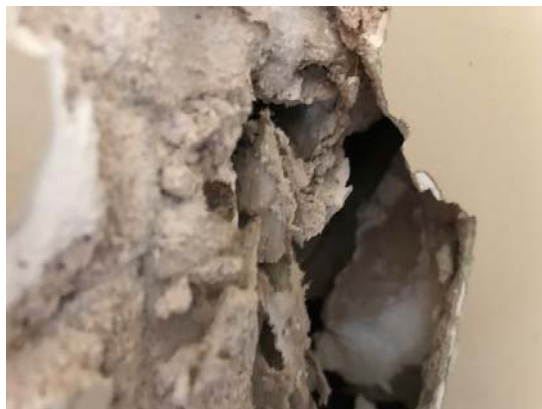
Photo 5 – Plaster over unfinished drywall walls.

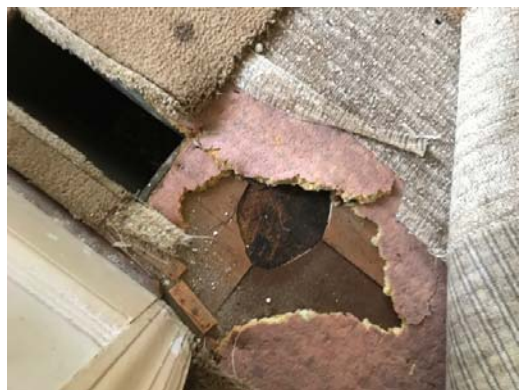
Photo 6 – Two colors of vinyl tile and mastic under carpet in living room.

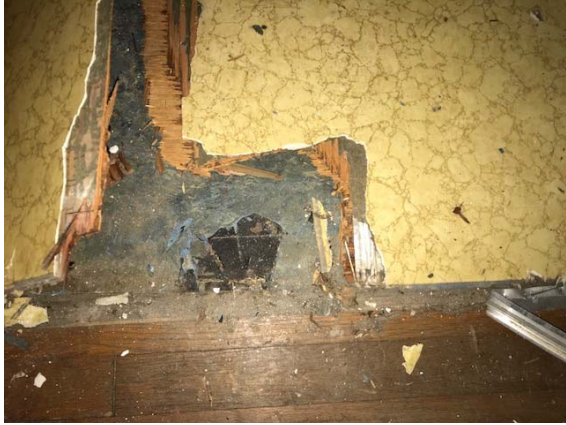
Photo 7 – Bathroom roll vinyl over wood over vinyl tile with mastic.

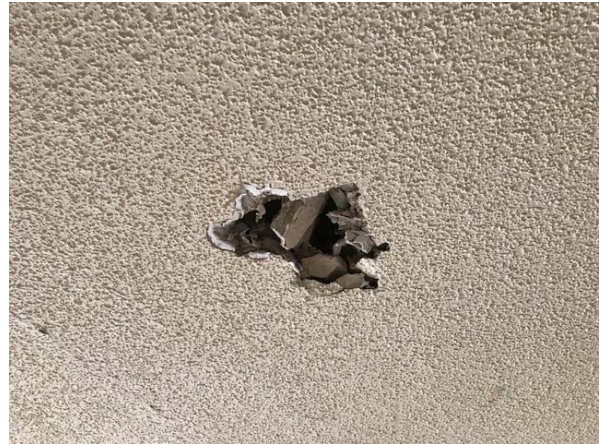
Photo 8 – Ceiling texture in living room and dining room.
