**STRUCTURAL ASSESSMENT
OF
MARSHWALK AND VETERANS PIER
MURRELLS INLET, SC
EW #: 161166.003**

February 24, 2021

**GEORGETOWN COUNTY
PARKS AND RECREATION DEPARTMENT**

**The EARTHWORKS Group
11655 HIGHWAY 707
MURRELLS INLET, SC 29576
843-651-7900**

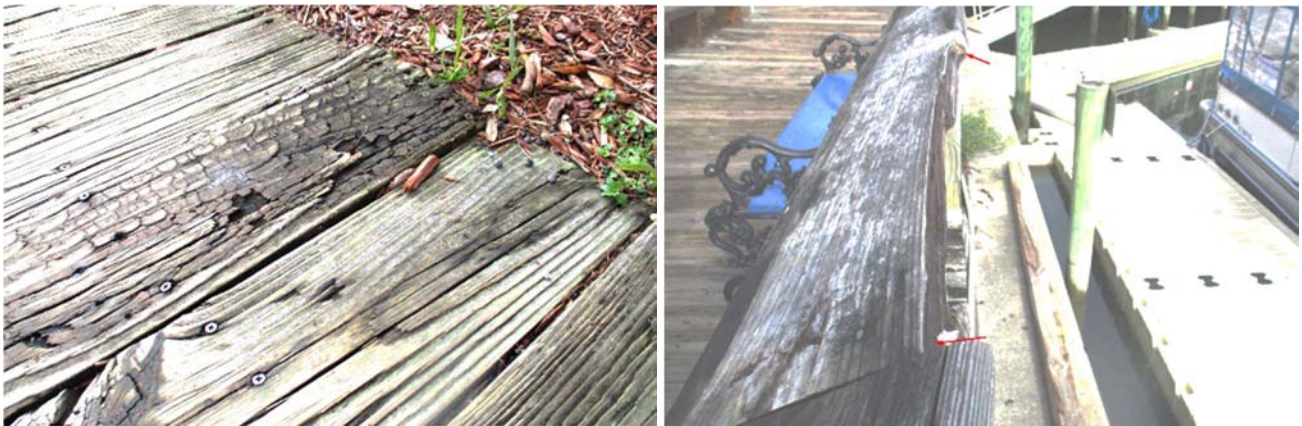
The boardwalk decking consists of treated 2x8s attached to the joists using galvanized or coated screws. Structural damage, including wood rot from moisture and splitting/checking of wood was observed in numerous locations consistent with exterior use (pedestrian traffic and environmental exposure to sun and rain).

The guardrail consists of 6x6 posts, 2x6 lower guardrail, a 2x6 middle guardrail, and a combination 2x6 and 2x12 cap rail screwed together for structural integrity. The guardrail in Phase 1A will require repairs due to damaged boards, corrosion of connectors, and other age related deterioration.

Photo 4 & 5 – Deteriorated wood decking and guardrails in Phase 1A due to age of materials

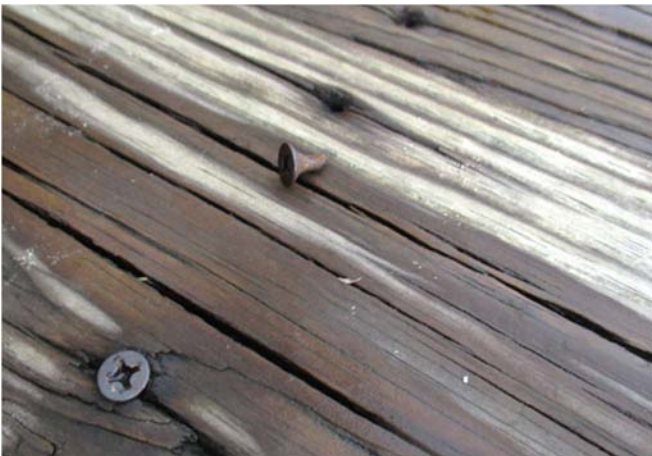
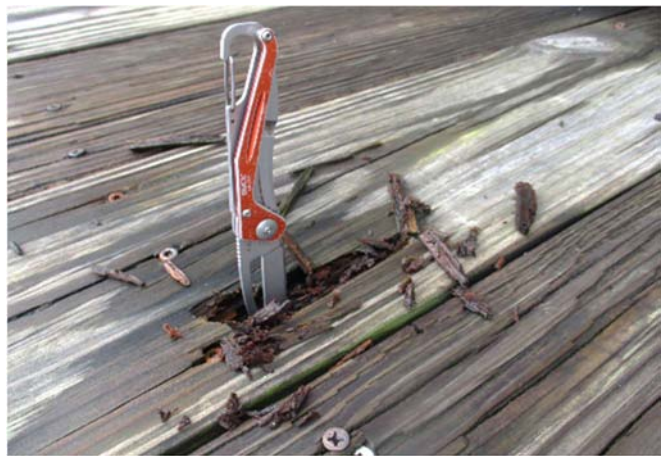
Corrosion of Metal Fasteners – Metal fasteners in this Phase were in various states of corrosion, with some fasteners completely corroded and other having light rust. The majority of the pile cap to joist connectors in this phase were in good condition and do not require replacement. A few of the galvanized

bolts connecting pile caps, braces, and guardrail posts were corroded and should be marked for replacement.

Photo 8 & 9 – Metal connector (screw) corrosion failure and wood deterioration of deck boards

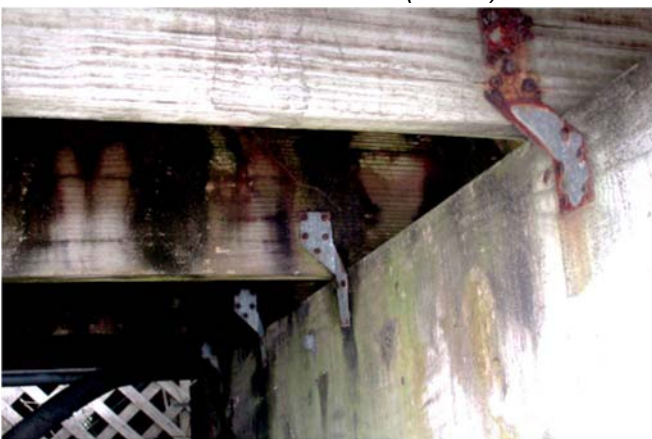
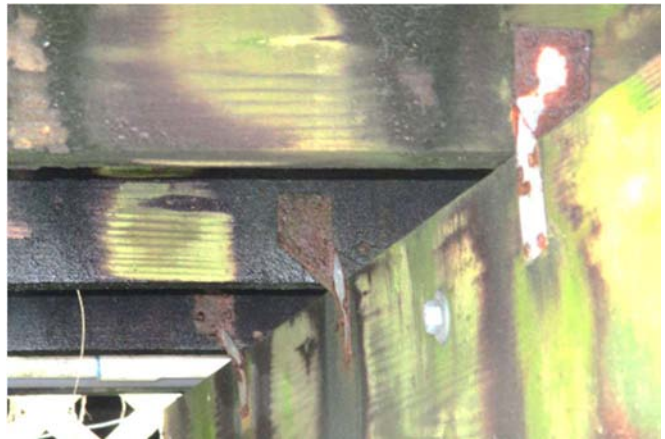
The boardwalk decking consists of treated 2x8s attached to the joists using galvanized or ceramic coated screws. Structural damage, including wood rot from moisture and splitting/checking of wood was observed in scattered locations consistent with exterior use (pedestrian traffic and environmental exposure to sun and rain).

Photo 10 & 11 – Metal connector (screw) corrosion failure and wood deterioration of deck boards

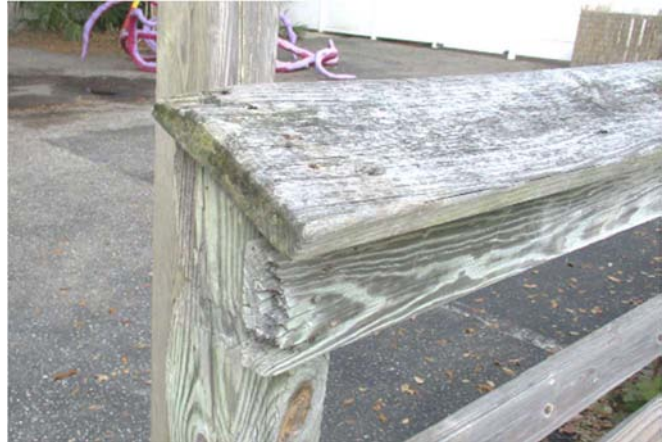
Photo 13 – Inside Guardrail cap deterioration

The guardrail consists of 6x6 posts, 2x6 lower guardrail, a 2x6 middle guardrail, and a combination 2x6 and 2x12 cap rail screwed together for structural integrity. The outside guardrail in Phase 1C was repaired in 2018, but the interior guardrail was not included with this work. Some portions of the inside guardrail show wood deterioration consistent with the age, including splitting and checking, as well as metal connector failure. Portions of the rails have been replaced, new connectors have been installed into the existing rails to replace corroded connectors.

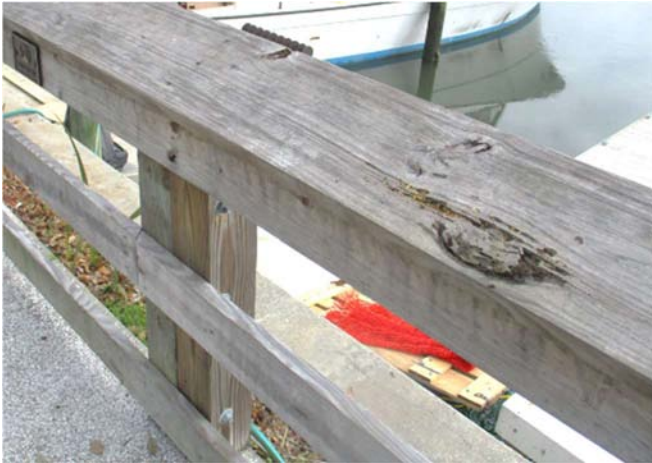
Photo 14 – Top rail deterioration due to knots

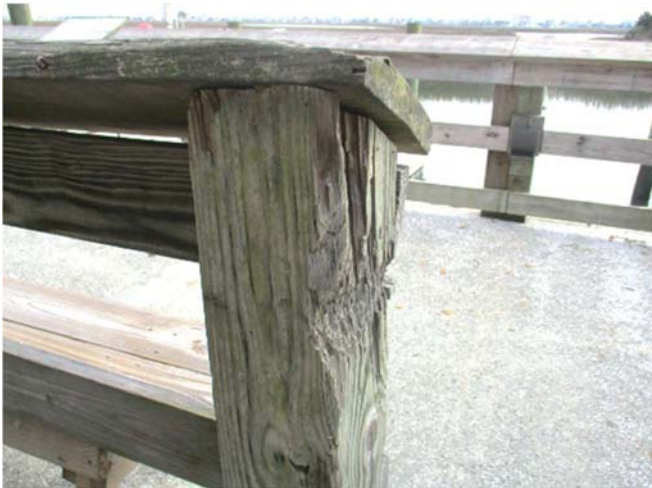
Photo 16 – Post damage at north entry point

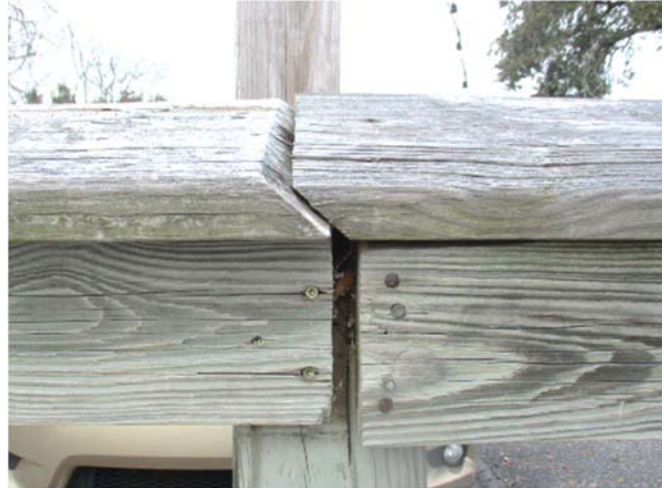
Photo 17 – Joint separation at post from shrinkage

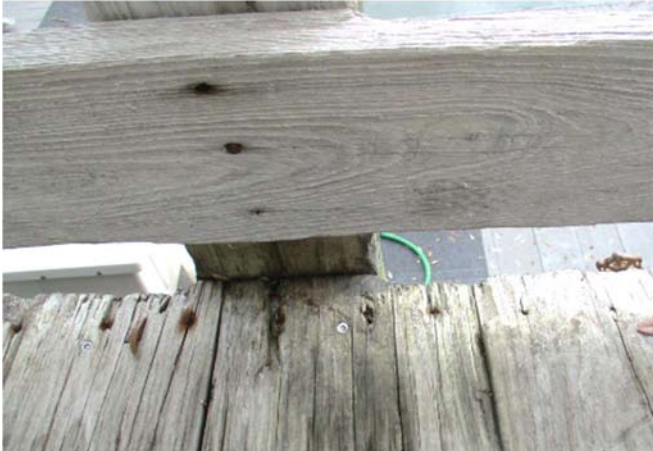
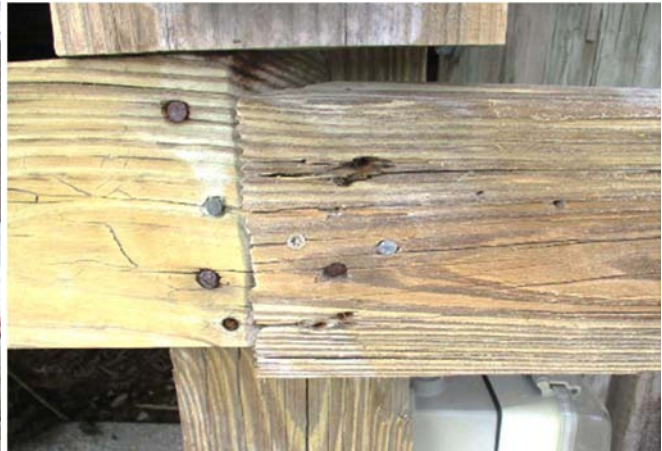
The guardrail consists of 6x6 posts, and 2x6 lower guardrail, a 2x6 middle guardrail, and a combination 2x6 and 2x12 cap rail screwed together for structural integrity. The outside guardrail post is bolted directly into the outside 3x8 joist to transfer lateral loads. The guardrail in Phase 1D will require repairs due to damaged boards, corrosion of connectors, and other age related deterioration.

Corrosion of Metal Fasteners – Metal fasteners in this Phase were in various states of corrosion, with some fasteners completely corroded and other having light rust. The majority of the pile cap to joist connectors in this phase were in good condition and do not require replacement. Some of the galvanized bolts connecting pile caps, braces, and guardrail posts were corroded and should be marked for replacement.

Photo 22 & 23 - Typical deck board and rail damage at ends and corroded/replaced connectors

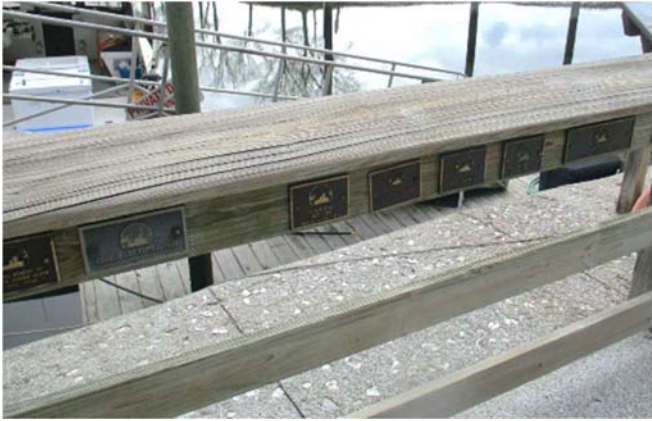
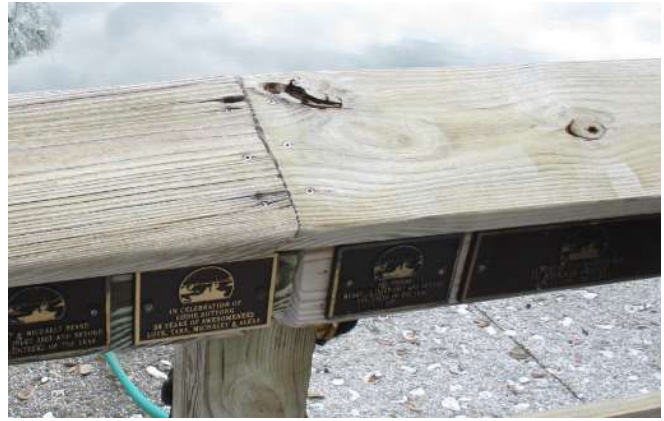
Photos 26 & 27 – Typical top cap of replaced guardrail with material defects (knots, splitting/checking)

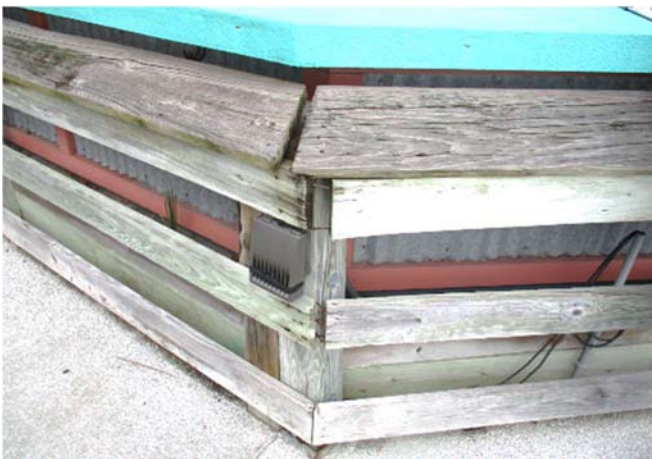
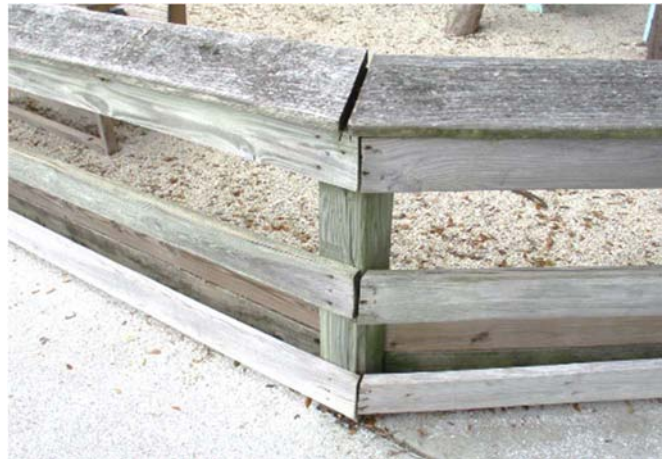
Photos 30 & 31 – Inside guardrail joint separation at corners showing damaged ends and connectors

Corrosion of Metal Fasteners – Metal fasteners in this Phase were mainly screws connecting the rails to the posts. Older connectors have been replaced in some areas with new screws due to corrosion failure. All new construction should be completed with stainless steel screws.

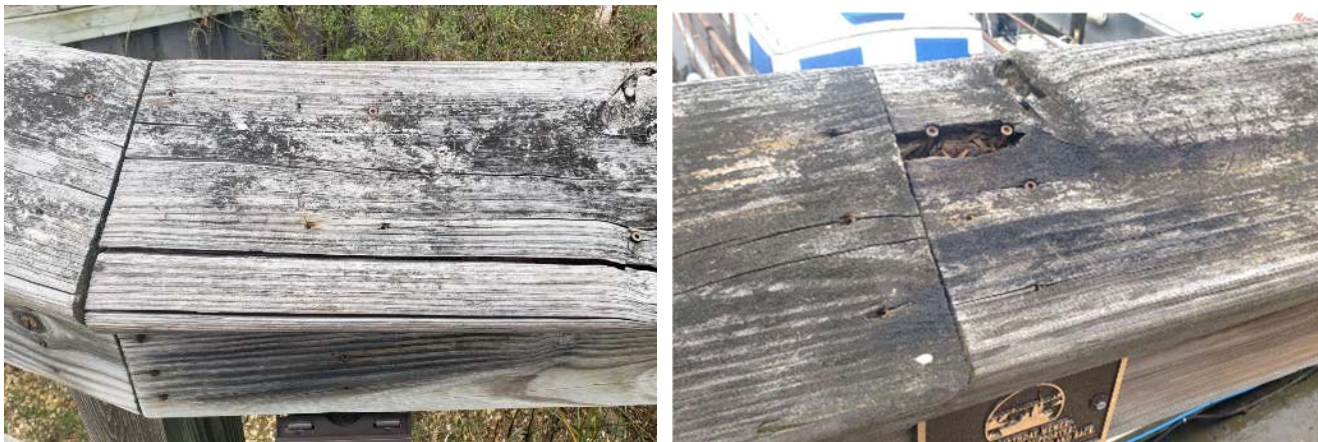
The guardrail consists of 6x6 posts, and 2x6 lower guardrail, a 2x6 middle guardrail, and a combination 2x6 and 2x12 cap rail screwed together for structural integrity. The outside guardrail post is bolted directly into the outside 3x8 joist to transfer lateral loads. The guardrail in Phase 2 will require repairs due to damaged boards, corrosion of connectors, and other age related deterioration.

Photos 38 & 39 – Guardrail damage included missing, split and broken boards due to age and moisture

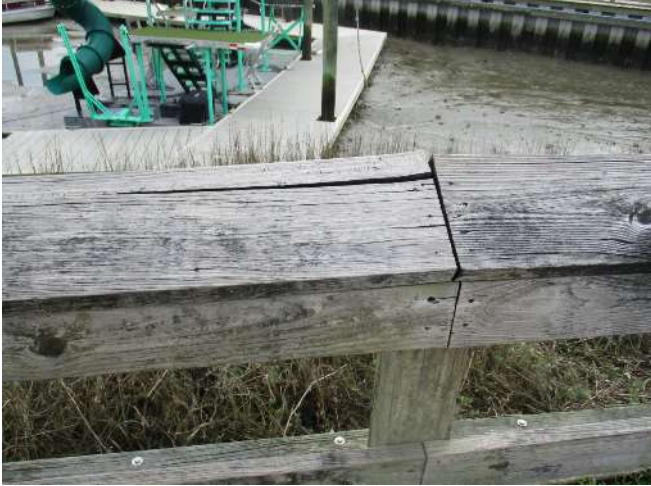
The guardrail consists of 6x6 posts, 2x4 lower guardrail, a 2x6 middle guardrail, and a combination 2x6 and 2x12 cap rail screwed together for structural integrity. The guardrail in Phase 3B is deteriorated due to exposure of the wood to the elements and will require replacement.

Photo 46 – Typical Cap rail damage in Phase 3B

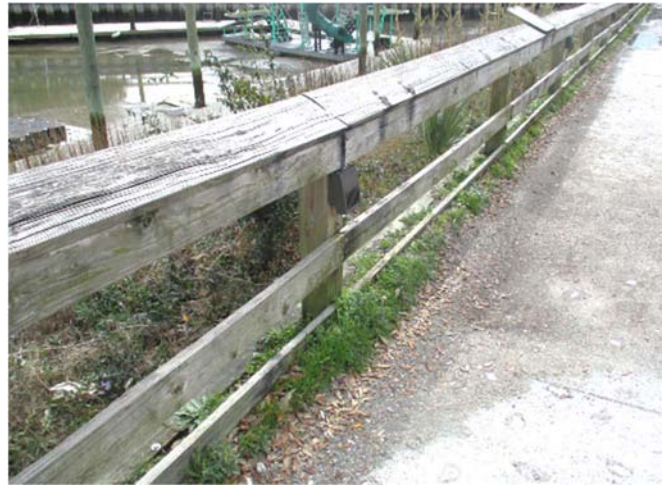
Photo 47 – Bottom rail mounted too close to ground

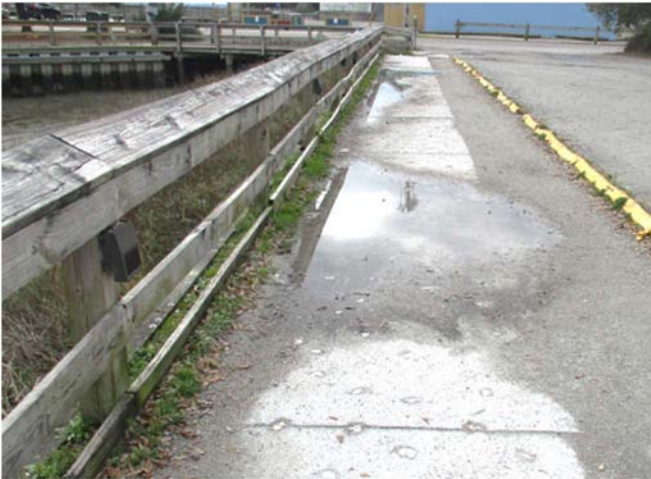
Concrete pathway settlement – Phase 3B is a concrete walkway subject to settlement. Several locations have been covered with sediment from the adjacent parking lot and several locations are holding water after rainfall events, but no significant settlement had been observed. The southerly portion adjacent to Phase 3C has several cracks and is lower than the adjacent wood boardwalk section, which allows standing water and sediment to collect at this location. Other sections in Phase 3B hold water due to trapped sediments at the bottom rail on the east side.

Photo 48 – Standing water due to blockage at rail

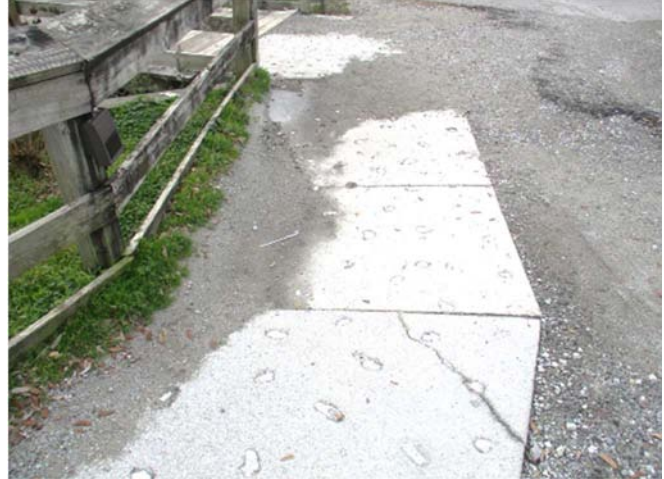
The boardwalk surface consists of tabby textured concrete with embedded shells and the majority of the damage observed beyond normal wear was cracks and settlement of edges near joints. This section of concrete sidewalk is at or below the slag and gravel surface of the parking lot, and surface runoff brings sediment onto the surface of the sidewalk. There are vehicle stops placed on the surface, which also contributes to sediment tracking onto the concrete sidewalk.

Photo 49 – Cracked concrete and trapped sediment

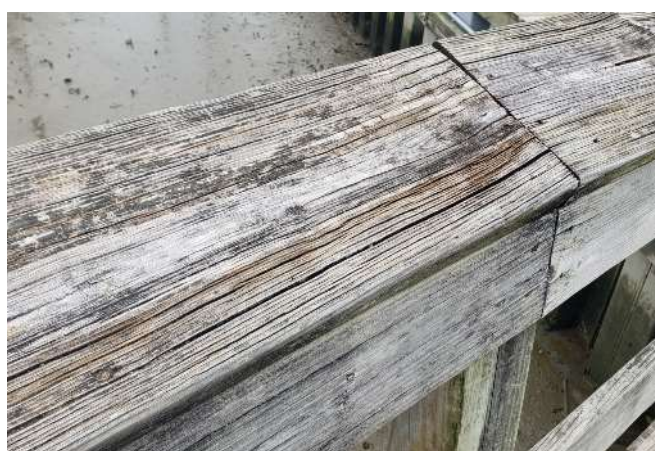
Photo 53 – Typical guardrail condition at Phase 3C

The guardrail consists of 6x6 posts, 2x6 or 2x4 lower guardrail, a 2x6 middle guardrail, and a combination 2x6 and 2x12 cap rail screwed together for structural integrity. The guardrails in Phase 3C will require repairs due to damaged boards, corrosion of connectors, and other age related deterioration.

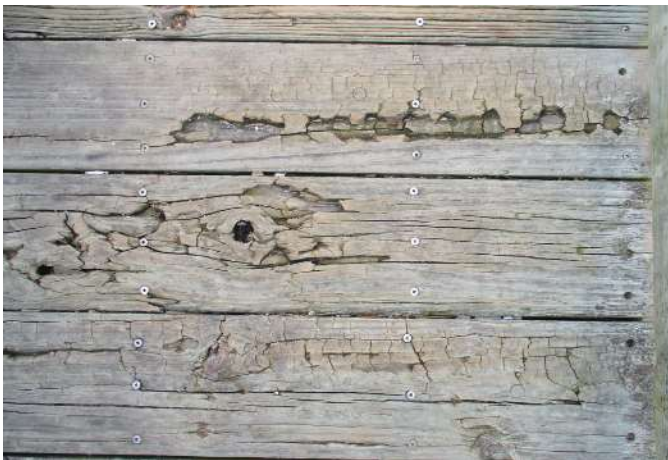
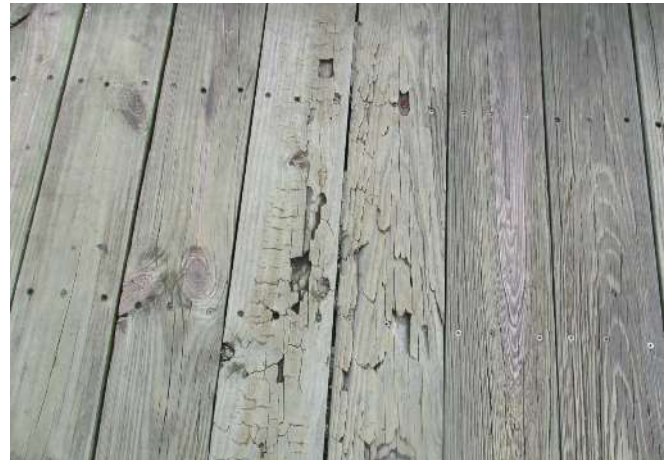
The boardwalk decking consists of treated 2x8s attached to the joists using stainless steel screws. Structural damage, including splitting and checking of wood was observed in numerous locations consistent with exterior use (pedestrian traffic and environmental exposure to sun and rain). Portions of the decking over land were replaced in 2017, with the portions over water originally constructed in 2005.

Photos 60 & 61 – Typical wood decking deterioration observed over large portions of Phase 4A

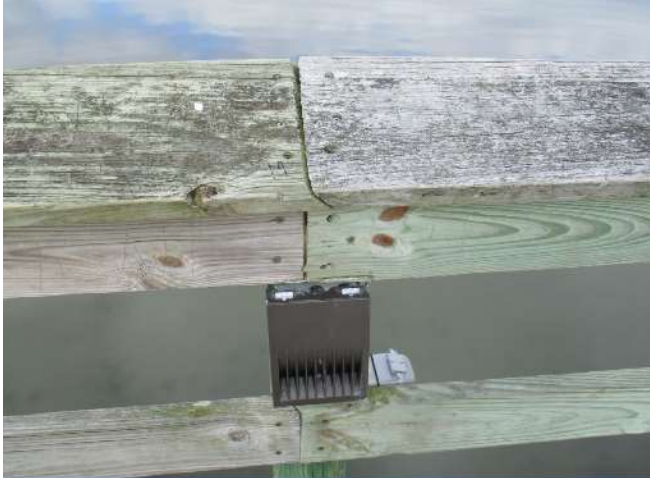
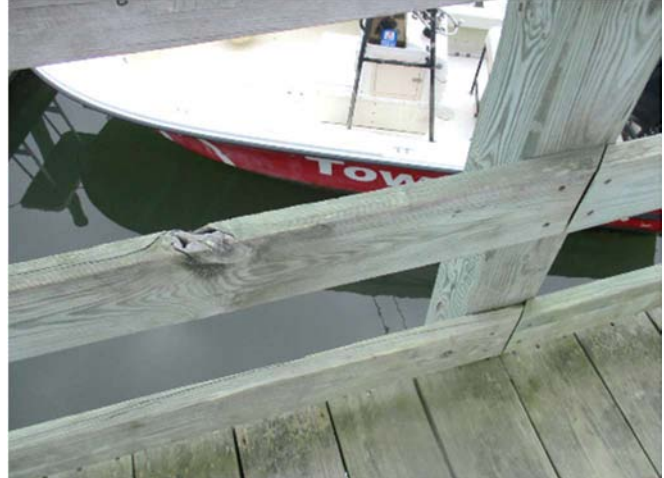
Photos 62 & 63 – Typical wood railing deterioration observed in isolated areas of Phase 4A

repaired by either complete replacement of the railings or by removal and replacement of railings that have significant damage. Approximately 25% of these boards need replacement but due to the age of the material, additional replacement would be required over the next 10 years if repairs are performed on a spot basis.

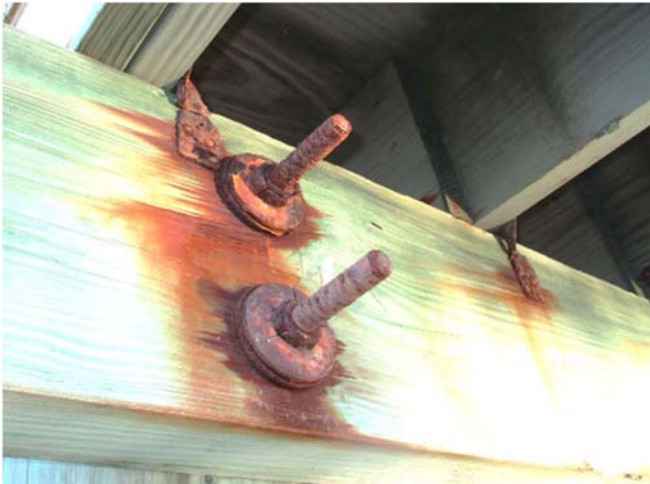
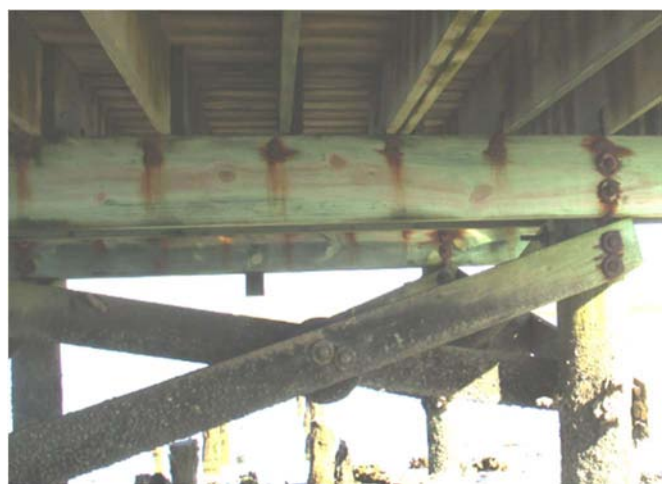
Photo 64 & 65 – Damaged metal connectors and galvanized bolts on Phase 4A to be replaced
