# City Of Waycross

## CONDITION ASSESSMENT REPORT

**Tank Name:**  
Industrial Blvd North Tank

**Project Number:**  
102429

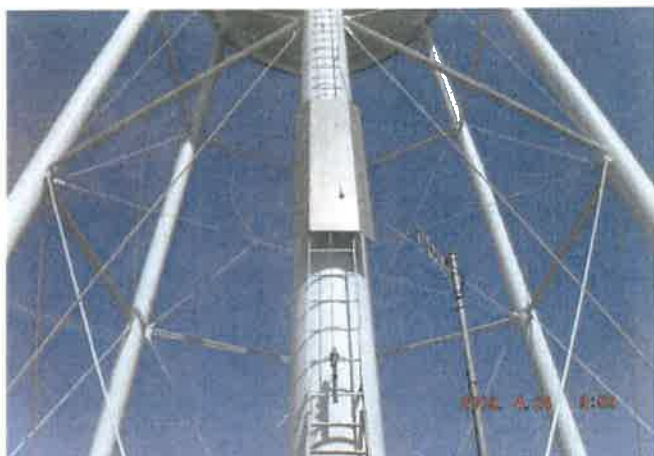
Ladder equipped with safety climb

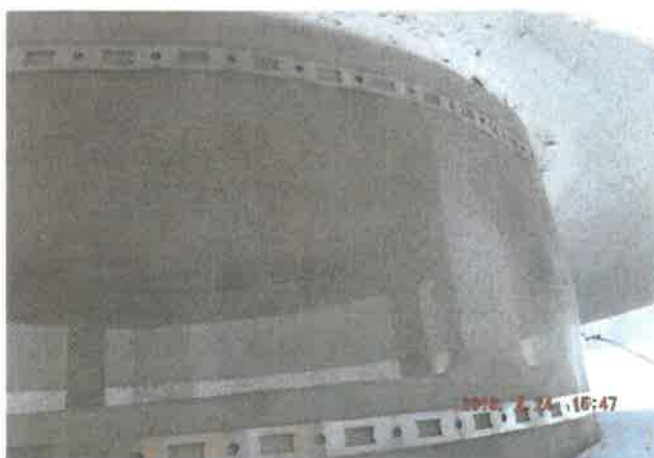
- **Vent Screen:** Vent screen was replaced during the inspection.
- **Evidence Of Foreign Matter:** No evidence of foreign matter observed.

Roof vent screen

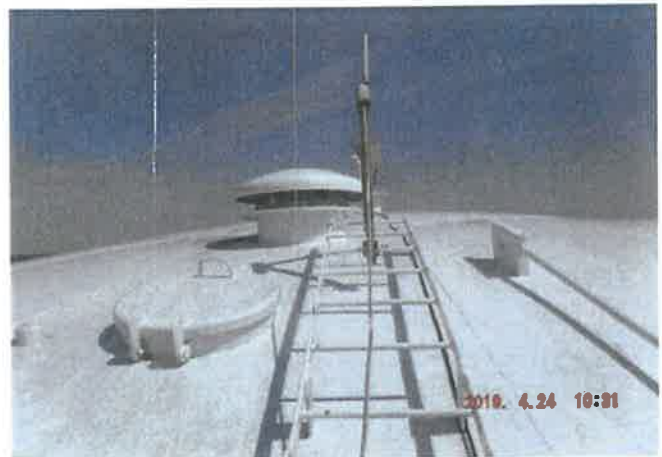
- **Vents:** Roof vent was beginning to show minor corrosion which was repaired during the inspection.
- **Overflow Pipe:** No deficiencies noted. Overflow pipe extends to ground level.
- **Welds:** No deficiencies noted with weld seams.
- **Float System:** Float system was repaired during the inspection.
- **Level Indicator:** Level indicator is in working condition with no deficiencies noted.

Roof vent

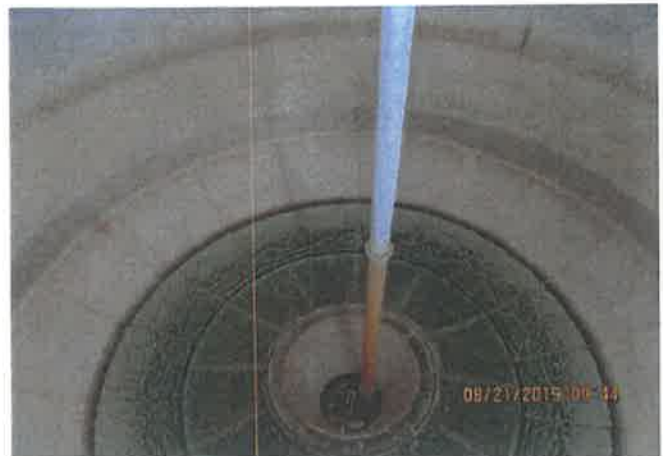
- **Vent Screen:** No deficiencies noted with vent screen.
- **Evidence Of Foreign Matter:** No evidence of foreign matter observed.
- **Sediments:** Light sediment in bottom of tank was cleaned out with pressure washing.

Interior During Washout

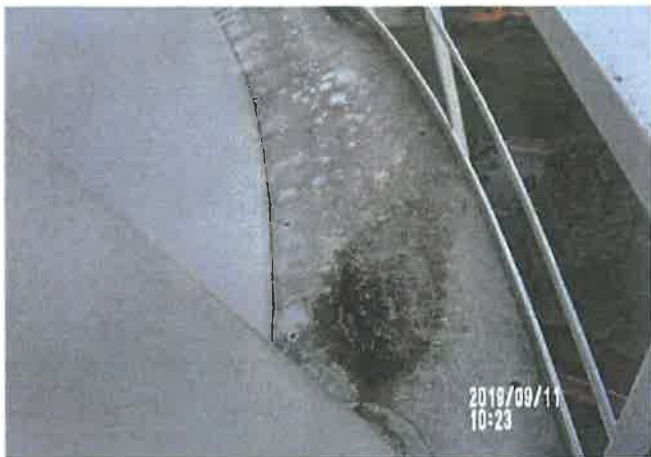
- **Balcony:** Balcony landings have several areas where water will not drain. Weep holes were installed at inspection so water can drain. No other deficiencies noted with balcony railing or landings.

Balcony Before Repairs

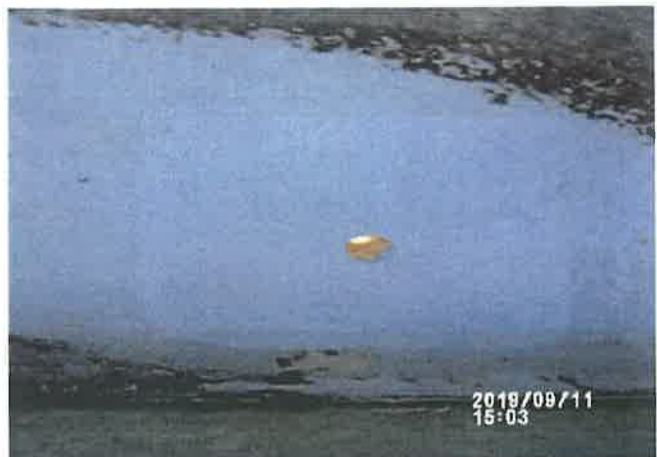
Balcony Weep Holes Drilled and Coated

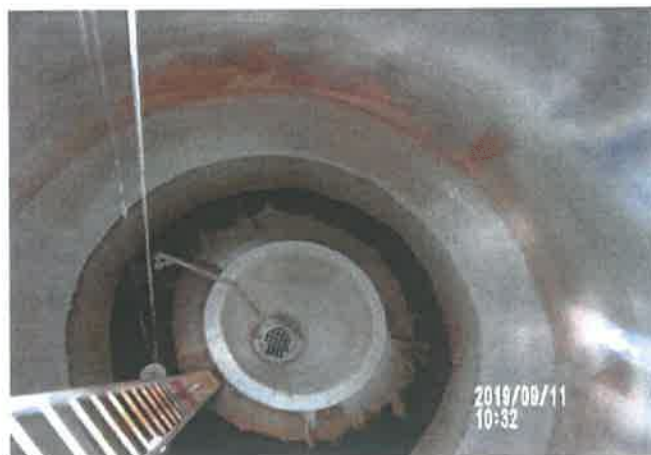
- **Interior Ladders:** Minor rust staining deficiencies noted with the visible portion of the interior access ladder. We will continue to monitor these areas.

Interior Access Ladder with Minor Deficiencies

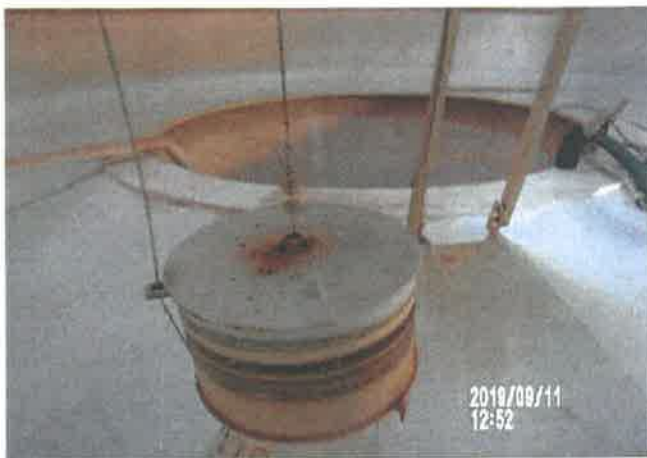
- **Welds:** No deficiencies noted with weld seams.
- **Float System:** Float system was repaired during the inspection.
- **Level Indicator:** Level indicator is in working condition with no deficiencies noted.

Float Repaired During Washout

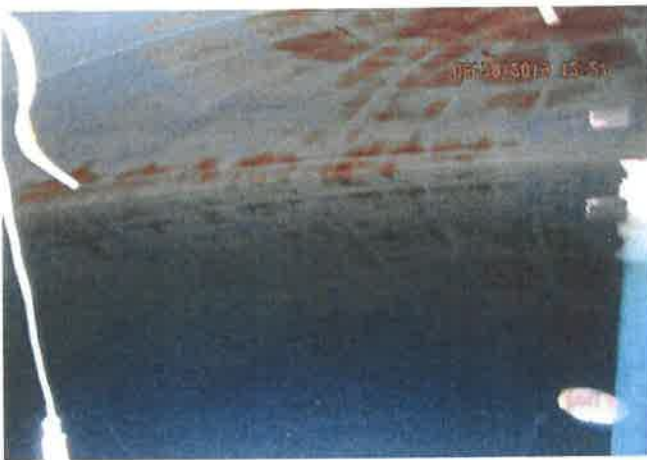
- **Interior Coating Condition:** Interior coating is beginning to show minor breakdown below the high water level. The interior coatings will be reviewed for scheduling renovation.
- **Exterior Coating Condition:** Exterior coating has chalked and faded, but still continues to provide protection. Areas will continue to be monitored.
- **Logo Condition:** No deficiencies noted.

Interior Sidewall/Roof Coating

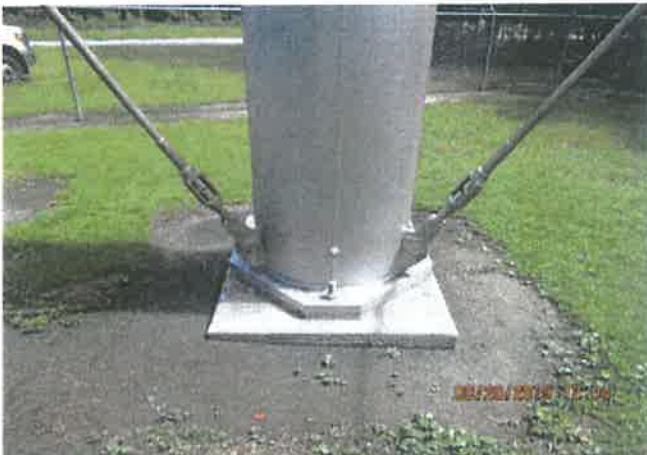
- **Foundation:** Foundation appears in good condition, no deficiencies noted.
- **Legs:** No deficiencies noted with tank legs. Paint coating continues to protect the substrate. Light mildew exists on structure.

Leg Structure

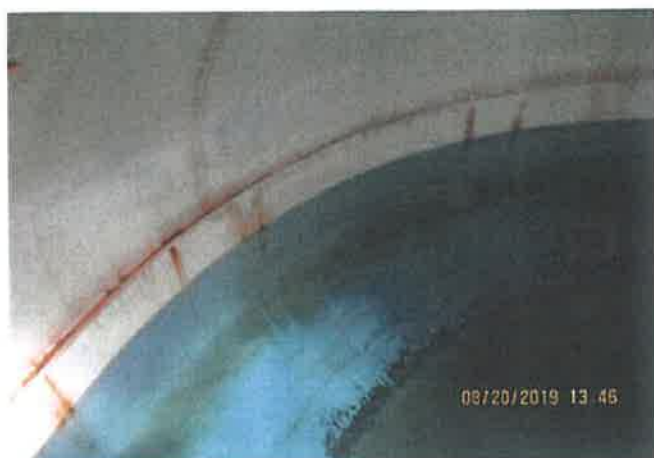
- **Interior Coating Condition:** Minor rust streaking/staining deficiencies were noted with the interior coating. Areas will continue to be monitored.
- **Exterior Coating Condition:** No deficiencies noted in the exterior coating.
- **Logo Condition:** No deficiencies noted.

Interior Sidewall/Roof Coating

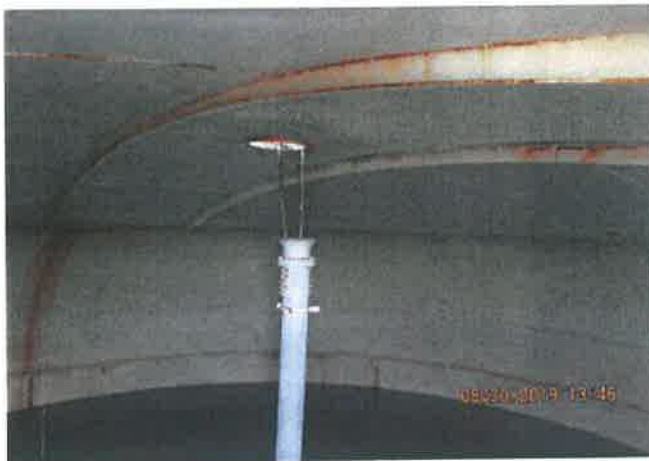
- **Roof:** The interior roof was partially inspected from the hatch. Minor rust streaking/staining and spot corrosion was present in on the roof. Areas will continue to be monitored.

Interior Roof with Deficiencies

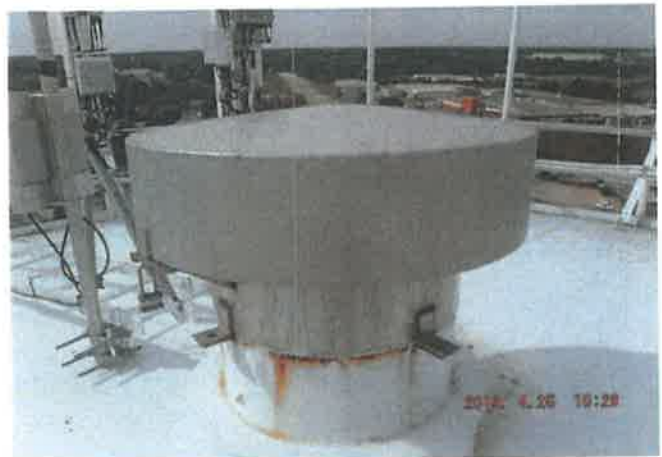
- **Roof:** Interior roof structure partially inspected from hatch. No deficiencies noted with roof trusses, rafters and their connections.
- **Vents:** Roof vent is beginning to show minor corrosion and will be scheduled for repair or replacement.
- **Overflow Pipe:** Tank is equipped with an internal overflow.
- **Welds:** No deficiencies noted with weld seams.

Roof vent
