**STRUCTURE B-2-A**  
**INSPECTION DATE: 1/19/2022**

Single Barrel, 54" Diameter x 97' Long

Location:	Lake Apopka MFW
	B-2-A
Latitude:	28.6695 N
Longitude:	81.6918 W
Type:	Gated Culvert
No. Barrels:	One
Inspection	
Start Date:	1/19/2022
End Date:	1/19/2022

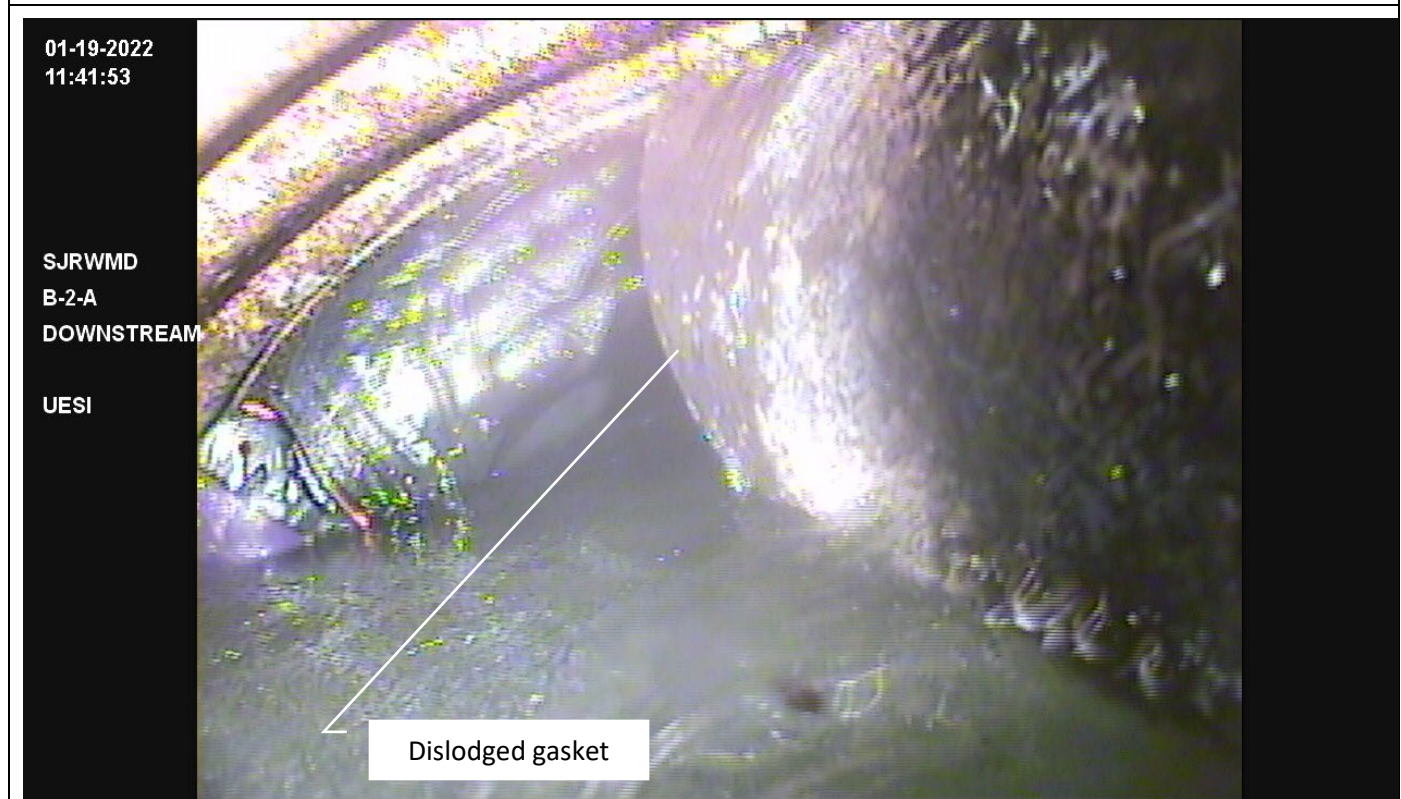
- Item DS115: (1) The construction joint at 80' in from the downstream end had exposed rubber gasket exposed all around and completely pulled out over more than 50% of the circumference. The diver did not penetrate beyond this point for safety reasons (entanglement) and potential damage of pulling out more gasket and causing a major leak. There were moderate leaks at 12:00 and 2:00.
  - Recommended Action: Install a new push clamp at the 80' construction joint. Use aluminum clamp and stainless steel bolts. This may require trimming the existing gasket and installing a new gasket under the new clamp. Divers are needed for this repair.

Item No.: DS115 Culverts	Rating: C-4	Photo Description: Dislodged gasket at 80' penetration
<p>Deficiency: The construction joint at 80' in from the downstream end had exposed rubber gasket exposed all around and completely pulled out over more than 50% of the circumference. The diver did not penetrate beyond this point for safety reasons (entanglement) and potential damage of pulling out more gasket and causing a major leak. There were moderate leaks at 12:00 and 2:00.</p>		
<p>Probable Cause: The dislodged gasket and leak at the 80' construction joint may have occurred during construction or a repair.</p>		
<p>Recommendation: Install a new push clamp at the 80' construction joint. Use aluminum clamp and stainless steel bolts. This may require trimming the existing gasket and installing a new gasket under the new clamp.</p>

DS115	Culverts	4	(1) C-4: The construction joint at 80' in from the downstream end had exposed rubber gasket exposed all around and completely pulled out over more than 50% of the circumference. The diver did not penetrate beyond this point for safety reasons (entanglement) and potential damage of pulling out more gasket and causing a major leak. There were moderate leaks at 12:00 and 2:00. (2) C-3: The culvert has a push clamp at the construction joint at 20' in from the downstream end. The clamp is loose. The clamp has two sets of bolts at 3:00 and 9:00 with three bolts each. Two of the 3 bolts at 3:00 are out of the clamp and have minor to moderate corrosion. The three bolts at 9:00 have minor to moderate corrosion. (3) C-3: The culvert has a similar push clamp at the construction joint at 45' in from the downstream end. The clamp is loose and all six bolts have minor to moderate corrosion. (4) C-3: The culvert has a similar push clamp at the construction joint at 64' in from the downstream end. The clamp is tight, but all six bolts have minor to moderate corrosion.	(1) Install a new push clamp at the 80' construction joint. Use aluminum clamp and stainless steel bolts. This may require trimming the existing gasket and installing a new gasket under the new clamp. Divers are needed for this repair. (2, 3, 4) Replace all of the bolts for the push clamps with stainless steel and use washers. Realign and tighten each clamp. Divers are needed for this repair.	(1) The dislodged gasket and leak at the 80' construction joint may have occurred during construction or a repair. (2, 3, 4) The clamp bolts have experienced galvanic corrosion due to contact of dissimilar metals (mild steel and aluminum). Some of the washers may have failed due to corrosion - or were not installed, allowing the bolts to detach from the clamp and the clamp to become loose.

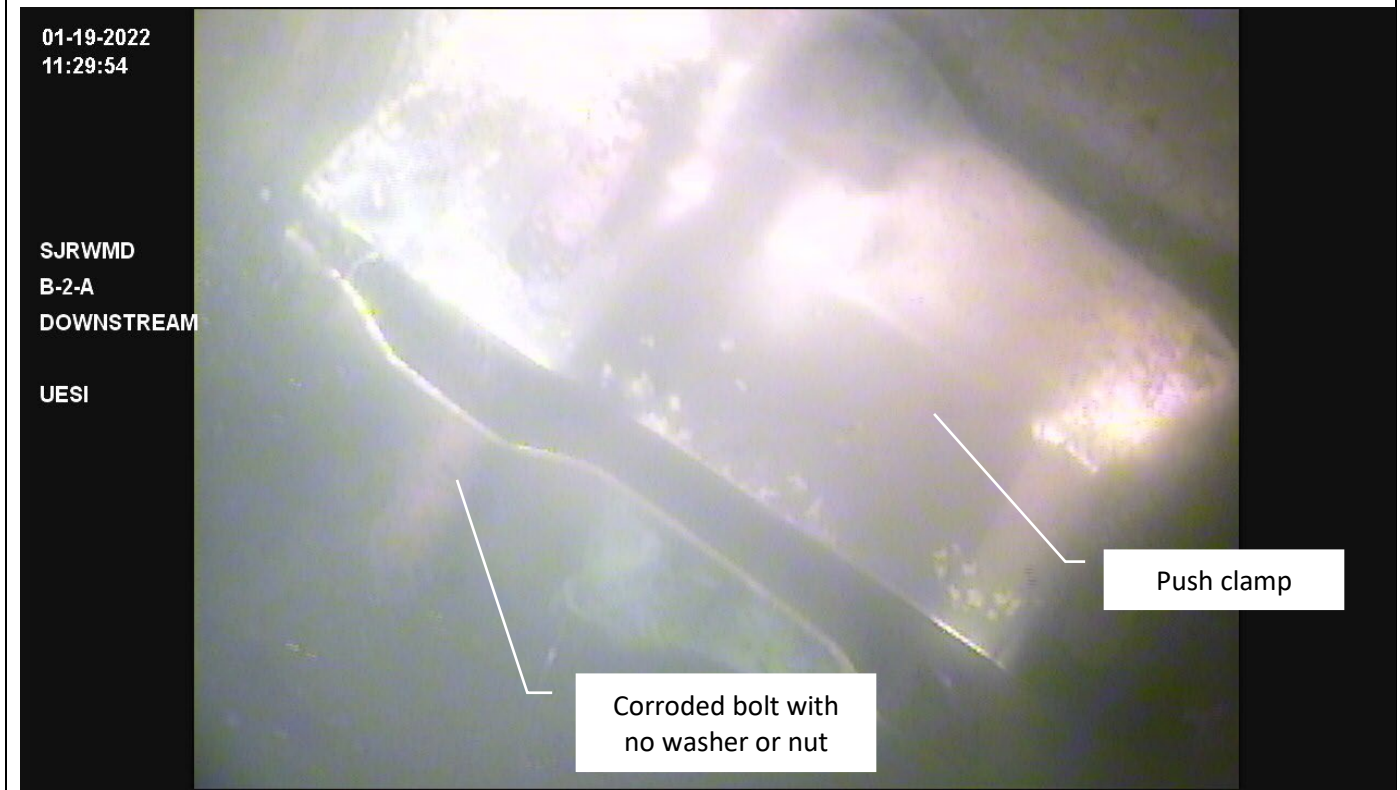
moderate corrosion. (2) The culvert has a similar push clamp at the construction joint at 45' in from the downstream end. The clamp is loose and all six bolts have minor to moderate corrosion. (3) The culvert has a similar push clamp at the construction joint at 64' in from the downstream end. The clamp is tight, but all six bolts have minor to moderate corrosion.

Item No.: DS115 Culverts	Rating: C-3	Photo Description: Push clamp at 45' penetration showing corroded bolt
-----------------------------	-------------	---

Deficiency: (1) The culvert has a push clamp at the construction joint at 20' in from the downstream end. The clamp is loose. The clamp has two sets of bolts at 3:00 and 9:00 with three bolts each. Two of the 3 bolts at 3:00 are out of the clamp and have minor to moderate corrosion. The three bolts at 9:00 have minor to moderate corrosion. (2) The culvert has a similar push clamp at the construction joint at 45' in from the downstream end. The clamp is loose and all six bolts have minor to moderate corrosion. (3) The culvert has a similar push clamp at the construction joint at 64' in from the downstream end. The clamp is tight, but all six bolts have minor to moderate corrosion.

Probable Cause: The clamp bolts have experienced galvanic corrosion due to contact of dissimilar metals (mild steel and aluminum). Some of the washers may have failed due to corrosion - or were not installed, allowing the bolts to detach from the clamp and the clamp to become loose.

Recommendation: Replace all of the bolts for the push clamps with stainless steel and use washers. Realign and tighten each clamp.

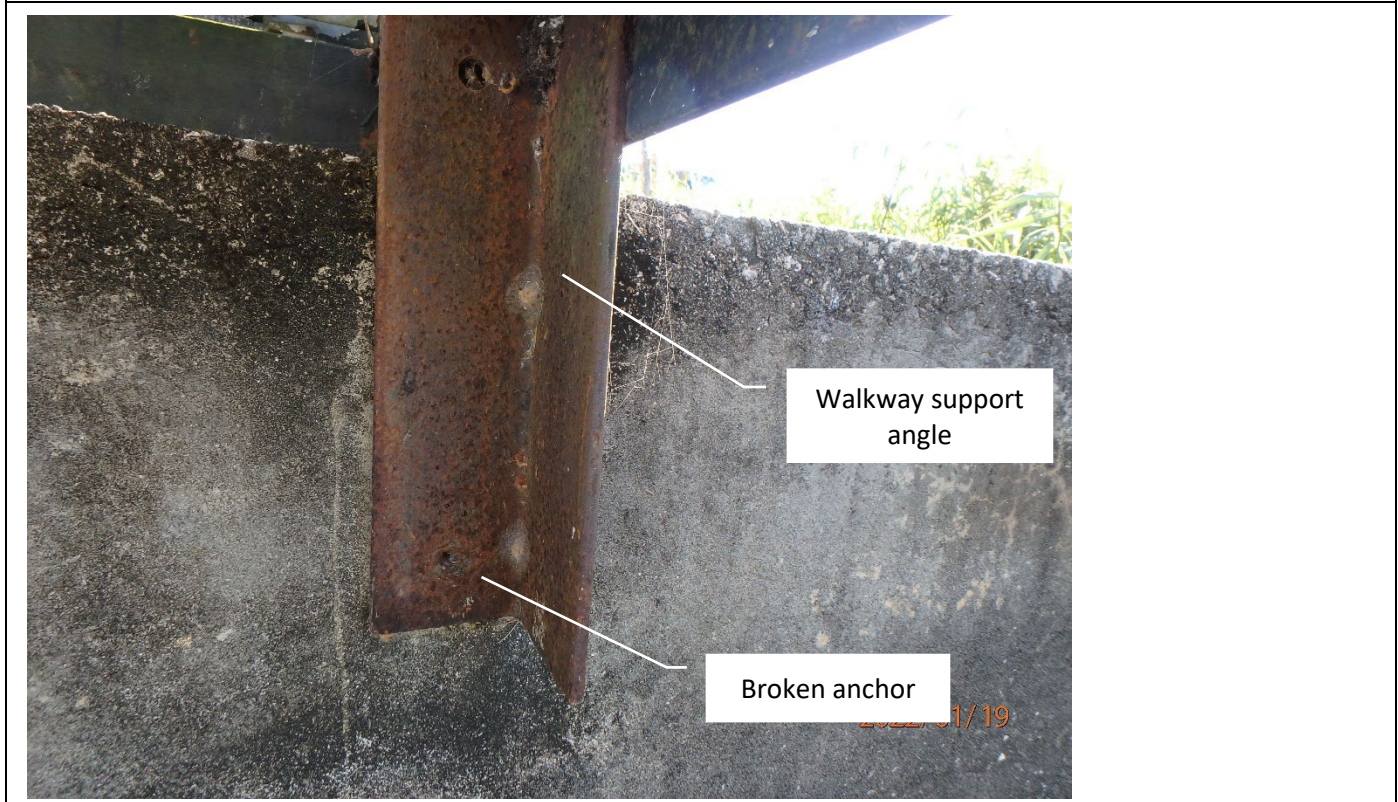
Item No.: US1001 Topside Walkway	Rating: C-3	Photo Description: Broken anchor for support angle
Deficiency: The anchor for the walkway angle support at the west pier has broken due to corrosion.		
Probable Cause: The anchor failed due to corrosion.		
Recommendation: Install a new anchor for the walkway support anchor at the west pier.
