STRUCTURE B-2-D
INSPECTION DATE: 1/19/2022

Single Barrel, 54" Diameter x 97' Long

Location:	Lake Apopka MFW
	B-2-D
Latitude:	28.6731 N
Longitude:	81.6918 W
Type:	Gated Culvert
No. Barrels:	One
Inspection	
Start Date:	1/19/2022
End Date:	1/19/2022

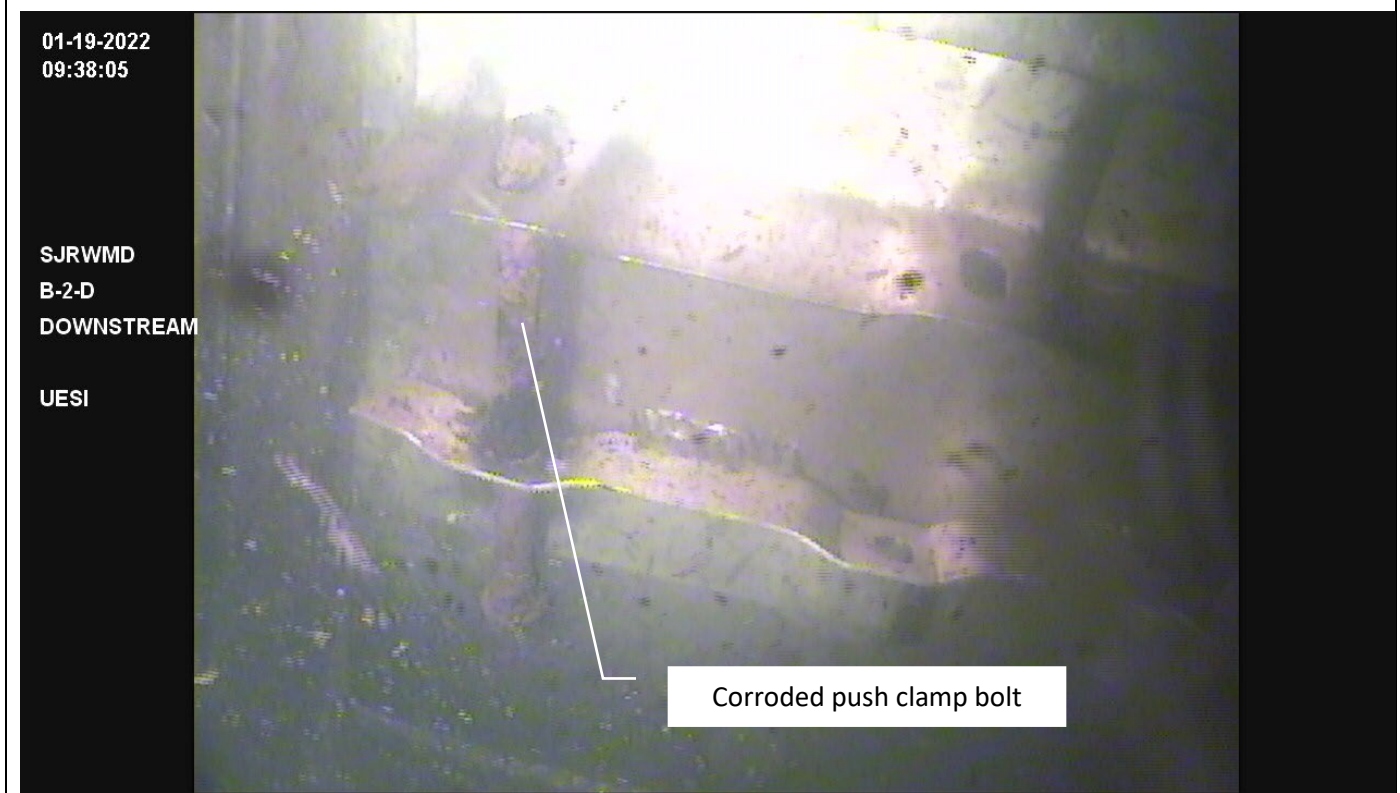
- Item DS115: The culvert has a push clamp at the construction joint at 89' in from the downstream end. The clamp is tight, but all six bolts have minor to moderate corrosion.
 - Recommended Action: Replace all of the bolts for the push clamp at 89' with stainless steel and use washers. Divers are needed for this repair.
- Item US57: The upstream waterway has thick vegetation in front of the gate.
 - Recommended Action: Remove the vegetation in front of the gate to allow for full drainage capacity.
- Item US1001: The walkway angle support at the SE corner (stairs) does not extend into the ground and has moderate corrosion with minor section loss. The support at the NE corner has been cut by a mower through one leg of the angle. (2) The stair stringers have 100% coating loss and moderate corrosion.

Item No.: DS115 Culverts	Rating: C-3	Photo Description: Corroded push clamp bolt
<p>Deficiency: The culvert has a push clamp at the construction joint at 89' in from the downstream end. The clamp is tight, but all six bolts have minor to moderate corrosion.</p>		
<p>Probable Cause: The clamp bolts have experienced galvanic corrosion due to contact of dissimilar metals (mild steel and aluminum).</p>		
<p>Recommendation: Replace all of the bolts for the push clamp at 89' with stainless steel and use washers. Divers are needed for this repair.</p>

DS115	Culverts	3	(1) C-3: The culvert has a push clamp at the construction joint at 89' in from the downstream end. The clamp is tight, but all six bolts have minor to moderate corrosion. (2) C-2: The culvert has four minor leaks at the joint between the barrel and the ring at the gate. The leaks are from the 10:00 position to the 2:00 position.	(1) Replace all of the bolts for the push clamp at 89' with stainless steel and use washers. Divers are needed for this repair. (2) Monitor the construction joint at the gate ring for higher flow leaks.	(1) The clamp bolts have experienced galvanic corrosion due to contact of dissimilar metals (mild steel and aluminum). (2) The minor leaks at 89' are most likely due to construction.
-------	----------	---	--	--	--

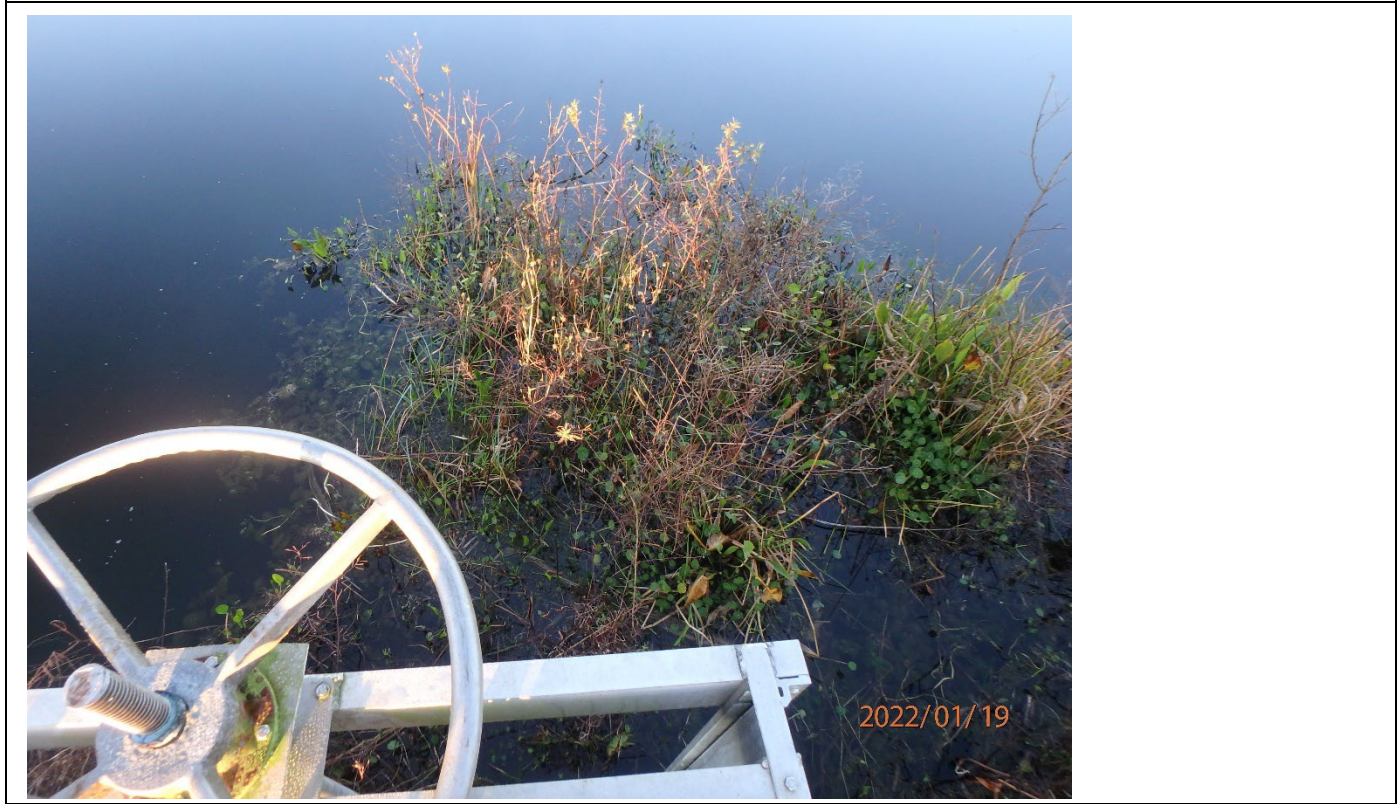
Item No.: US57 Fouling / Marine Growth	Rating: C-3	Photo Description: Vegetation adjacent to gate.
Deficiency: The upstream waterway has thick vegetation in front of the gate.		
Probable Cause: Grasses and weeds and natural. Need to keep up with maintenance clearing.		
Recommendation: Remove the vegetation in front of the gate to allow for full drainage capacity.

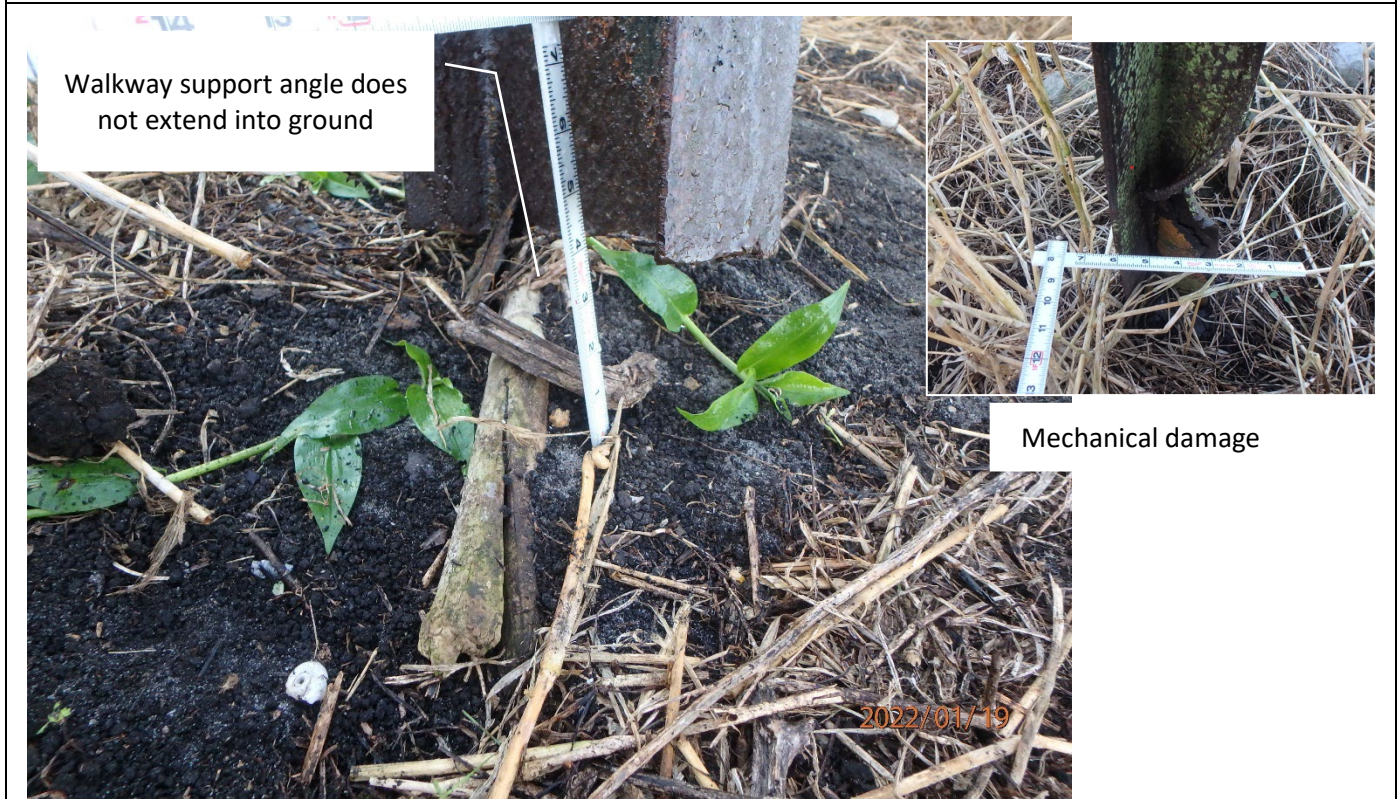
Item No.: US1001 Topside Walkway	Rating: C-3	Photo Description: Support angle doesn't extend to ground; Damaged support angle
-------------------------------------	-------------	--

Deficiency: (1) The walkway angle support at the SE corner (stairs) does not extend into the ground and has moderate corrosion with minor section loss. The support at the NE corner has been cut by a mower through one leg of the angle. (3) The stair stringers have 100% coating loss and moderate corrosion.

Probable Cause: The ground may have washed away or the support was not made long enough for proper embedment. The damaged support on the NE corner was hit by a mower. The protective coating has reached the end of its service life, allowing corrosion to occur.

- Recommended Action: Drive in a new angle next to the existing leg at the SE corner and secure with bolts. Bolt in a splice plate over the damaged leg on the NE corner. (2)
Apply a new protective coating to the stair stringers.

Recommendation: (1) Drive in a new angle next to the existing leg at the SE corner and secure with bolts. Bolt in a splice plate over the damaged leg on the NE corner. (2) Apply a new protective coating to the stair stringers.
