## **Asbestos Assessment**

City of Spartanburg  
1010 Carson Avenue  
Spartanburg, South Carolina 29306

Project Number: 0123-01

May 12, 2023

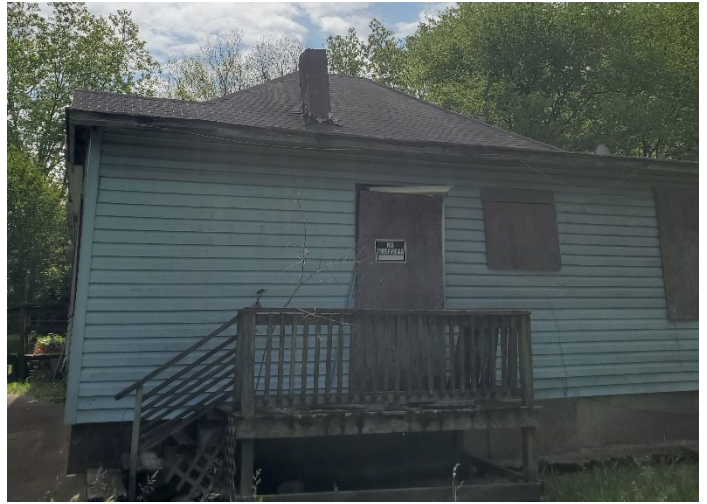
The residence was found to have damage to the side porch. Several piles of household debris were located throughout the residence. A full assessment was conducted.

Photo 2 – Side view of 1010 Carson Avenue. Porch has missing floor boards and steps unstable.

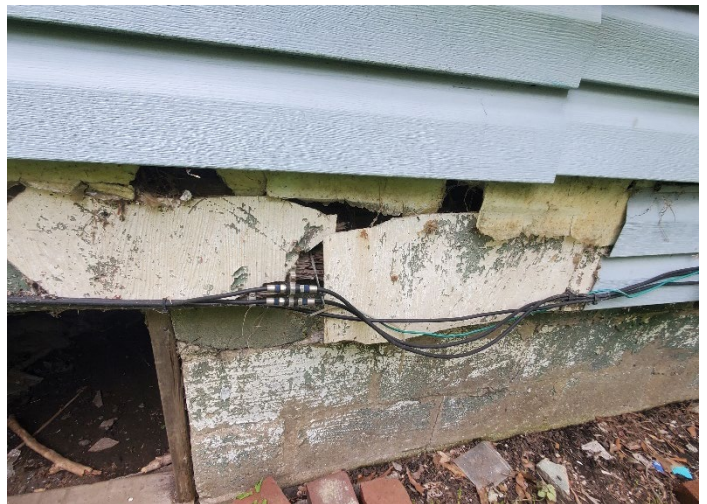
- Approximately 2,000 SF of white transite beneath the vinyl siding
- Approximately 8 LF of assumed chimney tar.

Photo 4 – Top layer of vinyl siding over transite siding. Transite is over wood siding. Transite is ACM.

1. Abate the asbestos containing materials in the structure prior to renovation or demolition.
2. Perimeter asbestos air monitoring should be performed during abatement by demolition activities and a visual clearance at the conclusion of the project.

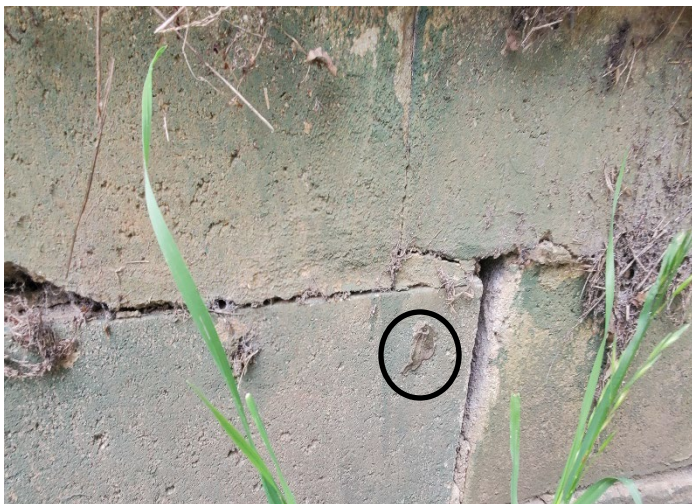
Photo 5 – Caulk located sporadically on foundation CMU blocks.

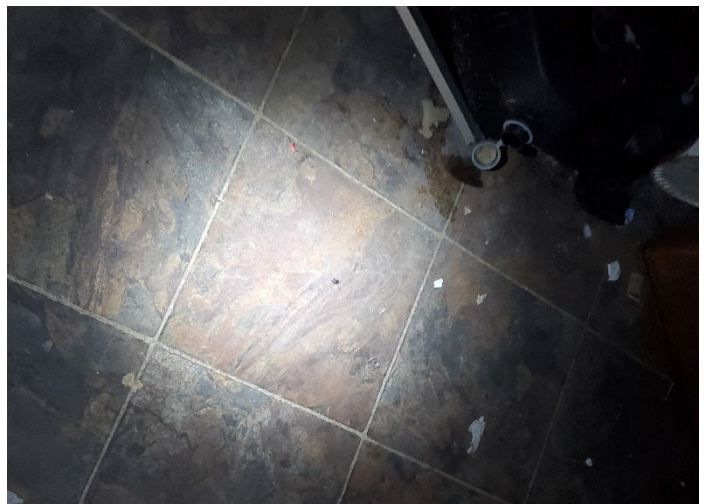
Photo 6 – Brown/Gray marble roll vinyl located in hallway and hallway bathroom.

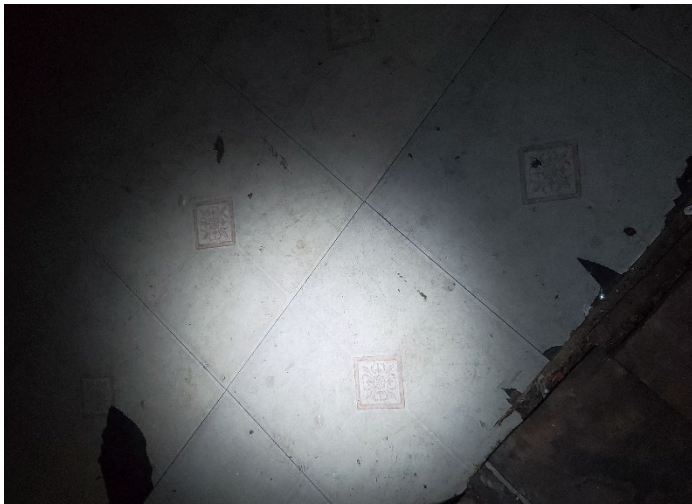
Photo 5 – 12x12 white self-stick flooring with diamond pattern located in room with fireplace.

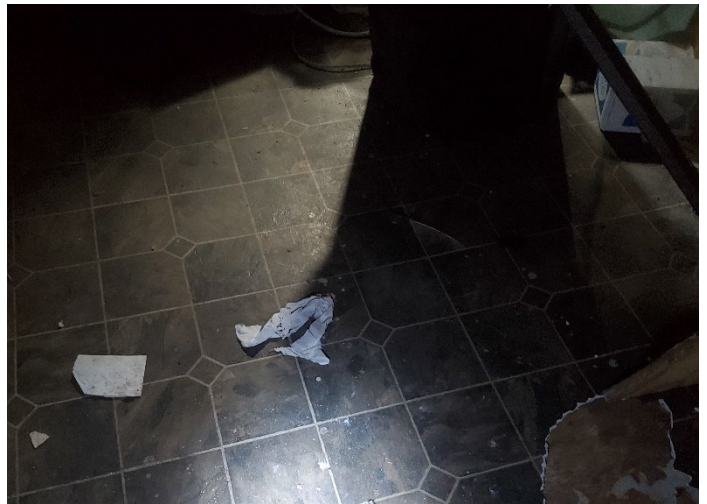
Photo 6 – Brown square with diamond pattern roll vinyl located in the kitchen.

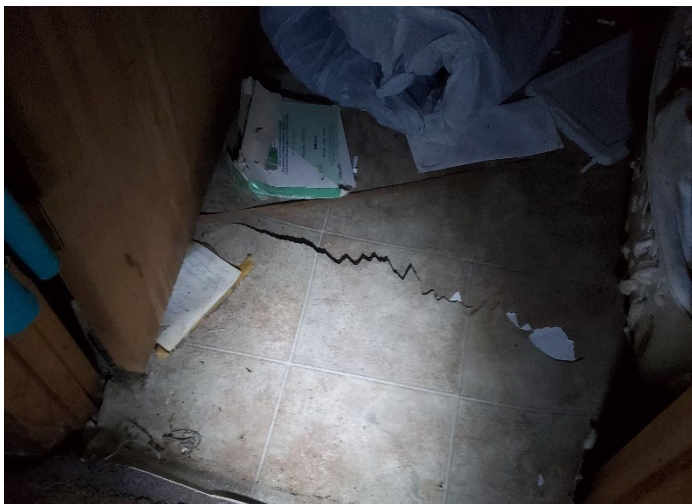
Photo 7 – Tan roll vinyl located within master bathroom.

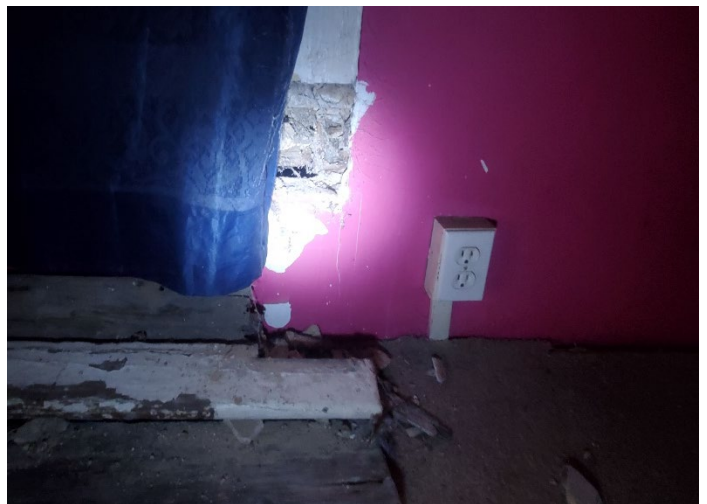
Photo 8 – Plaster located behind drywall walls and on ceiling.

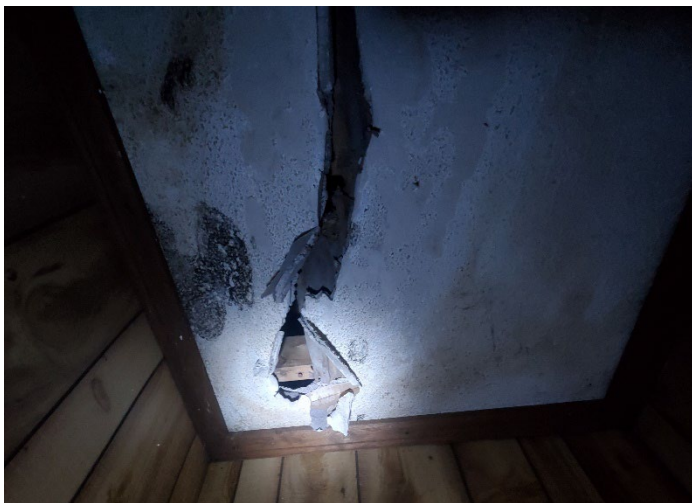
Photo 9 – Textured ceiling located throughout.

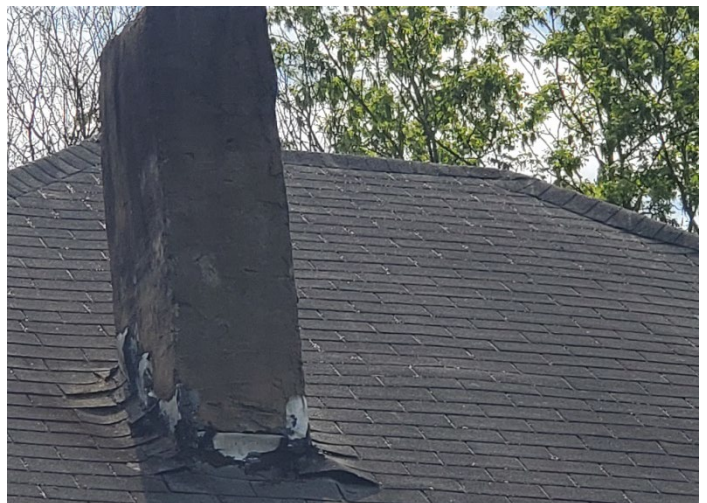
Photo 10 – Chimney tar is assumed asbestos containing material.
