Asbestos Assessment

City of Spartanburg
844 Carson Avenue
Spartanburg, South Carolina 29306

Project Number: 0123-01

May 5, 2023

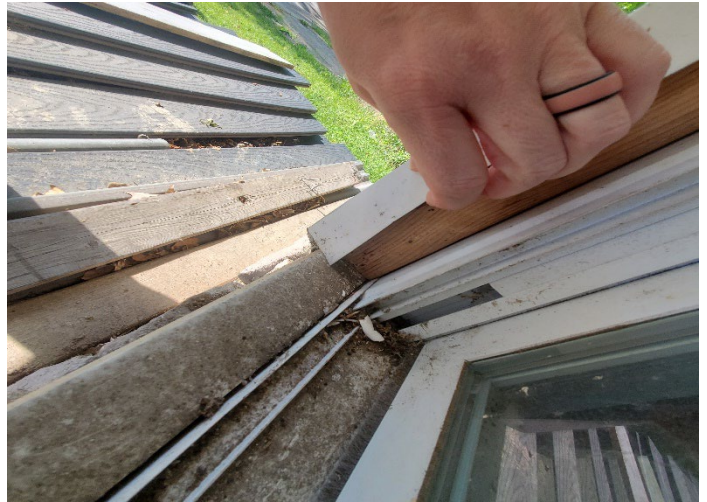
Photo 2 – Exterior vinyl windows with metal wrap and no caulk

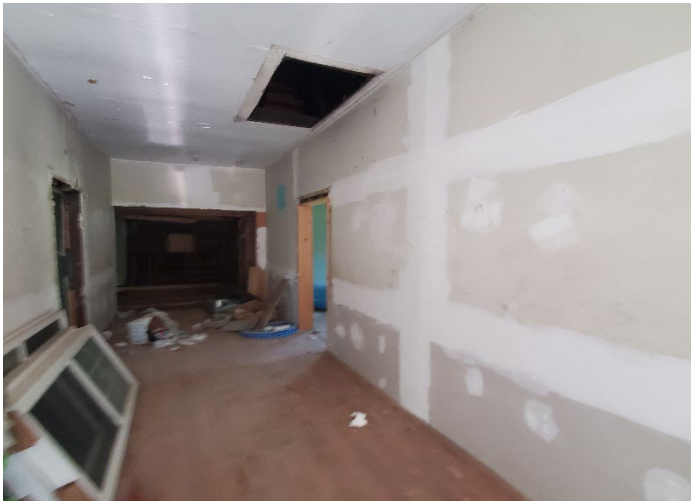
Photo 3 – Drywall and joint compound throughout walls.

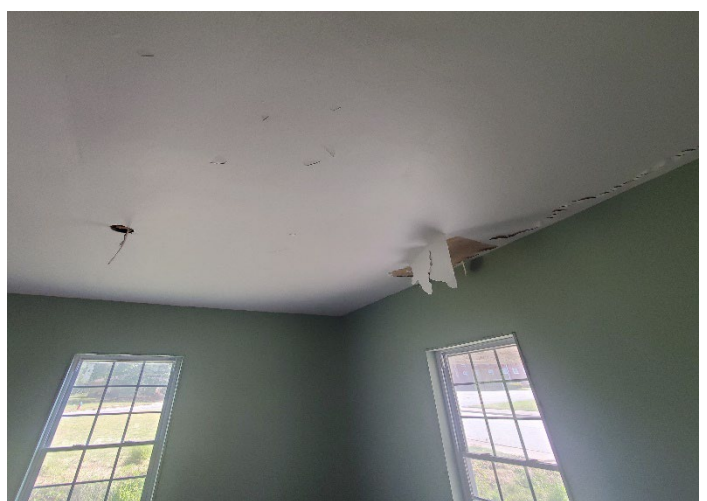
Photo 4 – Ceiling with flat skim coat over plywood located in back right room, front right and left rooms.

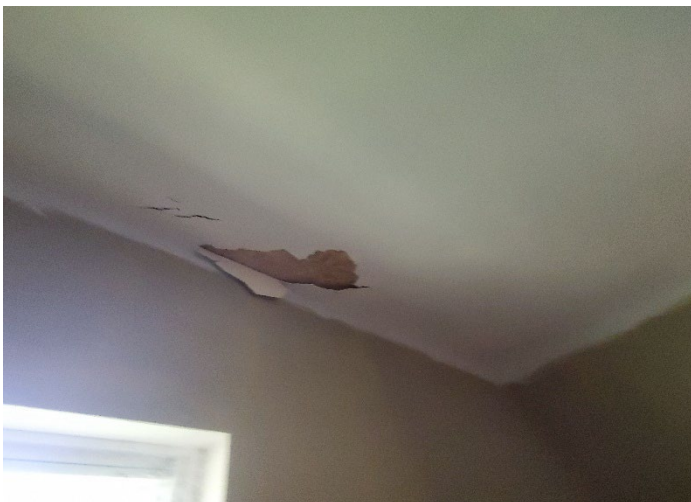
Photo 5 – Ceiling with textured coat over plywood located in back left room.

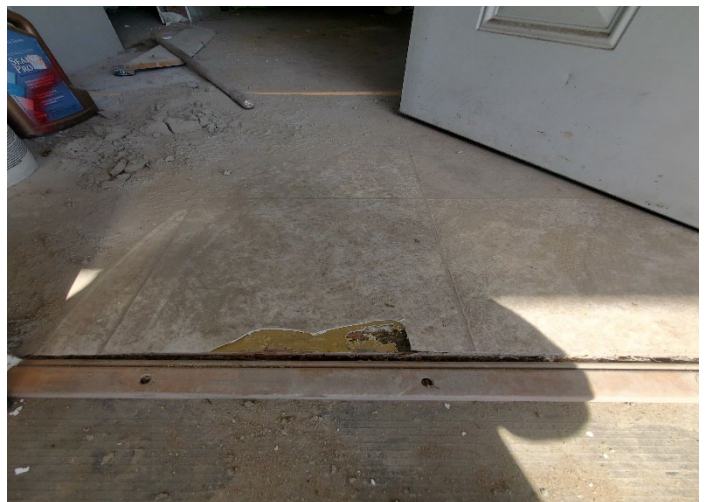
Photo 6 – White/gray roll vinyl flooring located in hallway entry.

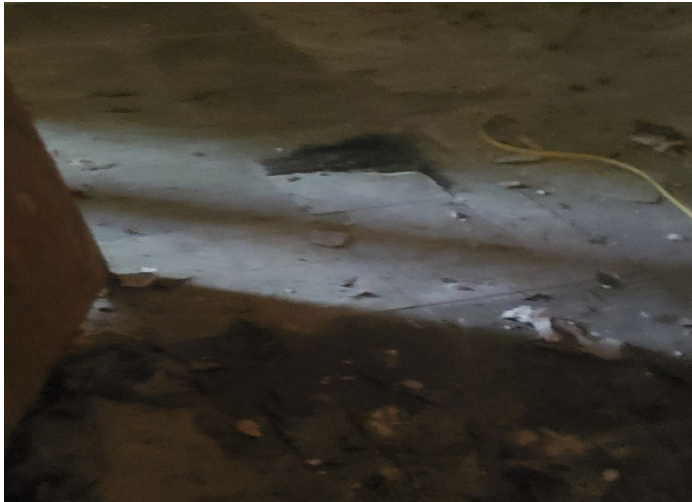
Photo 5 – Roll vinyl with glue located within kitchen area.

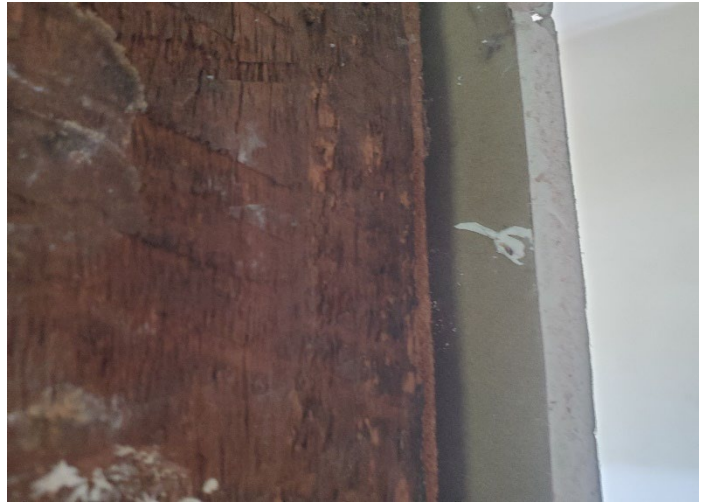
Photo 6 – White caulk found sporadically throughout interior door ways

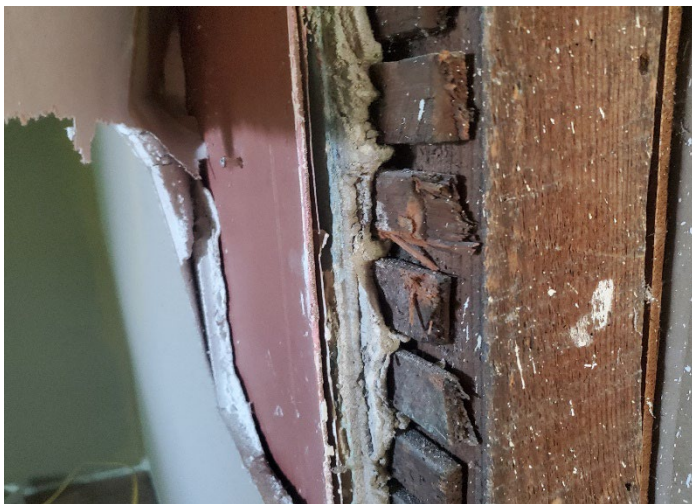
Photo 7 – Plaster and felt located under drywall throughout walls.

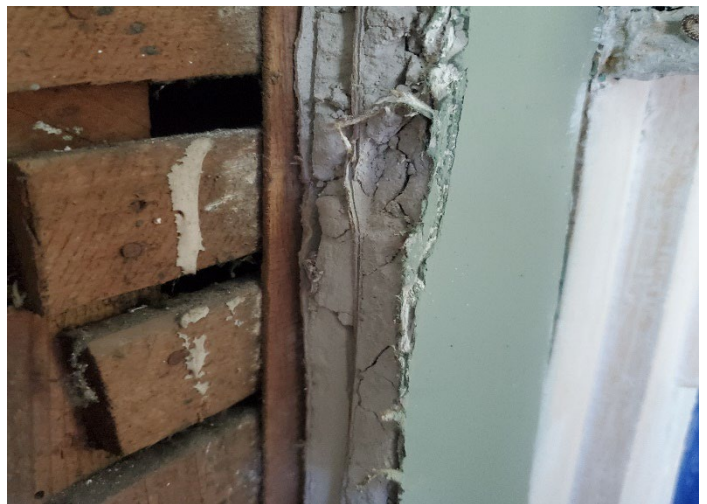
Photo 8 – Double layers of drywall located sporadically throughout the walls.

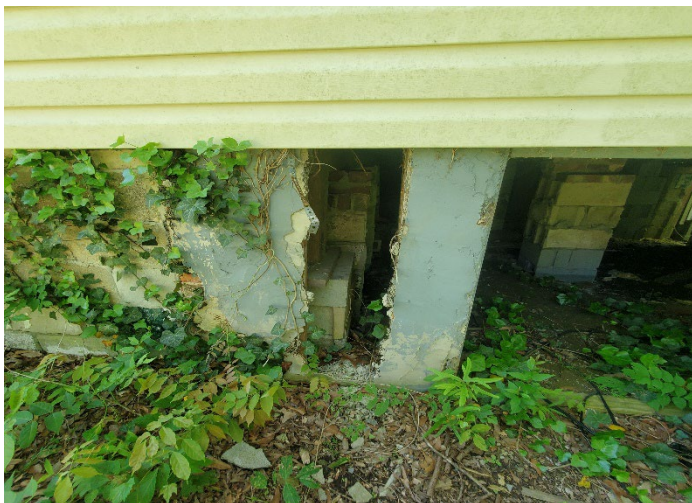
Photo 9 – Plaster and skim coat located on exterior foundation.

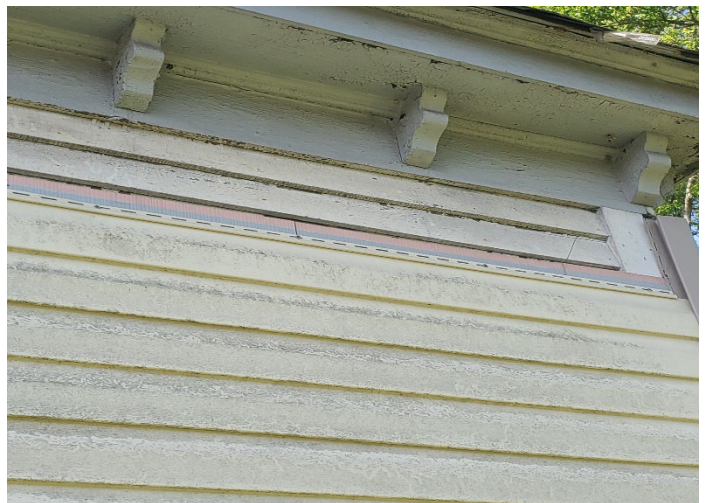
- Approximately 1,600 SF of gray transite beneath the vinyl siding

Photo 10 – Transite and two layers of felt located under vinyl siding. Gray transite is ACM.

1. Abate the asbestos containing materials in the structure prior to renovation or demolition.
2. Perimeter asbestos air monitoring should be performed during abatement by demolition activities and a visual clearance at the conclusion of the project.

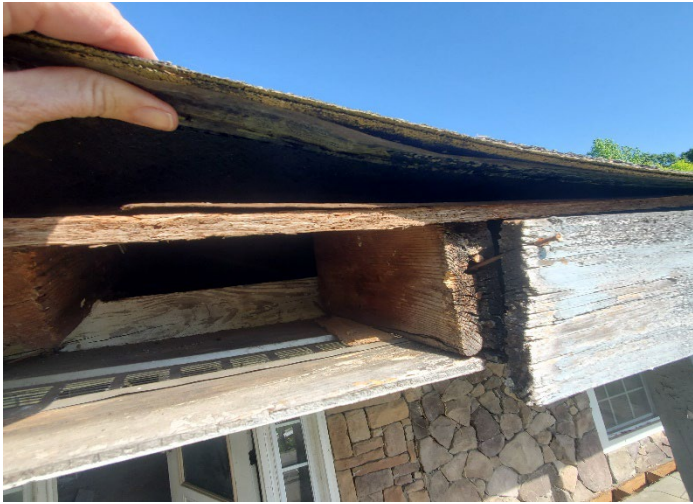
Photo 11 – Layer of shingles with one layer of felt located on the roof.
