## **Asbestos & Lead Based Paint Assessment**

City of Spartanburg  
645 Isom Street  
Spartanburg, South Carolina 29303

Project Number: 0123-01

January 16, 2023

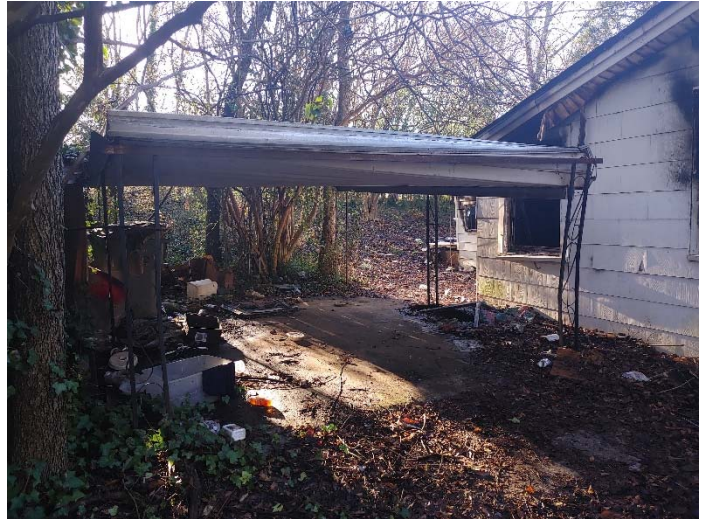
The exterior carport/canopy and metal shed were fully assessed and no asbestos containing materials were identified.

Photo 2 – Exterior carport/canopy with hard white caulk on the front side of the roof

1. No asbestos was identified within the exterior metal shed and carport/canopy; therefore, no recommendations are warranted at this time.
2. Demolish the residence with presumed ACM in place and dispose of the waste stream as friable Regulated Asbestos Containing Materials (RACM) and delivered to an asbestos approved hazardous waste landfill for disposal.

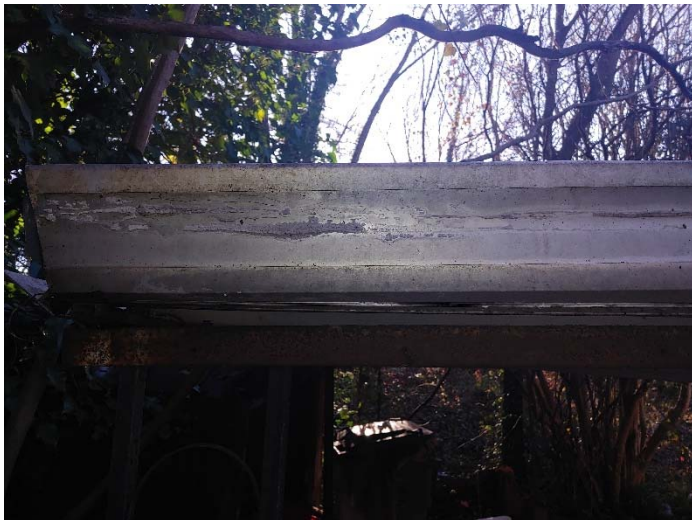
Photo 3 – Exterior carport/canopy with hard white caulk on the front side of the roof

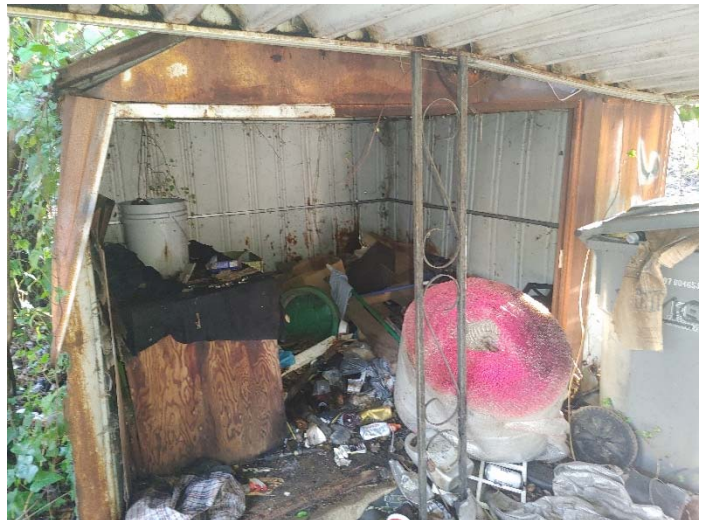
Photo 4 – Exterior metal shed with no suspect ACM identified

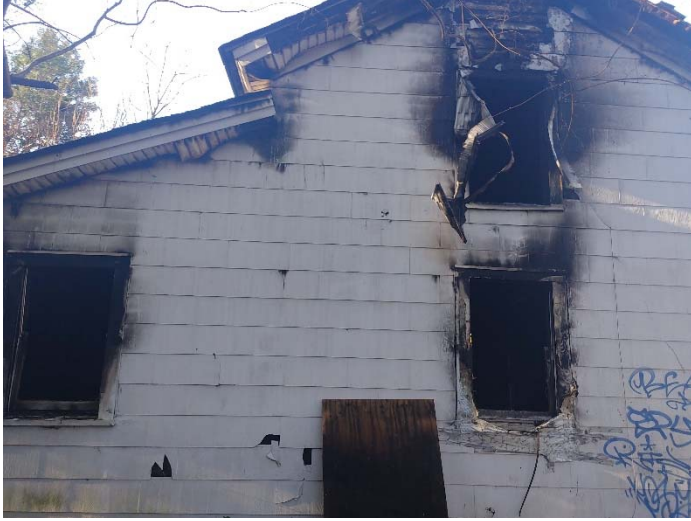
At the time of the assessment, the residence was found to have fire and structural damage throughout the interiors and exteriors. Safety concerns while performing sampling were addressed and no samples were collected from the residence during the assessment.

Subsequently, the building materials and finishes from the residence should be presumed to be ACM. Apex recommends that the residence be demolished in place and materials be treated and disposed of as regulated asbestos containing materials (RACM).

Photo 5 – Typical view of fire damage

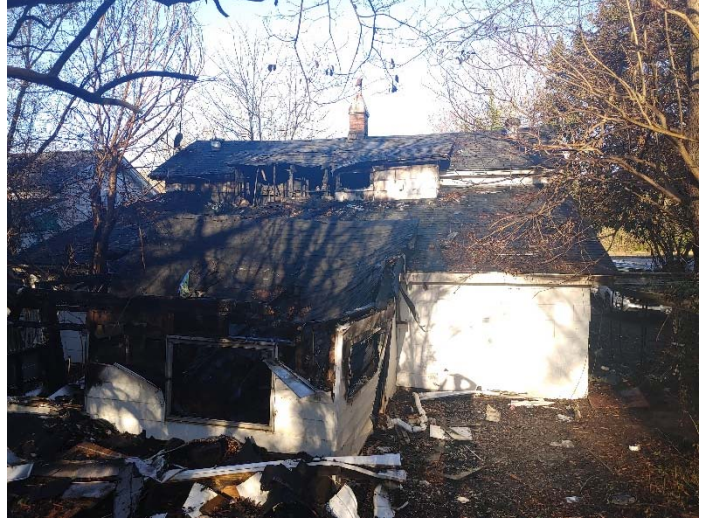
Photo 6 – Typical view of fire damage

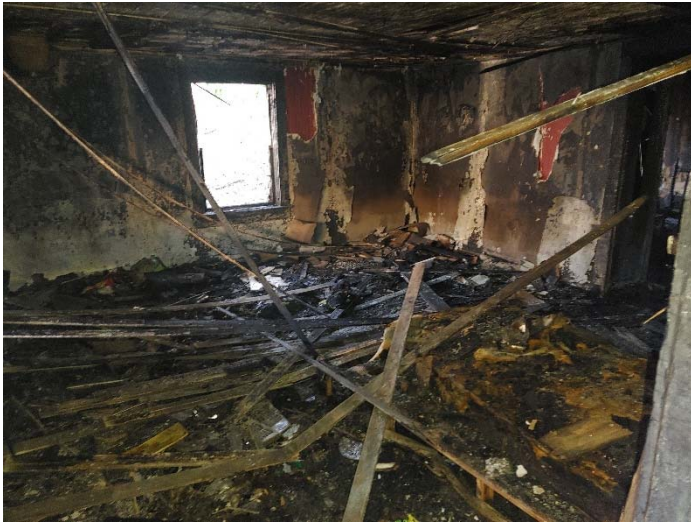
Photo 7 – Typical view of fire damage

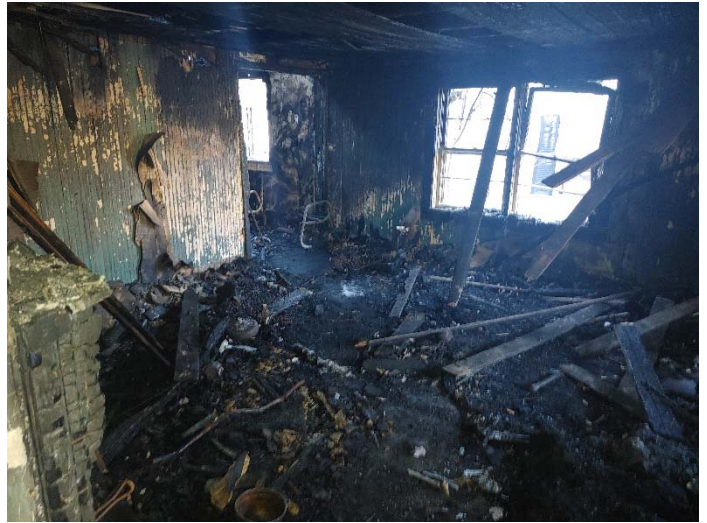
Photo 8 – Typical view of fire damage
