Asbestos containing black mastic associated with non-asbestos containing floor tile designated as F2 and F4 (Approximately 600 sf). Please know that the black mastic is underlying 1 layer of floor tile in the corridor and record room and underlying two layers of flooring in the kitchens.

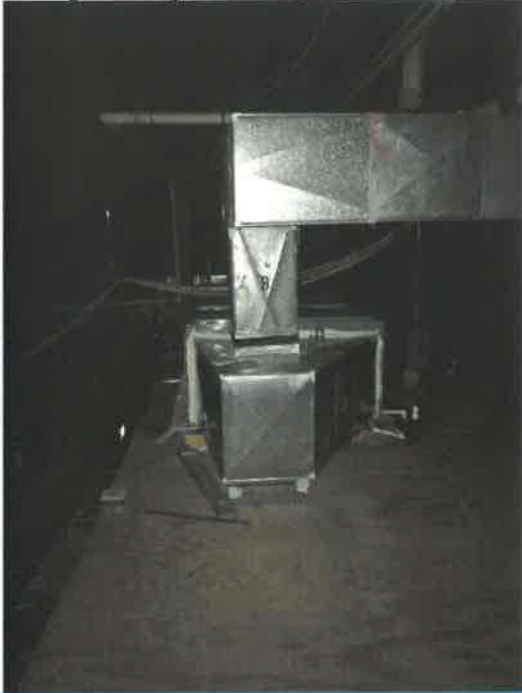
HVAC system and insulation piping above ceiling tiles in public lobby

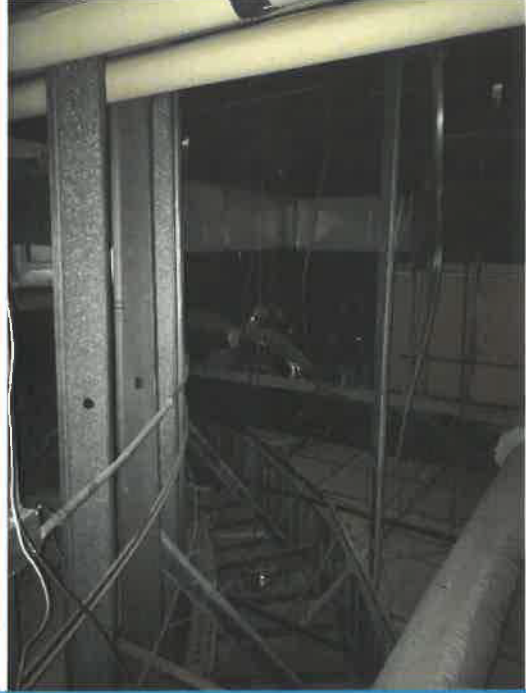
HVAC system and insulation piping above ceiling tiles in public lobby

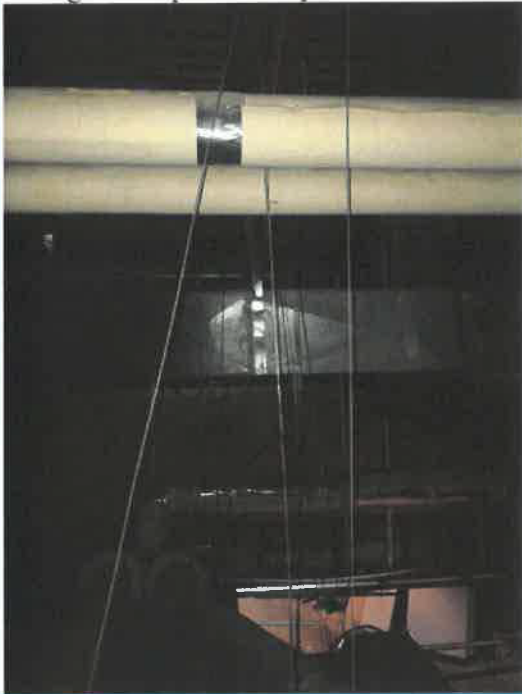
HVAC system and insulation piping above ceiling tiles in public lobby

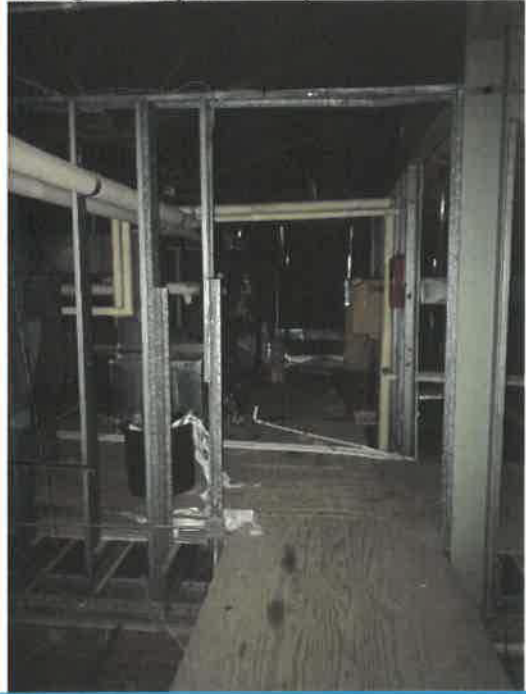
HVAC system and insulation piping above ceiling tiles in public lobby

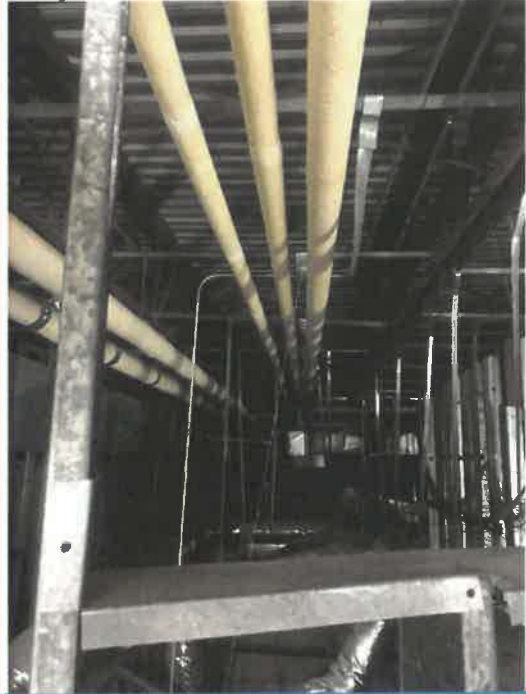
Pipe insulation above ceiling tiles in public lobby

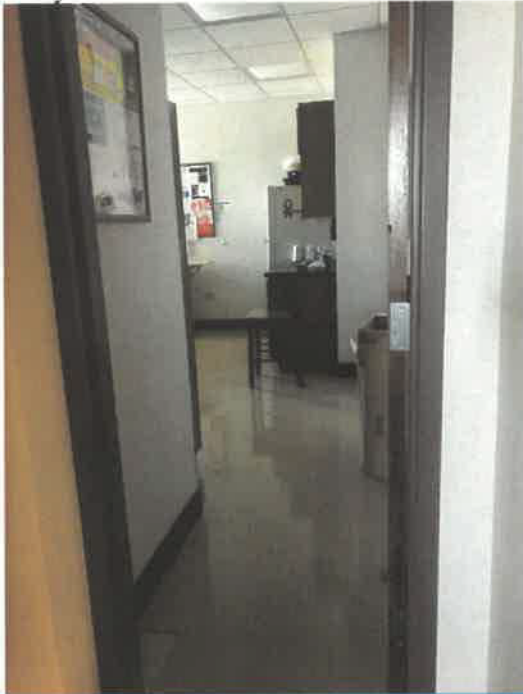
Breakroom with F4 over F2 on right side of lobby

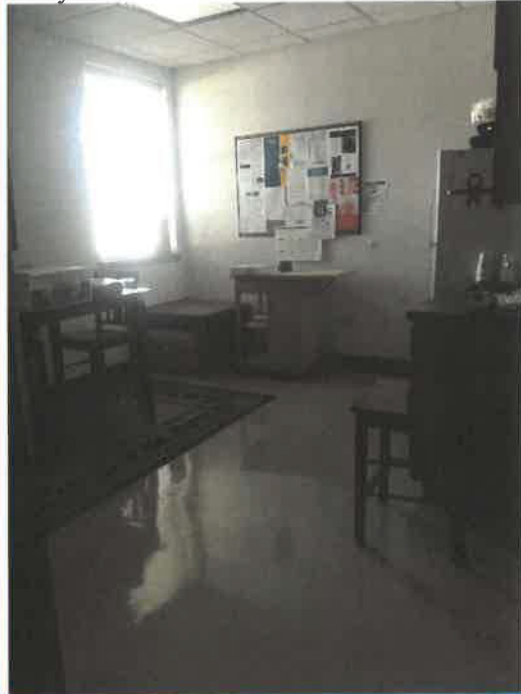
Breakroom with F4 over F2 on right side of lobby

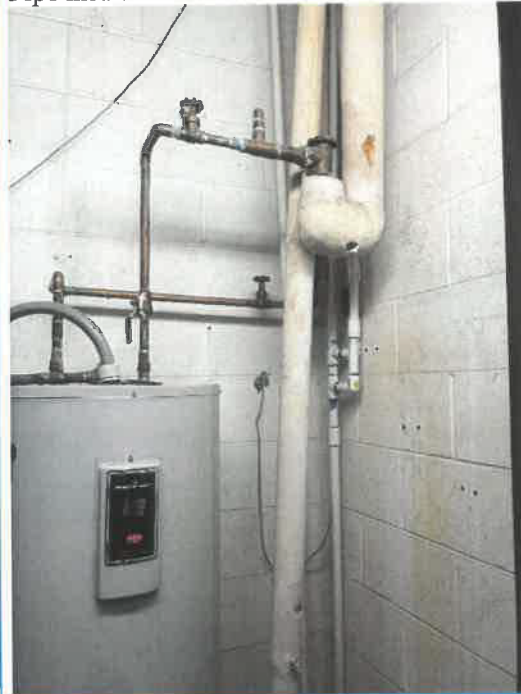
Pipe insulation elbows

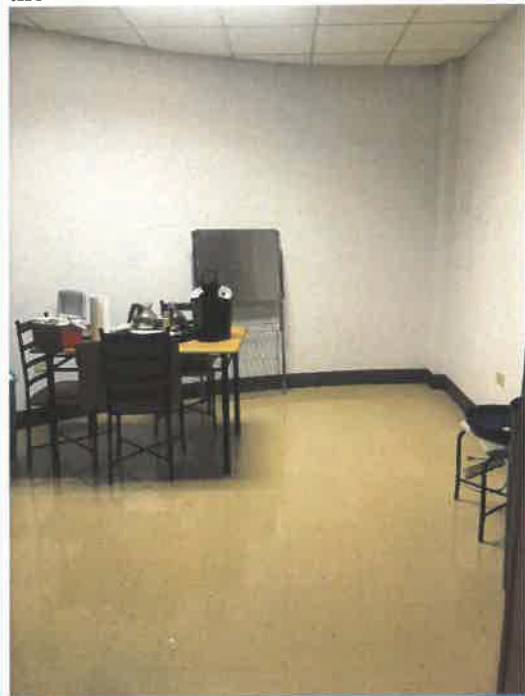
Breakroom with F4 floor tile over F2 floor tile

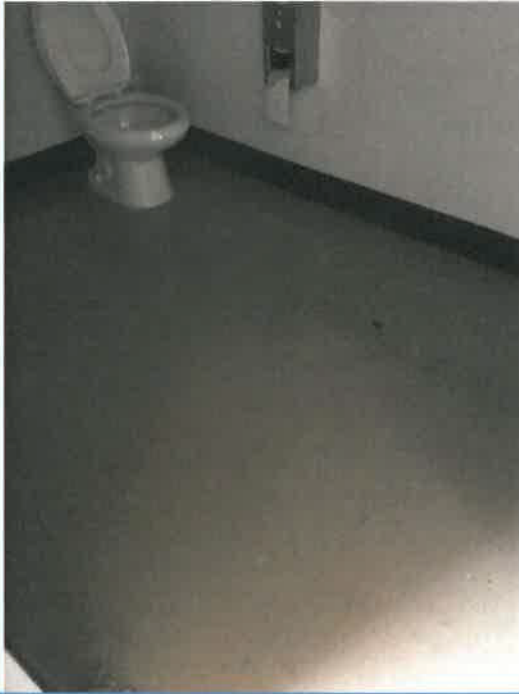
Women's restroom with F5 floor tile

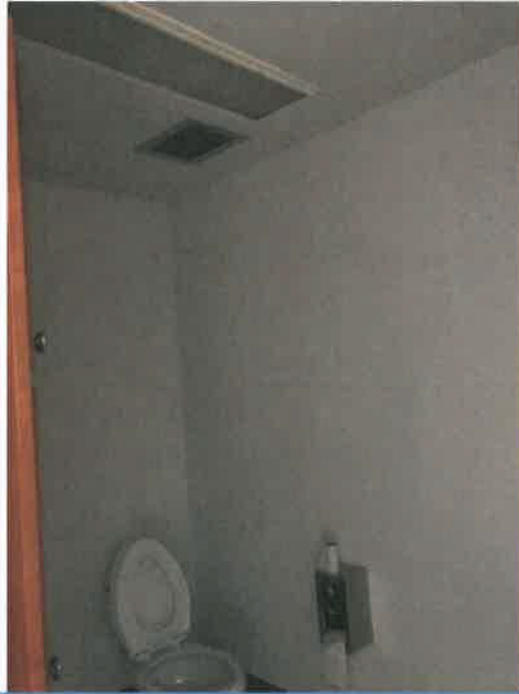
Women's restroom with F5 floor tile
