**ASBESTOS INSPECTION REPORT**  
**GEORGETOWN CITY HALL**  
Georgetown, South Carolina  
Asbestos Inspections, LLC Project # 2018-152  
*Performed in general accordance with SCDHEC regulation 61-86.1  
along with OSHA regulation 29 CFR 1926*

**Inspection Completed On – June 18, 2018**  
**Report Prepared On – June 27, 2018**

Subject: Asbestos Inspection Report  
Georgetown City Hall  
120 North Fraser Street  
Georgetown, South Carolina  
Asbestos Inspections, LLC Project # 2018-152

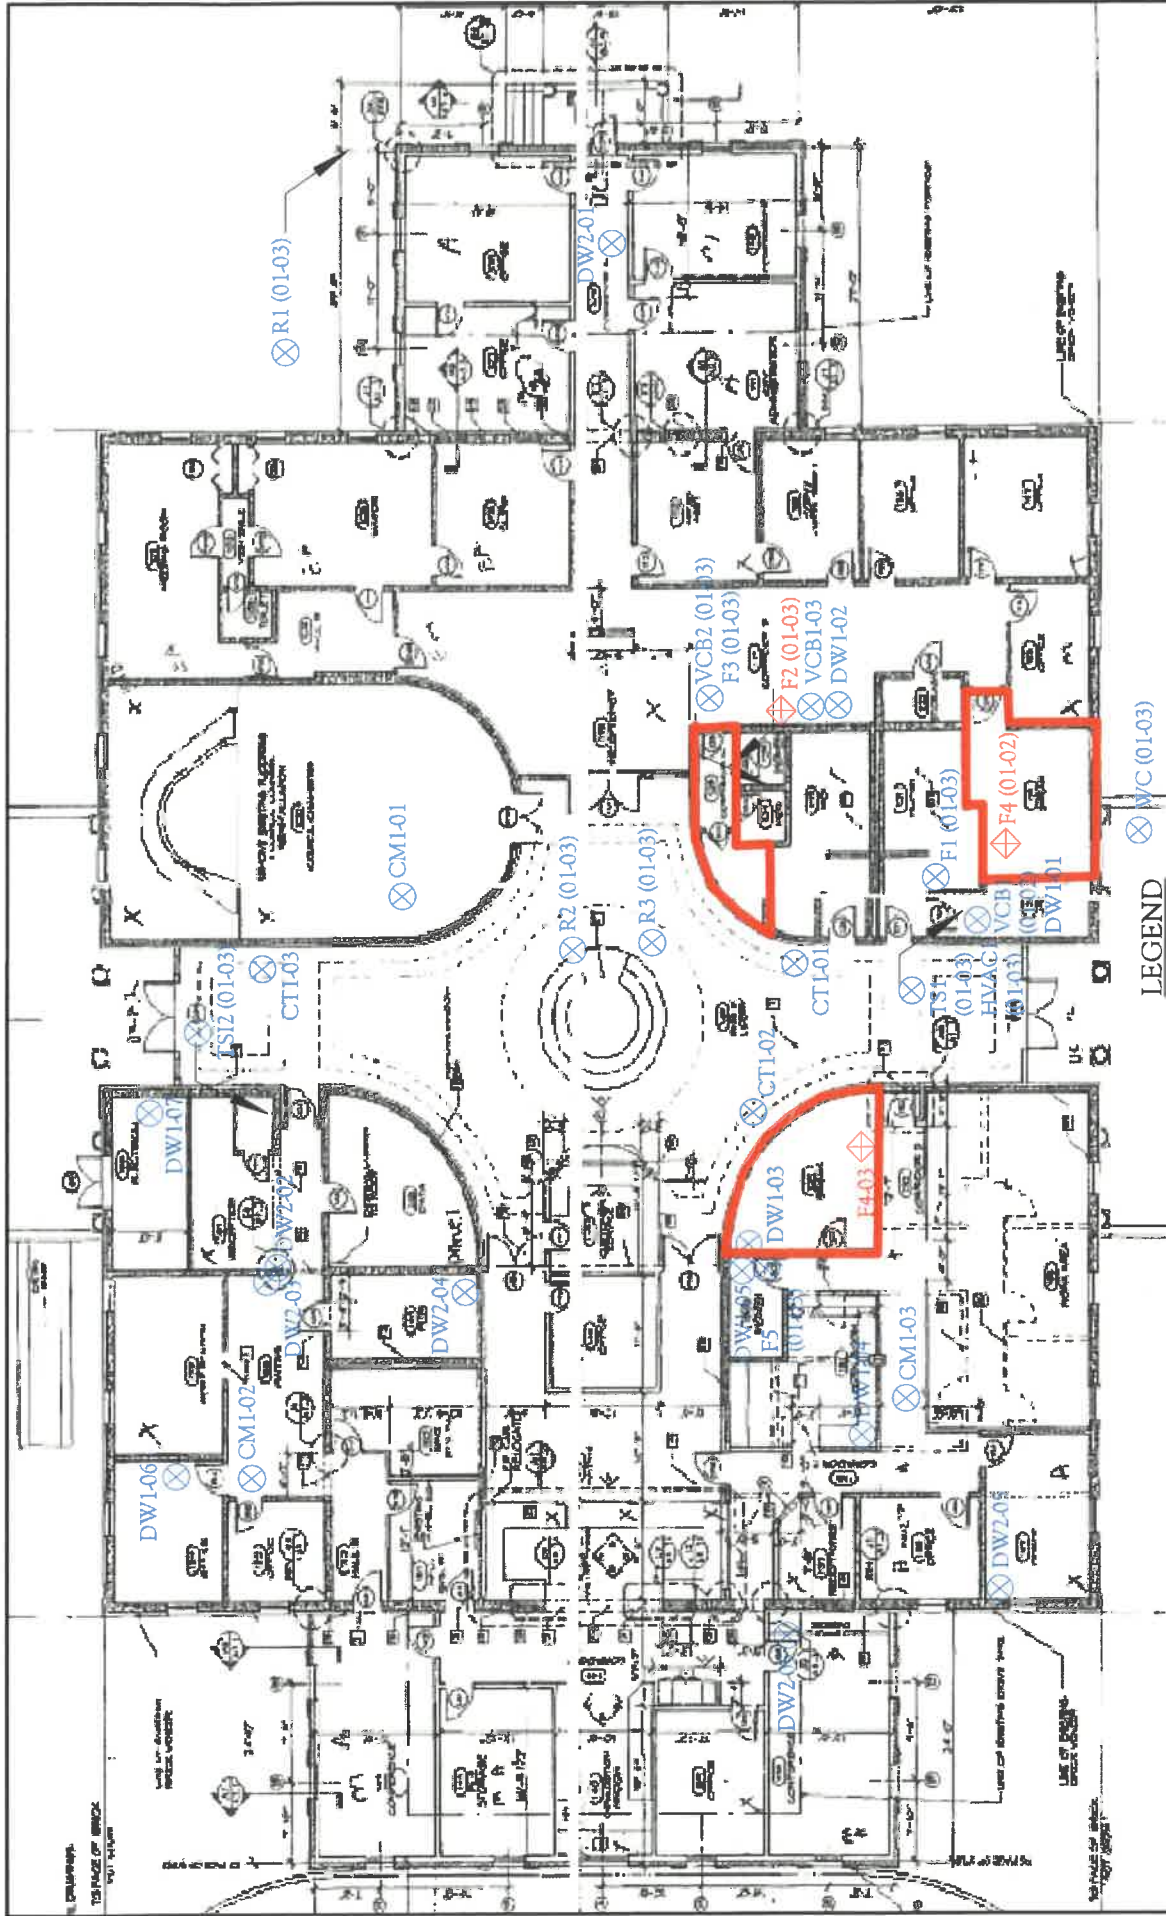
**Figure 2**

Asbestos containing black mastic associated with non-asbestos containing floor tile designated as F2 and F4 (Approximately 600 sf). Please know that the black mastic is underlying 1 layer of floor tile in the corridor and record room and underlying two layers of flooring in the kitchens.

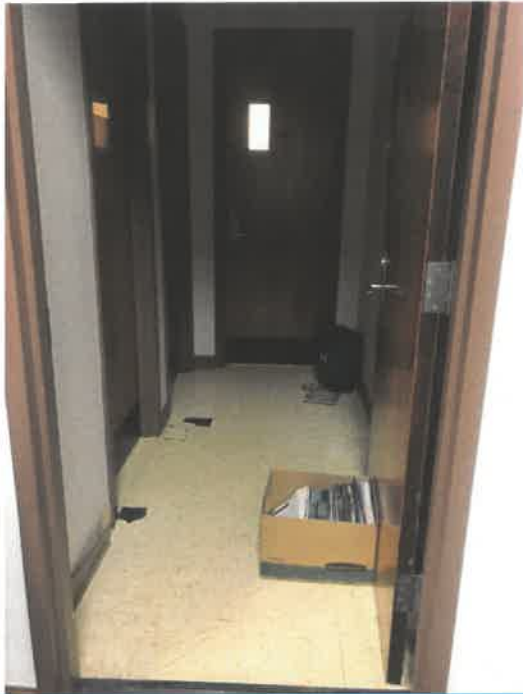
- F2 – Asbestos containing black mastic associated with non-asbestos white floor tile in Corridor C and adjoining records room – Approximately 300 sf

A copy of this report along with an application for abatement must be submitted to SCDHEC 4 working days prior to abatement and 10 working days prior to demolition. Additionally, a copy of this report should be provided to the contractors to assist with compliance with applicable State and Federal regulations.

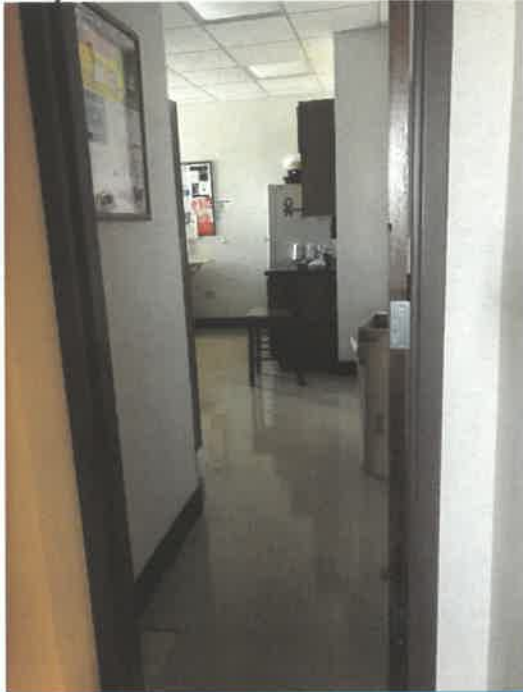
- F4 – Asbestos containing black mastic underlying 2 layers of non-asbestos containing white floor tile/ brown mastic/and tan floor tile. Located in Break Rooms 119 and 129 – Approximately 300 sf.

Breakroom with F4 over F2 on right side of lobby

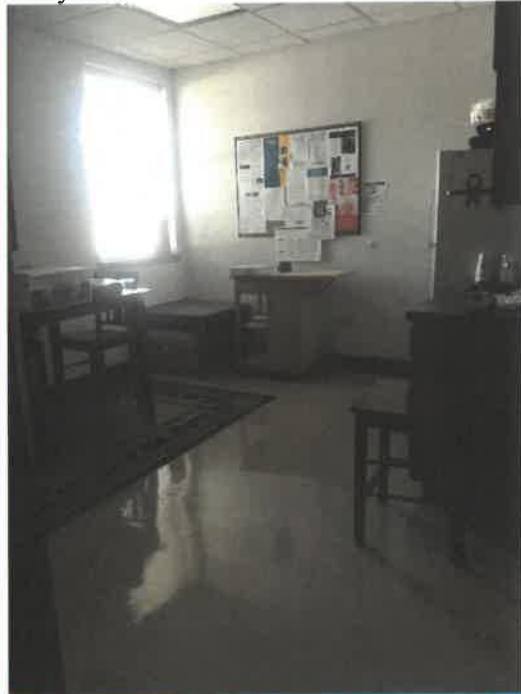
Breakroom with F4 over F2 on right side of lobby

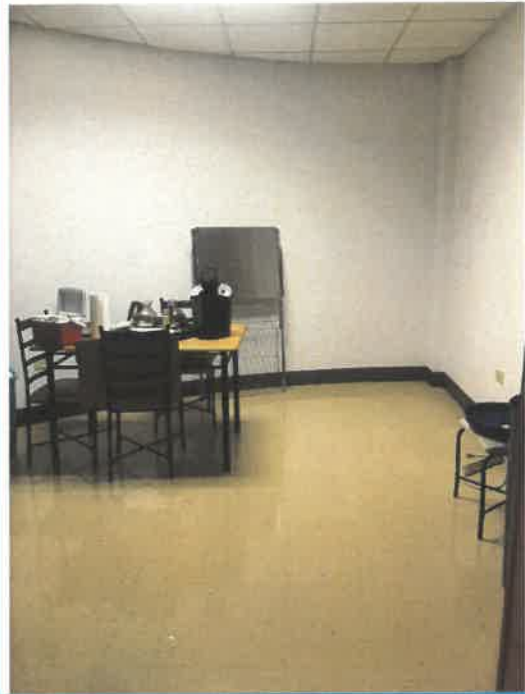
Breakroom with F4 floor tile over F2 floor tile
