AHERA/NESHAP ASBESTOS INSPECTION REPORT 110 A STREET RESIDENTIAL PROPERTY

City of Georgetown 110 A Street Georgetown, SC 29440

September 27, 2022

SUMMIT Job No. 0069.E0001

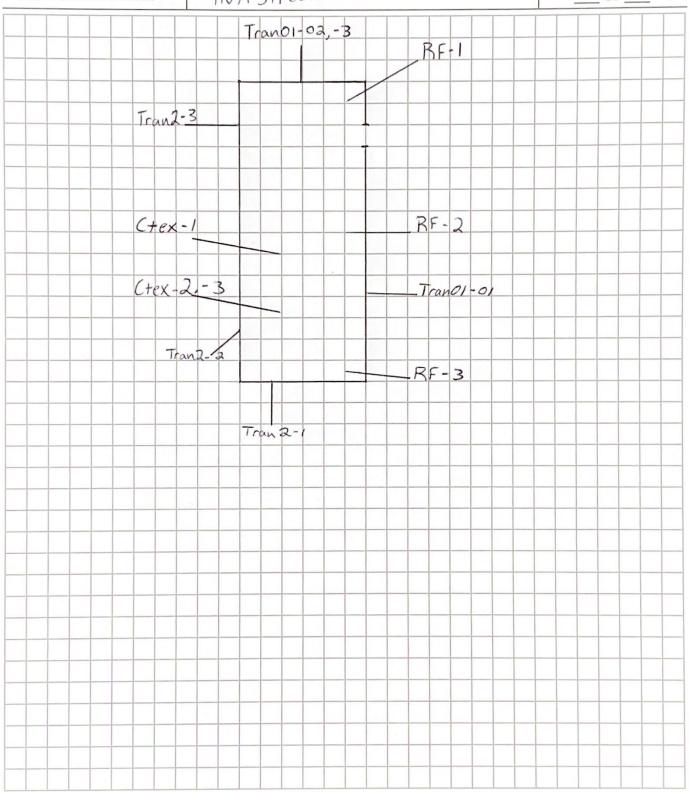
110 A Street

The cementitious board siding was sampled from outside the structure. The results indicated that the material is classified as an Asbestos Containing Material (ACM). The material contains 20% Chrysotile and there is approximately 500 SF of the material. The material is classified as a friable, miscellaneous material and is in good condition with a low potential for damage. The sample analysis of the material is enclosed in Appendix A. A detailed map showing the locations of the sampling locations can be found in the SUMMIT Documentation.

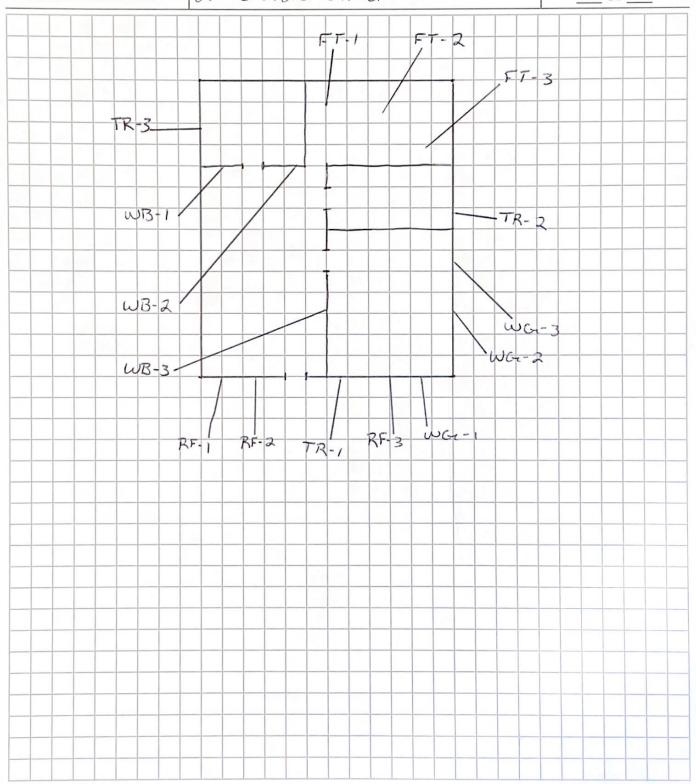
PROJECT NAME: West-End Dewolition SHEET NO
2005 Front Street ___OF__

The cementitious board was sampled from exterior of the structure. The results indicated that the material is classified as an Asbestos Containing Material (ACM). The material contains 20% Chrysotile and there is approximately 500 SF of the material. The material is classified as a non-friable, miscellaneous material and is in good condition with a low potential for damage. The sample analysis of the material is enclosed in Appendix A. A detailed map showing the locations of the sampling locations can be found in the SUMMIT Documentation.

The wallboard/joint compound was sampled from the interior of the structure. The results indicated that the material is classified as an Asbestos Containing Material (ACM). The material contains 2% Chrysotile and there is approximately 900 of the material. The material is classified as a friable, surfacing material and is in good condition with a low potential for damage. The sample analysis of the material is enclosed in Appendix A. A detailed map showing the locations of the sampling locations can be found in the SUMMIT Documentation.

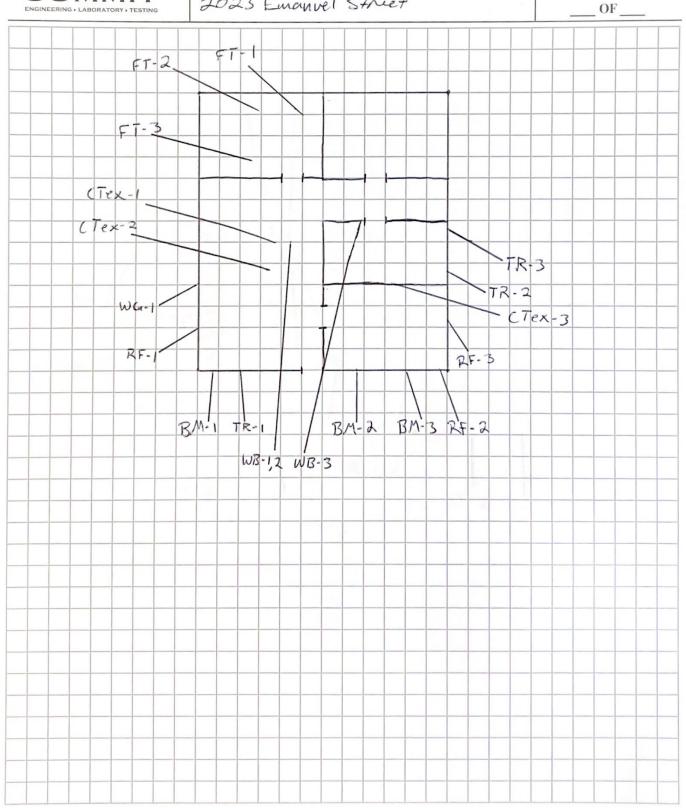
2023 Emanuel Street

The cementitious board was sampled from exterior of the structure. The results indicated that the material is classified as an Asbestos Containing Material (ACM). The material contains 10% Chrysotile and there is approximately 1,200 SF of the material. The material is classified as a non-friable, miscellaneous material and is in good condition with a low potential for damage. The sample analysis of the material is enclosed in Appendix A. A detailed map showing the locations of the sampling locations can be found in the SUMMIT Documentation.

The wallboard/joint compound was sampled from the interior of the structure. The results indicated that the material is classified as an Asbestos Containing Material (ACM). The material contains 2% Chrysotile and there is approximately 975 SF of the material. The material is classified as a friable, surfacing material and is in good condition with a low potential for

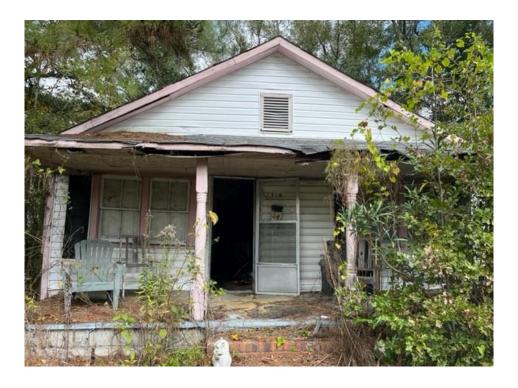
House structure

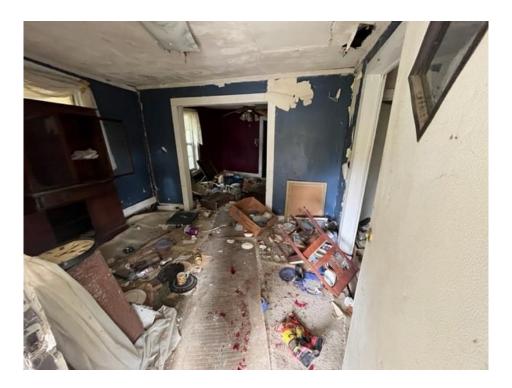
Inside of structure
