# LIMITED ASBESTOS SURVEY

THE ARSENAL  
2018 ROOF RENOVATION  
713 CRAVEN STREET  
BEAUFORT, SOUTH CAROLINA 29902

The Arsenal  
2018 Roof Renovation  
713 Craven Street  
Beaufort, SC 29902

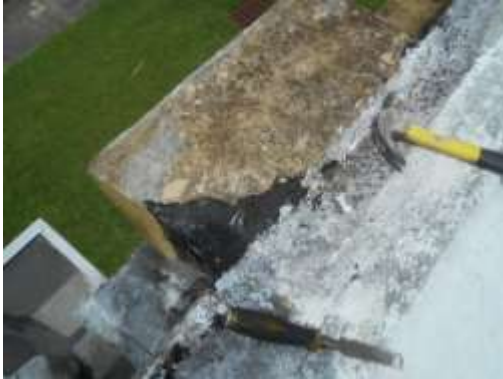
HOMOGENEOUS AREA 01  
ROOF FLASHING (LOW ROOF)

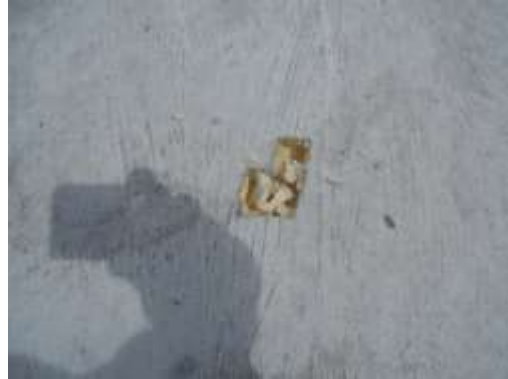
HOMOGENEOUS AREA 02  
ROOF CORE (LOW ROOF)

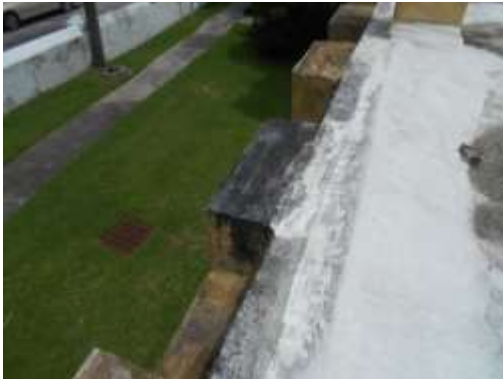
Asbestos fibers were identified in the Tar Application (low & high roof). Approximately 566 linear feet is in good condition and considered Category I – Non Friable Asbestos.

HOMOGENEOUS AREA 03  
TAR APPLICATION (LOW ROOF)

The identified asbestos containing building materials (ACBM's) to include the item(s) listed above. All removal work of the identified asbestos should be performed by a properly trained and licensed abatement contractor prior to the planned renovation/demolition activities.

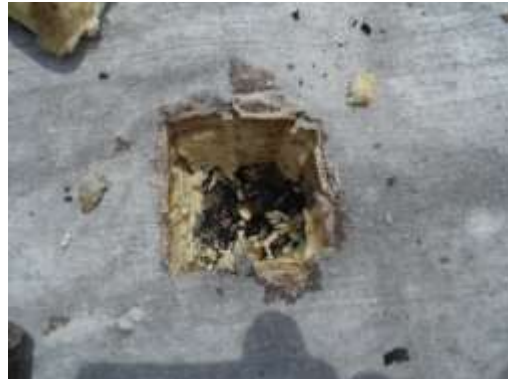
HOMOGENEOUS AREA 04  
ROOF FLASHING (HIGH ROOF)

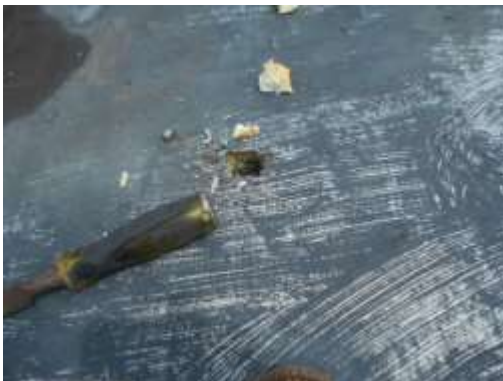
HOMOGENEOUS AREA 05  
ROOF CORE (HIGH ROOF)

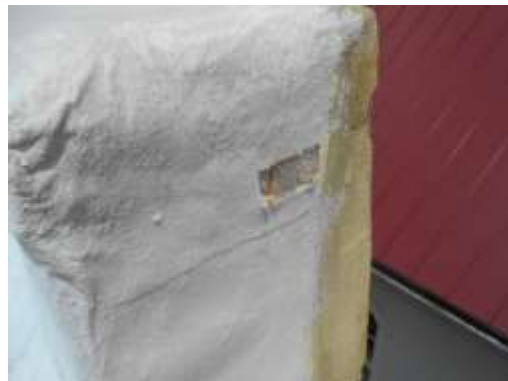
HOMOGENEOUS AREA 06  
CLOTH (HIGH ROOF)

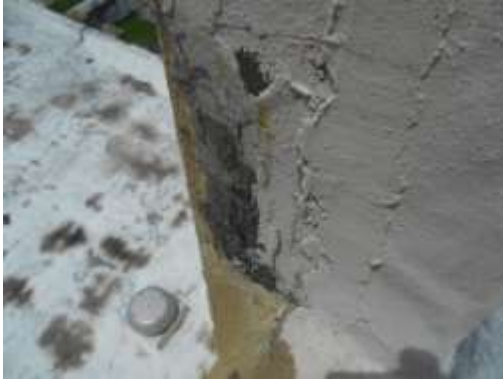
HOMOGENEOUS AREA 07  
ROOF FLASHING (LOW ROOF)

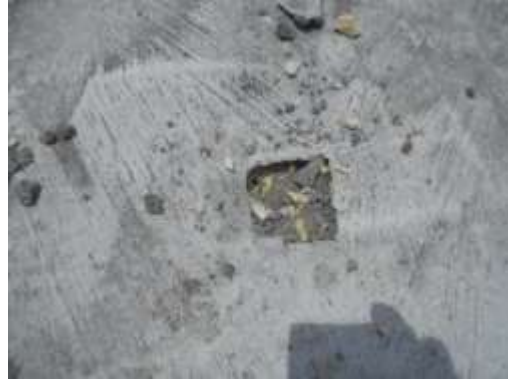
HOMOGENEOUS AREA 08  
ROOF CORE (LOW ROOF)
