Re: Pre-Demolition Hazardous Materials Survey
100 Maxwell Street
Pensacola, Escambia County, Florida

Re: Pre-Demolition Hazardous Materials Survey
100 W Maxwell Street
Pensacola, Florida
SESI Project No.: M20-584

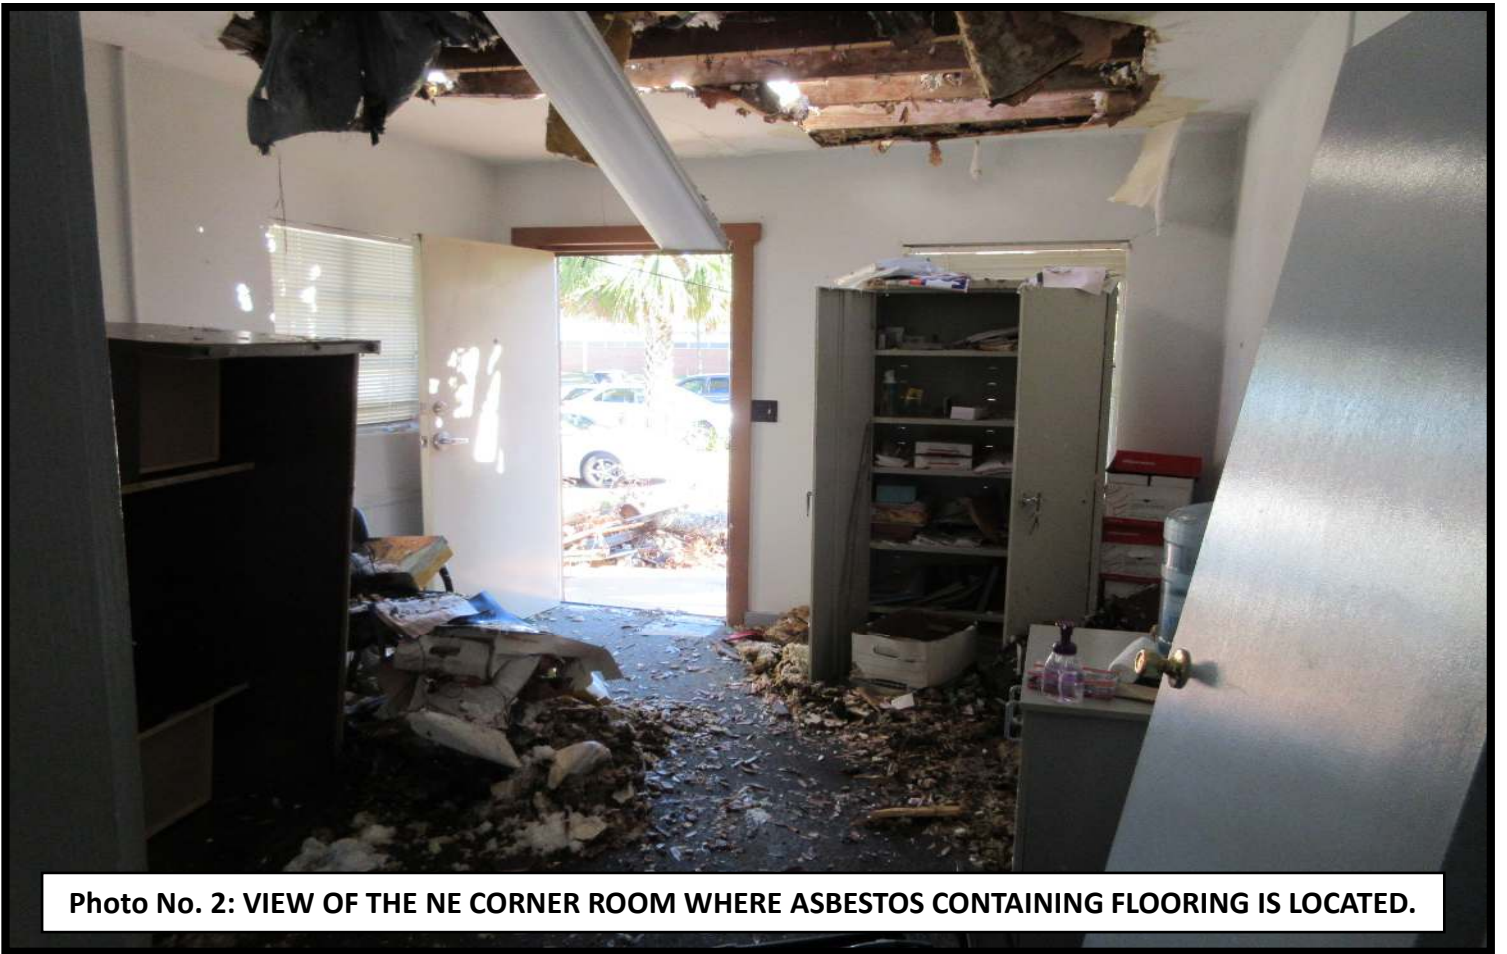
The yellow vinyl sheet Flooring (25% Chrysotile asbestos), yellow mastic (2% Chrysotile asbestos), off-white floor tile (3% Chrysotile asbestos) and black mastic (5% Chrysotile asbestos) located in the northeast corner are considered Category I non-friable ACMs under the NESHAP regulation. There is approximately 140 square feet of these materials.

Photo No. 2: VIEW OF THE NE CORNER ROOM WHERE ASBESTOS CONTAINING FLOORING IS LOCATED.

The asbestos containing vinyl sheet flooring and floor tile as well as the associated black and yellow flooring mastics are classified as Category I non-friable asbestos containing materials. Due to the propensity of vinyl sheet flooring to become friable during demolition activities, the asbestos containing yellow vinyl sheet flooring is considered RACM and must be removed prior to demolition. Due to the floor tile and associated flooring mastics being adhered to the vinyl sheet flooring, they must also be removed prior to demolition.

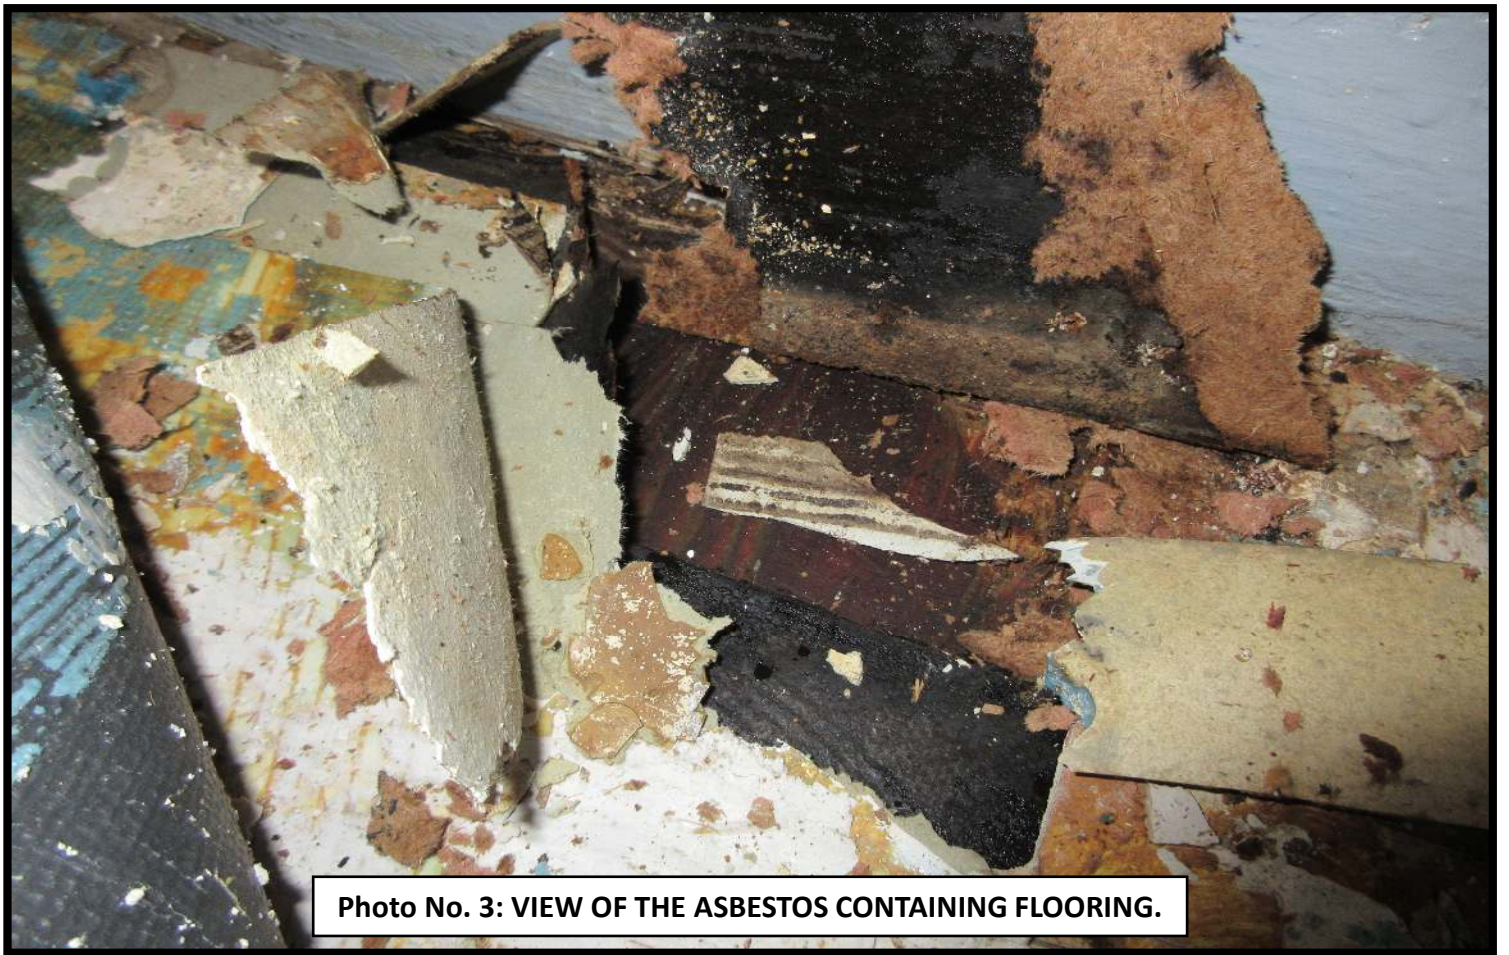
- Asbestos containing materials were identified in the northeast corner room of the structure and include the following:
 - Yellow Vinyl Sheet Flooring (25% Chrysotile);
 - Yellow Mastic (2% Chrysotile);
 - Off-White Floor Tile (3% Chrysotile); and
 - Black Mastic (5% Chrysotile).

Photo No. 3: VIEW OF THE ASBESTOS CONTAINING FLOORING.
