LIMITED HAZARDOUS MATERIALS SURVEY

ROOFS AND EXTERIOR AREAS OF VIRGINIA HOSPITAL CENTER

601 S. CARLIN SPRINGS ROAD
ARLINGTON, VIRGINIA 22204

ECS PROJECT NO. 47:1424-A

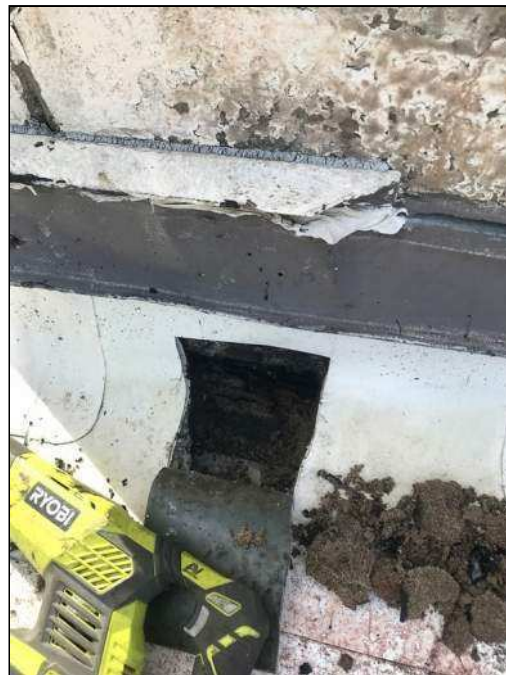
Asbestos-containing multiple layered flashing caulk was observed on the parapet wall adjacent to the southern multiple story section of the building. The asbestos-containing multiple layered flashing caulk appeared to be isolated to the connecting building parapet wall. Including a 20% contingency factor, approximately 50 linear feet of asbestos-containing multiple layered flashing caulk is associated with the parapet wall.

2 - View of Asbestos-Containing Multiple Layered Flashing Caulk on the Connecting Building Parapet Wall. Sample No. 61.

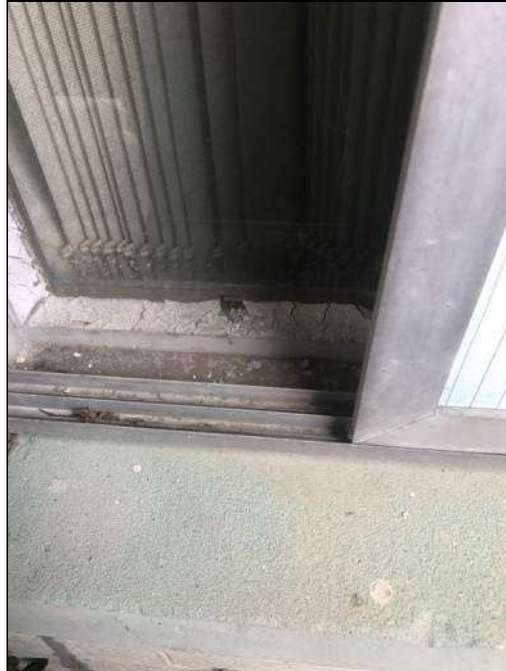
The asbestos-containing exterior gray window glazing was observed on the majority of exterior windows. Including a 20% contingency factor, approximately 6,000 linear feet of asbestos-containing exterior gray window glazing is located on exterior windows of the northern one-story and two-story sections of the building.

3 - View of Asbestos-Containing Gray Window Glaze on Exterior Windows. Sample No. 125.

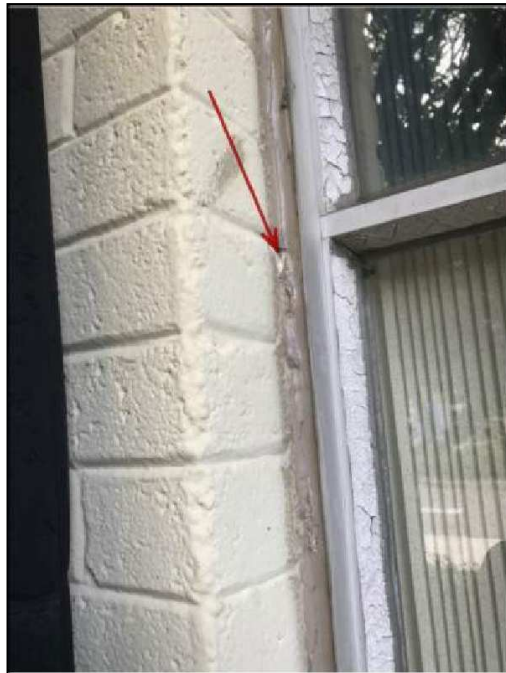
The asbestos-containing exterior white window caulk was observed on the majority of exterior windows. Including a 20% contingency factor, approximately 3,000 linear feet of asbestos-containing exterior white window caulk is located on exterior windows of the northern one-story and two-story sections of the building.

4 - View of Asbestos-Containing White Window Caulk on Exterior Windows. Sample No. 127-B.

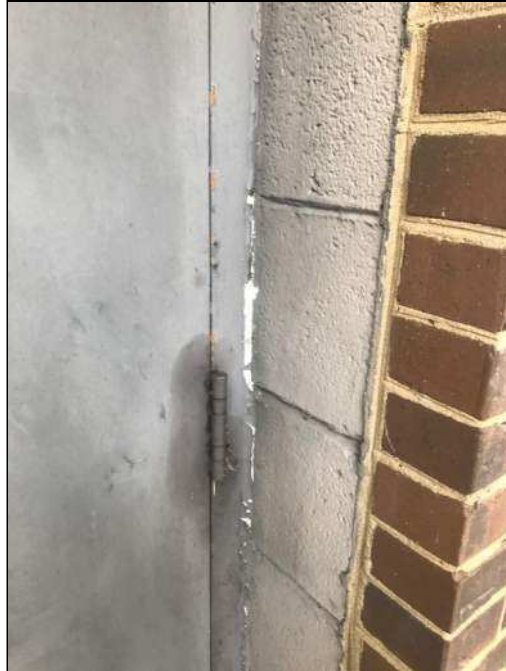
The asbestos-containing exterior tan door caulk was observed on several exterior doors. Including a 20% contingency factor, approximately 500 linear feet of asbestos-containing exterior tan door caulk is located on exterior doors around the northern one-story and two-story sections of the building.

5 - View of Asbestos-Containing Tan Door Caulk on Exterior Doors. Sample No. 149.

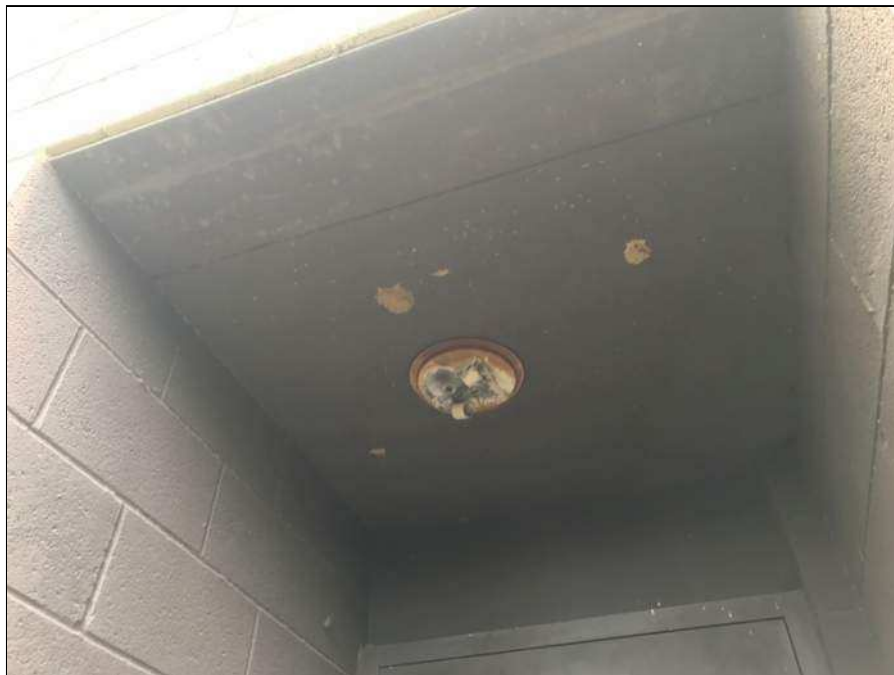
An asbestos-containing light shield insulation was observed underneath the several exterior soffits of the building. The asbestos-containing light shield insulation on one of the southeast soffits was observed in a damaged condition. Approximately 6 pieces of light shield insulation were observed on exterior soffits.

6 - View of Damaged Asbestos-Containing Light Shield Insulation on Exterior Soffits. Sample No. 164.

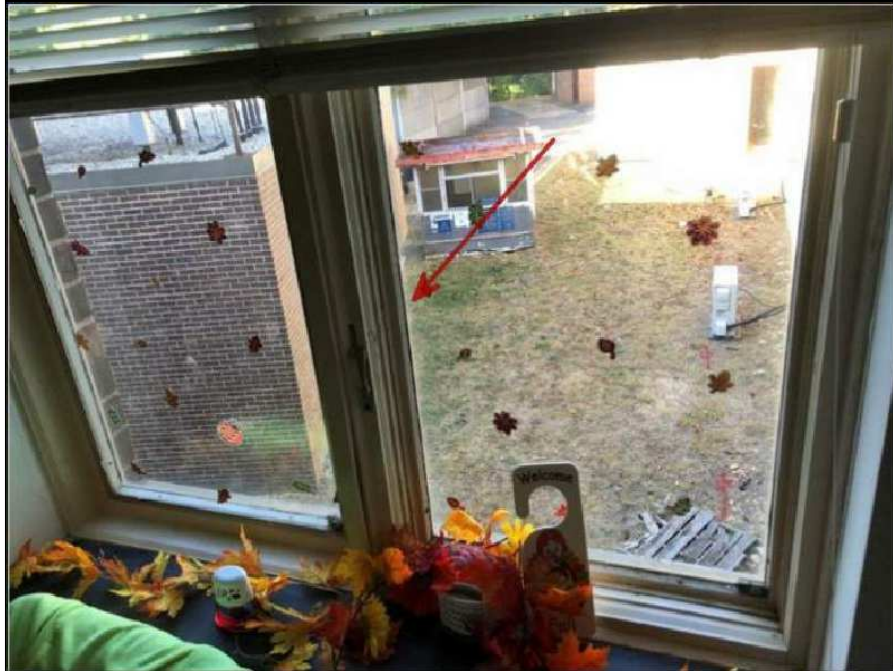
The section of building which connects the northern one-story and two-story sections with the southern multiple story section of the building appeared to have a distinct window system which is unique to the connecting building. The interior black window glaze on the connecting building windows was reported to contain asbestos. The windows are approximately four feet wide by six feet tall. Including a 20% contingency factor, approximately 275 linear feet of interior black window glazing was observed.

7 - View of Asbestos-Containing Interior Black Window Glazing on Connecting Building Windows. Sample No. 179.

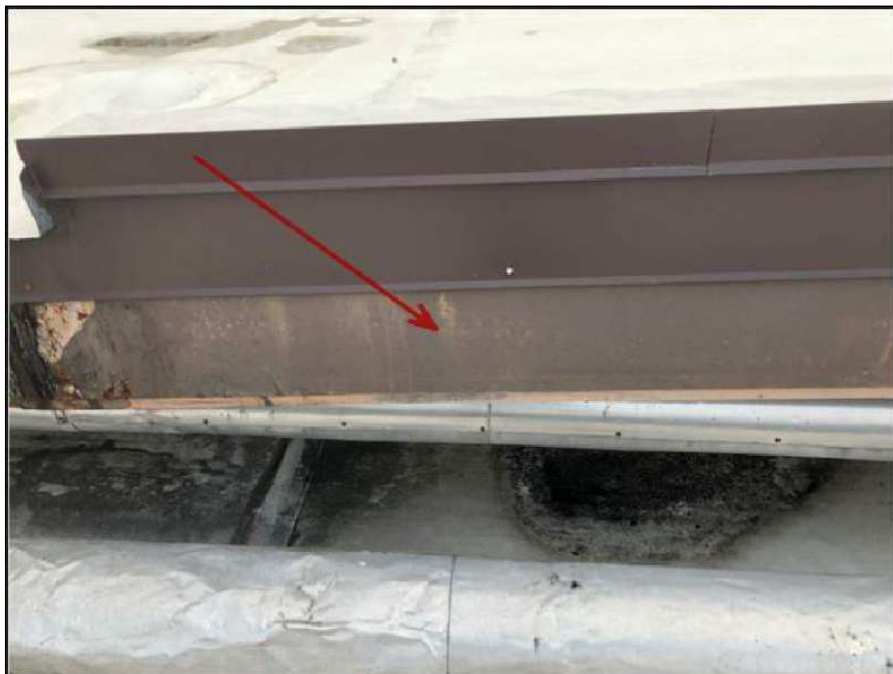
8 - View of Lead Based Paint on a Red Metal Beam on the Roof. XRF Reading No. 1031.

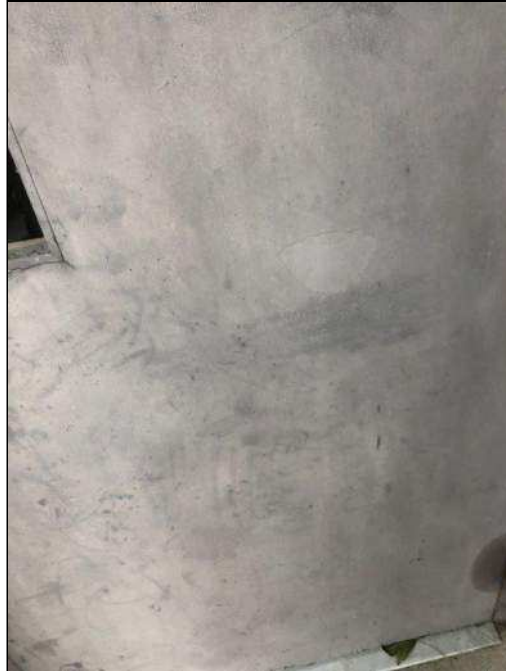
9 - View of Lead Based Paint on a Dark Gray Metal Door. XRF Reading Nos. 1050 and 1051.

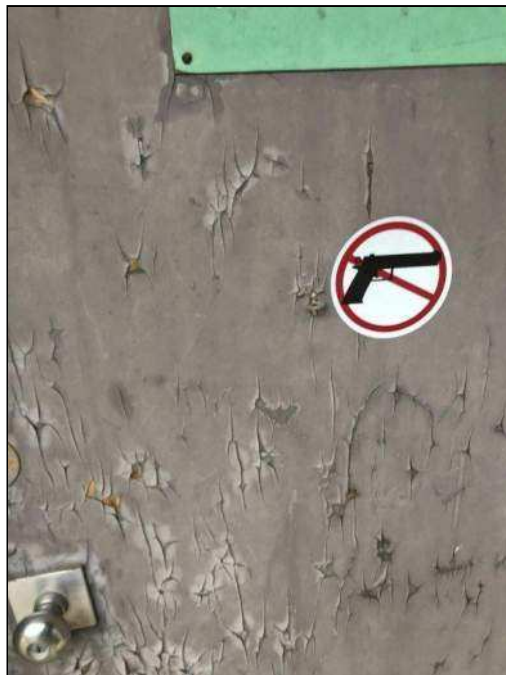
10 - View of Lead Based Paint on a Brown Metal Door. XRF Reading No. 1056.

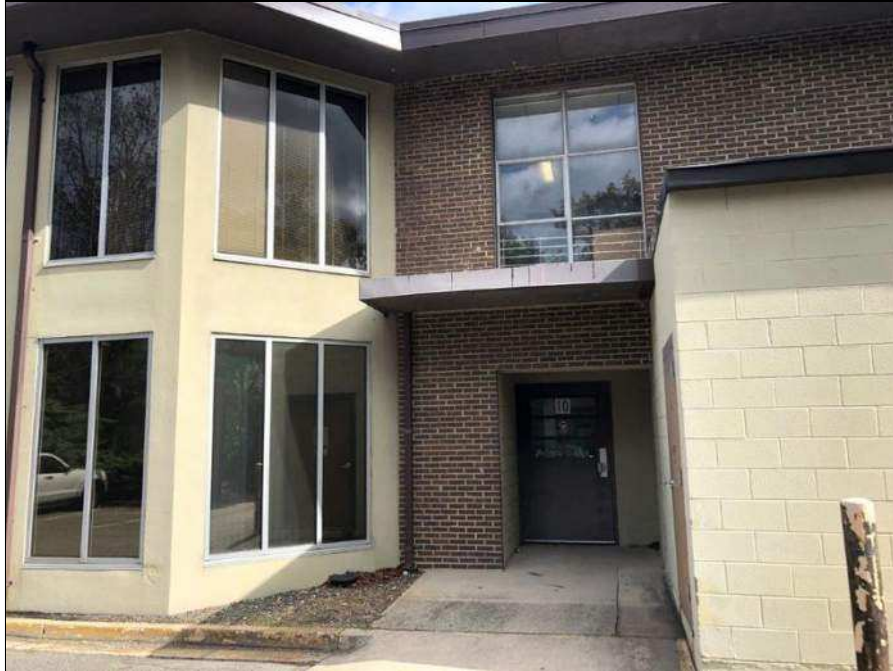
11 - View of Lead Based Paint on a Brown Metal Door. XRF Reading No. 1077.
