Asbestos & Lead Based Paint Assessment

City of Spartanburg
118 Overbrook Circle
Spartanburg, South Carolina 29306

Project Number: 0120-17

February 10, 2020

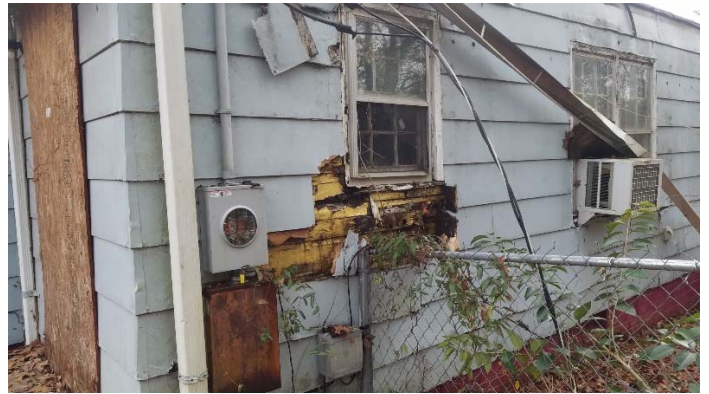
Photo 2 – Black felt under wood siding.

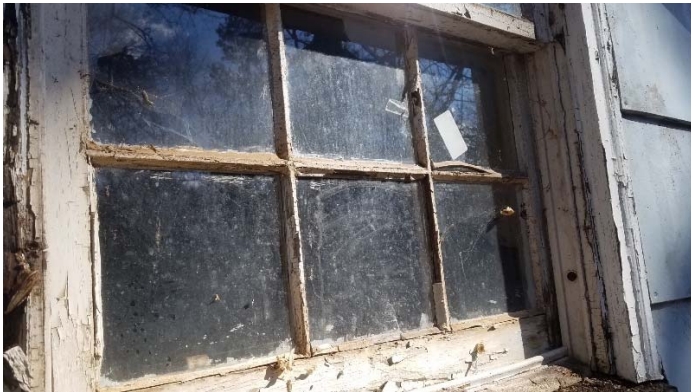
Photo 3 – Window glaze and caulk.

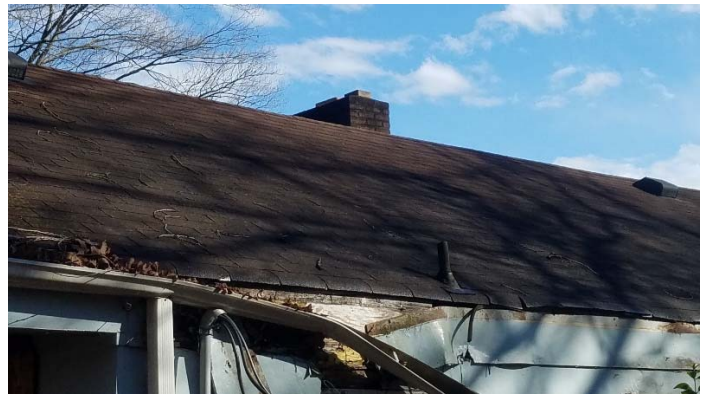
- Approximately 220 SF of orange sheet flooring located in the kitchen and dining room.
- Approximately 120 SF of 9" x 9" burgundy floor tile and mastic in the front right room.
- Approximately 6 LF of chimney tar. (Assumed).

Photo 4 – Shingled roof and assumed asbestos chimney tar.

1. Abate the asbestos containing materials in the structure prior to renovation or demolition.
2. Follow applicable asbestos regulations during renovation or demolition of the structure. You should be aware that stringent requirements are imposed upon anyone renovating or demolishing a structure in which ACM will be disturbed. This work must be performed in accordance with OSHA asbestos regulations, 29 CFR 1910 & 1926, and NESHAP asbestos regulations 40 CFR 61, subpart M. South Carolina regulations require the accreditation of personnel who work in the asbestos field and notification and permitting fees for asbestos removal projects. There is a 10 working day notification period required prior to abatement of asbestos in a facility. Failure to take proper precautions and actions to protect human health and the environment can result in penalties, danger to personnel, and construction delays.

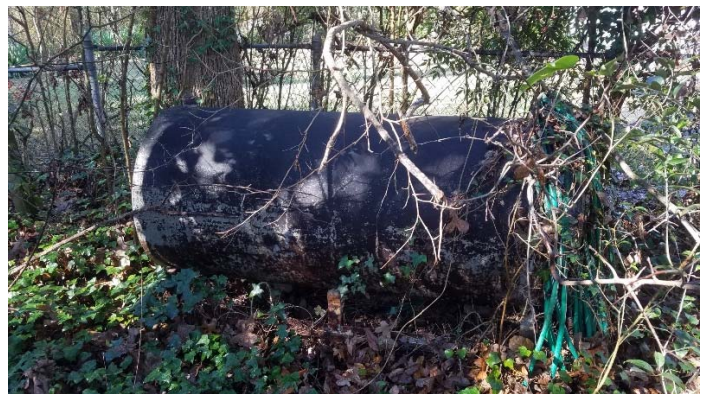
Photo 6 – 300 gallon fuel oil tank behind detached shed.

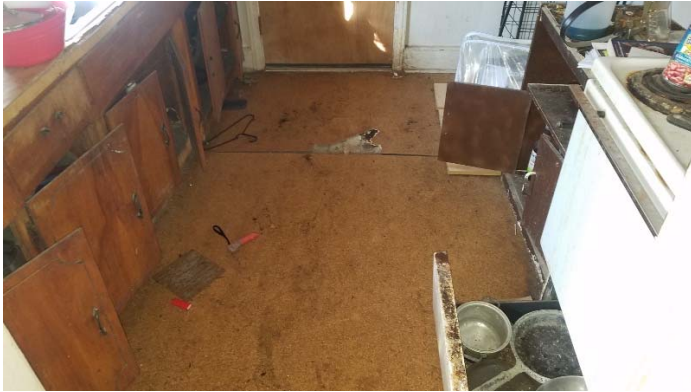
Photo 7– Orange roll vinyl kitchen flooring with felt.

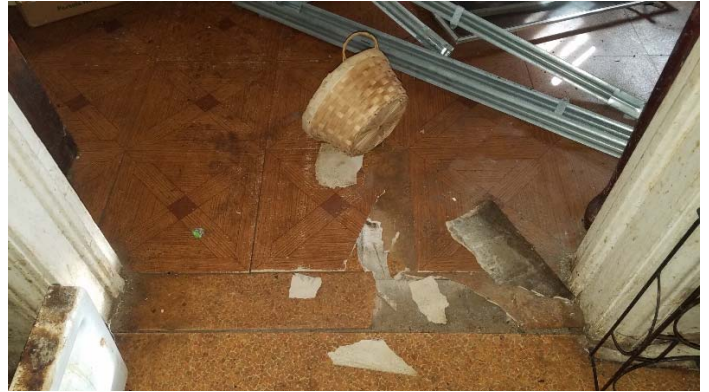
Photo 8 – Dining room wood pattern self-stick tile over orange roll vinyl flooring with felt.

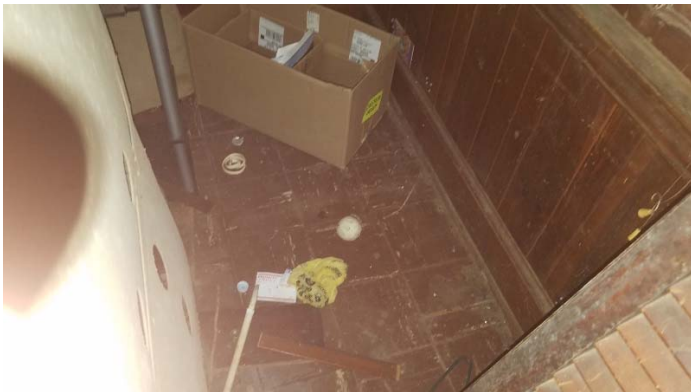
Photo 9 – Front right room burgundy 9"x 9" floor tile and mastic.

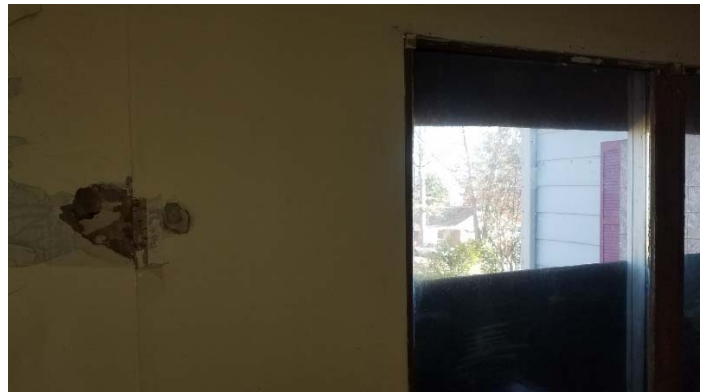
Photo 10 – Plaster over unfinished drywall walls and ceilings.

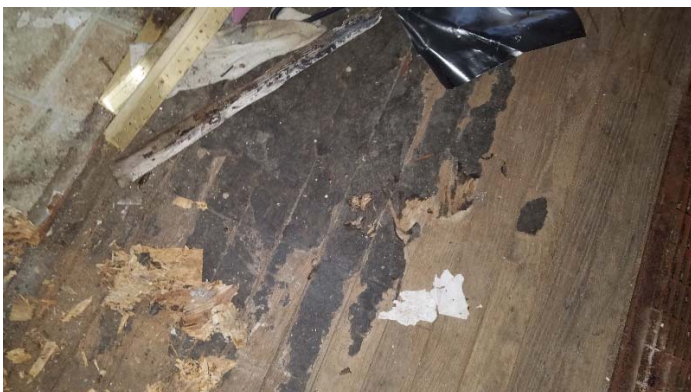
Photo 11 – Black felt on wood flooring in bathroom, hallway and hall closet floor.

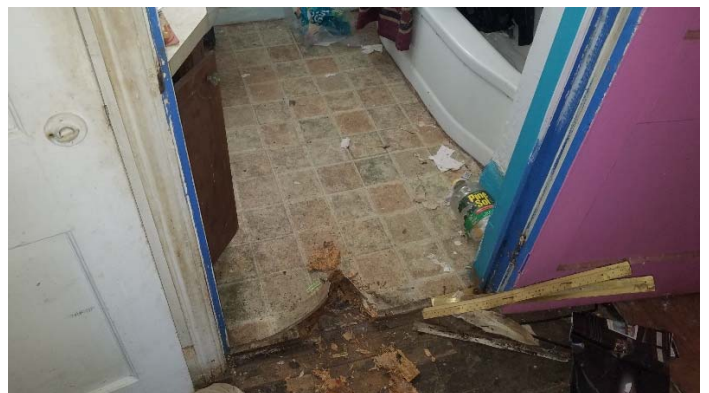
Photo 12 – Bathroom tan square pattern roll vinyl flooring with mastic. Black felt below flooring and wood sub-floor.

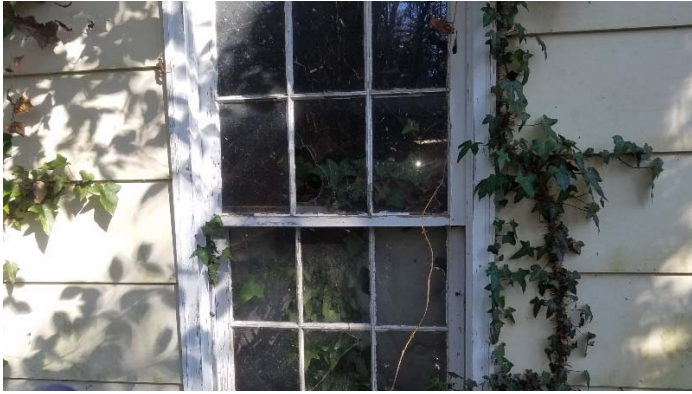
Photo 13 – Window glaze on detached shed.

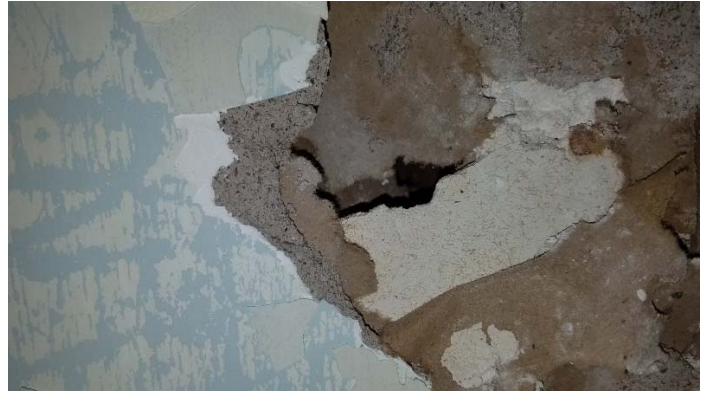
Photo 14 – Plaster over unfinished drywall.

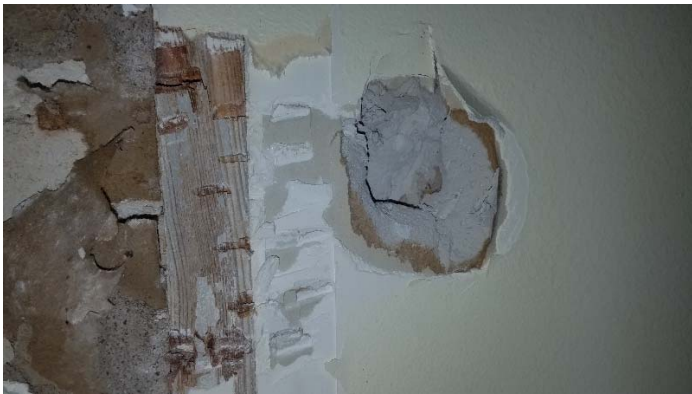
Photo 15 – Transition from plaster over drywall to drywall with joint compound at front window repair.
