Apex Project Number 0120-17

February 10, 2020

Reference: Asbestos Reassessment and Lead-Based Paint Services
124 Georgia Street
Spartanburg, South Carolina 29306

Asbestos & Lead Based Paint Assessment

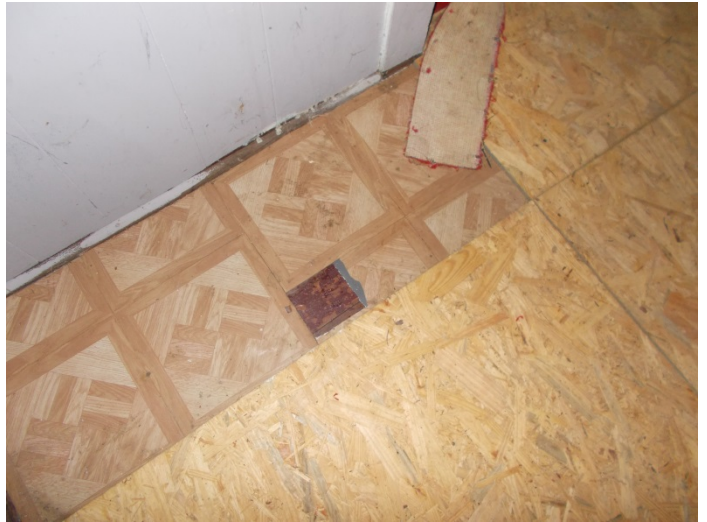
Photo 2 – Two layers of self-stick tile under wood in the kitchen.

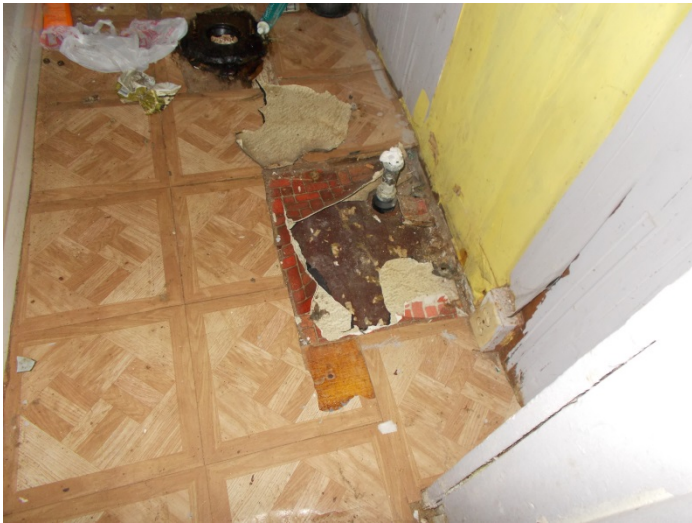
- Approximately 15 SF of self-stick tile under linoleum and wood in the bathroom.
- Approximately 6 LF of chimney caulk, assumed positive.

Photo 3 – Three layers of self-stick tile, under linoleum and wood in the bathroom.

1. Abate the asbestos containing materials in the structure prior to renovation or demolition.
2. Follow applicable asbestos regulations during renovation or demolition of the structure. You should be aware that stringent requirements are imposed upon anyone renovating or demolishing a structure in which ACM will be disturbed. This work must be performed in accordance with OSHA asbestos regulations, 29 CFR 1910 & 1926, and NESHAP asbestos regulations 40 CFR 61, subpart M. South Carolina regulations require the accreditation of personnel who work in the asbestos field and notification and permitting fees for asbestos removal projects. There is a 10 working day notification period required prior to abatement of asbestos in a facility. Failure to take proper precautions and actions to protect human health and the environment can result in penalties, danger to personnel, and construction delays.

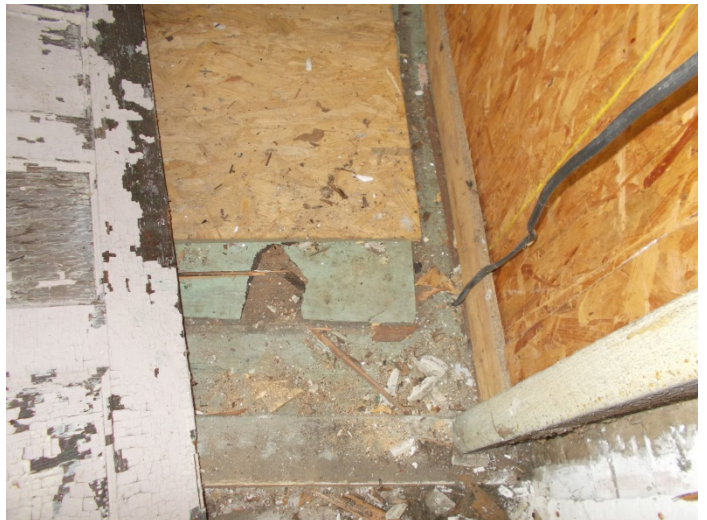
Photo 4 – Green sheet flooring in the back room.

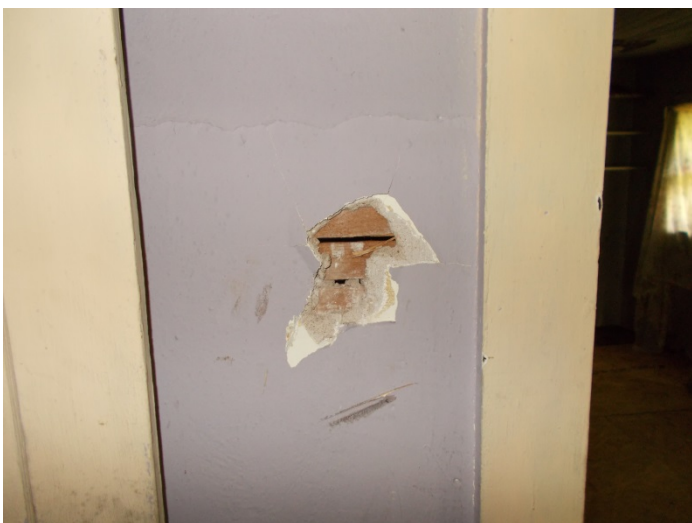
Photo 5 – Plaster with skim coat walls in the left room.

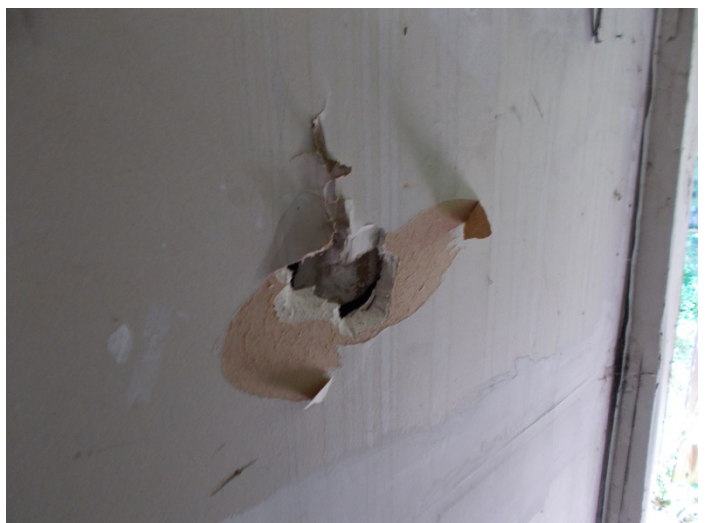
Photo 6 – Drywall with joint compound in the back room.

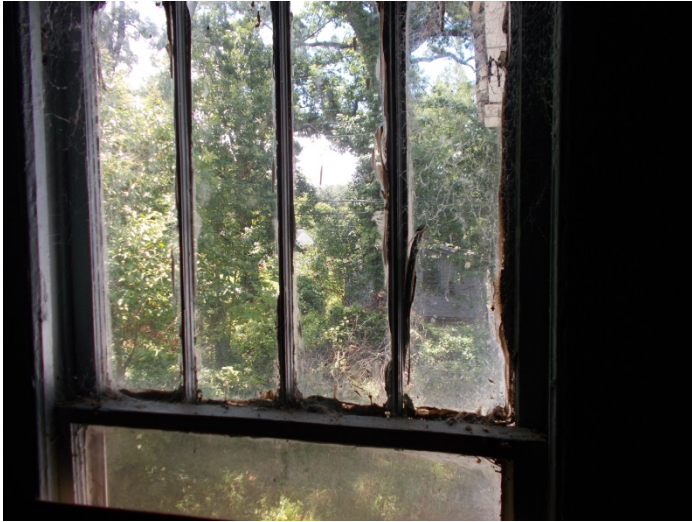
Photo 7 - Window glazing on the exterior windows.

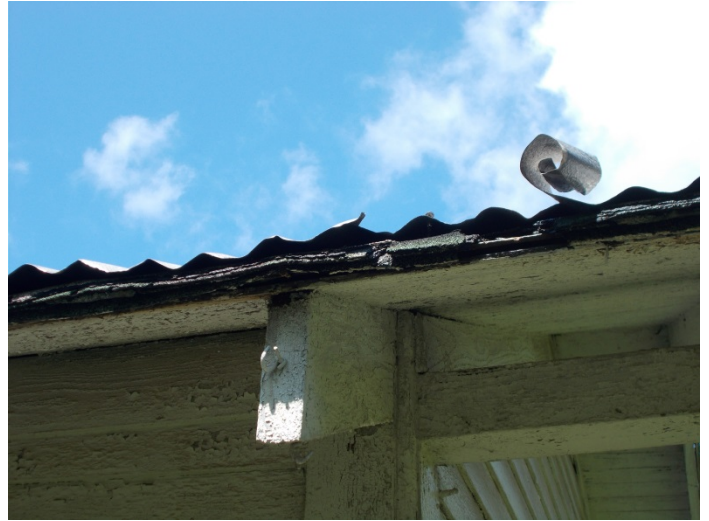
Photo 8 - Four layers of shingles and a layer of felt on the pitched wooden roof.
