Asbestos & Lead Based Paint Assessment

City of Spartanburg
183 E. Columbia Avenue
Spartanburg, South Carolina 29306

Project Number: 0120-17

February 10, 2020

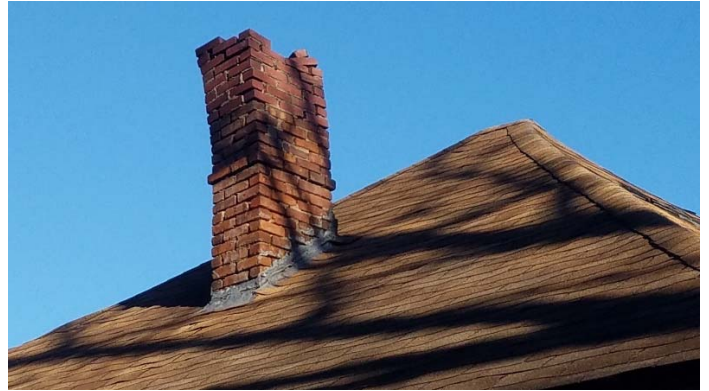
Photo 2 – Shingled Roof and assumed asbestos black tar on damaged, leaning chimney. 2 chimneys exist.

1. Abate the asbestos containing materials in the structure prior to renovation or demolition.
2. Follow applicable asbestos regulations during renovation or demolition of the structure. You should be aware that stringent requirements are imposed upon anyone renovating or demolishing a structure in which ACM will be disturbed. This work must be performed in accordance with OSHA asbestos regulations, 29 CFR 1910 & 1926, and NESHAP asbestos

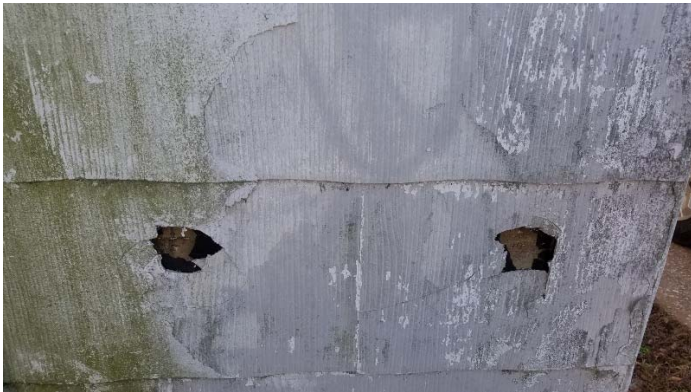
Photo 3 – Transite exterior siding with felt.

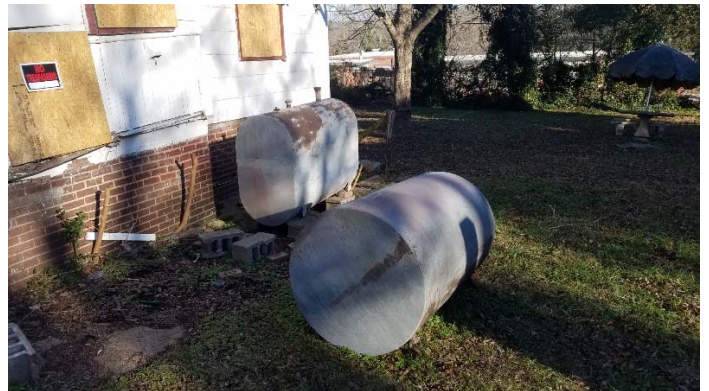
Photo 4 – Two fuel oil tanks behind the house.

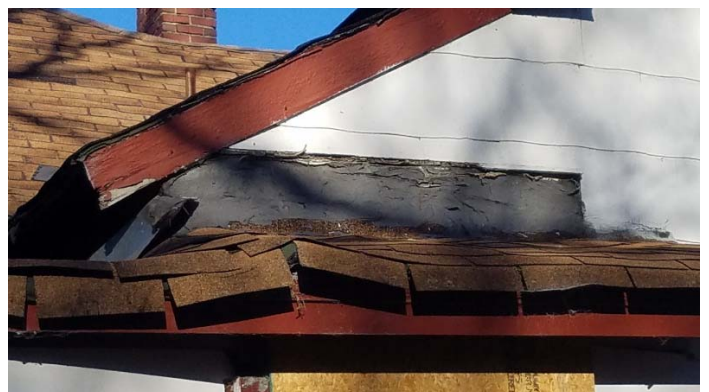
Photo 6 – Assumed asbestos back porch roof flashing tar.

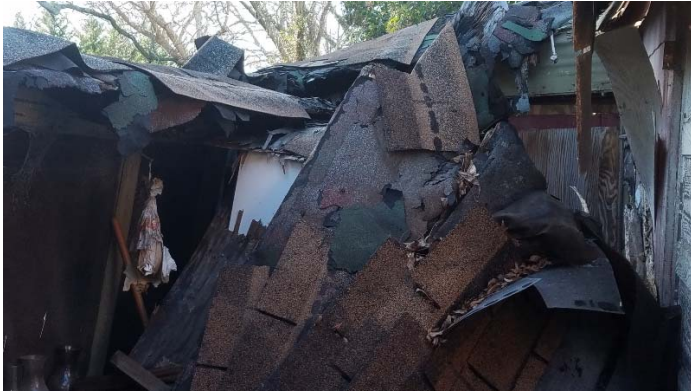
Photo 7 – Back porch collapsed roof.

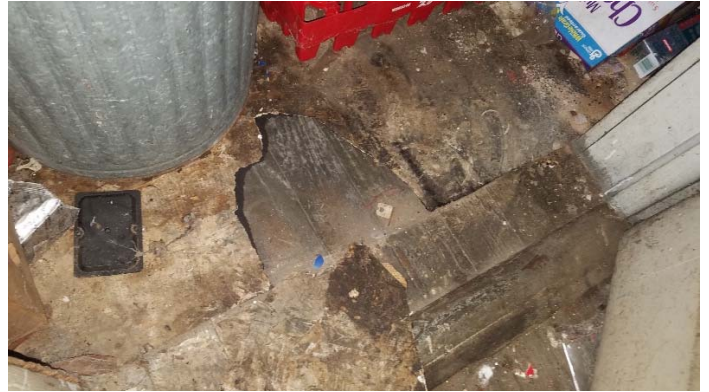
Photo 8 – Back porch closet flooring.

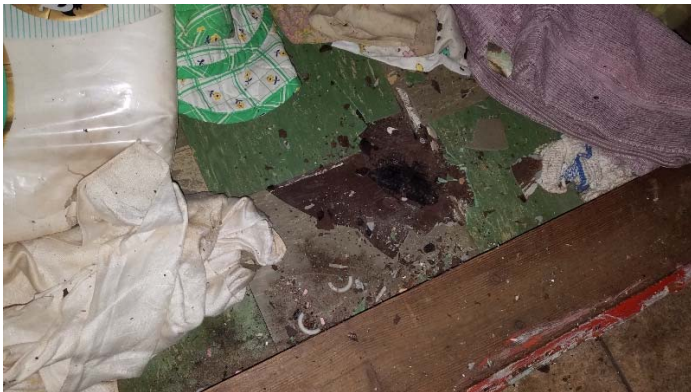
- Approximately 12 SF of green/grey tile located in the bathroom closet.
- Approximately 12 SF of brown tile located under the green/grey tile in the bathroom closet.
- Approximately 12 SF of black mastic under brown tile in the bathroom closet.
- Approximately 4,200 SF of white transite siding.
- Approximately 12 LF of black tar from 2 chimney's (Assumed).
- Approximately 25 SF of flashing tar from the back porch roof (Assumed).

Photo 9 – Bathroom closet flooring.

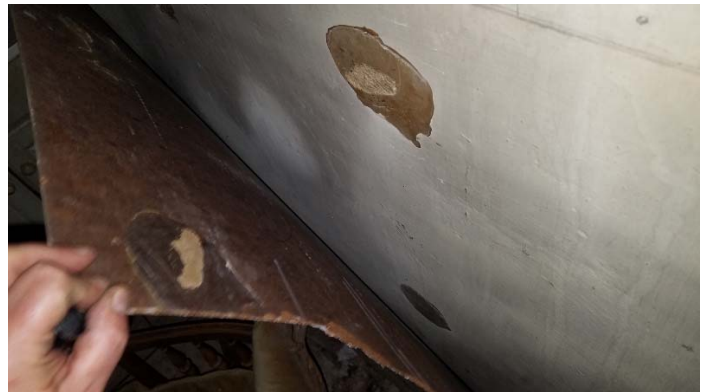
Photo 10 – Bathroom mastic behind wall-board.

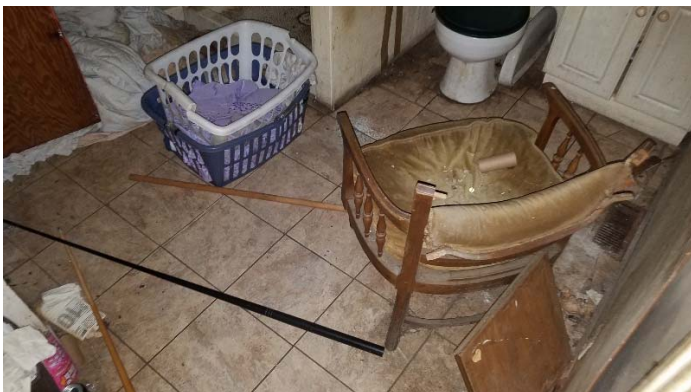
Photo 11 – Bathroom 12"x 12" tan self-stick tile.

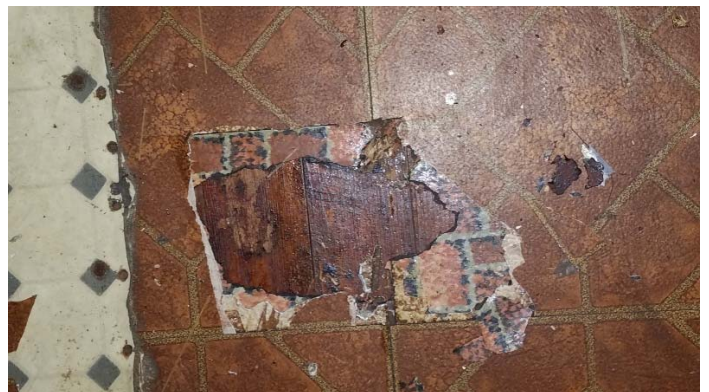
Photo 12 – Multiple layers of kitchen flooring.

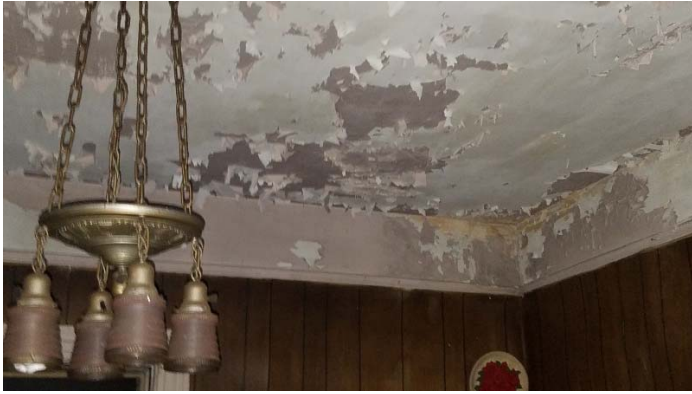
Photo 13 – Plaster ceiling.

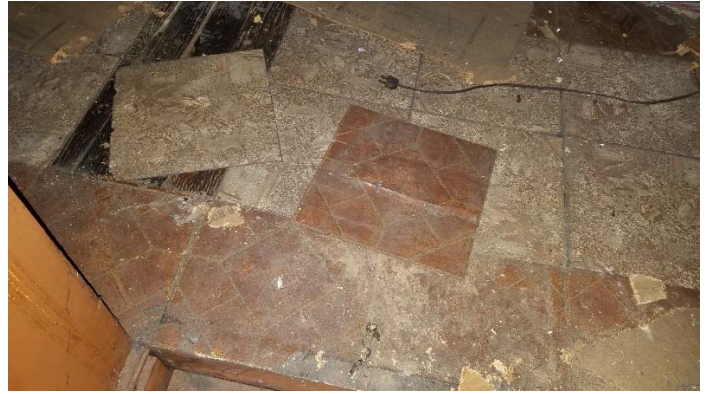
Photo 14 – Self-stick tile flooring in partially finished attic. Same as two layers in kitchen samples.
