## **Asbestos & Lead Based Paint Assessment**

City of Spartanburg  
4 Buckthorn Road  
Spartanburg, South Carolina 29301

Project Number: 0120-17

February 10, 2020

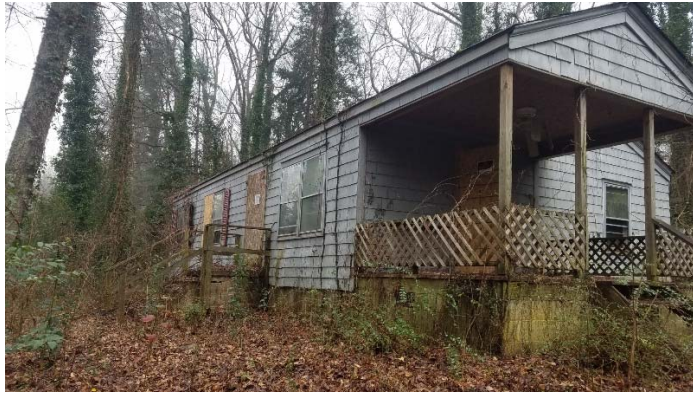
Photo 1 – 4 Buckthorn Road in Spartanburg, South Carolina.

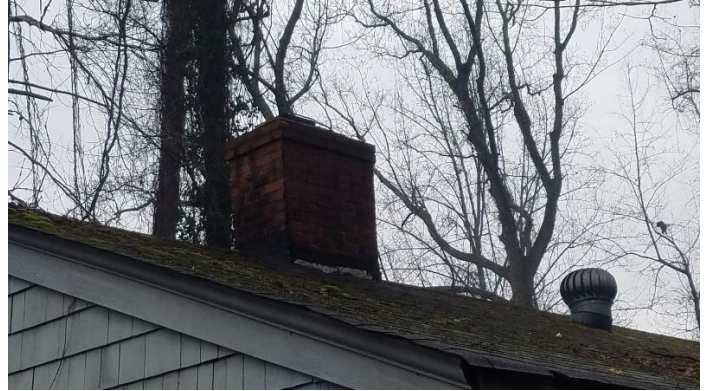
- Approximately 3,700 SF of joint compound throughout the walls and ceiling.
- Approximately 6 LF of chimney tar. (Assumed)

Photo 2 – Assumed asbestos chimney tar.

1. Abate the asbestos containing materials in the structure prior to renovation or demolition.
2. Follow applicable asbestos regulations during renovation or demolition of the structure. You should be aware that stringent requirements are imposed upon anyone renovating or demolishing a structure in which ACM will be disturbed. This work must be performed in accordance with OSHA asbestos regulations, 29 CFR 1910 & 1926, and NESHAP asbestos regulations 40 CFR 61, subpart M. South Carolina regulations require the accreditation of personnel who work in the asbestos field and notification and permitting fees for asbestos removal projects. There is a 10 working day notification period required prior to abatement of asbestos in a facility. Failure to take proper precautions and actions to protect human health and the environment can result in penalties, danger to personnel, and construction delays.

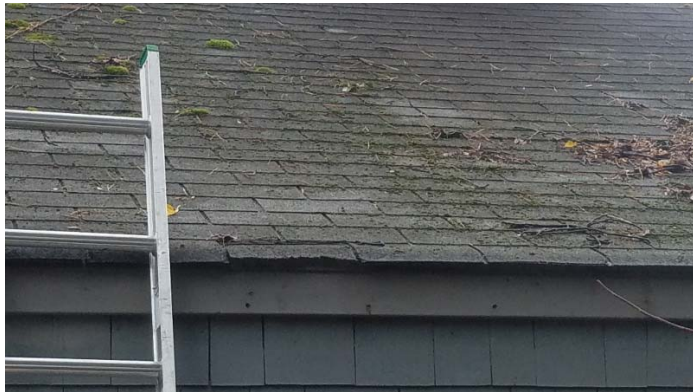
Photo 3 – Shingled roof.

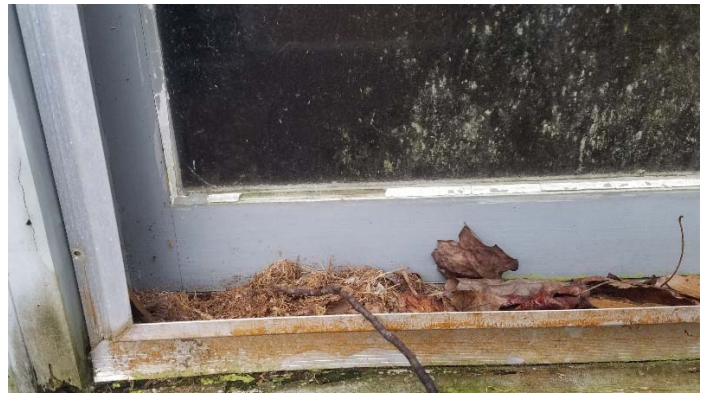
Photo 4 – Window glazing.

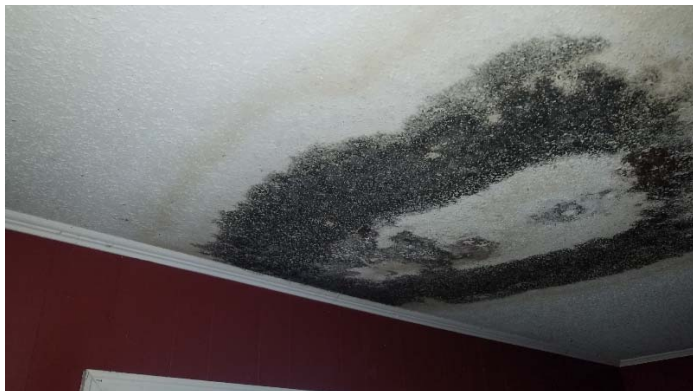
Photo 5 – Ceiling texture.

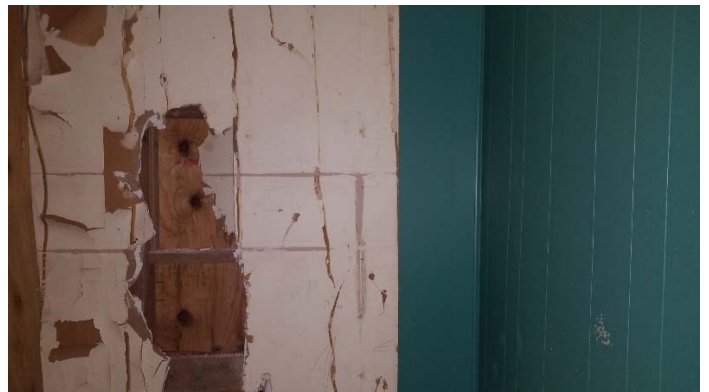
Photo 6 – Mastic behind wooden wall paneling.

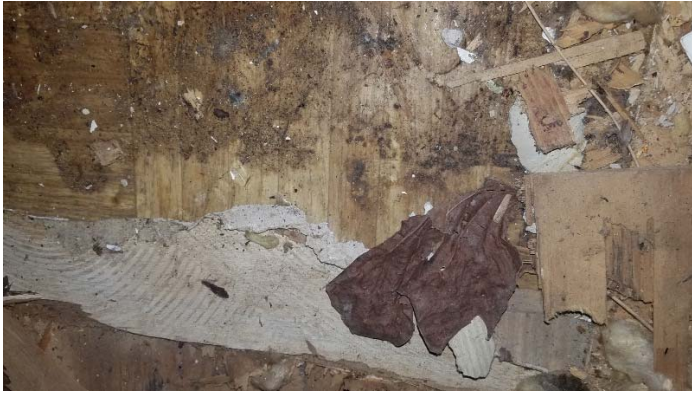
Photo 7 – Kitchen wood pattern roll vinyl flooring with mastic under tile and wood sub-floor.

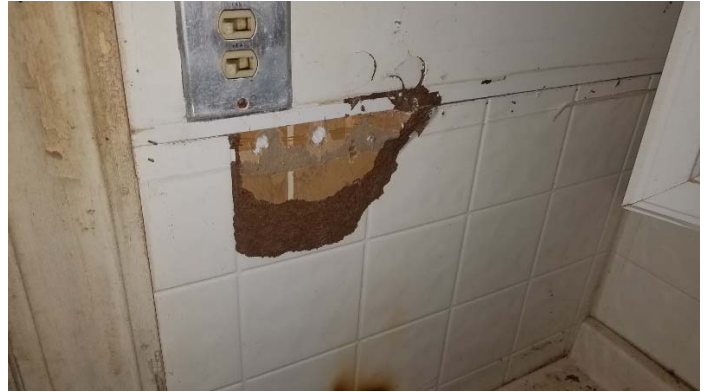
Photo 8 – Bathroom mastic behind wall-board.

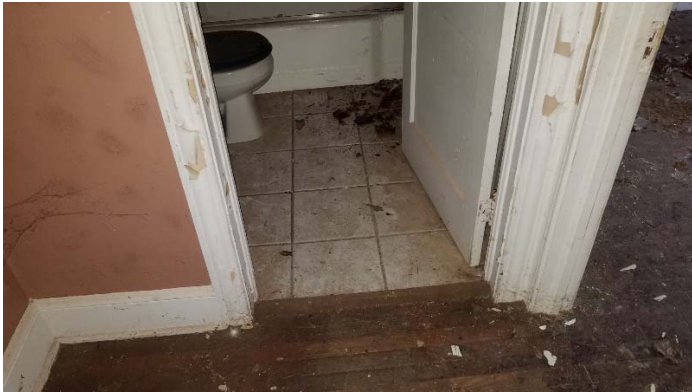
Photo 9 – Bathroom tan roll vinyl flooring with mastic under tile and wood sub-floor.

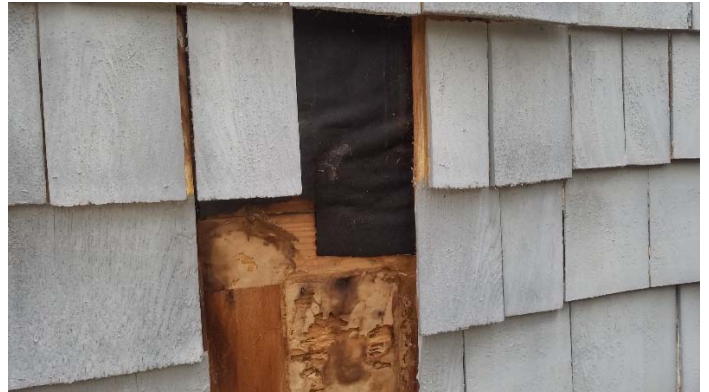
Photo 10 – Black felt under exterior cedar shake siding.
