Asbestos & Lead Based Paint Assessment

City of Spartanburg
688 Saxon Avenue
Spartanburg, South Carolina 29301

Project Number: 0120-17

February 10, 2020

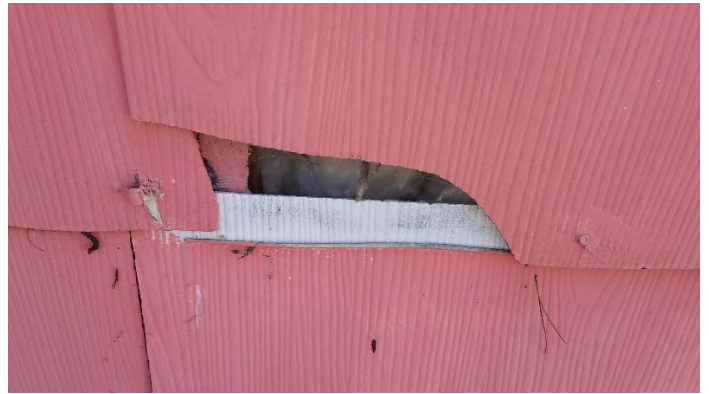
- Approximately 2,400 SF of pink transite siding.
- Approximately 12 windows with window glazing.
- Approximately 12 LF of chimney tar on 2 chimney's (Assumed).

Photo 2 – Transite exterior siding without felt.

1. Abate the asbestos containing materials in the structure prior to renovation or demolition.
2. Follow applicable asbestos regulations during renovation or demolition of the structure. You should be aware that stringent requirements are imposed upon anyone renovating or demolishing a structure in which ACM will be disturbed. This work must be performed in accordance with OSHA asbestos regulations, 29 CFR 1910 & 1926, and NESHAP asbestos regulations 40 CFR 61, subpart M. South Carolina regulations require the accreditation of personnel who work in the asbestos field and notification and permitting fees for asbestos removal projects. There is a 10 working day notification period required prior to abatement of asbestos in a facility. Failure to take proper precautions and actions to protect human health and the environment can result in penalties, danger to personnel, and construction delays.

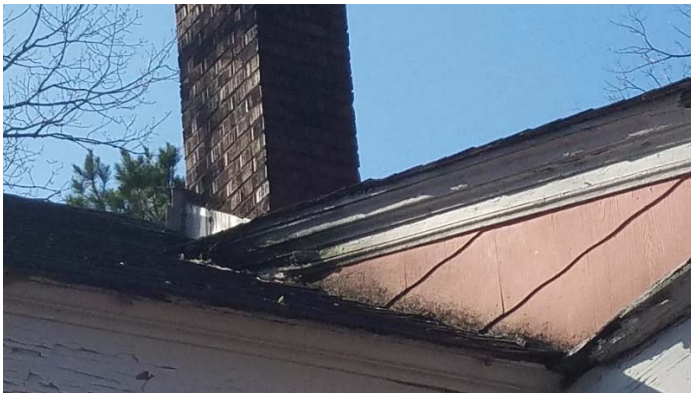
Photo 3 – 2 Chimneys with assumed asbestos chimney tar.

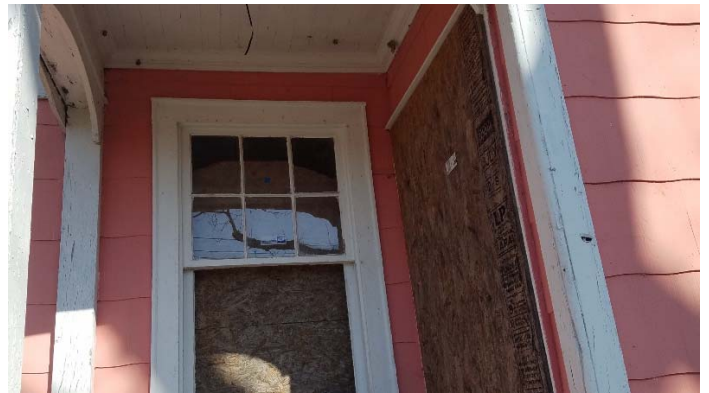
Photo 4 – Exterior window glaze and caulk.

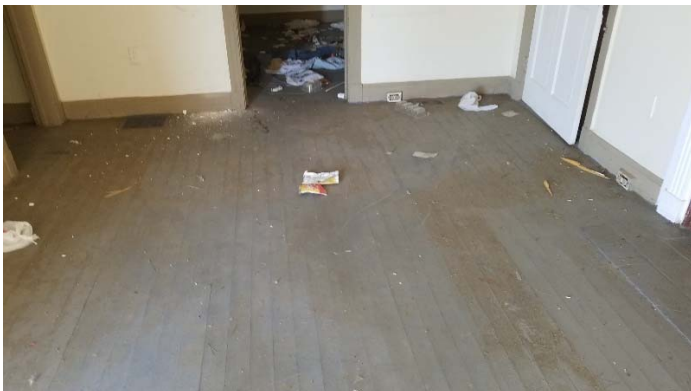
Photo 5 – Wood flooring.

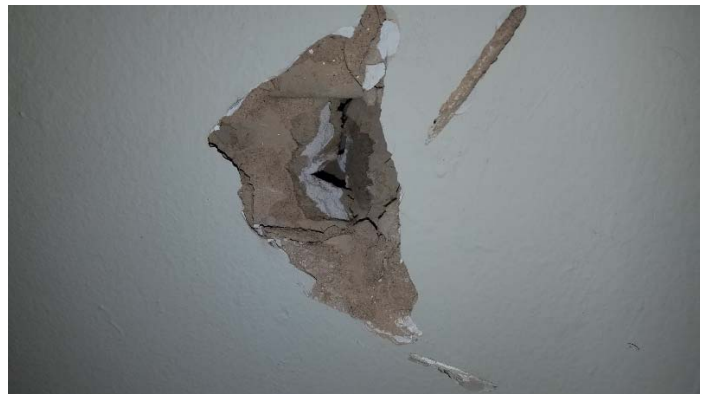
Photo 6 – Plaster over unfinished dry wall.

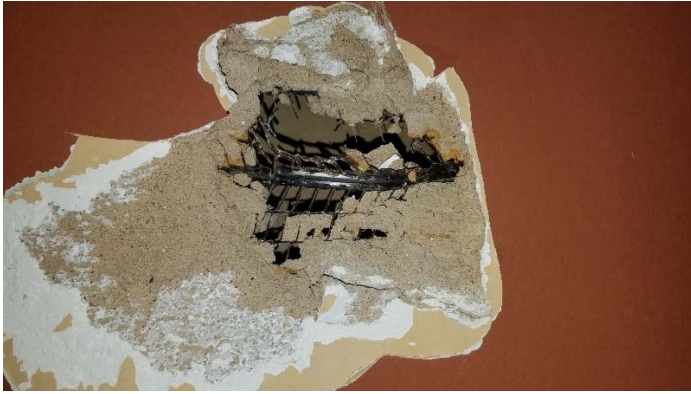
Photo 7 – Plaster over expanded metal without dry wall.

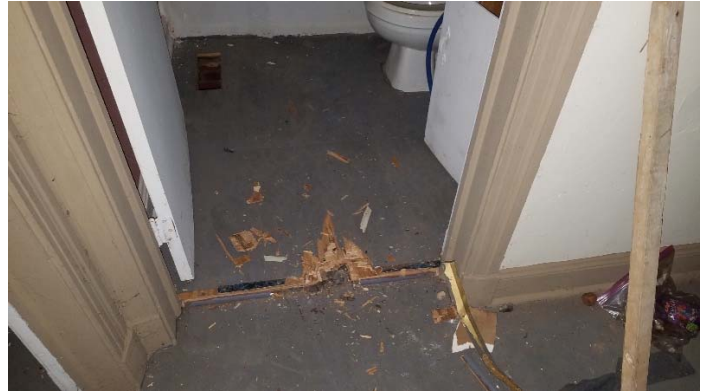
Photo 8 – Bathroom tile under wood sub-floor.

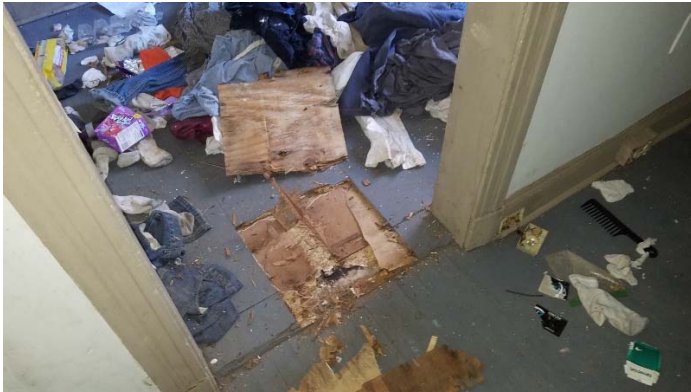
Photo 9 – Kitchen flooring under wood sub-floor.
