## **Asbestos & Lead Based Paint Assessment**

City of Spartanburg  
690 Saxon Avenue  
Spartanburg, South Carolina 29301

Project Number: 0120-17

February 10, 2020

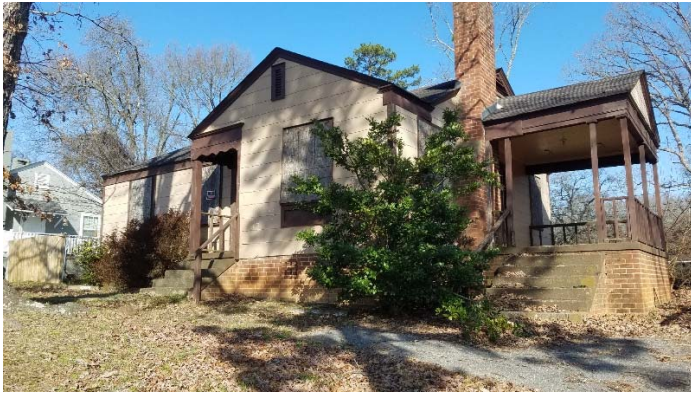
Photo 1 – 690 Saxon Avenue in Spartanburg, South Carolina.

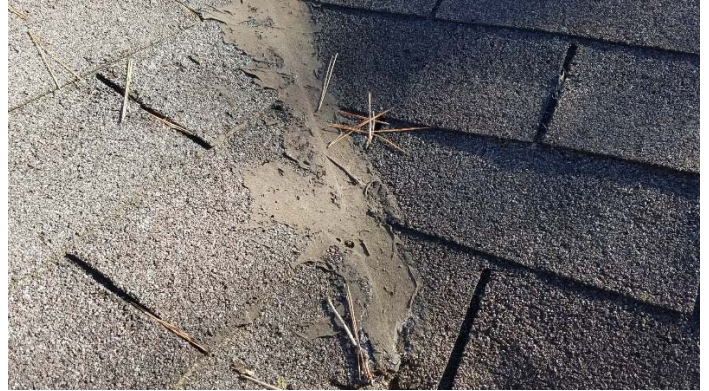
Photo 2 – Roof valley tar.

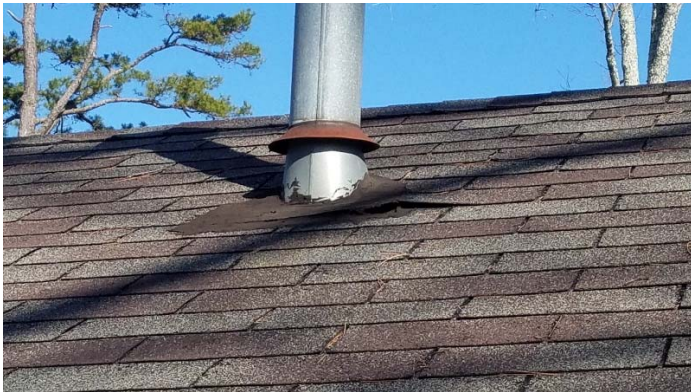
Photo 3 – Roof vent tar same as roof valley.

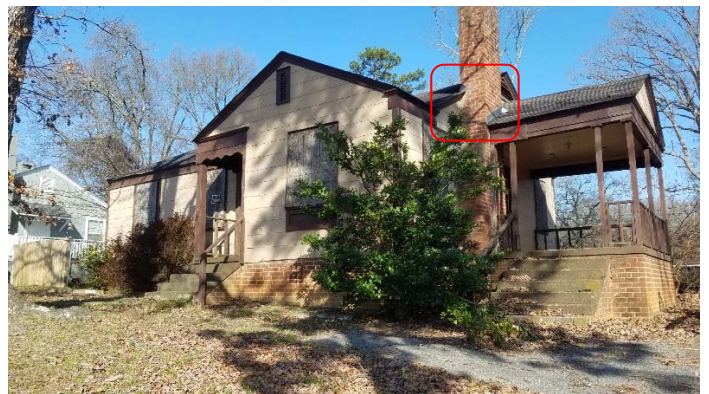
Photo 4 – Chimney flashing tar.

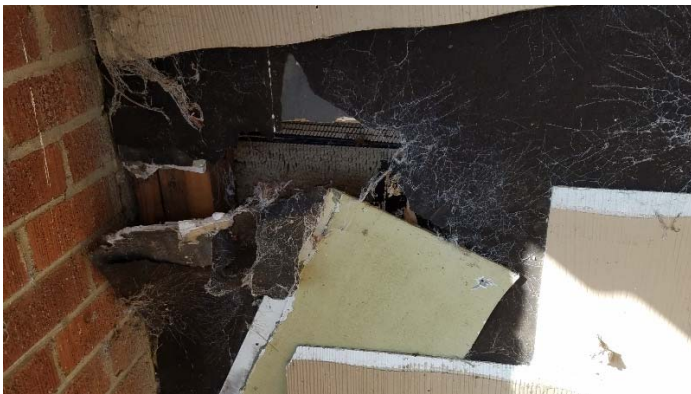
- Approximately 2,400 SF of exterior transite siding.

Photo 5 – Transite siding over black felt over drywall with attached black paper.

1. Abate the asbestos containing materials in the structure prior to renovation or demolition.
2. Follow applicable asbestos regulations during renovation or demolition of the structure. You should be aware that stringent requirements are imposed upon anyone renovating or demolishing a structure in which ACM will be disturbed. This work must be performed in accordance with OSHA asbestos regulations, 29 CFR 1910 & 1926, and NESHAP asbestos regulations 40 CFR 61, subpart M. South Carolina regulations require the accreditation of personnel who work in the asbestos field and notification and permitting fees for asbestos removal projects. There is a 10 working day notification period required prior to abatement of asbestos in a facility. Failure to take proper precautions and actions to protect human health and the environment can result in penalties, danger to personnel, and construction delays.

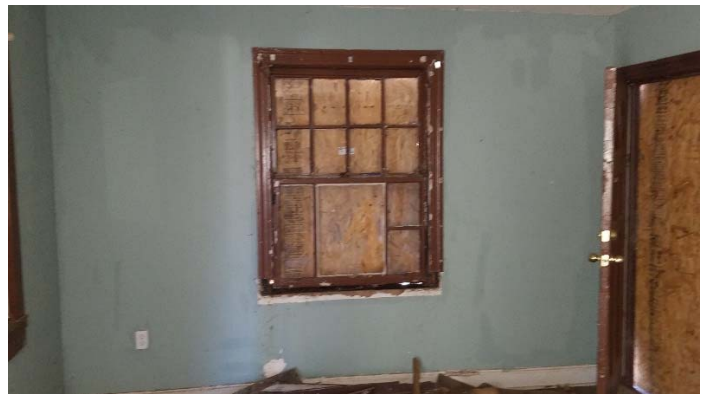
Photo 6 – Exterior window glaze and caulk.

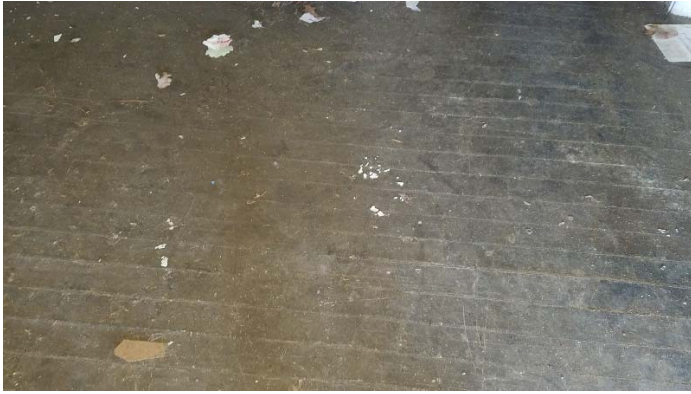
Photo 7 – Wood flooring.

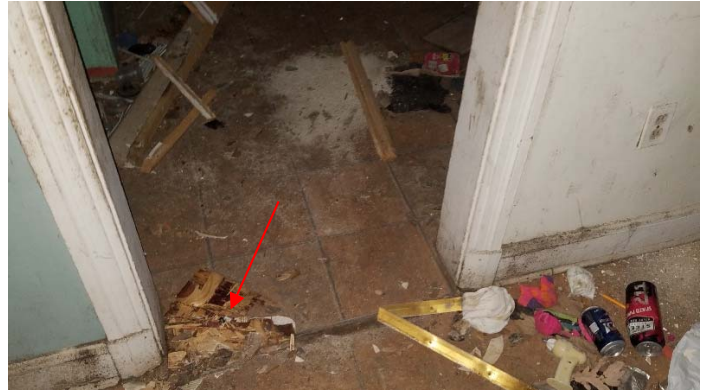
Photo 8 – Kitchen flooring layers under wood sub-flooring.

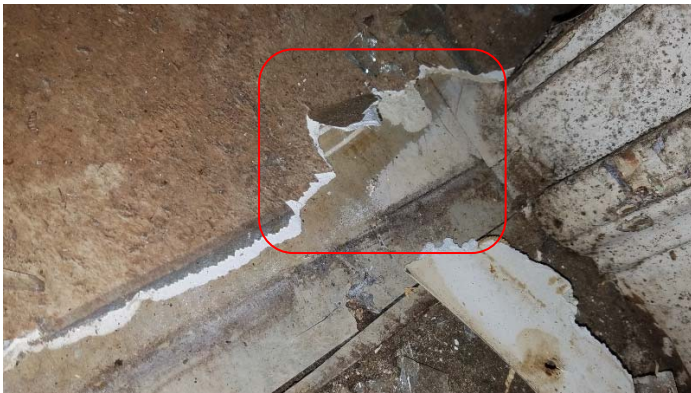
Photo 9 – Dining room flooring layers.

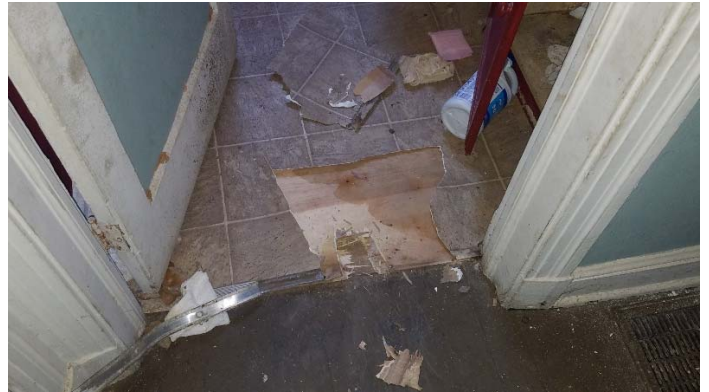
Photo 10 – Bathroom flooring.

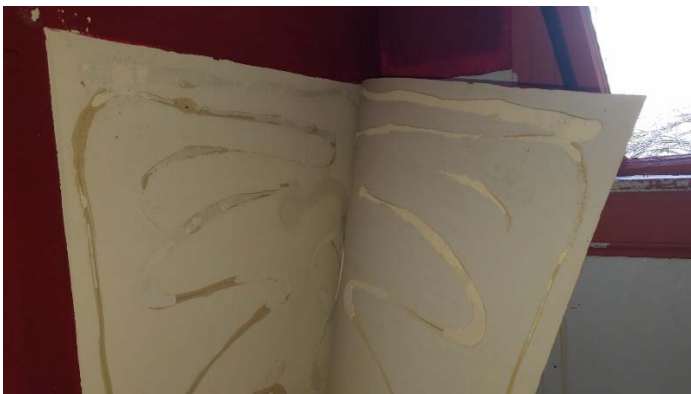
Photo 11 – Bathroom tub-surround mastic.
