Asbestos & Lead Based Paint Assessment

City of Spartanburg
700 Saxon Avenue
Spartanburg, South Carolina 29301

Project Number: 0120-17

February 10, 2020

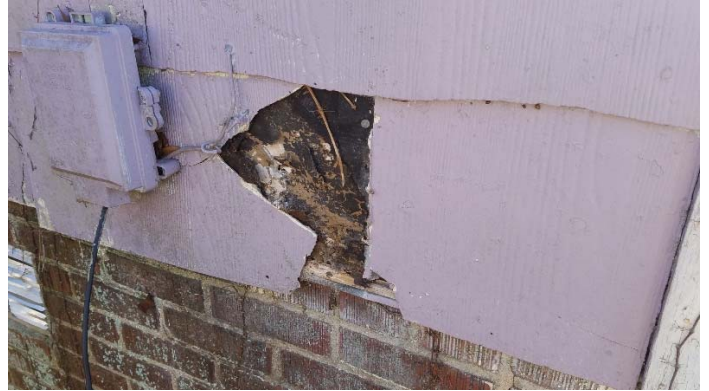
- Approximately 2,400 SF of transite siding.
- Approximately 240 SF brown floor tile located in the dining room and kitchen.
- Approximately 12 LF of chimney tar on 2 chimney's (Assumed).

Photo 2 – Transite exterior siding with felt.

1. Abate the asbestos containing materials in the structure prior to renovation or demolition.
2. Follow applicable asbestos regulations during renovation or demolition of the structure. You should be aware that stringent requirements are imposed upon anyone renovating or demolishing a structure in which ACM will be disturbed. This work must be performed in accordance with OSHA asbestos regulations, 29 CFR 1910 & 1926, and NESHAP asbestos regulations 40 CFR 61, subpart M. South Carolina regulations require the accreditation of personnel who work in the asbestos field and notification and permitting fees for asbestos removal projects. There is a 10 working day notification period required prior to abatement of asbestos in a facility. Failure to take proper precautions and actions to protect human health and the environment can result in penalties, danger to personnel, and construction delays.

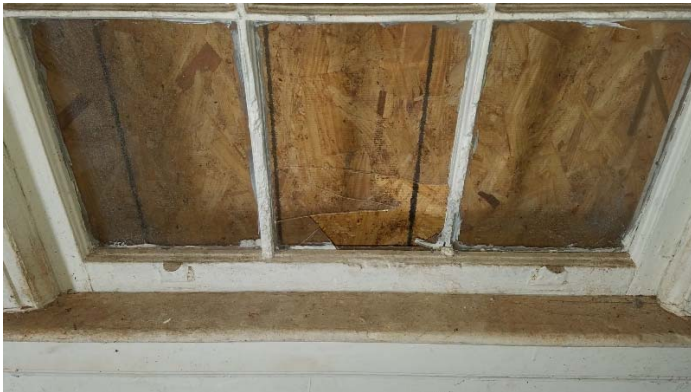
Photo 3 – Exterior window glazing.

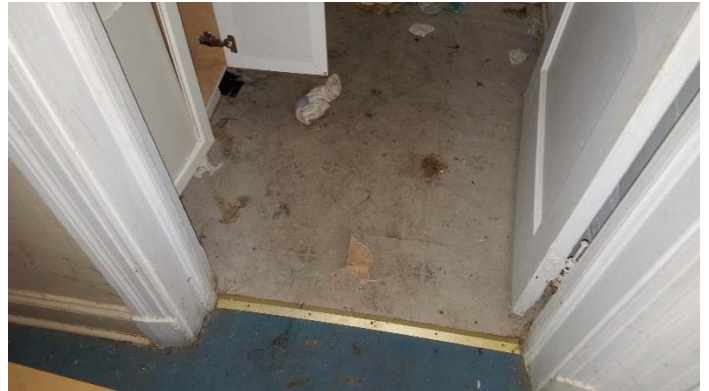
Photo 4 – Bathroom flooring.

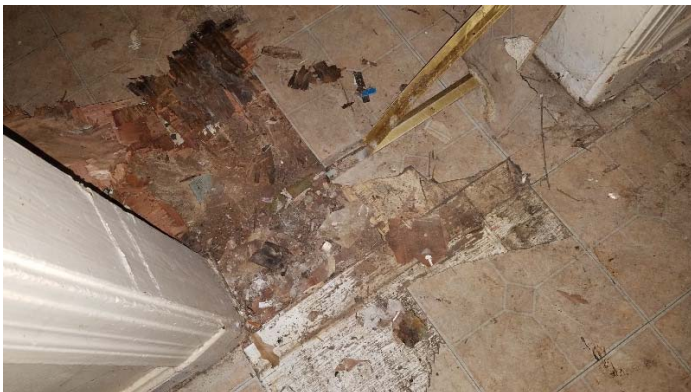
Photo 5 – Multiple flooring layers kitchen and dining room.

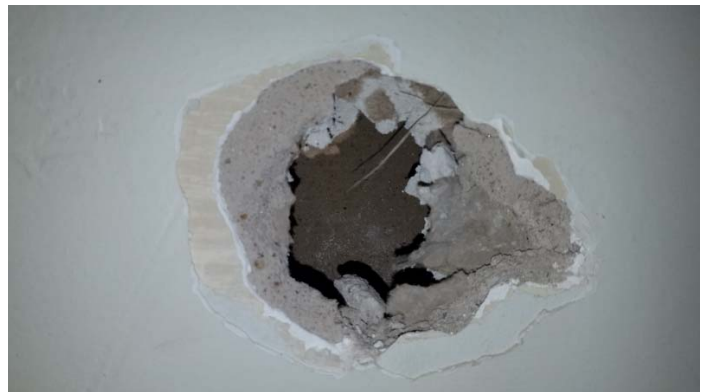
Photo 6 – Plaster over unfinished dry wall.
