## **Asbestos & Lead Based Paint Assessment**

City of Spartanburg  
938 Ansel Street  
Spartanburg, South Carolina 29306

Project Number: 0120-17

February 10, 2020

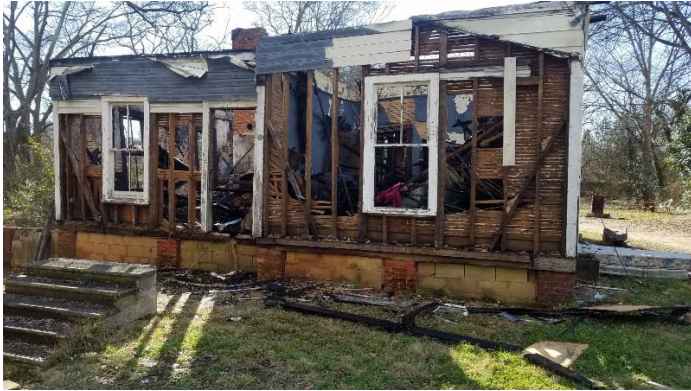
The residence has fire and structural damage throughout the interior and exterior. A limited assessment was conducted due to safety concerns. Sampling was performed in areas Apex could safely access suspect materials through exterior openings and in debris piles. Apex recommends that the residence be demolished in place and materials be treated and disposed of

Photo 1 – 938 Ansel Street in Spartanburg, South Carolina. Typical view of fire damage throughout the residence.

1. Demolish the residence with ACM in place and dispose of the waste stream as friable Regulated Asbestos Containing Materials (RACM) and delivered to an asbestos approved hazardous waste landfill for disposal.
2. Follow applicable asbestos regulations during renovation or demolition of the structure. You should be aware that stringent requirements are imposed upon anyone renovating or

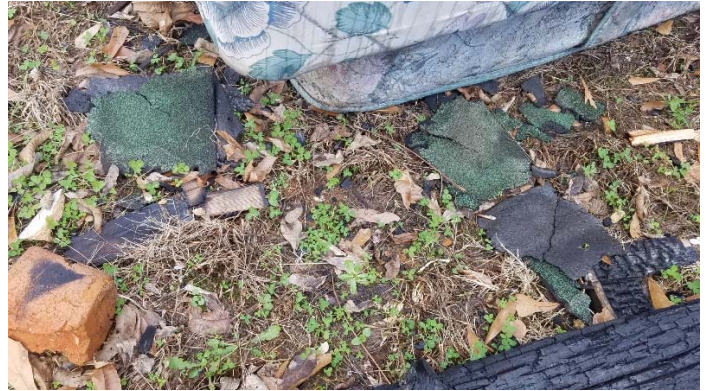
Photo 2 – House shingle remnants.

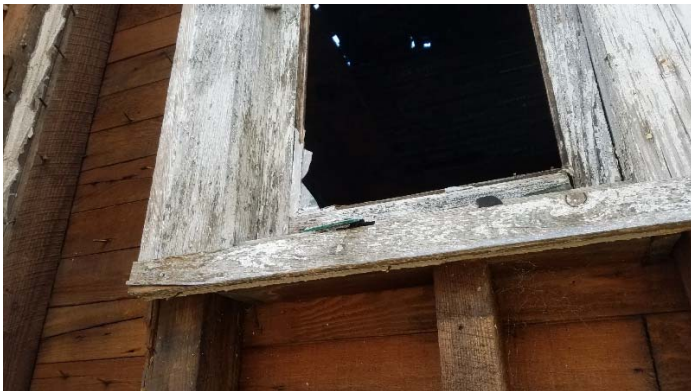
Photo 3 – Exterior window glazing.

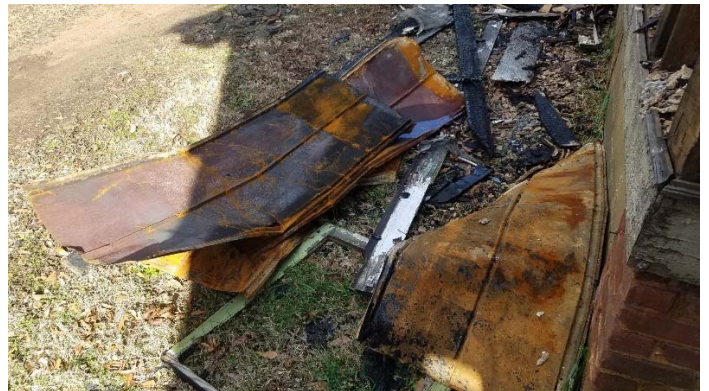
- Approximately 200 SF tar on metal roof.
- Approximately 150 SF tan tile and associated gray layer in the middle room on the right side of building.
- Approximately 2,000 SF contaminated and unassessed debris within the residence and associate debris piles.

Photo 4 – Tar on metal roofing.

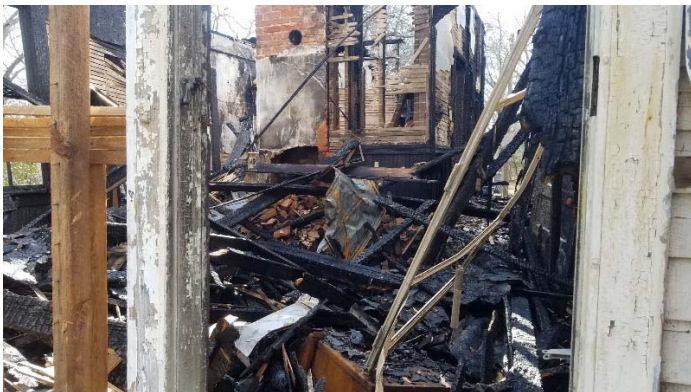
Photo 5 – Front living room.

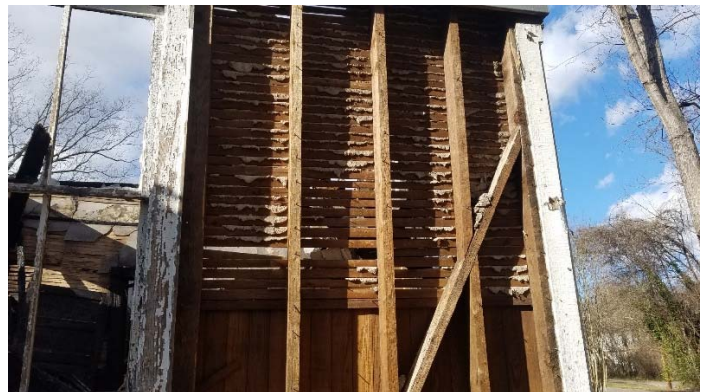
Photo 6 – Wall plaster.

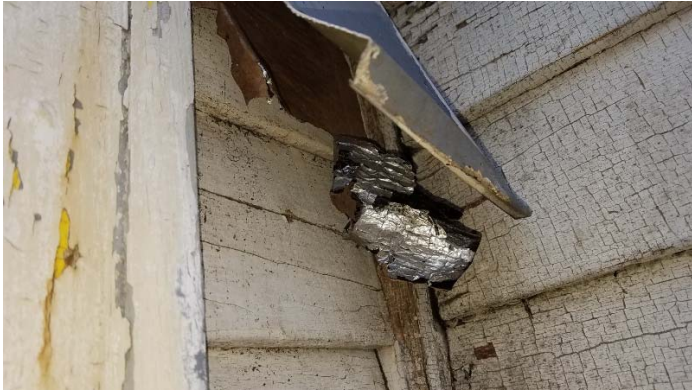
Photo 7 – Aluminum wrap with black layer under exterior siding.

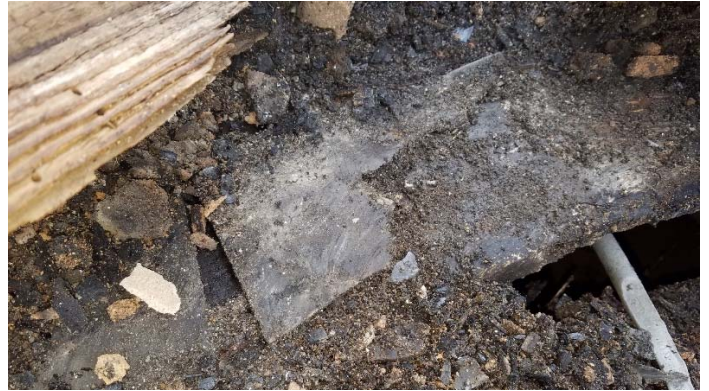
Photo 8 – right middle room flooring.

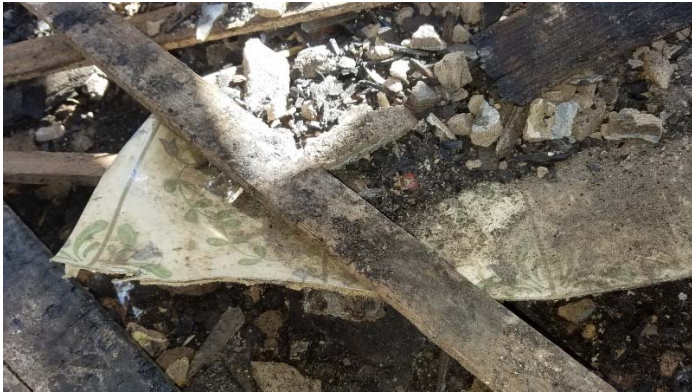
Photo 9 – right rear room flooring.

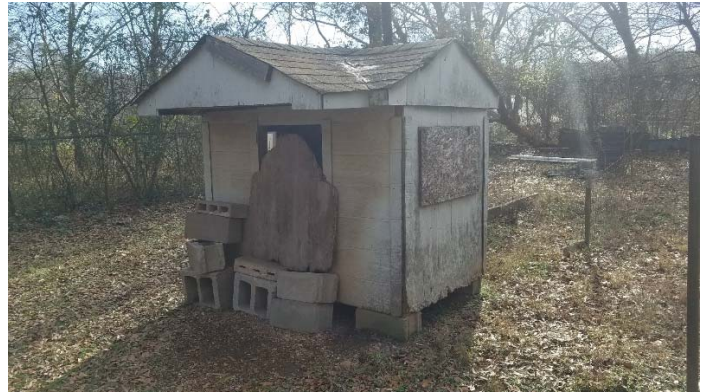
Photo 10 – Exterior shed.
