City of Springfield

Bid #1061 Summary

Panasonic Corporation of North America

## Report of operation monitoring of ECO i systems at The Center

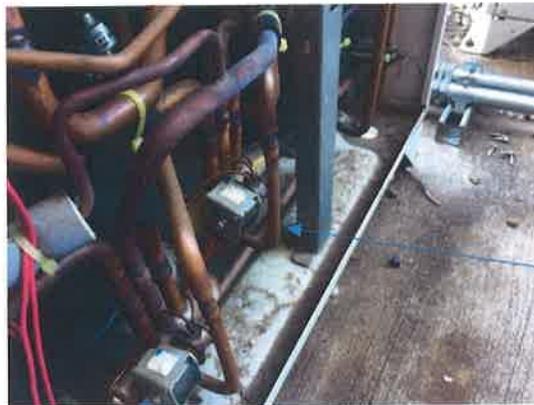
SCV2  
623 309 4885  
Reversing Valve  
STF-0248G

SCV2 valve is stuck in cooling mode position. It needs replacing. Temporarily, the coil of DCV2 is removed from the stem to disable the heat exchanger, so after replacing the SCV2, please put back the coil on the DCV2.

SCV2 valve is stuck in cooling mode position. It needs replacing.

The SCV2 that needs to be replaced looks like the picture below, and the service parts number is 623 309 4885 Reversing Valve STF-0248G.

Temporarily, the coil of DCV2 is removed from the stem to disable the heat exchanger, so after replacing the SCV2, please put back the coil on the DCV2.
