**17<sup>th</sup> Street  
Over Norf/Sou Railway  
Br. Loc. No. 47-FAU 3780-00.31  
ID No. 47M37800001**

**BRIDGE MAINTENANCE RECOMMENDATIONS**

Tennessee Department of Transportation

BRIDGE INSPECTION REPORT

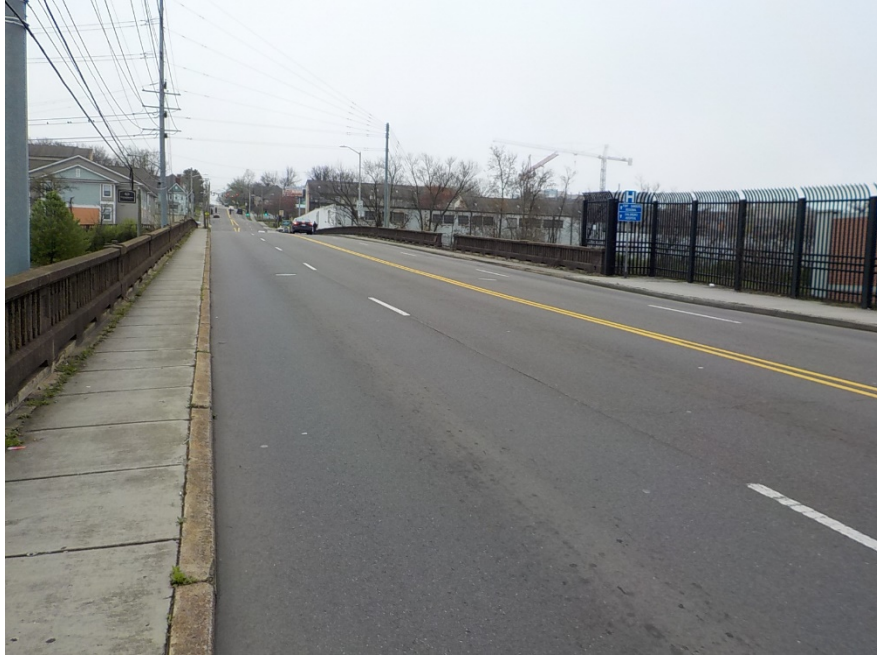
APPROACH FORWARD ON LOG

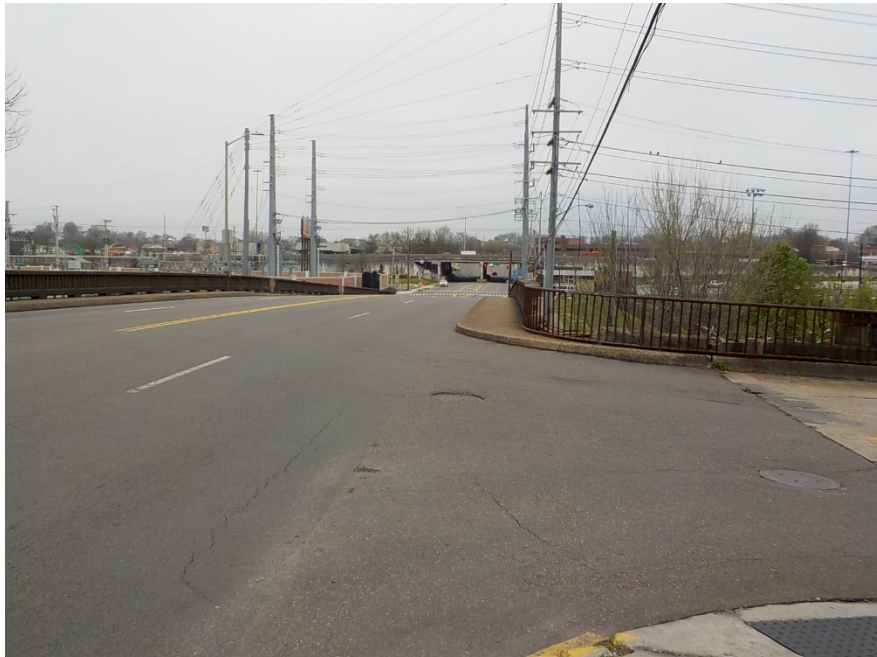
APPROACH BACK ON LOG - RAIL REPAIRED 2 LEFT

No.	RECOMMENDATIONS	REPAIR DATE	REPAIRED BY
1.	PATCH COLUMN NO. A BENT NO. 1		
2.	REPAIR BRIDGERAIL AT APPROACH 2 (LEFT)		
3.	REPAIR CONC. BREASTWALL AT ABUTMENT NO. 1

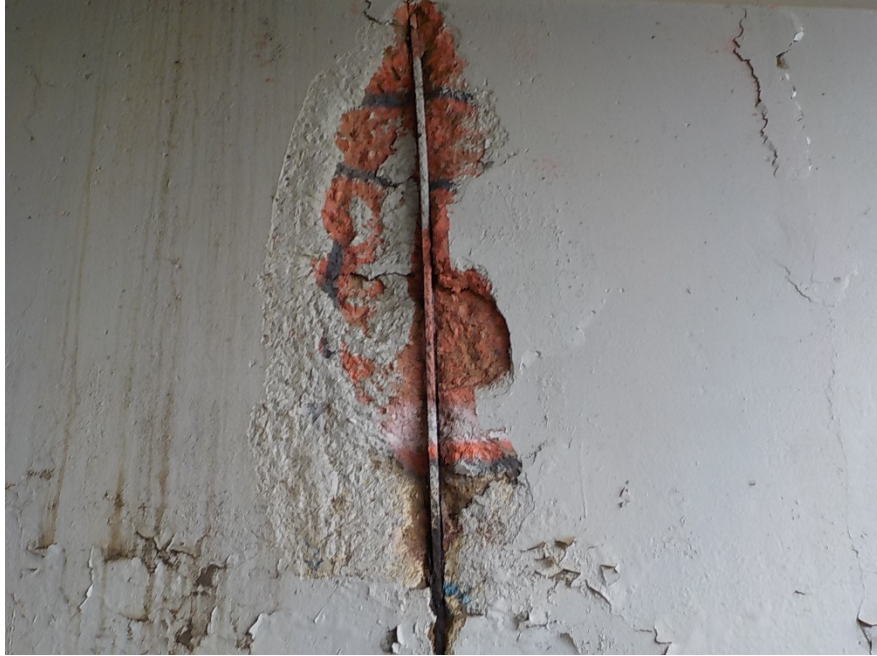
ABUTMENT 1 EXP REBAR TYPICAL

CAPS	G	F	P	C	N/A
BREASTWALL	G	<b><u>F</u></b>	P	C	SCALE UP TO 3" DEEP @ NO. 1_W/REBAR EXPOSED 1" OPEN VERTICAL CRACK UNDER BEAM I
WINGS	G	<b><u>F</u></b>	P	C	BREAK-OUTS, HAIRCRACKS
BACKWALL	G	<b><u>F</u></b>	P	C	HAIRCRACKS, DELAMINATION @ #1
PLUMB	<b><u>G</u></b>	F	P	C	
FOOTING	G	F	P	C	N/V
PILES	G	F	P	C	N/V
EMBANKMENT	G	F	P	C	N/A
BEARING SURFACE	<b><u>G</u></b>	F	P	C	
SLOPE PAVING	G	F	P	C	N/A
RIP RAP	G	F	P	C	N/A

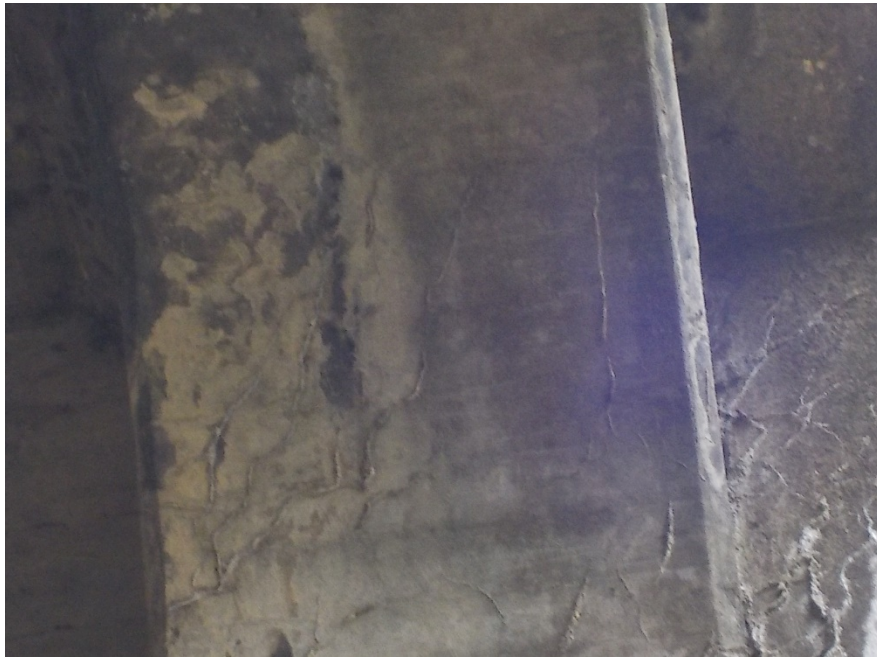
OUTSIDE BEAM CRACKING TYPICAL

BEARING DEVICES	G	<u>F</u>	P	C	LIGHT CORROSION @ ROLLERS
GIRDERS OR BEAMS	G	<u>F</u>	P	C	SCALING, HAIRCRACKS, DISCOLORATION AT ENDS
FLOOR BEAMS	G	F	P	C	N/A
STRINGERS	G	F	P	C	N/A
DIAPHRAGMS	G	<u>F</u>	P	C	SCALING @ BENT 2
BRACING	G	F	P	C	N/A
TRUSSES - GENERAL	G	F	P	C	N/A
- PORTALS	G	F	P	C	N/A
- BRACING	G	F	P	C	N/A
PAINT	G	F	P	C	NONE
ALIGNMENT OF MEMBERS	<u>G</u>	F	P	C

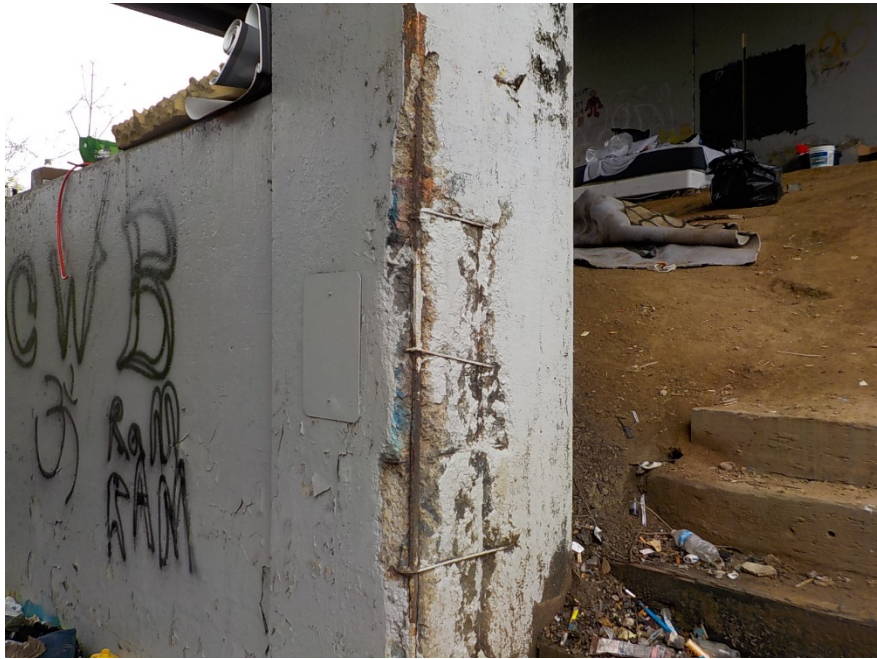
COLUMN A BENT 1 EXP REBAR TYPICAL

CAPS	G	<b><u>F</u></b>	P	C	SCALING
COLUMNS	G	<b><u>F</u></b>	P	C	1" DEEP SCALE @ #1, W/REBAR EXPOSED
PLUMB	<b><u>G</u></b>	F	P	C	
FOOTINGS	G	F	P	C	N/A
PILES	G	F	P	C	N/A
BEARING SURFACE	<b><u>G</u></b>	F	P	C

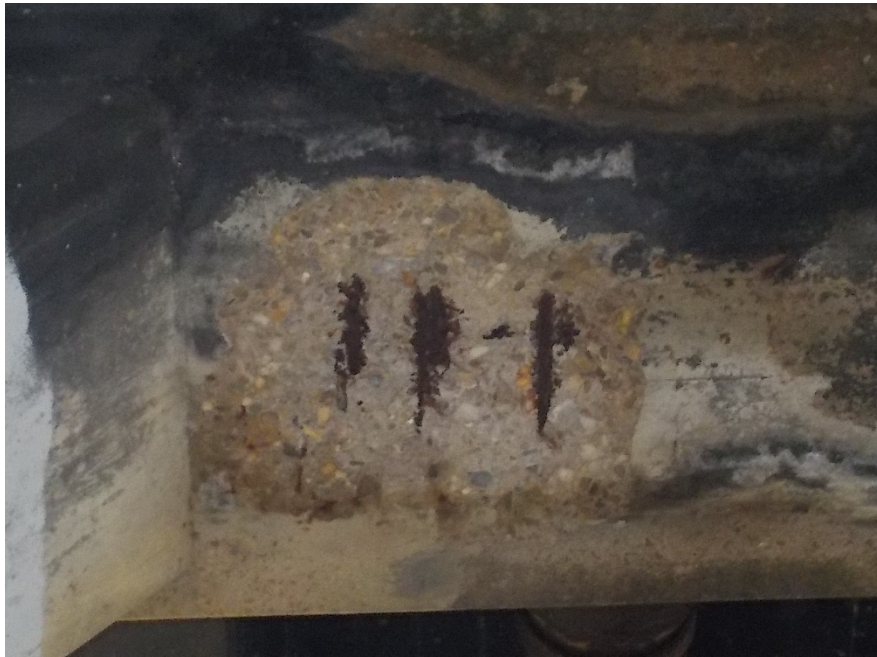
BENT CAP 1 EXP REBAR TYPICAL

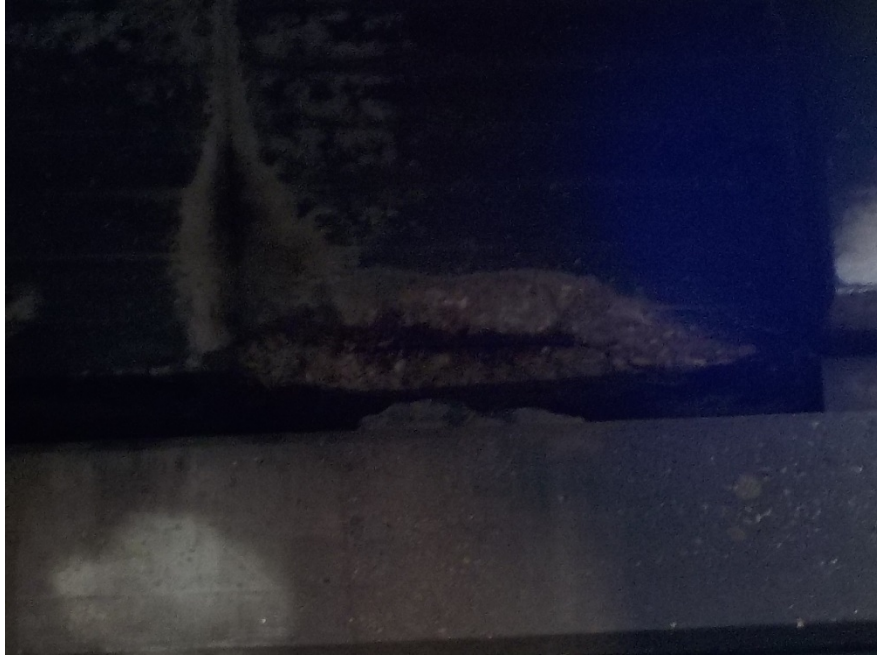
DIAPHRAM BENT 2 EXP REBAR TYPICAL

SUGGESTED ROUTINE MAINTENANCE AND COMMENTS
REPAIR DIAPHRAGMS IN SPAN NO. 3
CLEAN AND PAINT BEARING AT BENT NO. 2
REPAIR SIDEWALKS @ APPROACHES
APPROACH GUARDRAILS ARE SUB-STANDARD
BRIDGERAILS ARE SUBSTANDARD

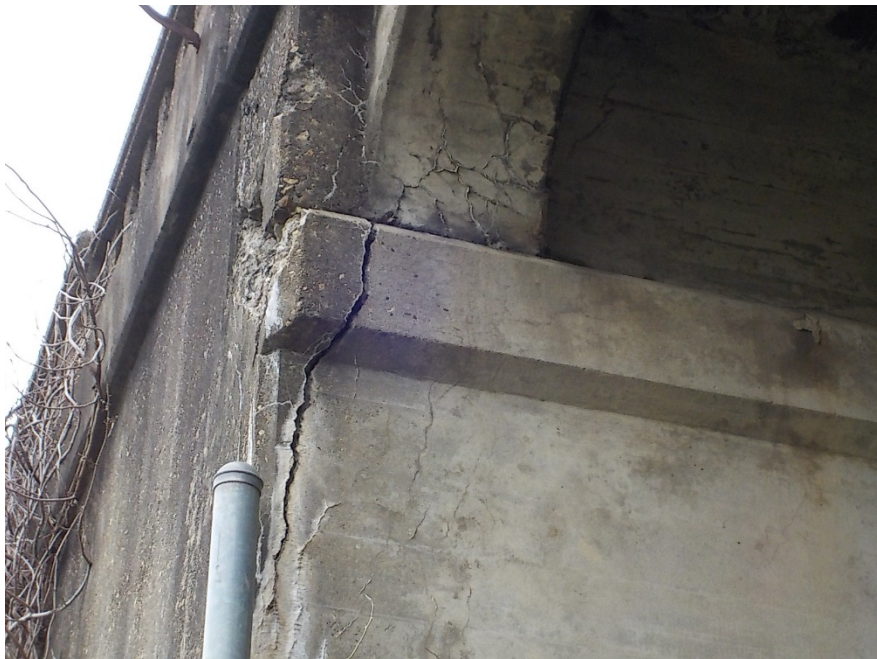
ABUTMENT 1 BREASTWALL CRACK

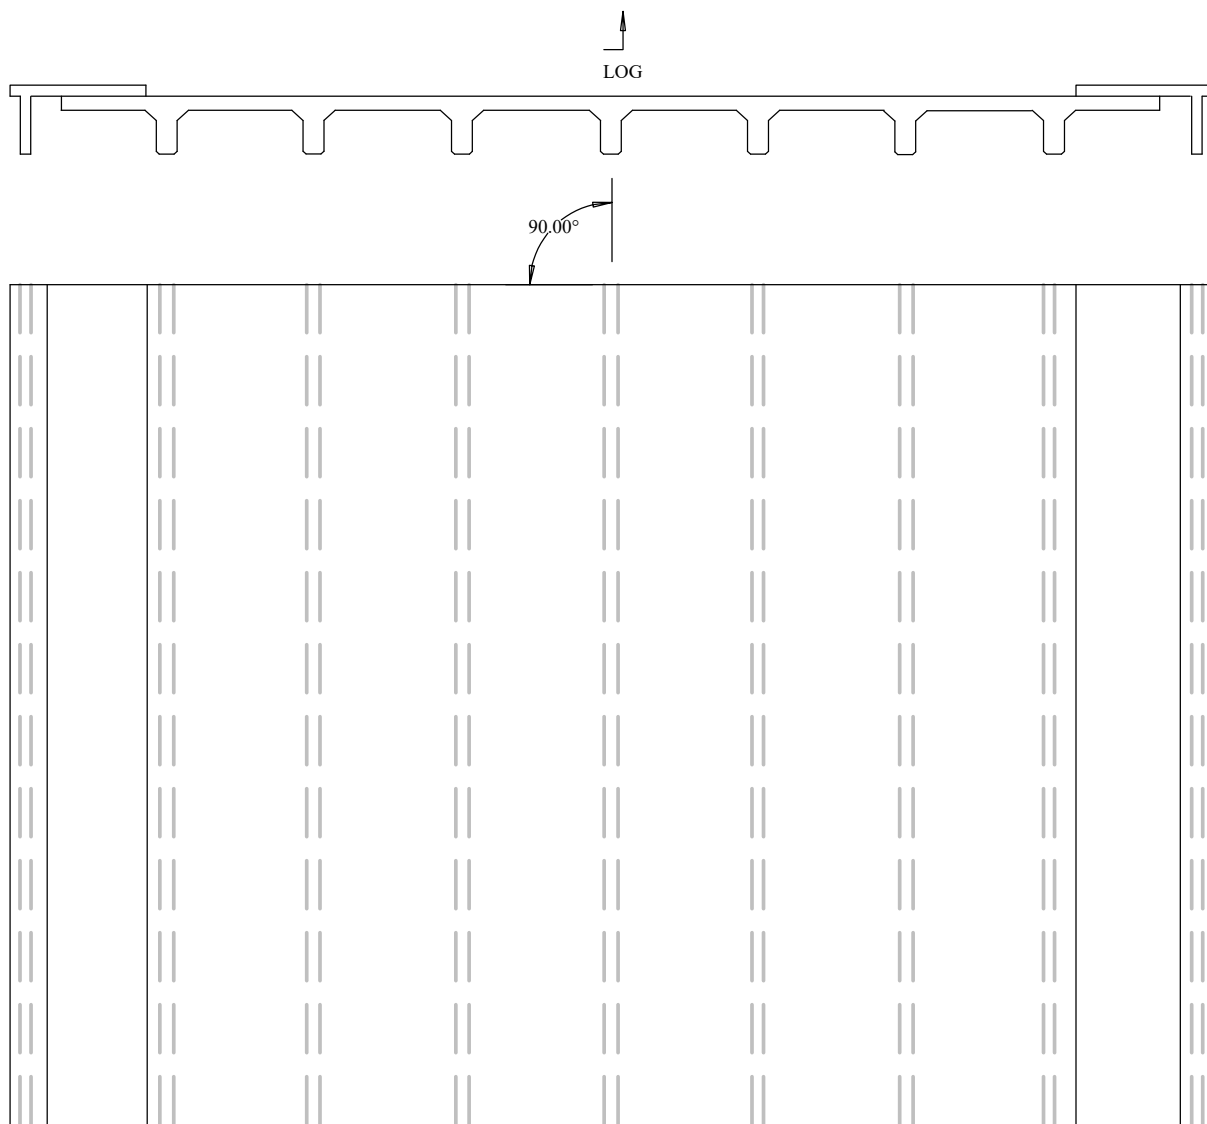
TOP DECK SPAN 1&3

WEARING SURFACE	G	
BRIDGE RAIL	F	LIGHT SCALE
SIDEWALK	F	LIGHT SCALE

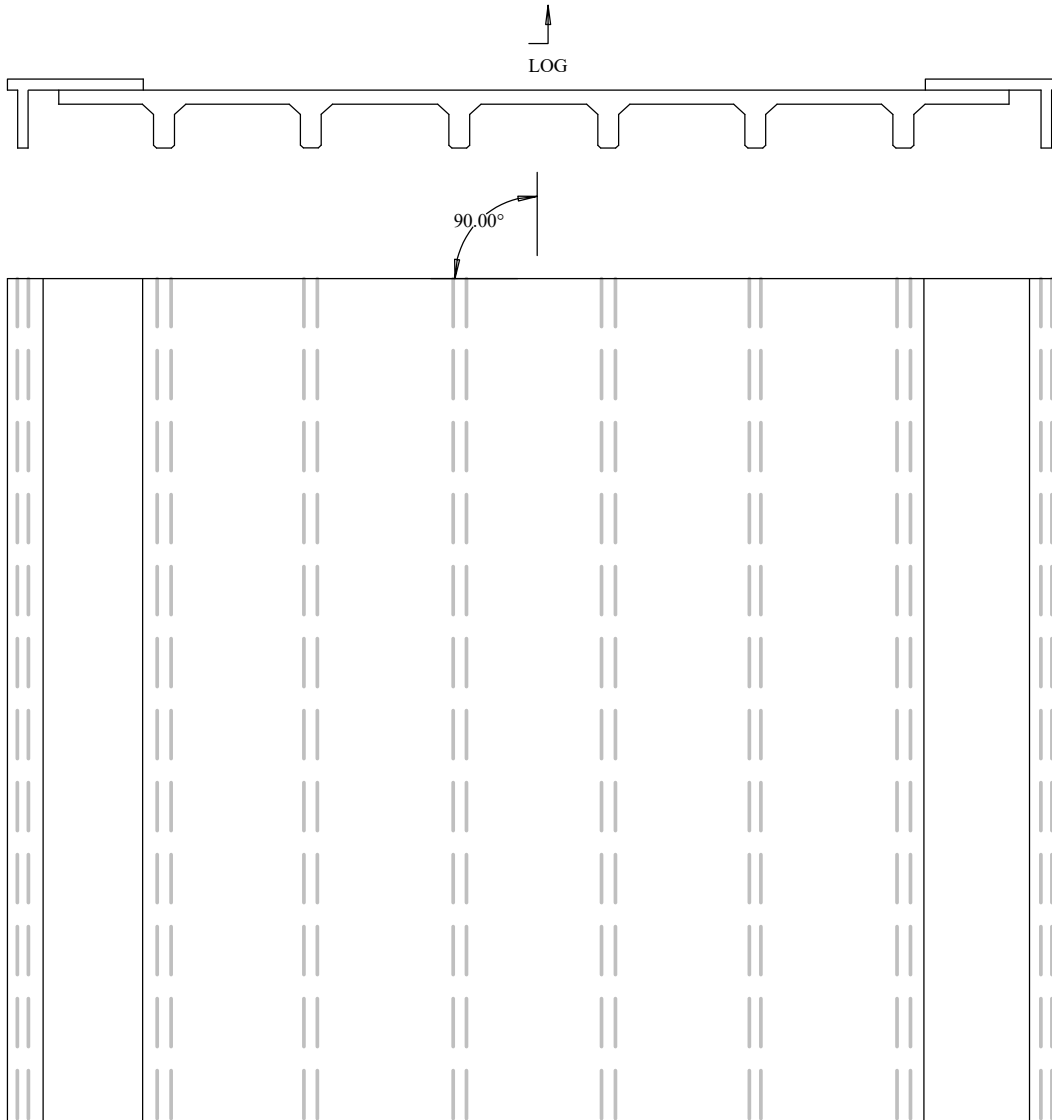
TOP DECK SPAN 2

WEARING SURFACE	G	
BRIDGE RAIL	F	LIGHT SCALE
SIDEWALK	F	LIGHT SCALE

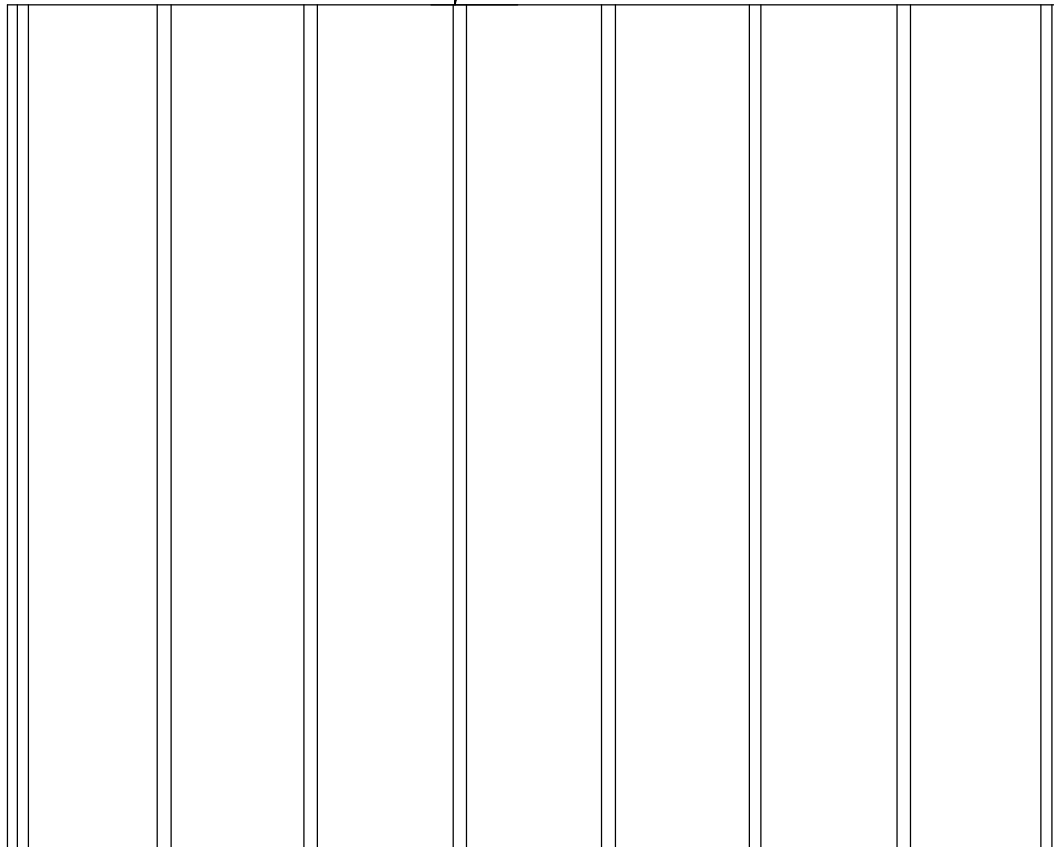
BOTTOM DECK SPAN 2

BOTTOM DECK	F	HAIRCRACKS/STAINING
BEAMS	F	HAIRCRACKS/STAINING
DIAPHRAGMS	F	SCALE/HAIRCRACKS/LEACHING

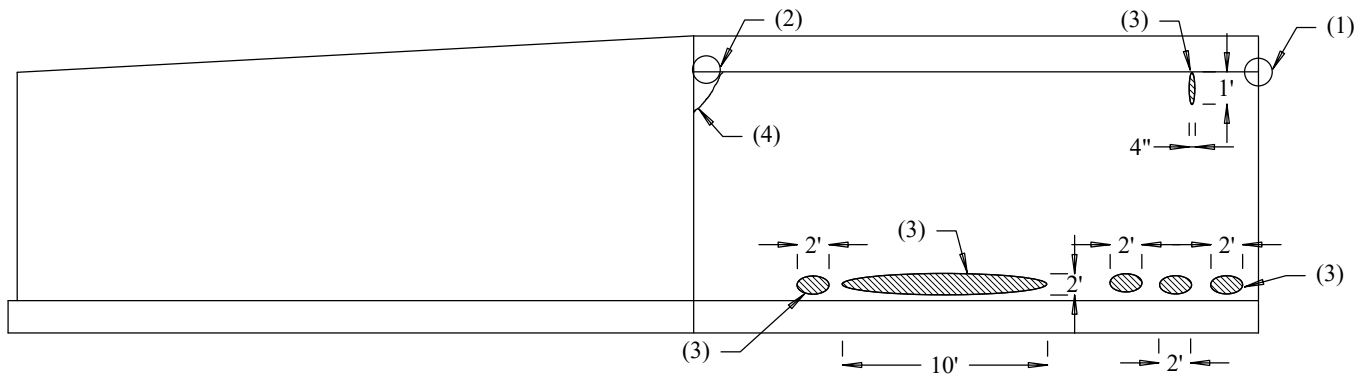
ABUTMENT 1

BREASTWALL	F	(1) 3" DEEP SPALLING UNDER BEAM A (4) 1" OPEN CRACK UNDER BEAM I
		(2) 2" DEEP SPALLING UNDER BEAM I
		(3) NUMEROUS AREAS OF 2" DEEP SPALLING ALONG BOTTOM
BACKWALL	F	HAIRCRAKS/STAINING
WINGS	F	HAIRCRAKS/STAINING

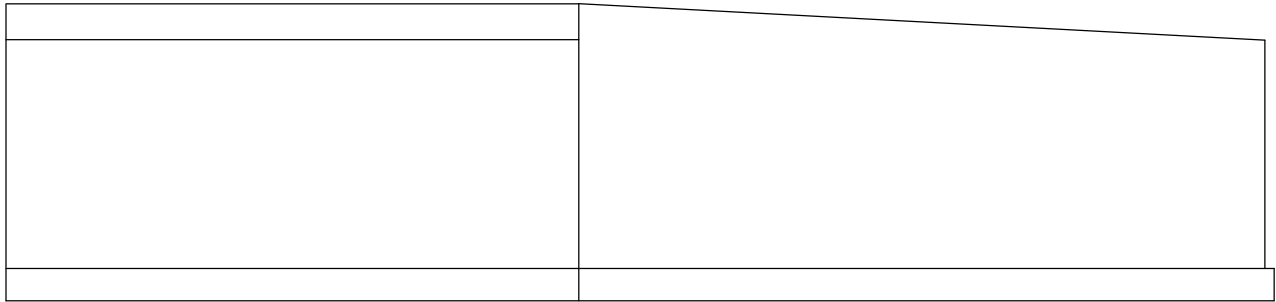
ABUTMENT 2

BREASTWALL	F	HAIRCRAACKS/STAINING
BACKWALL	F	HAIRCRAACKS/STAINING
WINGS	F	HAIRCRAACKS/STAINING

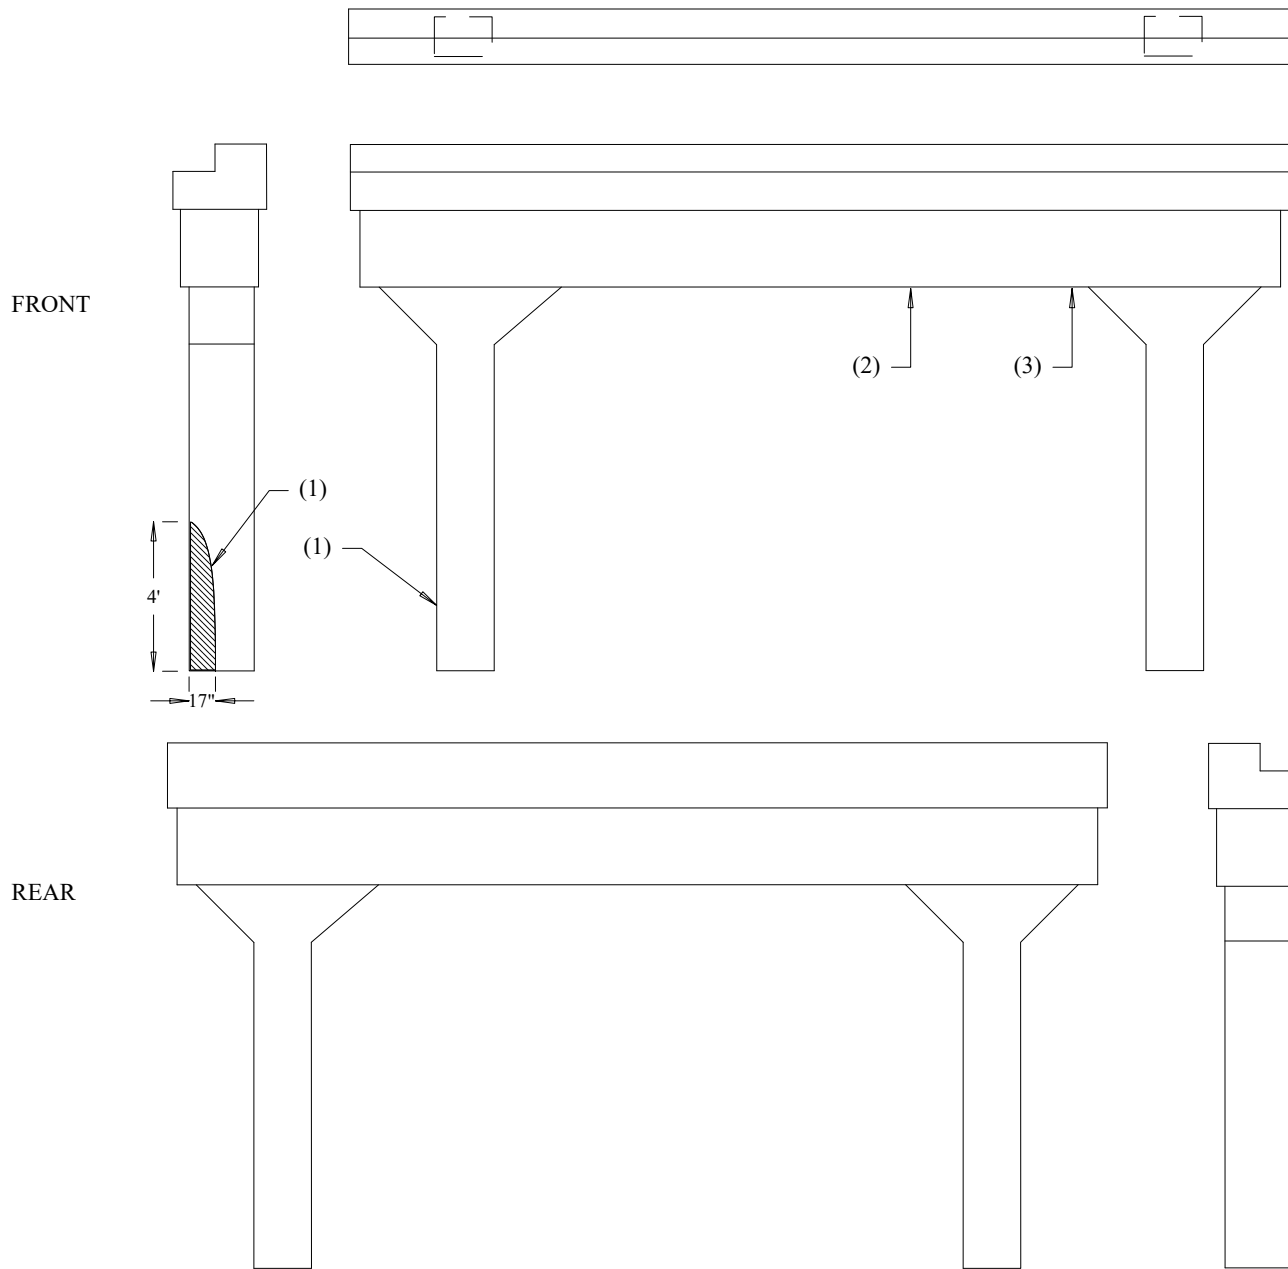
BENT 1

CAP	F	LIGHT SCALE/HIGH STEEL POPOUTS
		(2) IN PLACE SPALLING/DELAMINATION BOTTOM
		(3) SPALL W/EXPOSED REBAR 2' DIAMETER BOTTOM
COLUMNS	F	(1) 1" DEEP SCALING W/BROKEN REBAR COLUMN A

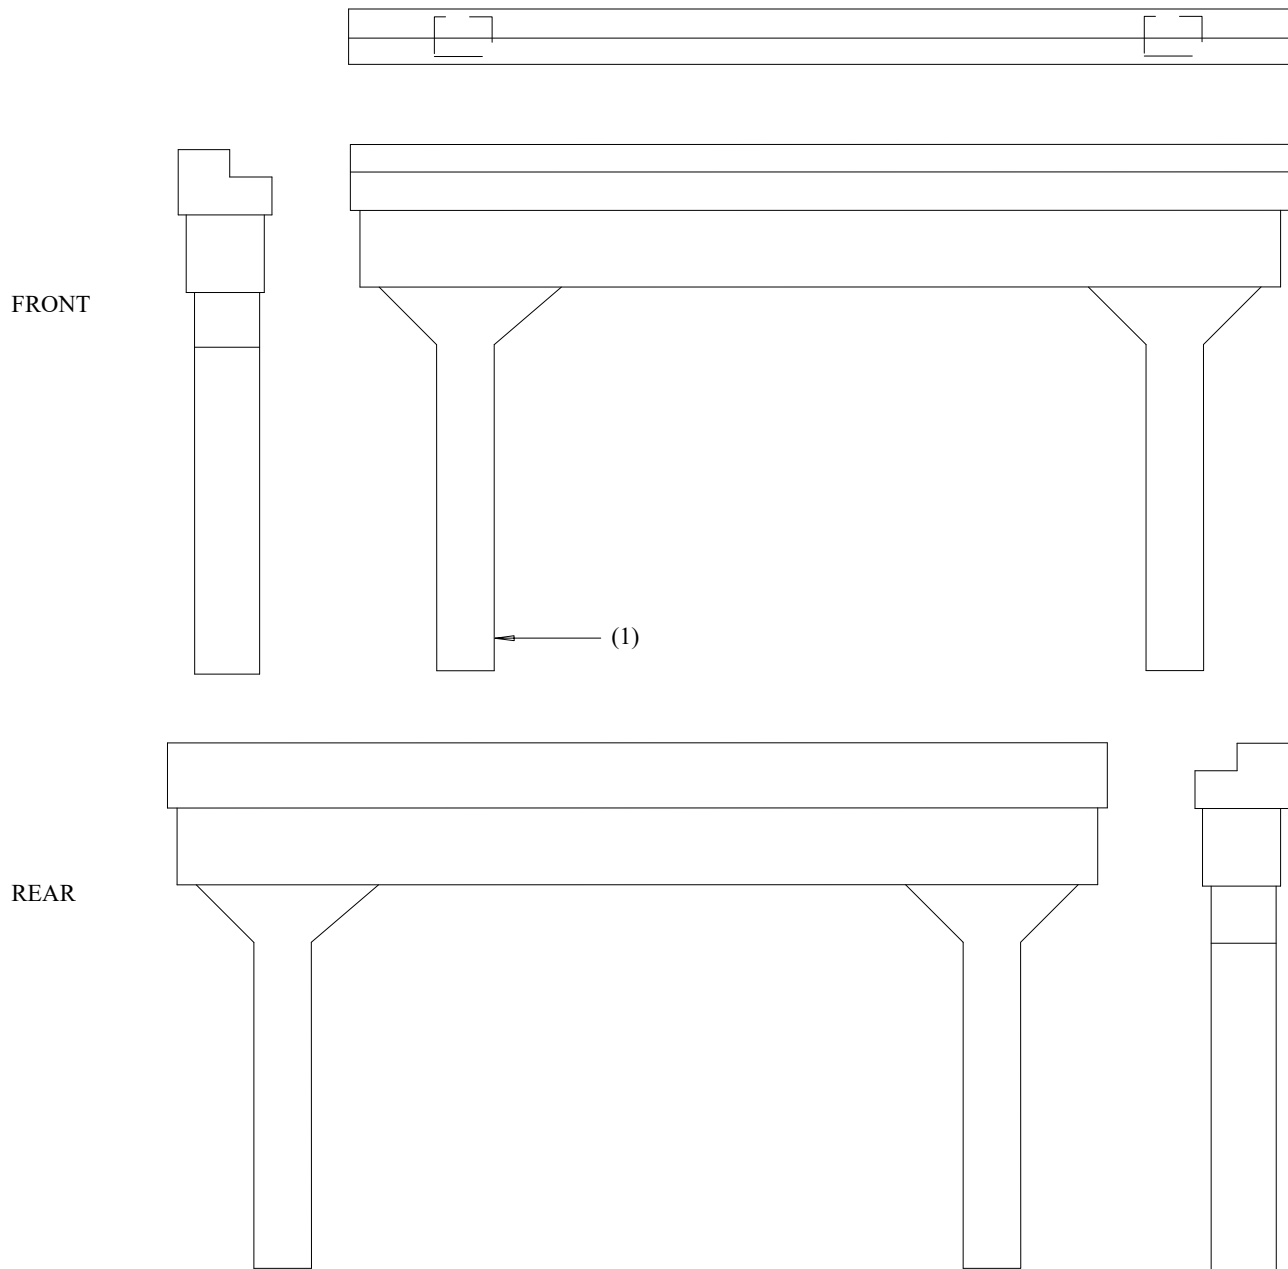
BENT 2

CAP	F	LIGHT SCALE/HIGH STEEL POPOUTS
COLUMNS	F	LIGHT SCALE/HIGH STEEL POPOUTS
		(1) SPALL W/EXPOSED REBAR 2' DIAMETER COLUMN A
