**LANEY COLLEGE TITLE IX LOCKER ROOM RENOVATION PROJECT**

**ADDENDUM ONE**

**HAZARDOUS BUILDING MATERIAL SURVEY REPORT  
LOCKER ROOMS TITLE IX PROJECT  
LANEY COLLEGE  
OAKLAND, CALIFORNIA**

October 8, 2020

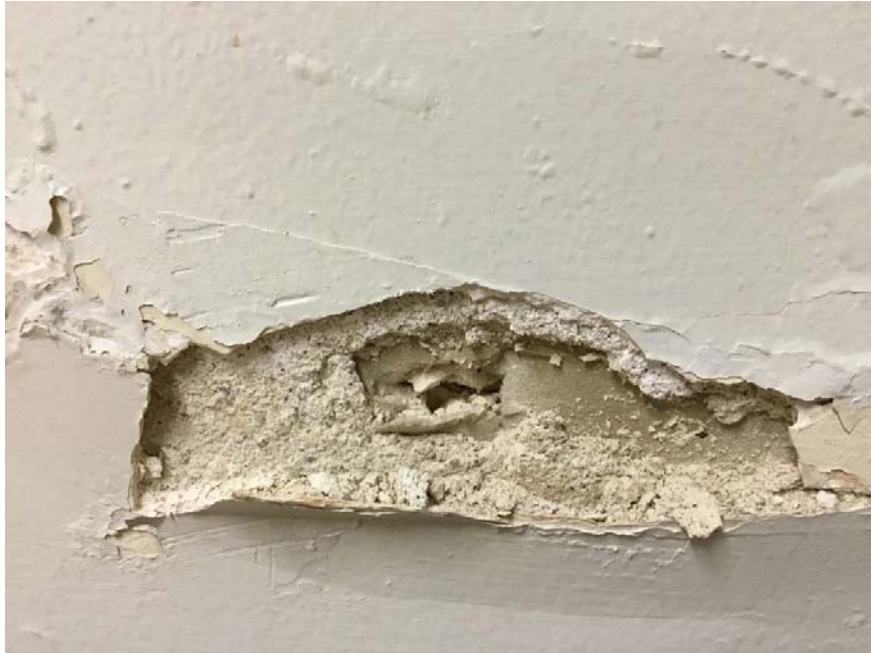
- The white texture associated with the interior gypsum walls was reported by the laboratory as containing between 0.75% and 1.25% asbestos by point count analysis. Based on EPA's round down rule, the result of 1.25% asbestos may be rounded down to 1%. The texture was observed to be in good condition and is classified as an ACCM.
- The tan coating applied to the black HVAC vibration dampers was reported by the laboratory as containing between 2.75% and 3.25% asbestos. The coating was observed to be in good condition and is classified as a Category II non-friable ACM.

**Photograph 7:**  
View depicting the ACM texture.

- The ACCMs, ACMs, and LCPs observed to be in good condition or intact can be “managed in place” unless the materials are disturbed, repaired, or removed. Prior to demolition or renovation activities, the owner(s) of the building should retain a California-licensed abatement contractor to perform the abatement/remediation of the ACCMs, ACMs, and LCPs, as needed, and prior to disturbance.

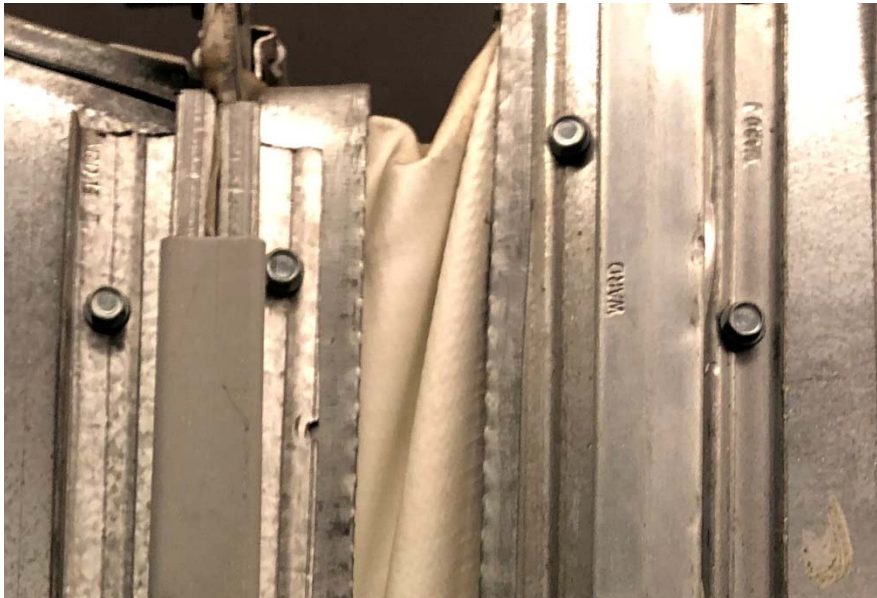
- The tan coating (sample numbers 15a and 15b) applied to the black HVAC vibration dampers was reported by the laboratory as containing 2% asbestos via PLM analysis. These samples were further assessed via point counting over 400 empty points and reported by the laboratory as containing between 3.25% and 2.75% asbestos. The vibration damper cloth was reported by the laboratory as not containing asbestos. The coating was observed to be in good condition, encompasses approximately 60 square feet, and is classified as an Category II non-friable ACM.

**Photograph 8:**  
View depicting the ACM tan coating.

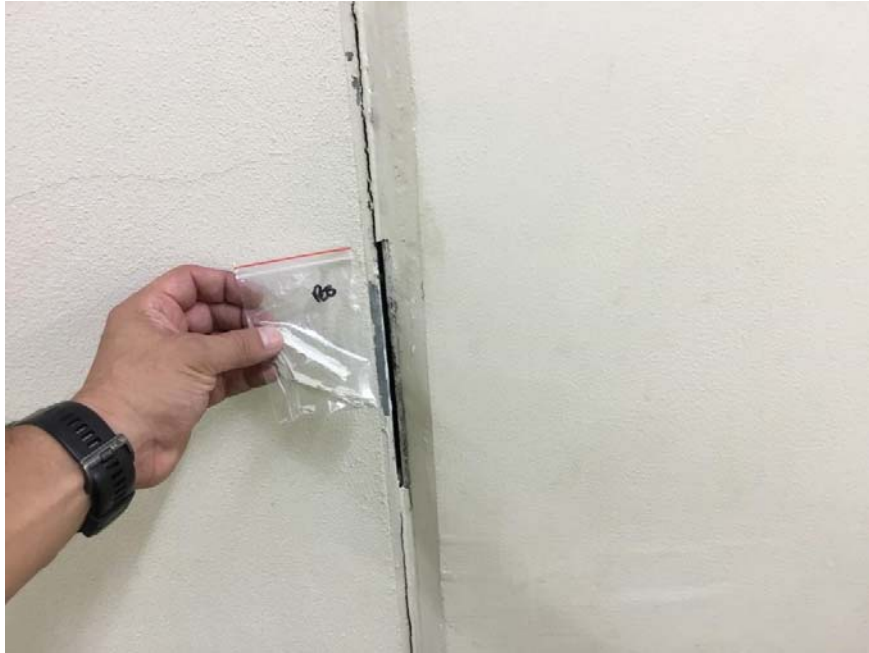
- White caulking (sample no. PCB-01) applied to the concrete wall seams was reported by the laboratory as containing PCBs at a concentration of 11,000 micrograms per kilogram (which converts to 11 mg/kg). The caulking was observed to be intact and contains trace amounts of PCBs.

Analysis of the bulk sample collected as part of this assessment indicated that the sample does not contain greater than 50 mg/kg PCBs. As a result, regulated PCBs do not appear to be present at the Site. Suspect PCB-containing ballasts were not observed during Terraphase's survey.

**Photograph 9:**  
View depicting the concrete caulking material located in the mechanical room hallway that contains trace amounts of PCBs.

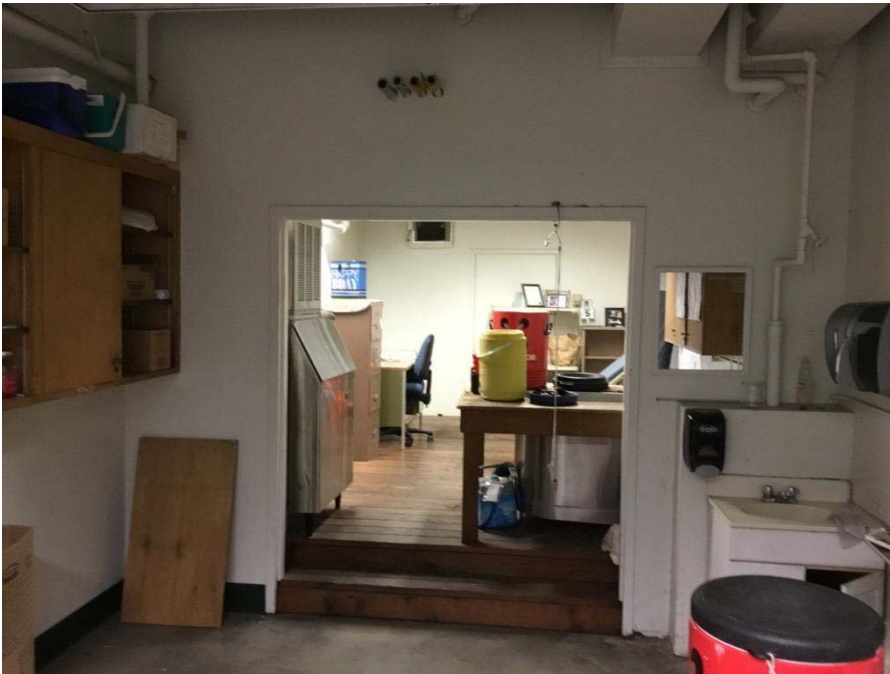
**Photograph 10:**  
View depicting the trainer room and CFC containing ice machine.

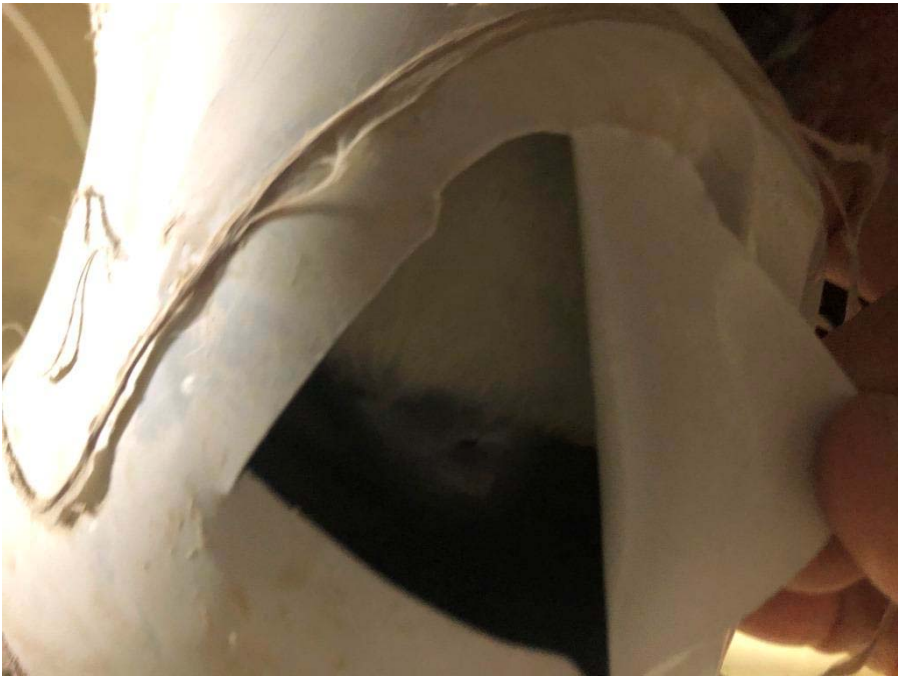
**Photograph 12:**  
View of non-asbestos insulation pipe runs.
