**ADVERTISEMENT FOR SEALED BID SALE
OF REAL PROPERTY
Indian River County Bid # 2019053**

Description: Former Fire Station 7

Bid 2019053 – Sealed Bid Sale of 1215 82nd Avenue (Former Fire Station 7)

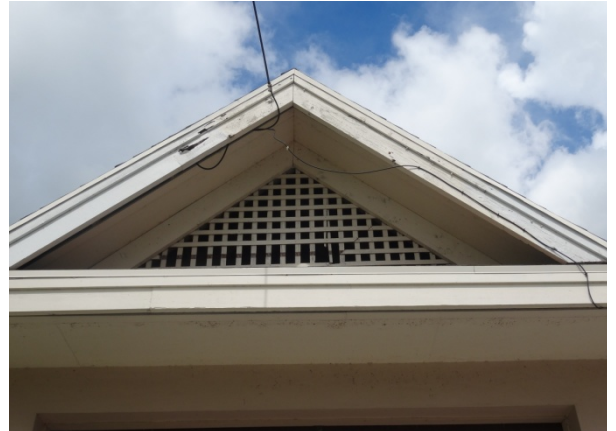
Photo 2
Damaged lattice above entry door

3. Deteriorated exterior components and/or issues (fascia, paint, cracking deterioration, etc.) should be demarcated, the root cause identified and remediated to prevent contribution to any future water intrusion episodes.

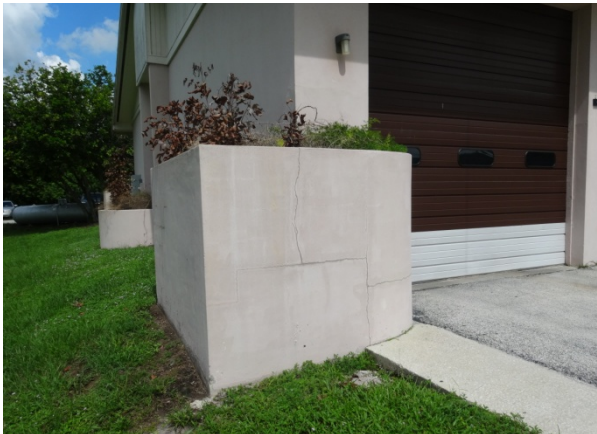
- There are numerous cracks in the stucco at the planter walls.
- The building fascia and soffit is deteriorated at many locations.
- Down spouts do not all divert the rain water away from the building.
- There a few old conduits or small holes in the walls.
- The paint has visibly degraded at some locations.
- The icemaker condensate drain does not have a p-trap and the moisture is not diverted away from the building.

Photo 3
Typical cracks in planter walls

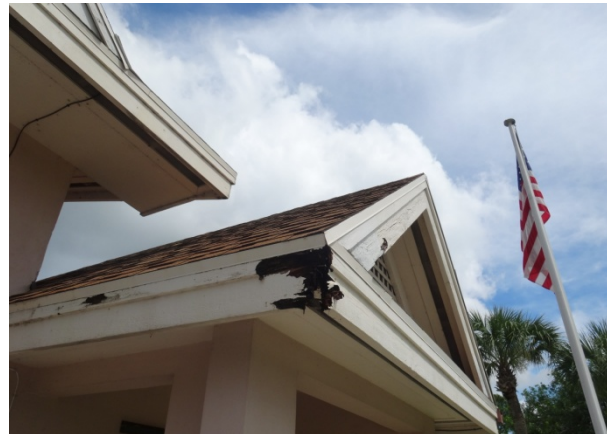
Photo 4
Deteriorated fascia above entry door

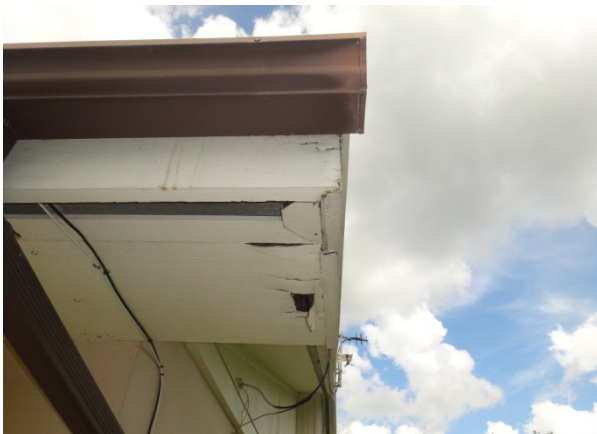
Photo 5
Deteriorated fascia and soffit

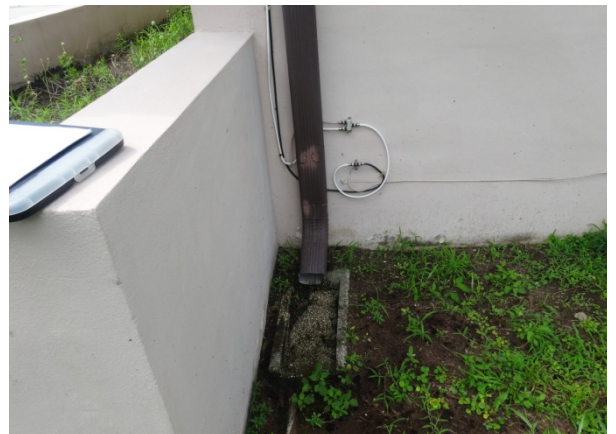
Photo 6
Downspout with minor washout and not effectively diverting water away

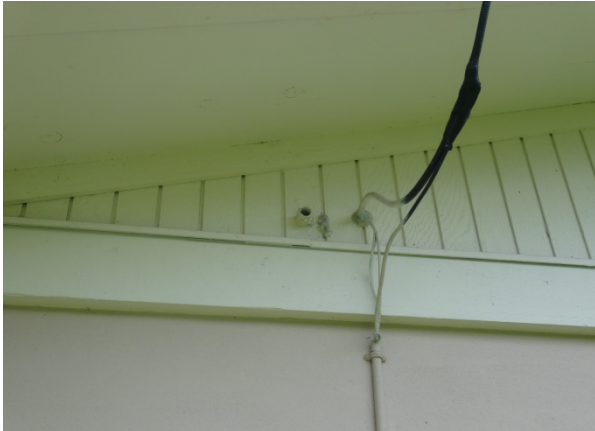
Photo 7
Open conduit into attic

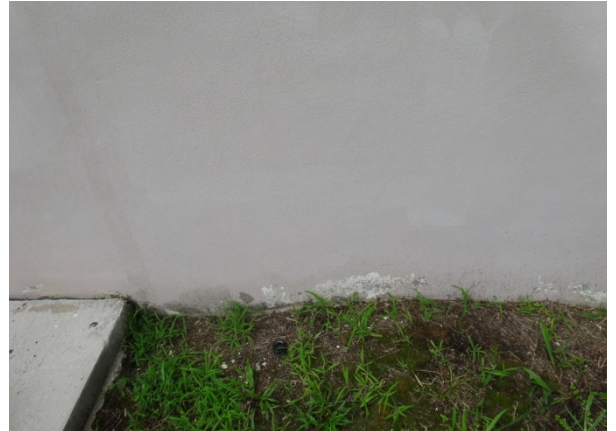
Photo 8
Paint degradation

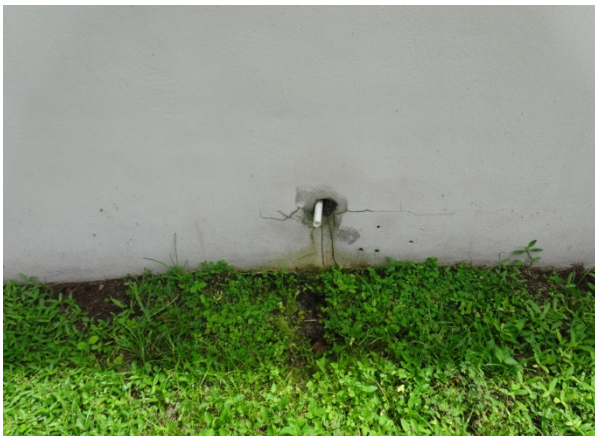
Photo 9
Condensate drain from icemaker – no p-trap
and moisture is not directed away from building

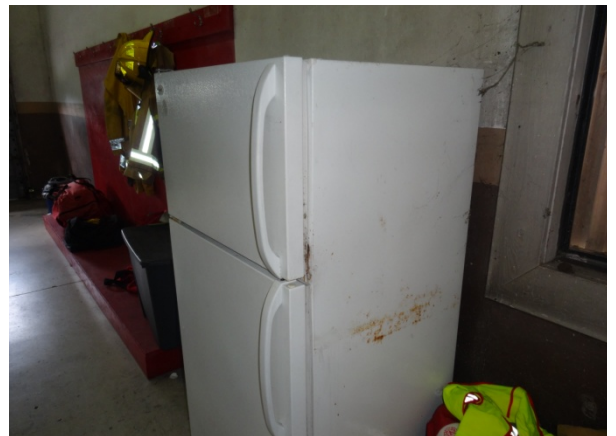
Photo 10
Refrigerator in apparatus bay with SVM

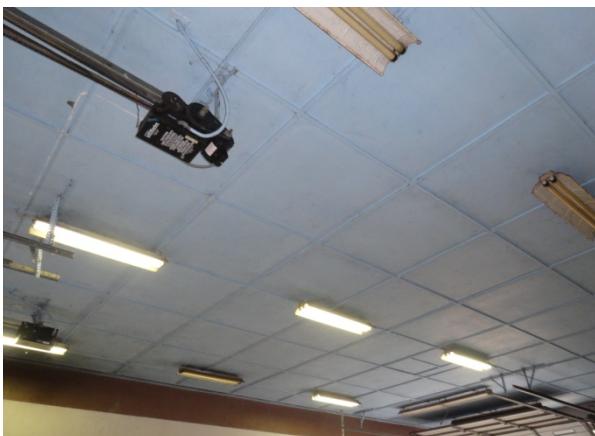
Photo 11
Plywood ceiling in apparatus bay – no evidence
of moisture intrusion

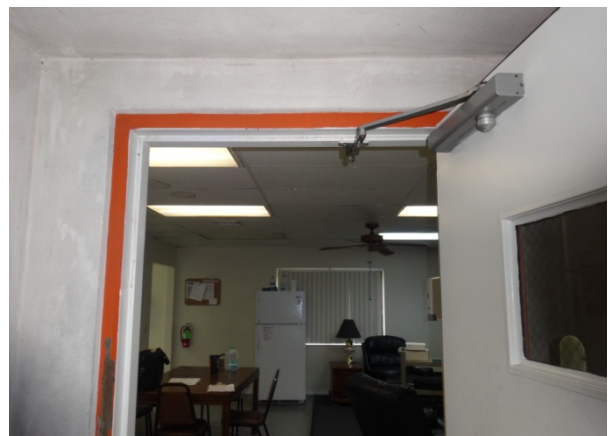
Photo 12
Door from apparatus bay into office area – no
weather-stripping

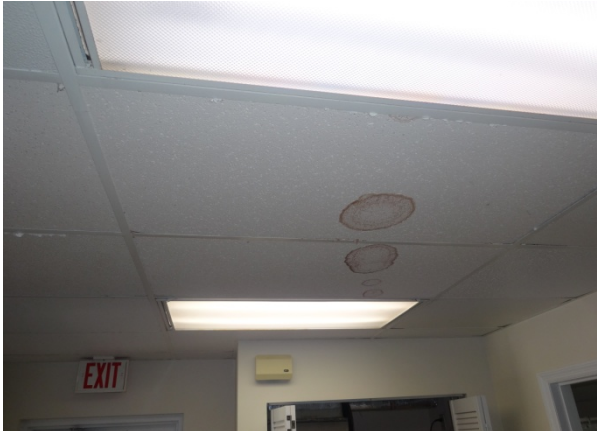
Photo 13
Stained ceiling tile in front of A/C closet –
moisture dripping from coolant line in attic

1. The water-stained, SVM ceiling tiles, and wet fiberglass duct and HVAC insulation should be replaced. Rusted louvers and metal components/grids should be replaced/repainted. Confirmation that all supply ducts are properly insulated, to reduce potential condensation issues, should also occur.

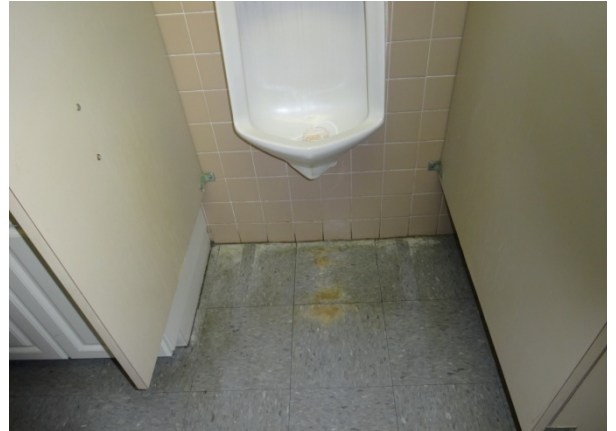
Photo 14
Moisture damage at vinyl floor tiles

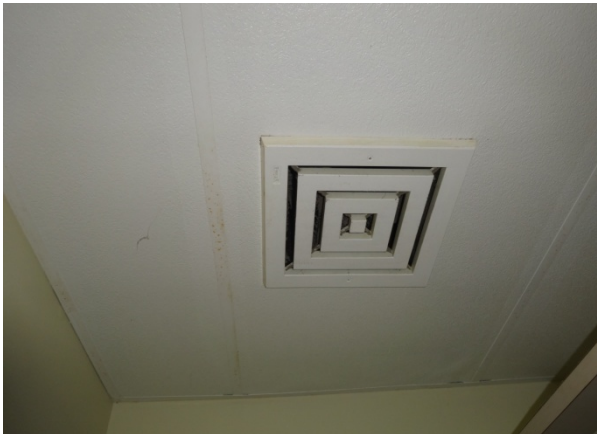
Photo 15
Vent fan in men's bathroom, exhausts into attic
– SVM, rust on ceiling grid

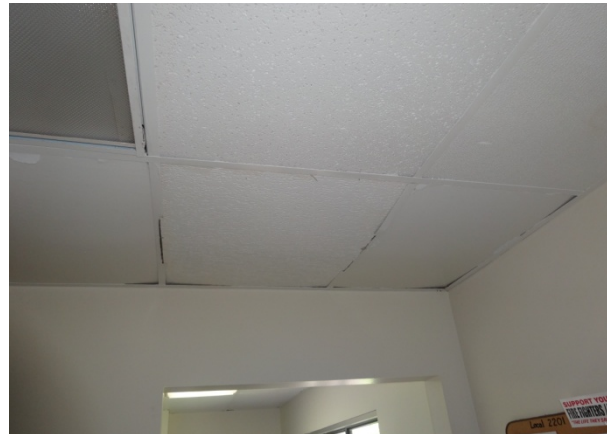
Photo 16
In front of entry to kitchen – example of painted
ceiling tiles previously stained

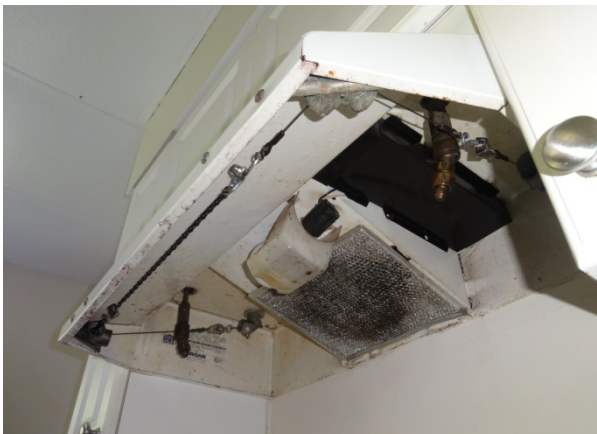
Photo 17
Underside of stove vent hood – needs cleaning
and SVM

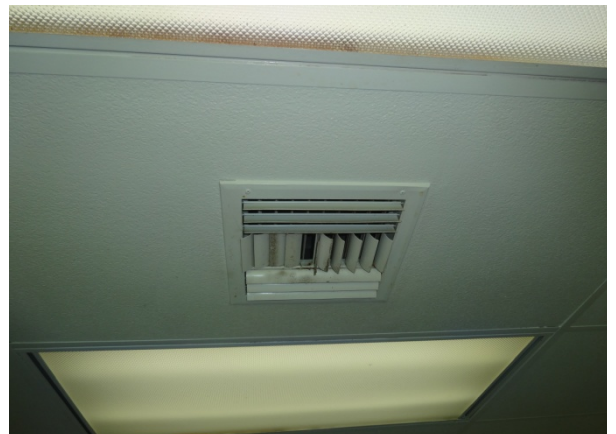
Photo 18
Diffuser in kitchen - SVM

2. AMEC recommends inspection and cleaning of mold-impacted and dirty HVAC Units, ducts and components using a hypochlorite (10% bleach and water) solution, BBJ MicroBiocide, Oxine, EnviroCon, Fiberlock Shockwave, or Fosters 40-80. Remove and replace all mold or water-damaged HVAC or duct insulation. Note, all mold remediation activities are to be accomplished by experienced, properly trained personnel in accordance with the State of Florida Statutes 468.84, et al.

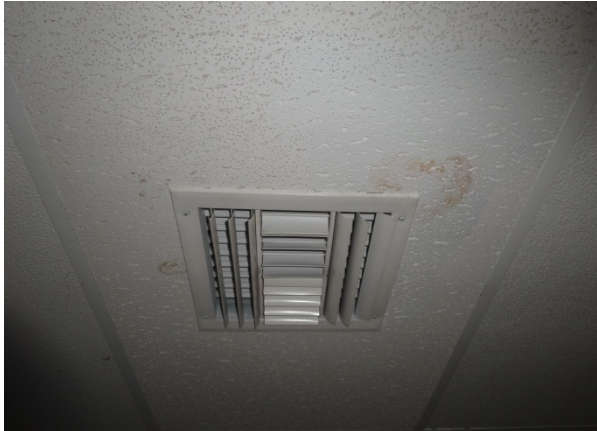
Photo 19
Stained ceiling tile and SVM on diffuser in ready room

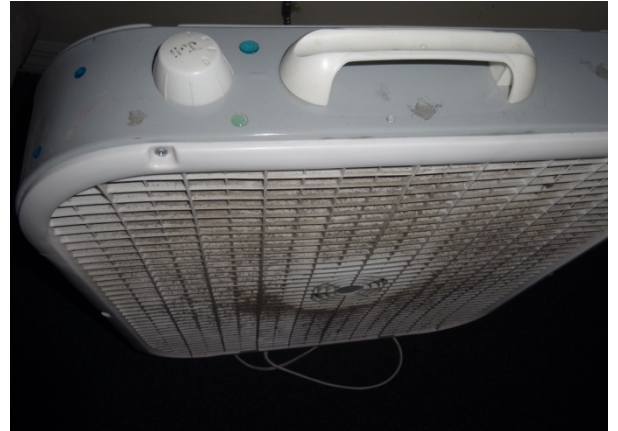
- A portable fan in the dormitory has SVM.
- There is a lack of sealant between the wall and window frames at many locations however there is no evidence of moisture intrusion.

Photo 20
Portable fan in dormitory - SVM

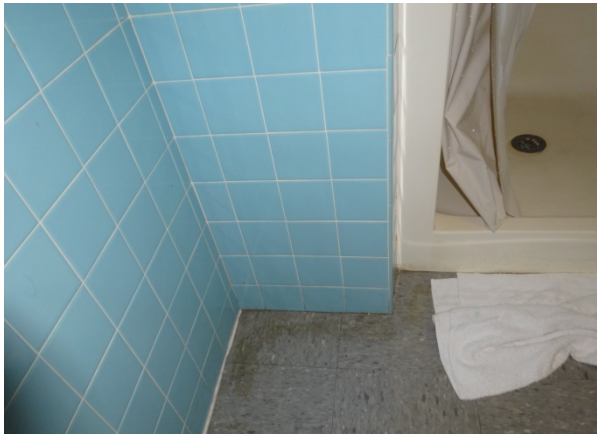
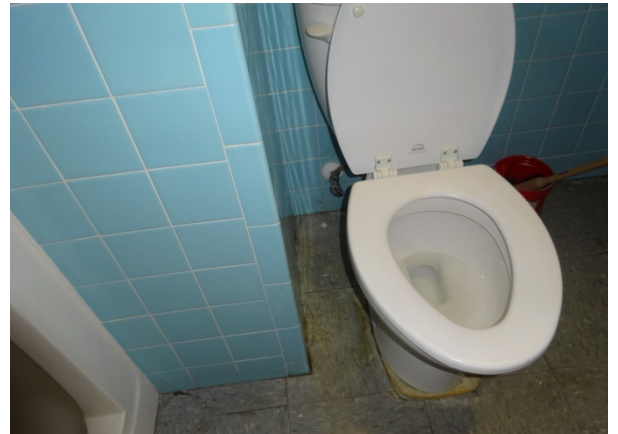
Photo 21
Bathroom – moisture damage to floor tile

Photo 22
Bathroom – moisture damage to floor tile

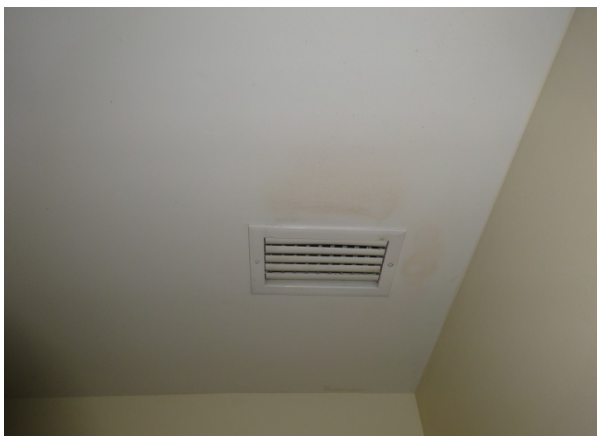
Photo 23
Bathroom, stains on ceiling (SVM) and diffuser has been painted

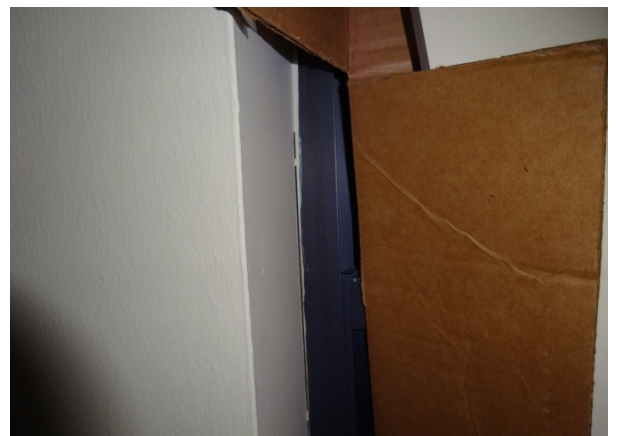
Photo 24
Window in dormitory with no sealant inside frame, no evidence of moisture intrusion

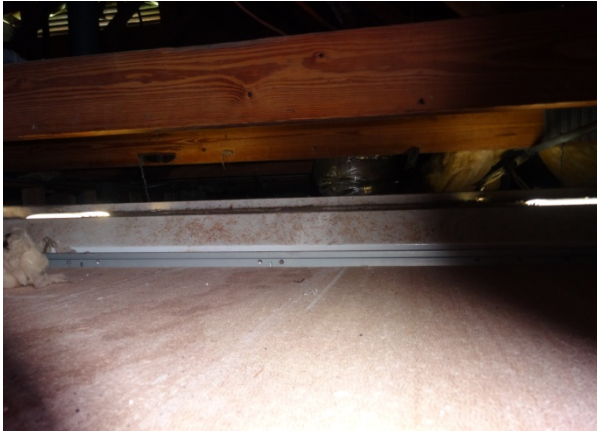
- Many of the light fixtures are rusted on the top side which is exposed to the attic space.
- A portion of the exterior wall sheathing in the attic has evidence of previous moisture intrusion.

Photo 25
Above ready room – rust on light fixture

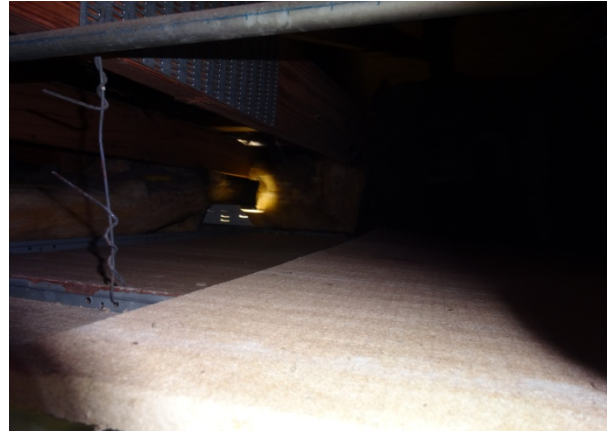
- The fiberglass batt insulation above the ceiling tiles has been moved out of position in numerous locations. There is no indication that an “air barrier exists between the conditioned occupied spaces and the vented attic. If an effective air barrier is not present, un-conditioned, hot humid air (particularly during the summer months) from the vented attic is allowed to come into contact with the metal ducts and supply/return components and ceiling tiles which are cooled by the HVAC for the occupied spaces below. This condition can be exacerbated by low thermostat set points (typically well below 72 degrees Fahrenheit) in the occupied areas. Painted drywall/joint compound walls and suspended acoustical tile ceiling with fiberglass batt insulation above are typically not air barriers as defined by Florida Building Code (FBC). The lack of an effective air barrier can result in condensation control issues, moisture vapor control issues, and higher heating and cooling costs.

Photo 26
Above ready room – insulation moved out of place

7. Confirm that a proper air barrier has been installed between the conditioned finished space and the “naturally ventilated” plenum space above the dropped ceiling tiles and batting, in order to prevent the potential for plenum moisture, in accordance with applicable Florida Building Code (Mechanical). Acceptable air barriers are generally made of durable, nonporous materials and are sealed to adjoining wall, ceiling or floor surfaces with suitable long-life mastics.

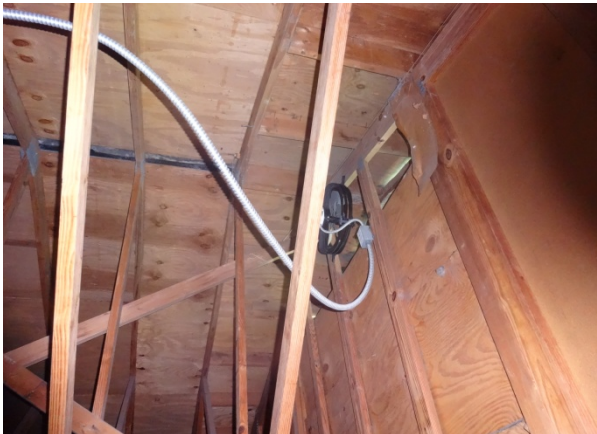
Photo 27
Attic exhaust fan – appears to be non-operational

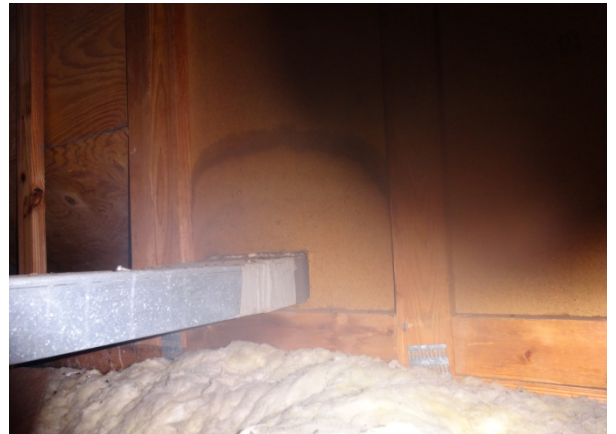
Photo 28
Moisture stain on exterior wall sheathing in attic at vent

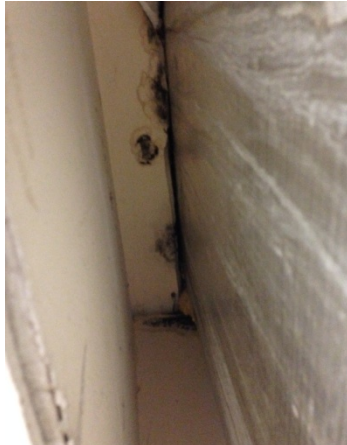
- One Trane and a Haier portable floor unit supplies A/C to property.
- The Trane unit located in Ready Room had visible signs of SVM on ceiling of A/C closet around duct penetration, some rust and lite moisture on coils and dust on filter grille of filter housing was also visible, unit also has a new Eco-aire, pleated filter marked with change date.
- The A/C return located in Dorm, had a clean pleated filter and showed signs of Dust and Suspect Visible Mold (SVM).
- The Haier floor model unit has dust in filter area.
- Condensate line in the Ready Room above ceiling tile, was wrapped in neoprene and flex seal 457 tape which was completely saturated.

Photo 31
Suspect Visible Mold (SVM) on ceiling of A/C closet

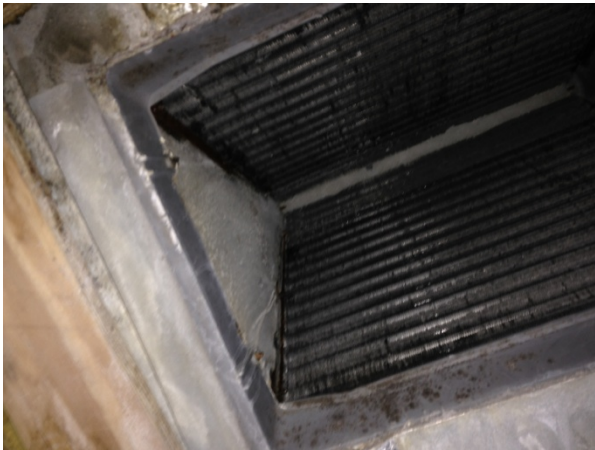
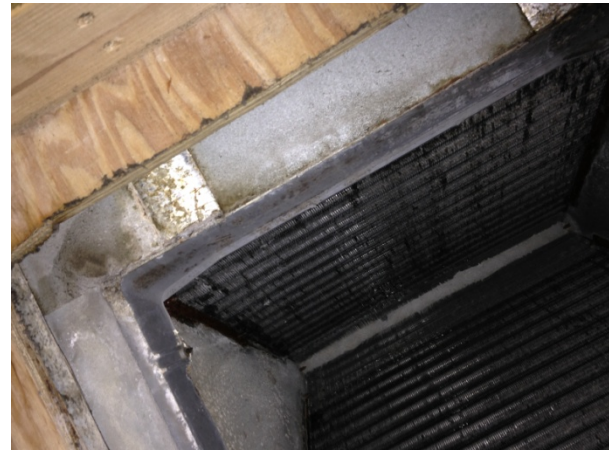
Photo 33
SVM at coils of AHU in Ready room

Photo 34
S.V.M at coils of AHU in Ready room

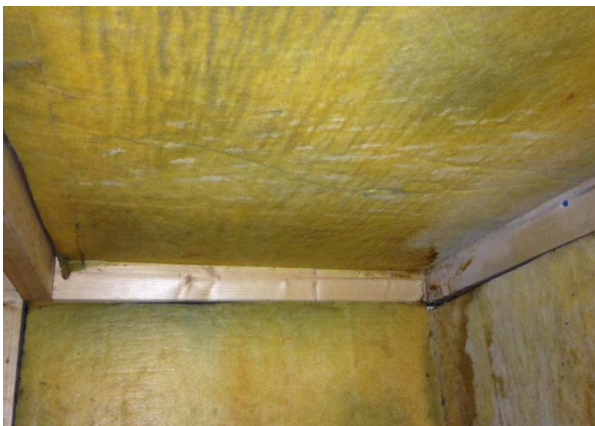
Photo 35
Stains on Fiberglass insulation of AHU

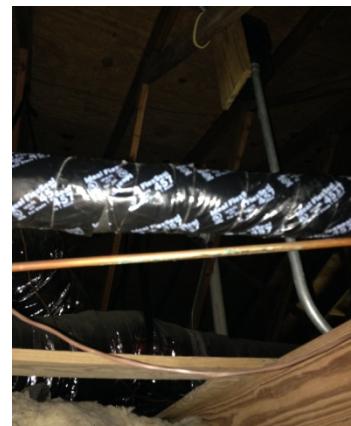
Photo 36
Wet insulation on condensate line, above ceiling tiles in Ready room

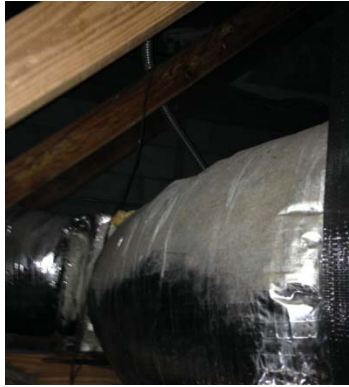
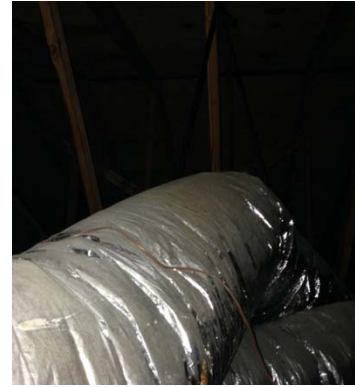
Photo 37
Dust on flexible fiberglass ducts above ceiling tiles

Photo 38
Dust on flexible fiberglass ducts above ceiling tiles

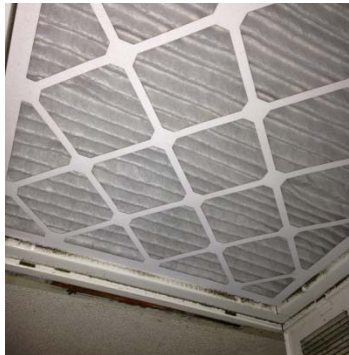
Photo 39
Visible signs of SVM on A/C return in Bunk area

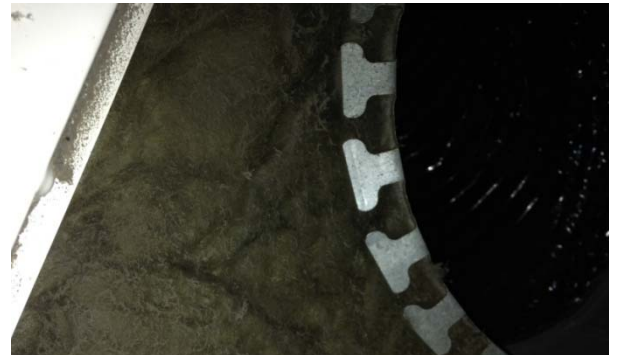
Photo 40
Dust at A/C return in Bunk area
