REPORT DATE: January 24, 2023
MAA PROJECT #: R3950.00

NESHAP ASBESTOS SURVEY REPORT

526 STEMMERY STREET
Wilson, Wilson County, North Carolina

**Subject: NESHAP Asbestos Survey Report
526 Stemmerly Street
Wilson, Wilson County, North Carolina
Mid-Atlantic Project No. R3950.00**

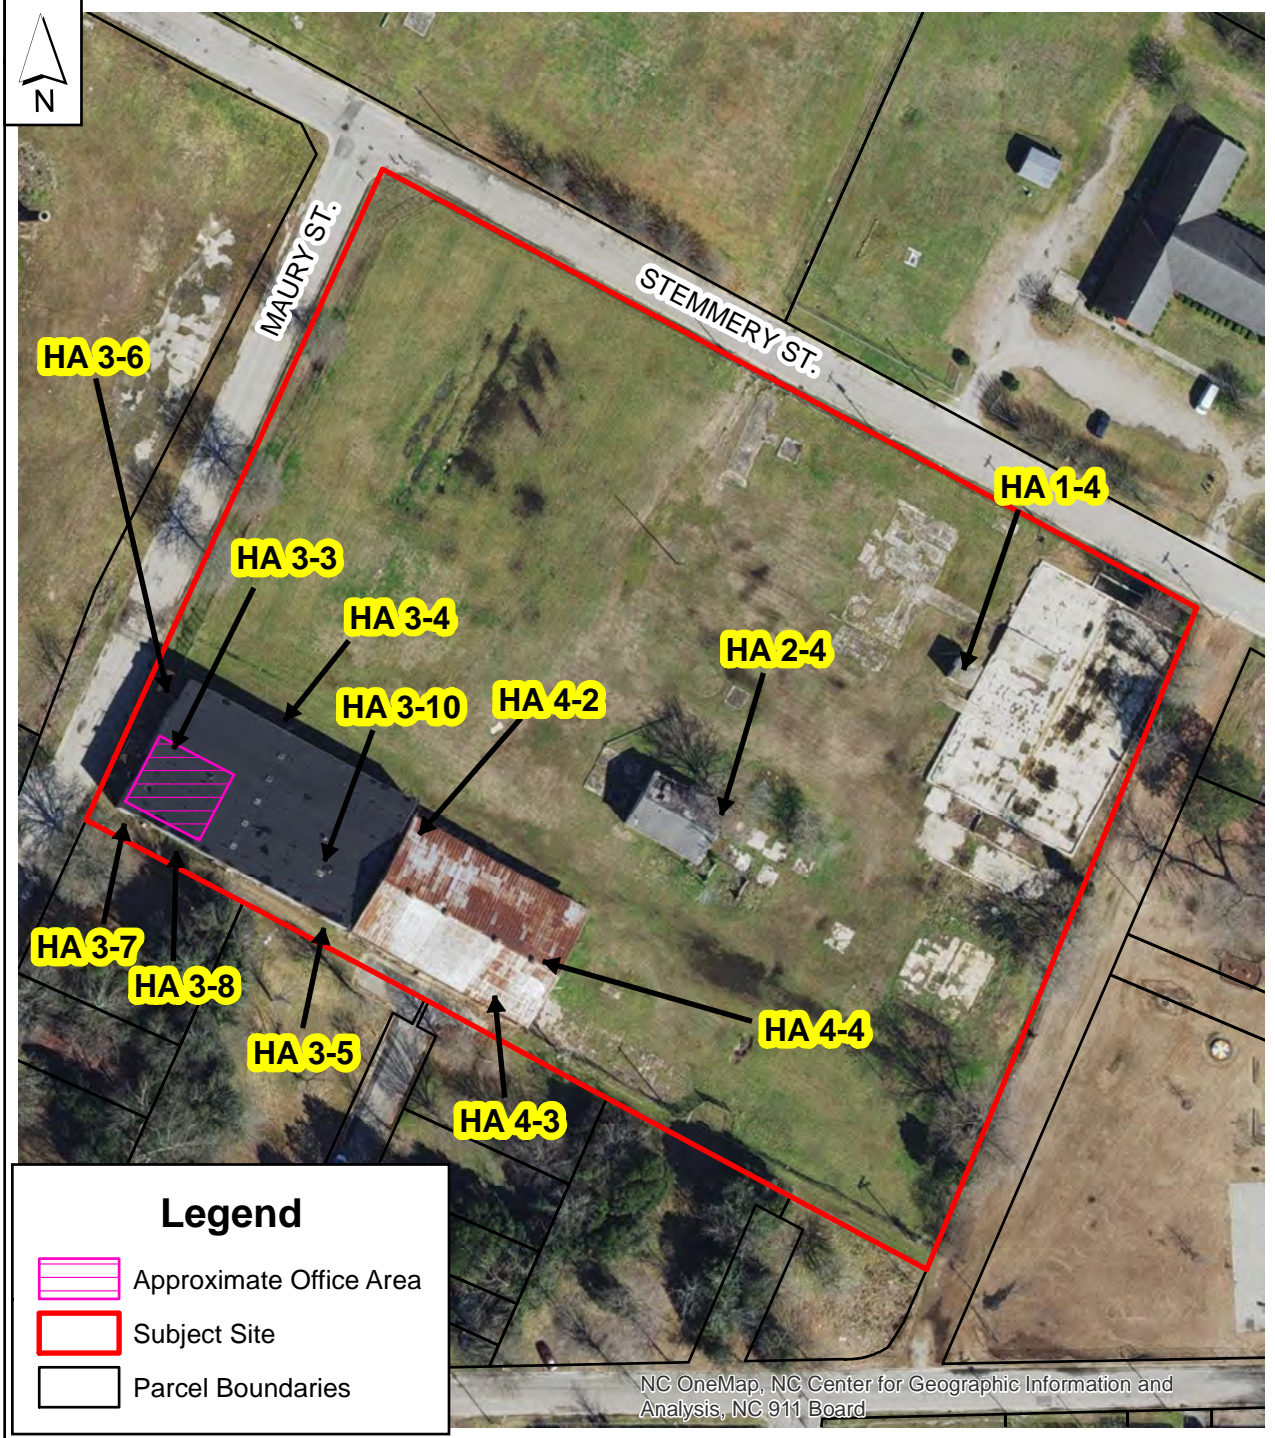
APPROXIMATE SAMPLE LOCATION MAP
526 STEMMERY STREET
WILSON, NORTH CAROLINA

At the time of this survey, friable ACM was observed in significantly damaged condition. Due to the degenerated state of the buildings, these building materials can be made friable if handled incorrectly and should be removed by professionals qualified in asbestos abatement. Non-friable ACM were observed in good condition during the assessment; however, non-friable materials can be made friable if handled incorrectly and should be removed by professionals qualified in asbestos abatement. A map illustrating sample locations of asbestos-containing materials is provided as [Drawing 2](#).

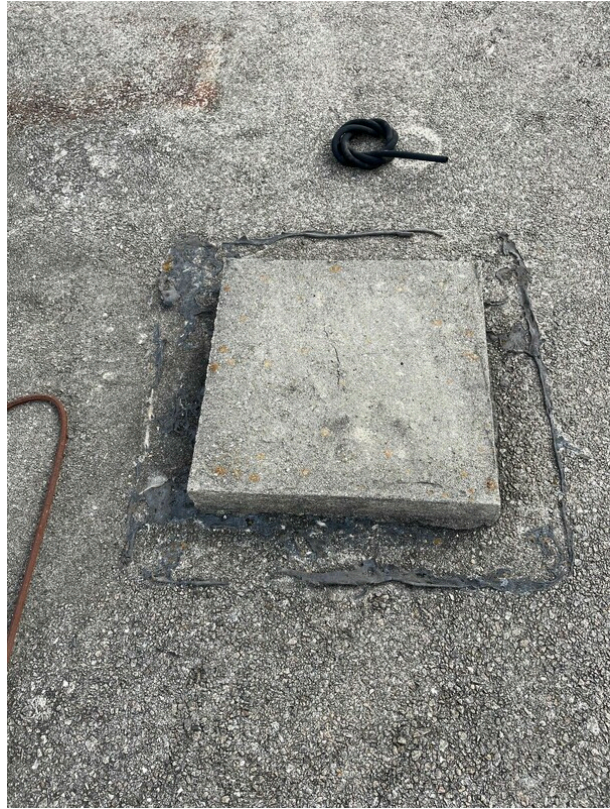
- Black/Gray Penetration Tar – 1 Roof Penetration

View of the asbestos-containing Black/Gray Penetration Tar (HA 1-4)

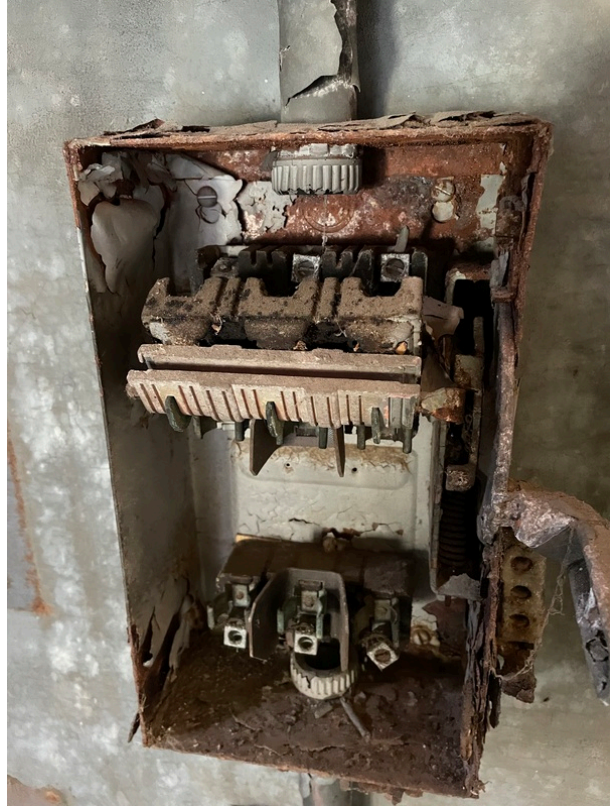
- Cementitious Electrical Breaker Bars were assumed to be asbestos-containing materials – 15 Electrical Breakers

NOTES: 15 cementitious electrical breaker bars associated with electrical breaker panels were observed on the east interior wall and are considered as asbestos-containing materials

View of the assumed asbestos-containing
Cementitious Electrical Breaker Bars
(HA 2-4)

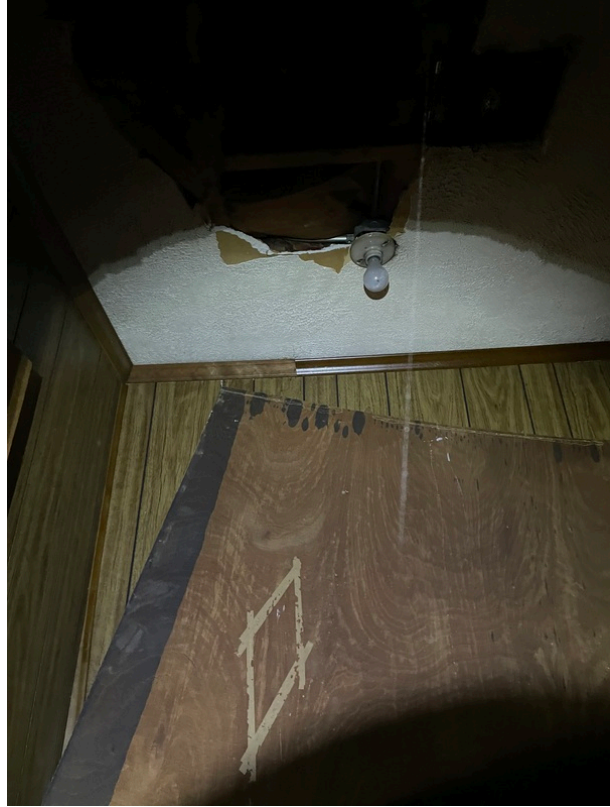
NOTES: Roof flashings were metal. Ceiling texture and wallboard were damaged/intermingled.

View of the asbestos-containing White Ceiling Texture over Wallboard (HA 3-3)

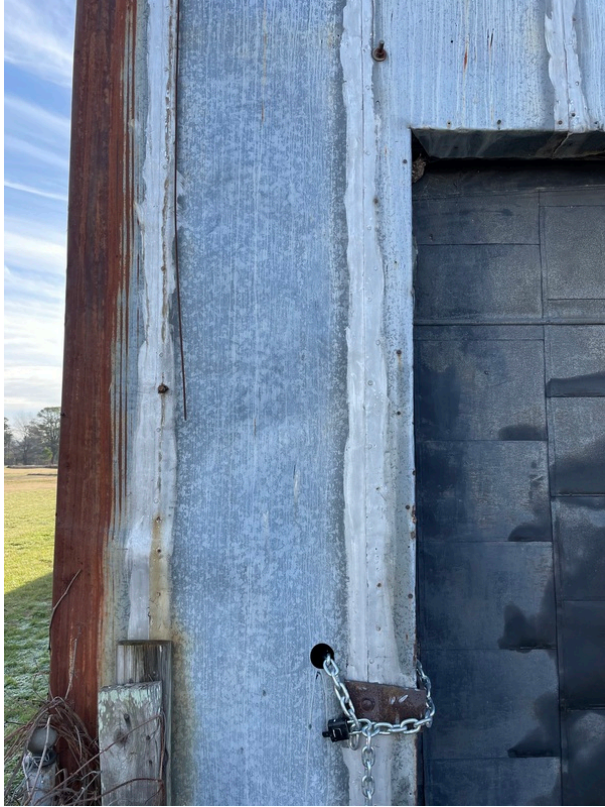
View of the asbestos-containing Silver Paint on Metal (HA 3-4)

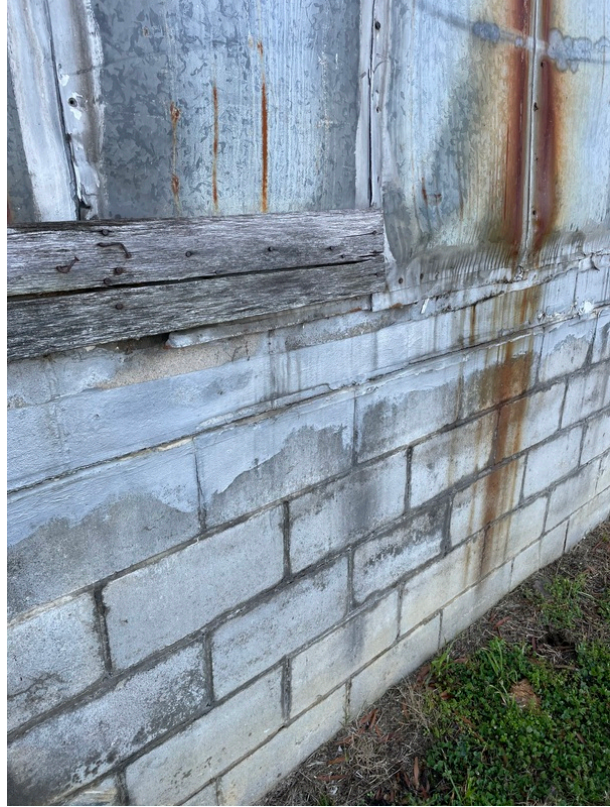
3-5-1	Silver Exterior CMU Surfacing	West Exterior	Good	750 ft ²	Friable	3% Chrysotile
3-5-2		North Exterior				Assumed >1% Asbestos
3-5-3		South Exterior				Assumed >1% Asbestos
3-6-1	Beige/Silver/Black Waterproofing	West Exterior Loading Dock	Good	20 ft ²	Friable	None Detected
3-6-2						2% Chrysotile
3-6-3						Assumed >1% Asbestos
3-7-1	White/Silver Exterior CMU Surfacing	South Exterior	Good	60 ft ²	Friable	2% Chrysotile
3-7-2						Assumed >1% Asbestos
3-7-3						Assumed >1% Asbestos
3-8-1	Grey/Silver/Black Exterior CMU/Metal Surfacing	South Exterior	Good	100 ft ²	Friable	None Detected
3-8-2		West Exterior				2% Chrysotile
3-8-3		South Exterior				Assumed >1% Asbestos
3-9-1	White Penetration Caulk	Roof Penetrations	Good	8 Penetrations	Non-Friable	None Detected
3-9-2						None Detected
3-10-1	Silver Penetration Paint	Roof Penetrations	Good	8 Penetrations	Friable	3% Chrysotile
3-10-2						Assumed >1% Asbestos

View of the asbestos-containing Silver Exterior CMU Surfacing (HA 3-5)

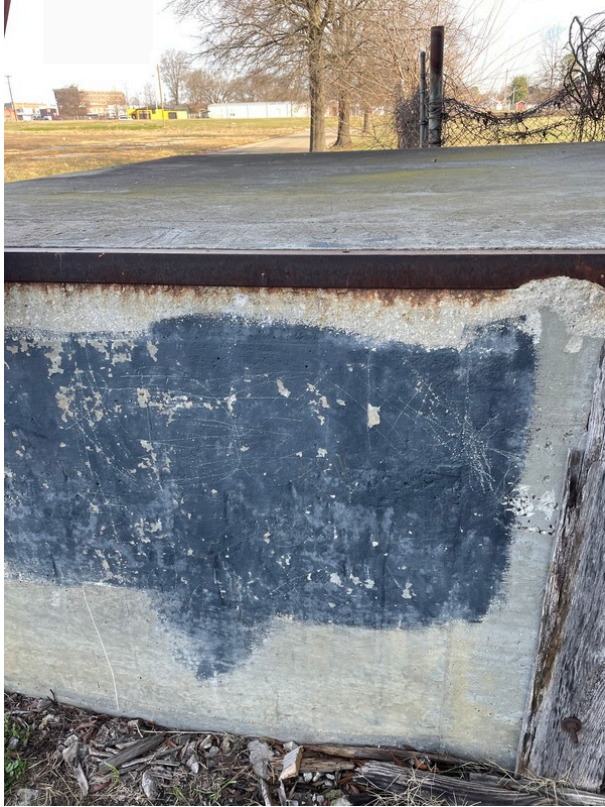
View of the asbestos-containing Beige/
Silver/Black Waterproofing (HA 3-6)

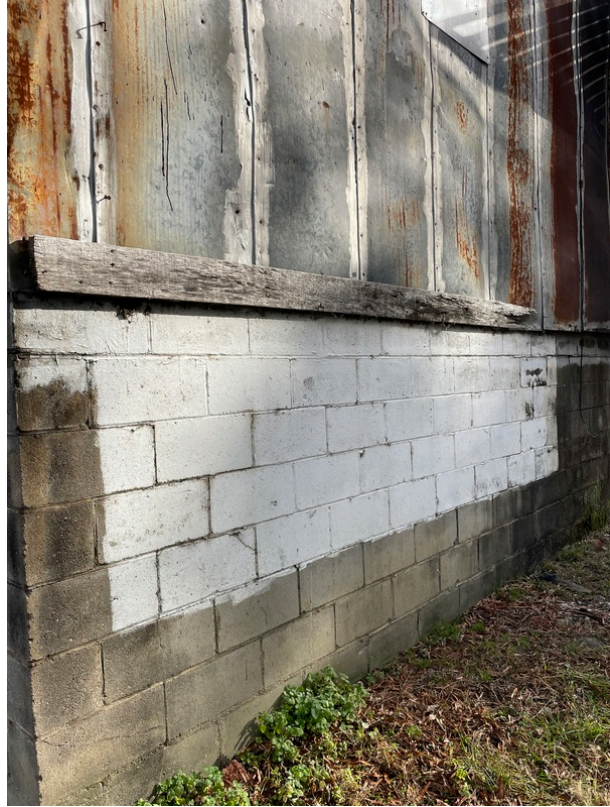
View of the asbestos-containing White/
Silver Exterior CMU Surfacing (HA 3-7)

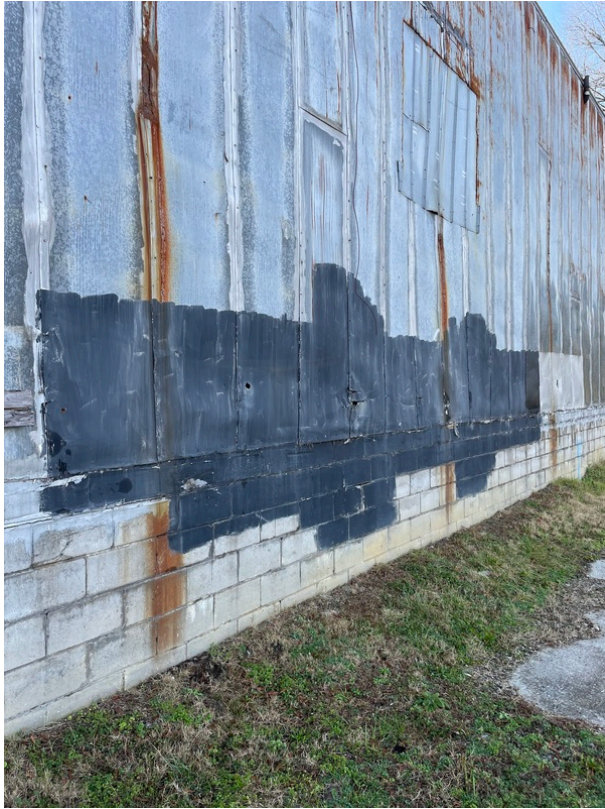
View of the asbestos-containing Grey/
Silver/Black Exterior CMU/Metal Surfacing
(HA 3-8)

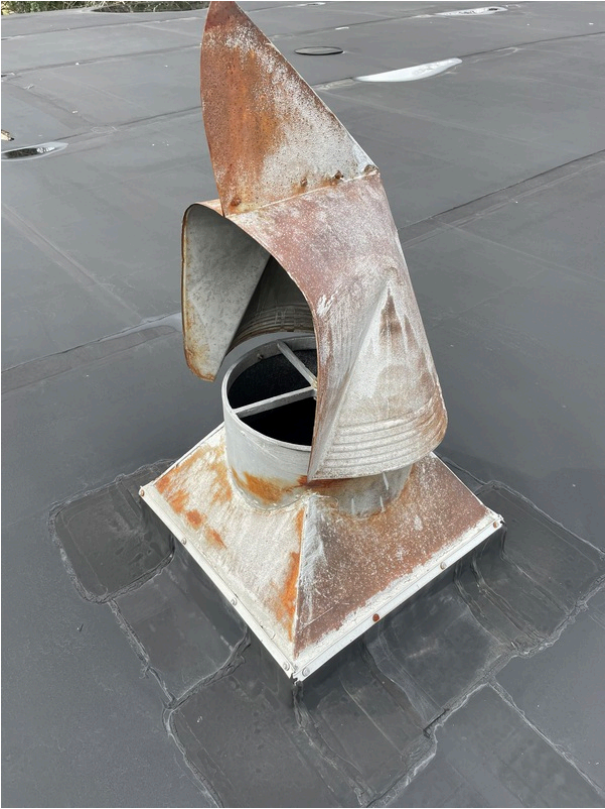
General view of the asbestos-containing
Silver Penetration Paint on a roof
penetration (HA 3-10)

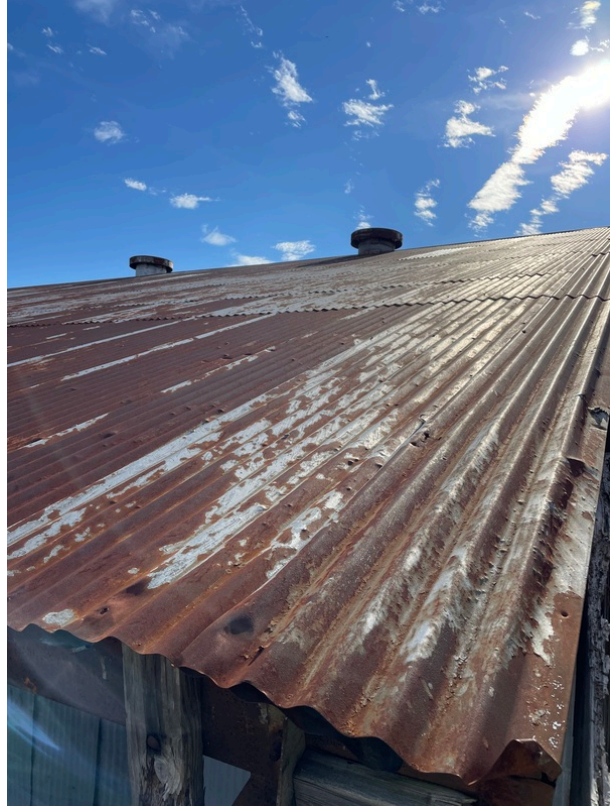
Quantity of Silver Roof Paint is the approximate size of the metal roof. The Silver Paint has faded and fallen off the roof, therefore no longer covers the entirety of the roof.

View of the asbestos-containing Silver
Roof Paint (HA 4-2)

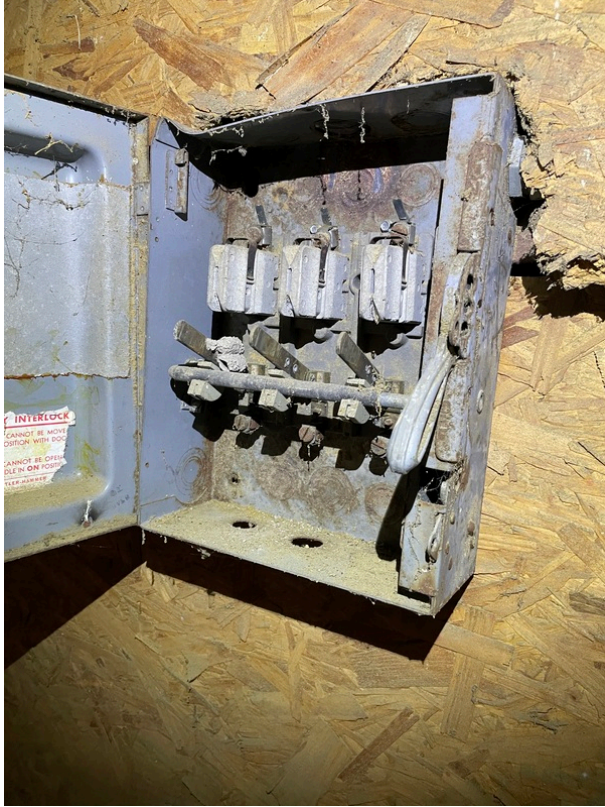
NOTES: 2 cementitious breaker bars were observed on the south interior wall, as well as one on the north interior wall, and are considered to be asbestos-containing materials.

View of the assumed asbestos-containing
Cementitious Electrical Breaker Bars
(HA 4-3)

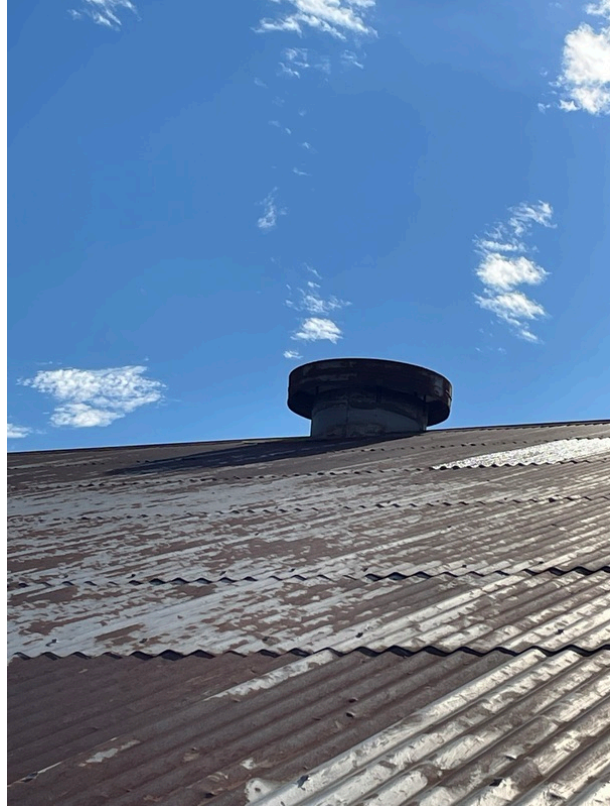
4 roof penetrations could not be safely accessed during the survey. Any building materials identified on the penetrations (silver paint, caulk, etc.) are considered ACM.

View of the assumed asbestos-containing
Roof Penetration Materials (HA 4-4)
