FCG Environmental

Subject: Asbestos Roofing Surveys
Meiners Oaks Elementary School – Building J
Topa Topa Elementary School – Building E
Matilija Junior High – Buildings F, C & D
Nordhoff High School – Buildings F, G, I & J
Mira Monte Elementary School – Buildings D, E, L & Q
Ojai, CA 93023
FCG Job Code: OUSD-48

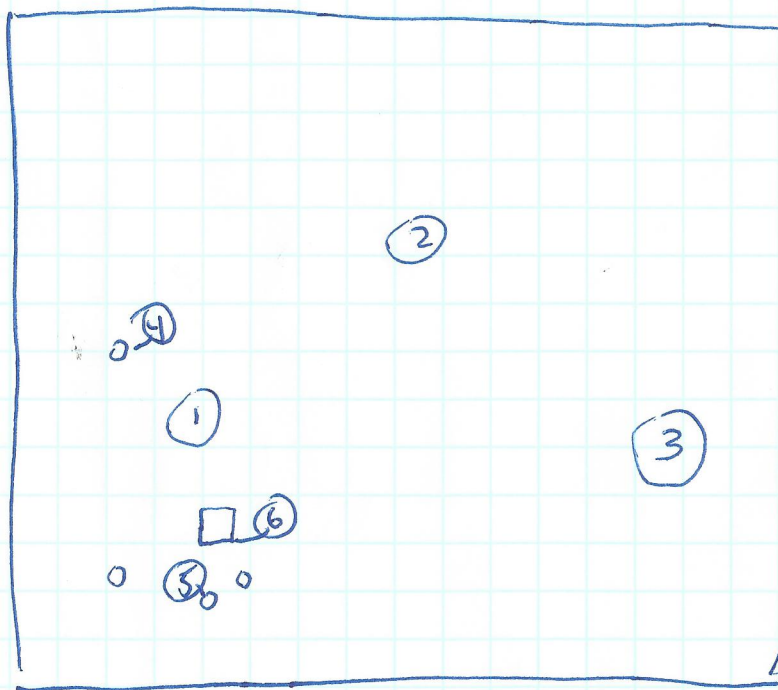
BUILDING J
HOT MOP W/ STONES

- Roofing Penetration Mastics (5% chrysotile) – Meiners Oaks ES, Building J at 2” and 6” vent pipe penetrations with approximately 6 square feet.
