**ASBESTOS PROJECT DESIGN
REGARDING
VACANT BUILDING
419 HAMPTON STREET
WALTERBORO, SOUTH CAROLINA**

Date of Design: October 08, 2019

**ASBESTOS SURVEY
REGARDING
VACANT BUILDING
419 HAMPTON STREET
WALTERBORO, SOUTH CAROLINA**

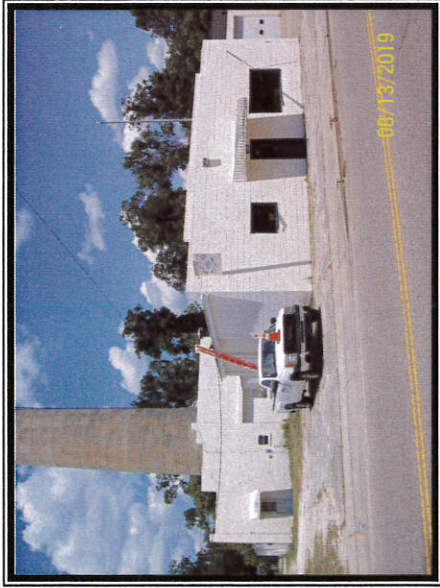
Photo #1
Northeast-facing View of Building

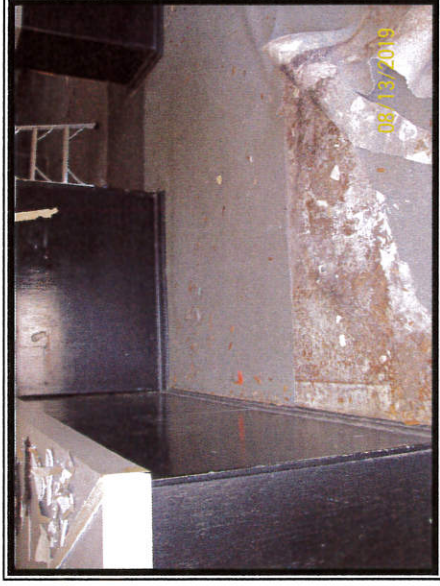
Photo #2
Asbestos Detected at **>1% in Parquet Flooring**;
No Asbestos Detected in Mottled Gray Flooring

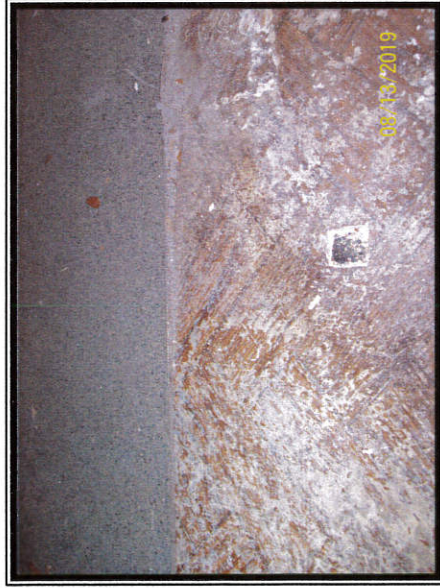
Photo #3
Asbestos Detected at **>1% in Tan Floor Tiles**
under Parquet Sheet Flooring at Counter Area

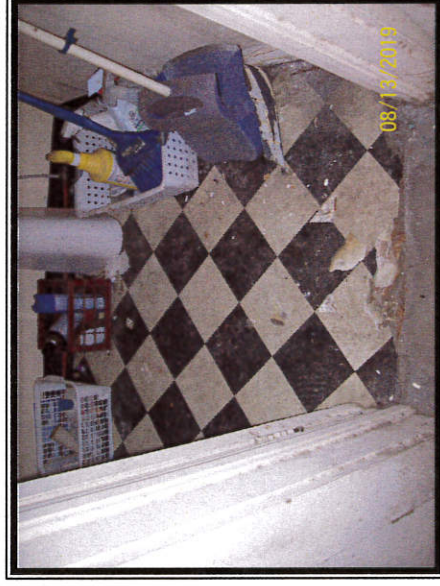
Photo #4
Parquet Sheet Flooring under non-asbestos
containing Checkerboard Sheeting in BR 2

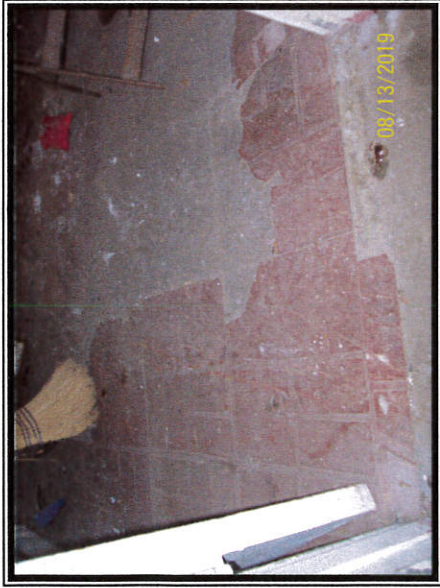
Photo #5

Asbestos Detected at >1% in Brick-patterned
Flooring Squares in Room 1

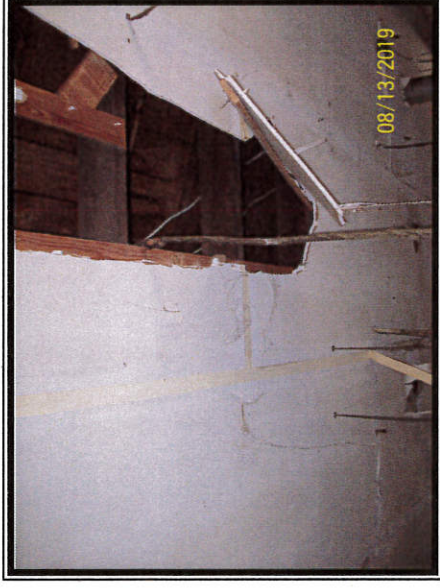
Photo #6

Asbestos Detected at >1% in Sheetrock with
Joint Compound Systems

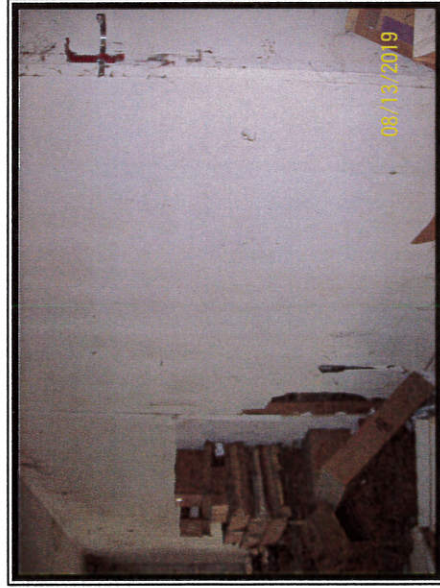
Photo #7

View of Sheetrock Wall System with Joint
Compound in Area 3

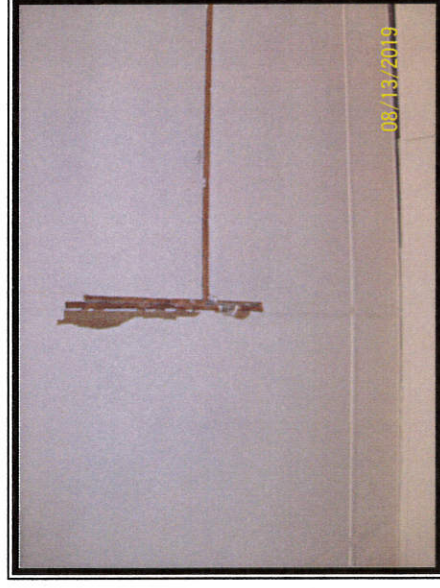
Photo #8

Asbestos Detected at >1% in Joint Compound
of Sheetrock with Furring Strips Systems

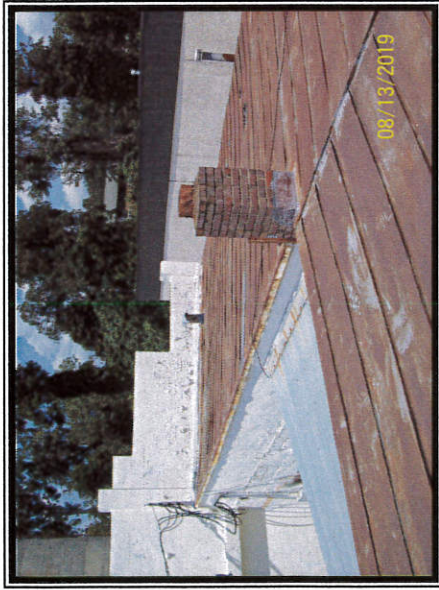
Photo #9
Northeast-facing view of Sheet Metal Roofing
System over Areas 1 & 2 (Rusted)

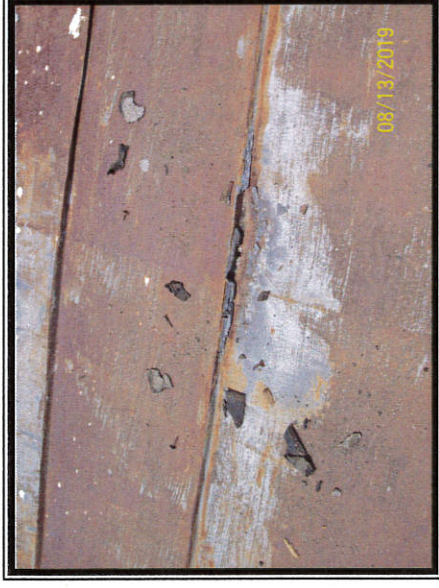
Photo #10
Asbestos Detected at >1% in Metal Roof Seam
Caulk of Areas 1 & 2

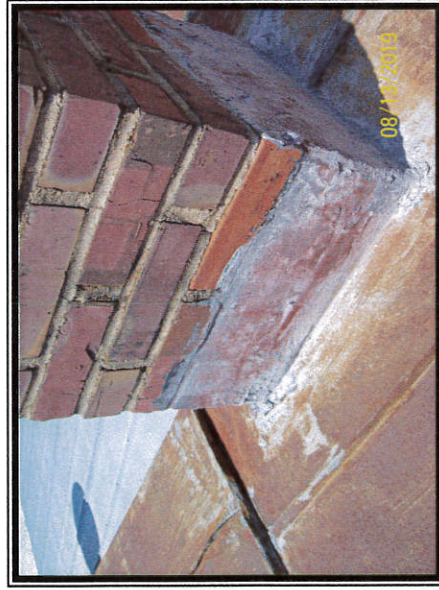
Photo #11
Asbestos Detected at >1% in Silver Roof
Sealant Material as Seen on Chimney

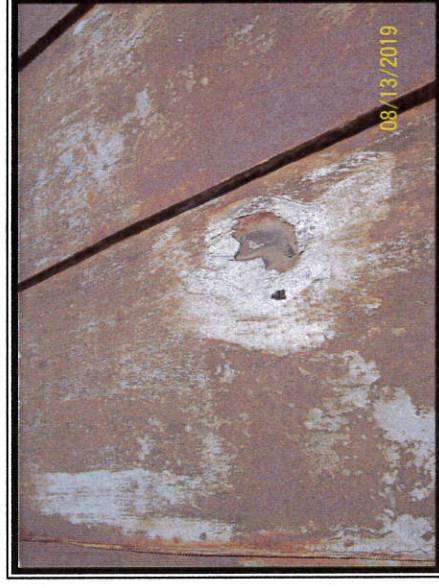
Photo #12
View of Silver Roof Sealant Material on Sheet
Metal Panel

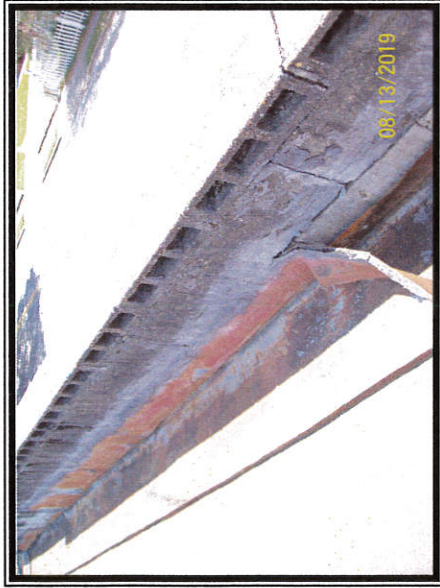
Photo #13

Asbestos Detected at >1% in Area 1 & 2 Roof
Parapet Flashing Sealant Materials

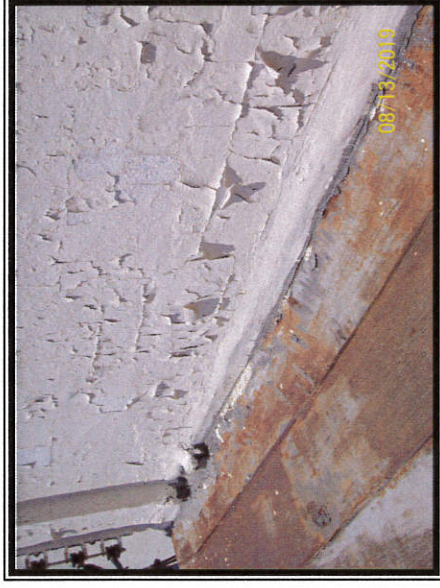
Photo #14

View of Flashing Sealant Materials at North End
of Area 2 Roof

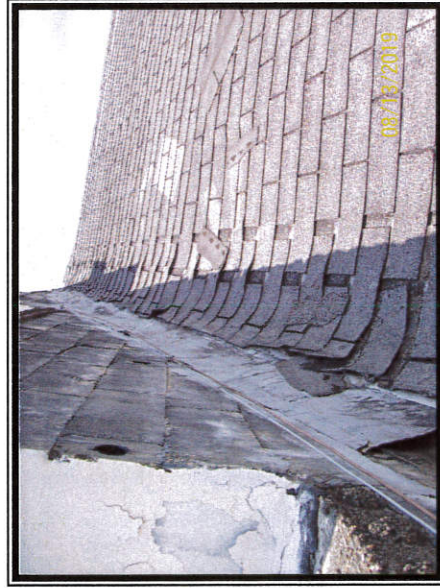
Photo #15

Asbestos Detected at >1% in Area 3 Parapet
Flashing Materials; No Asbestos in Shingles/Felt

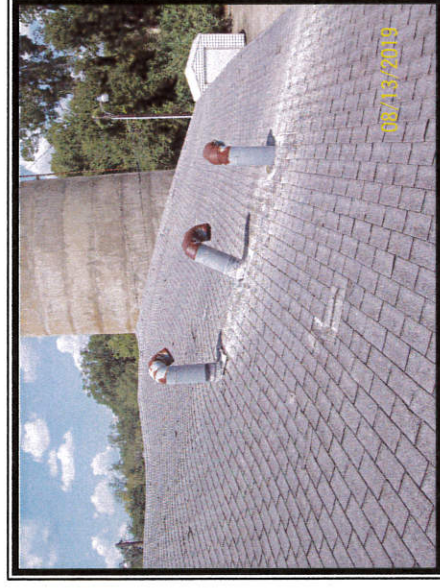
Photo #16

View of Area 3 Roof Vent Pipe with Asbestos-
containing Sealant Material

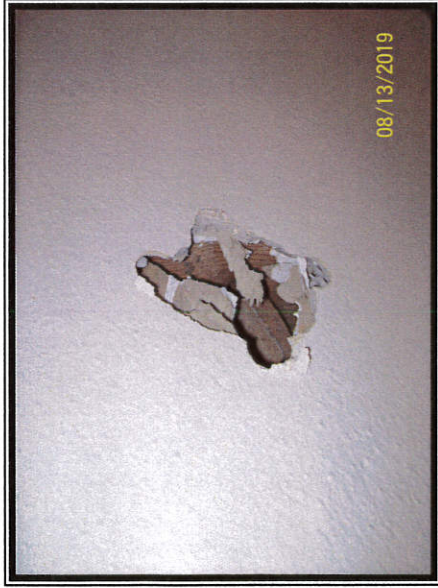
Photo #17

No Asbestos Detected in Cementitious Board and Sheetrock Combination Wall System

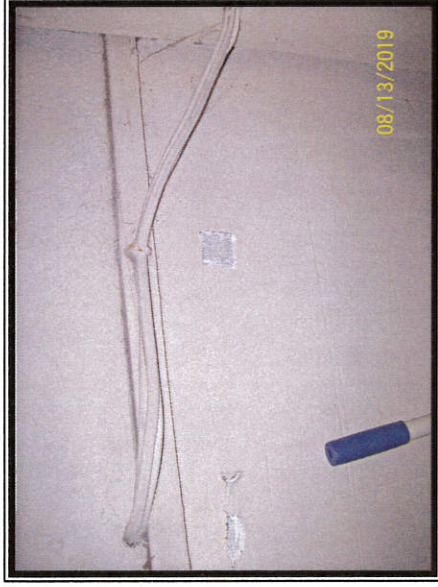
Photo #18

No Asbestos Detected in Simulated Tile Wall Surfacing in Bathrooms

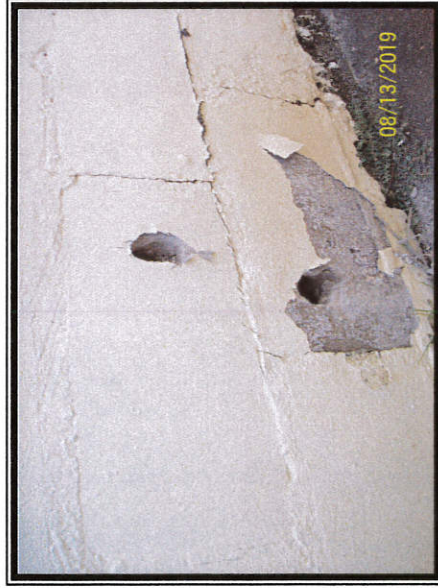
Photo #19

No Vermiculite in CMU; No Asbestos Detected in Exterior Paint or Block Fill Materials

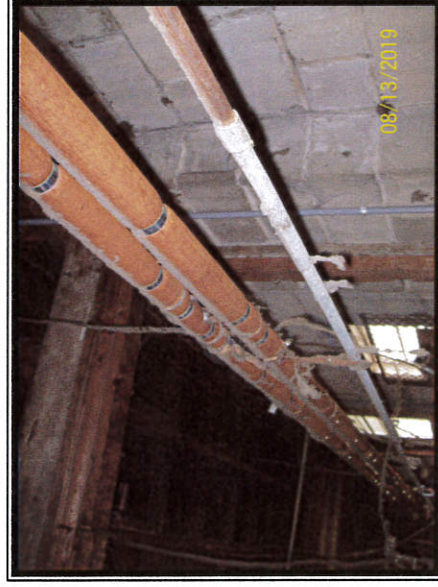
Photo #20

No Asbestos Detected in Any Pipe Wrap Materials
