Asbestos & Lead Based Paint Assessment

City of Spartanburg
213 Windigo Road
Spartanburg, South Carolina 29306

Project Number: 0124-01

June 13, 2024

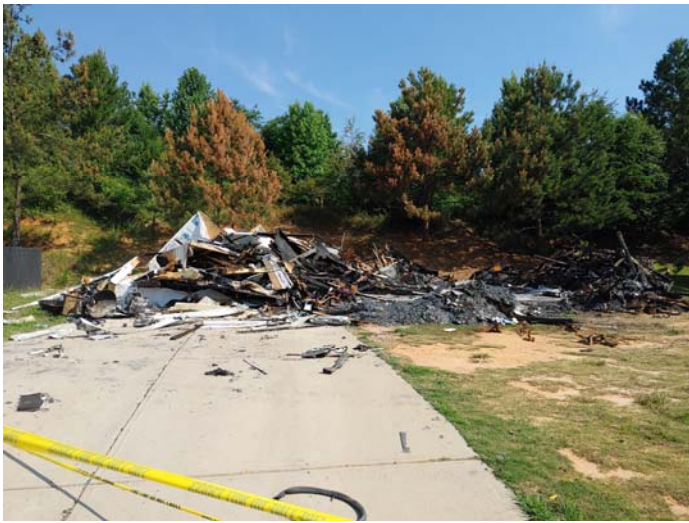
Photo 1 – Typical view of 213 Windigo Road in Spartanburg, South Carolina 29306

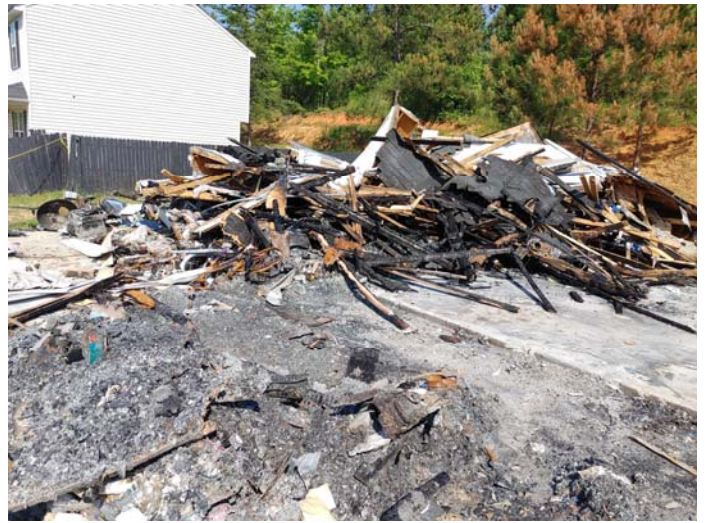
Photo 2 – Typical view of the burned remains of the house collapsed into a debris pile

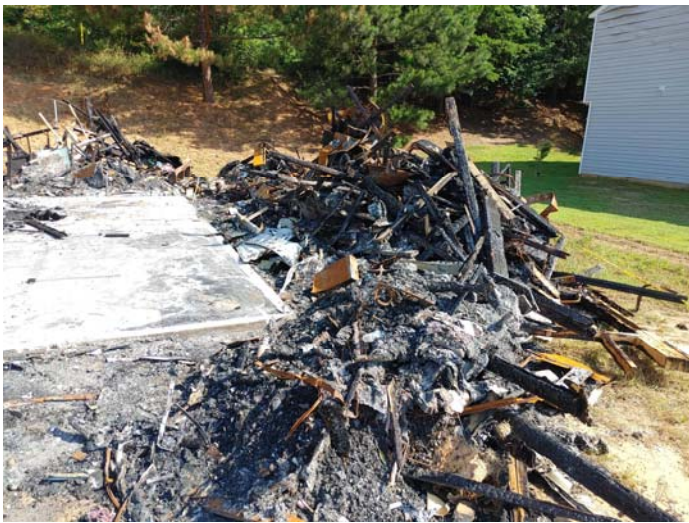
Photo 3 – Typical view of the burned remains of the house collapsed into a debris pile

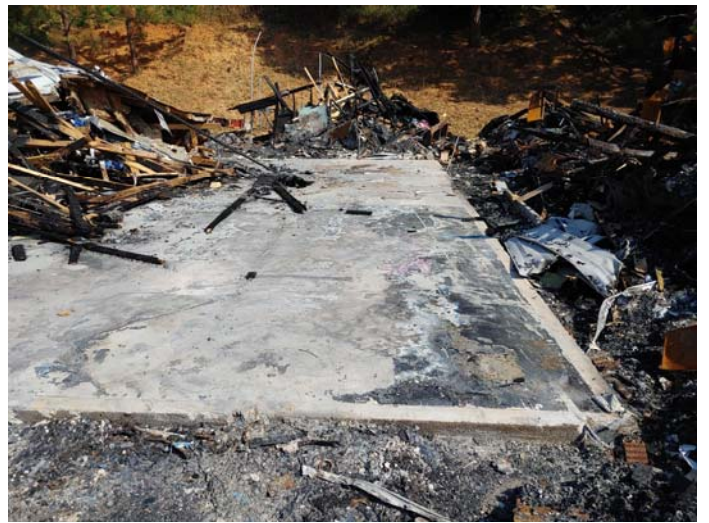
Photo 4 – Typical view of the burned remains of the house collapsed into a debris pile

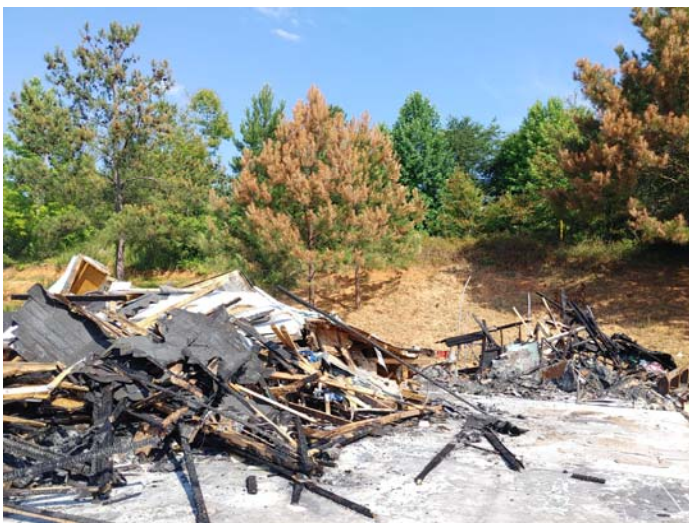
Photo 5 – Typical view of the burned remains of the house collapsed into a debris pile
