**STRUCTURE CS-3**  
**INSPECTION DATE: 2/21/2020**

Double Barrel, 48" Diameter x 102' Long

Location:	FWMA
	Levee FWMA
Latitude:	27.8229 N
Longitude:	80.6735 W
Type:	Gated Culvert
No. Barrels:	Two
Inspection	
Start Date:	2/21/2020
End Date:	2/21/2020

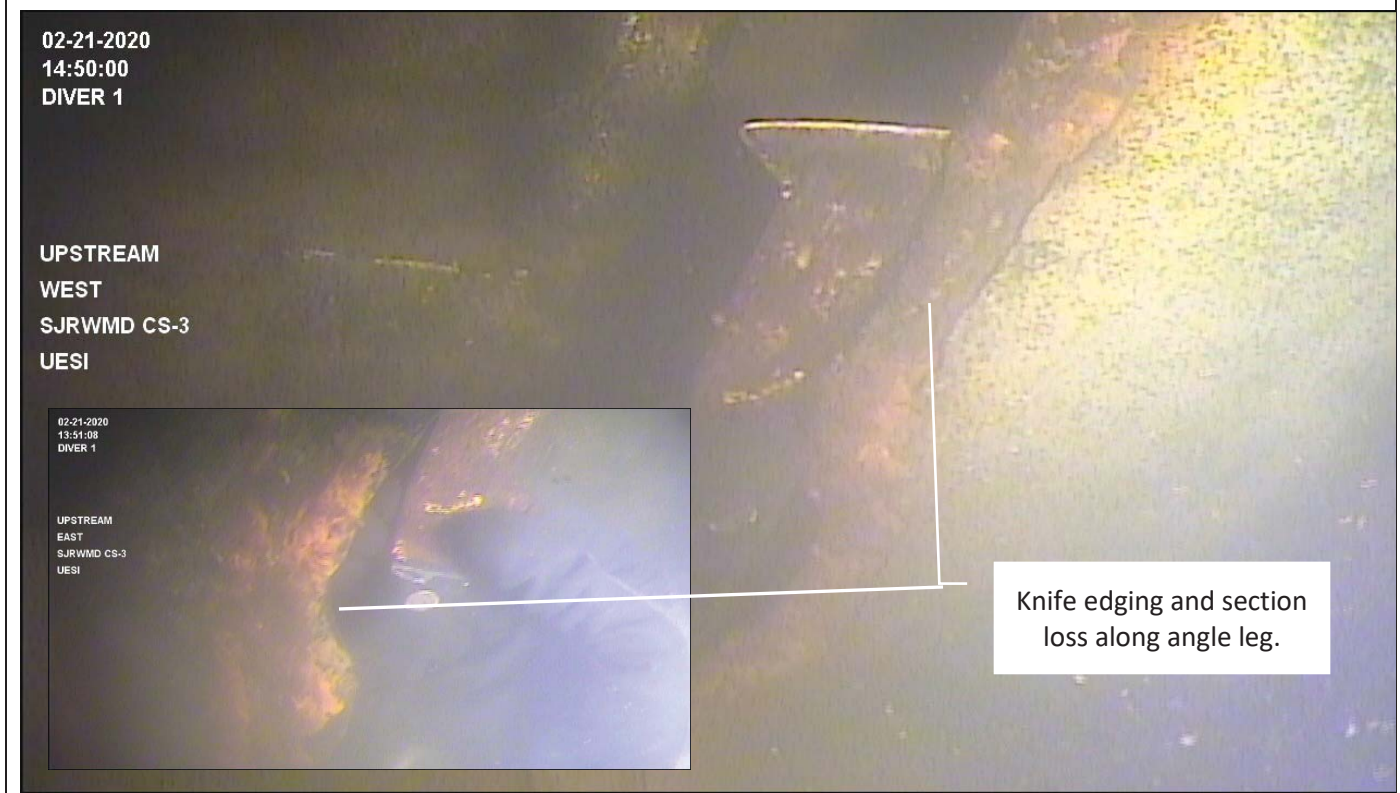
- Item US152: Both sides of both gates have moderate to major corrosion with minor to moderate section loss in the vertical angles located just above the top gate block. The section loss is knife edging with losses of 1/2" to 1.5" on the leg over a 3" to 12" length of angle, with associated thickness loss. The vertical angle frame outside of this area has minor coating blisters and corrosion.
  - Recommended Action: The gate frame areas with heavy corrosion and section loss should be cleaned and recoated and may need additional strength.
- Item DS56: Sediment in west barrel is hard mud approximately 4"-6" deep throughout. Some areas of mud have embedded plastic liner pieces of debris.

Item No.: US152 Gate Guides	Rating: C-3	Photo Description: Corrosion on angle leg edges
--------------------------------	-------------	--

Deficiency: Both sides of both gates have moderate to major corrosion with minor to moderate section loss in the vertical angles located just above the top gate block. The section loss is knife edging with losses of 1/2" to 1.5" on the leg over a 3" to 12" length of angle, with associated thickness loss. The vertical angle frame outside of this area has minor coating blisters and corrosion.

Probable Cause: The corrosion was due to chemical attack from the water and isolated areas of galvanic corrosion due to contact of dissimilar metals.

Recommendation: The gate frame areas with heavy corrosion and section loss should be cleaned and recoated and may need additional strength.
