**STRUCTURE CS-4**  
**INSPECTION DATE: 3/24/2020**

Double Barrel, 48" Diameter x 102' Long

Location:	FWMA
	Levee FWMA
Latitude:	27.8229 N
Longitude:	80.6909 W
Type:	Gated Culvert
No. Barrels:	Two
Inspection	
Start Date:	3/24/2020
End Date:	3/24/2020

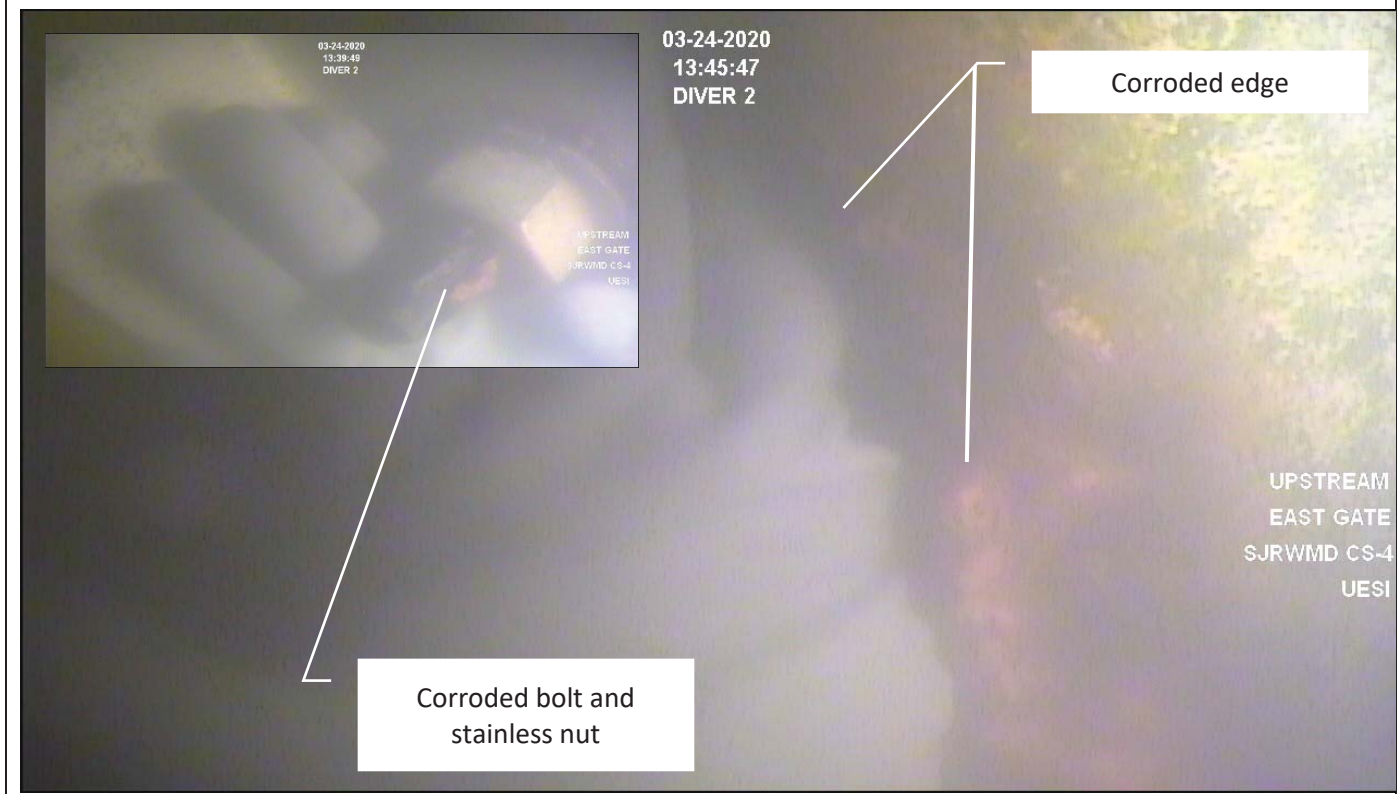
Item No.: US152 Gate Guides	Rating: C-3	Photo Description: Corrosion on angle leg edges
--------------------------------	-------------	--

Deficiency: (1) Both sides of both gates have moderate to major corrosion with minor to moderate section loss in the vertical angles located just above the top gate block. The section loss is knife edging with losses of 1/2" to 3/4" on the leg over a 2" to 6" length of angle, with associated thickness loss. The vertical angle frame outside of this area has minor coating blisters and corrosion. (2) The west side frame of the west gate has an isolated area of heavy corrosion and knife edging located at the 2nd anchor from the top. The loss of section is 1.5" on the leg over a 12" high length. (3) The bolts for the gate frames all have moderate corrosion on the bolt with up to 20% section loss, but the nuts are stainless steel and have no section loss. The top bolt on the west side of the east gate has 10% section loss with the nut also being carbon steel.

Probable Cause: The corrosion was due to chemical attack from the water and isolated areas of galvanic corrosion due to contact of dissimilar metals.

- Recommended Action: The gate frame areas with heavy corrosion and section loss should be cleaned and recoated and may need additional strength. The frame bolts should be replaced with either galvanized steel or with stainless steel with isolation materials.
- Item DS56: The east barrel has a build-up of mud up to 2' deep near 69' in from the downstream end.
  - Recommended Action: Remove the thick build-up of mud at 69' penetration.

Recommendation: The gate frame areas with heavy corrosion and section loss should be cleaned and recoated and may need additional strength. The frame bolts should be replaced with either galvanized steel or with stainless steel with isolation materials.
