STRUCTURE PS-2RO
INSPECTION DATE: 2/20/2020

Three Discharge Pipes, 78" x 83' Long CAP

Location:	FWMA
	Levee FWMA
Latitude:	27.7574 N
Longitude:	80.6929 W
Type:	Discharge Pipes w/Flap
No. Barrels:	Three
Inspection	
Start Date:	2/20/2020
End Date:	2/20/2020

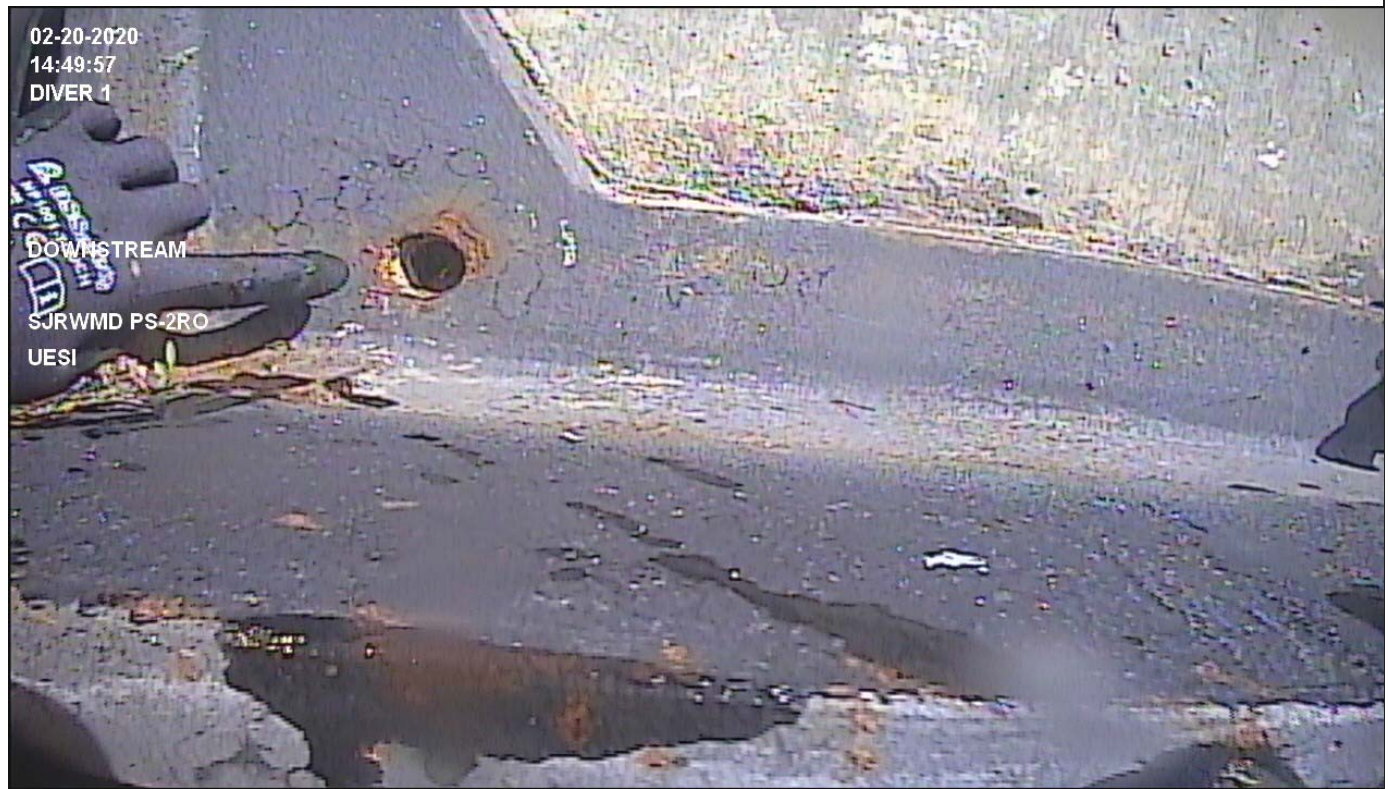
Item No.: PS206 Backflow Gates	Rating: C-3	Photo Description: Missing one anchor for Flap Gate 1
-----------------------------------	-------------	--

Deficiency: Flap Gate #1 is missing one anchor under the north hinge.

Probable Cause: The anchor most likely was not installed during construction - possibly due to rebar interference.

Recommendation: Install a new chemical anchor for Flap Gate 1. If there is interference with steel rebar, then do not install and monitor the other bolts for loosening.
