**STRUCTURE S-250B**  
**INSPECTION DATE: 2/11/2020**

Single Barrel, 72" Diameter x 111' Long

Location:	Jane Green South
	Levee L-74W
Latitude:	27.8229 N
Longitude:	80.7659 W
Type:	Gated Culvert
No. Barrels:	One
Inspection	
Start Date:	2/11/2020
End Date:	2/11/2020

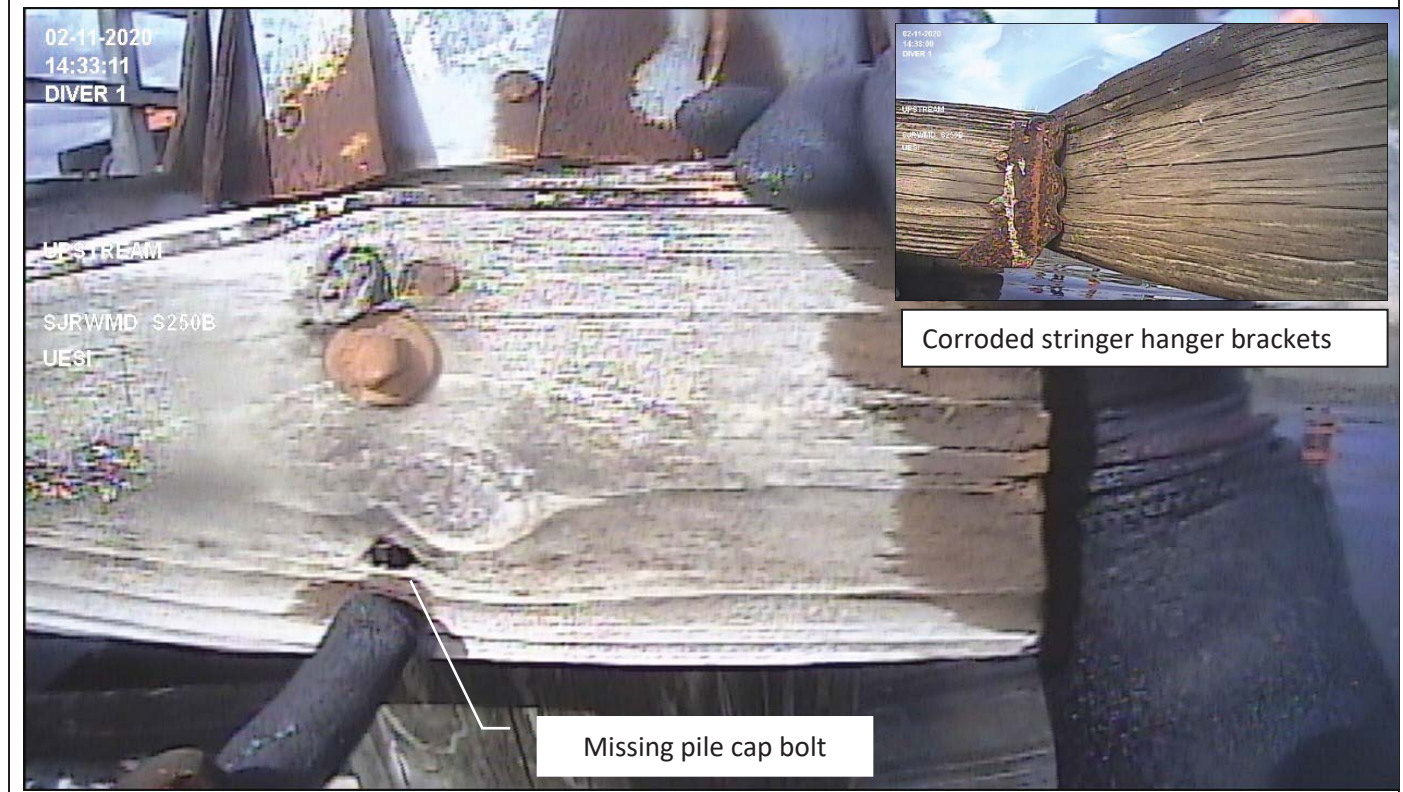
- Item US114: The access pier hardware for the cross bracing has moderate corrosion with moderate section loss of up to 20%. The Bent 2 (from shore) pile cap has only one of two bolts on the east side. The steel hanger brackets for the timber beams have moderate corrosion with up to 15% section loss. The south cap board on the northern bent, west pile has decay 4" high x 6" wide (up to hardware) x 1" deep.
  - Recommended Action: Replace the access pier cross bracing hardware, pile cap hardware, stringer hangers, and south cap beam, north bent, west pile. Monitor the timber condition for advanced decay. Consider replacing the pier elements. The piles can remain.
- Item DS115: The culvert has piles of twigs and logs from 25' to 38' of penetration from the downstream end. There is another collection of timber debris between 85' and 95' of penetration.

Item No.: US114 Structural Support and Bracing	Rating: C-3	Photo Description: Access pier with corroded hardware
Deficiency: The Bent 2 (from shore) pile cap has only one of two bolts on the east side. The access pier hardware for the cross bracing has moderate corrosion with moderate section loss of up to 20%. The steel hanger brackets for the timber beams have moderate corrosion with up to 15% section loss.		
Probable Cause: The corrosion was due to failed galvanizing, by age breakdown and chemical attack from the water. The missing pile cap bolt either failed from corrosion or was not installed.		
Recommendation: Replace the access pier cross bracing hardware, pile cap hardware, stringer hangers, and south cap beam, north bent, west pile. Consider replacing the pier.

(1) C-3: The access pier hardware for the cross bracing has moderate corrosion with moderate section loss of up to 20%. (2) C-3: The Bent 2 (from shore) pile cap has only one of two bolts on the east side. (3) C-3: The steel hanger brackets for the beams have moderate corrosion with up to 15% section loss. (4) C-3: The south cap board on the northern bent, west pile has decay 4" high x 6" wide (up to hardware) x 1" deep. (5) C-2: The stringers and decking have minor to moderate decay [14:29 to 14:52] .		
US114	Structural Support, Bracing or Frames	3		Replace the access pier cross bracing hardware, pile cap hardware, stringer hangers, and south cap beam, north bent, west pile. Monitor the timber condition for advanced decay. Consider replacing the pier elements. The piles can remain.	The corrosion was due to failed galvanizing, by age breakdown and chemical attack from the water. The timber decay is natural from the age of the structure and the wet environment.

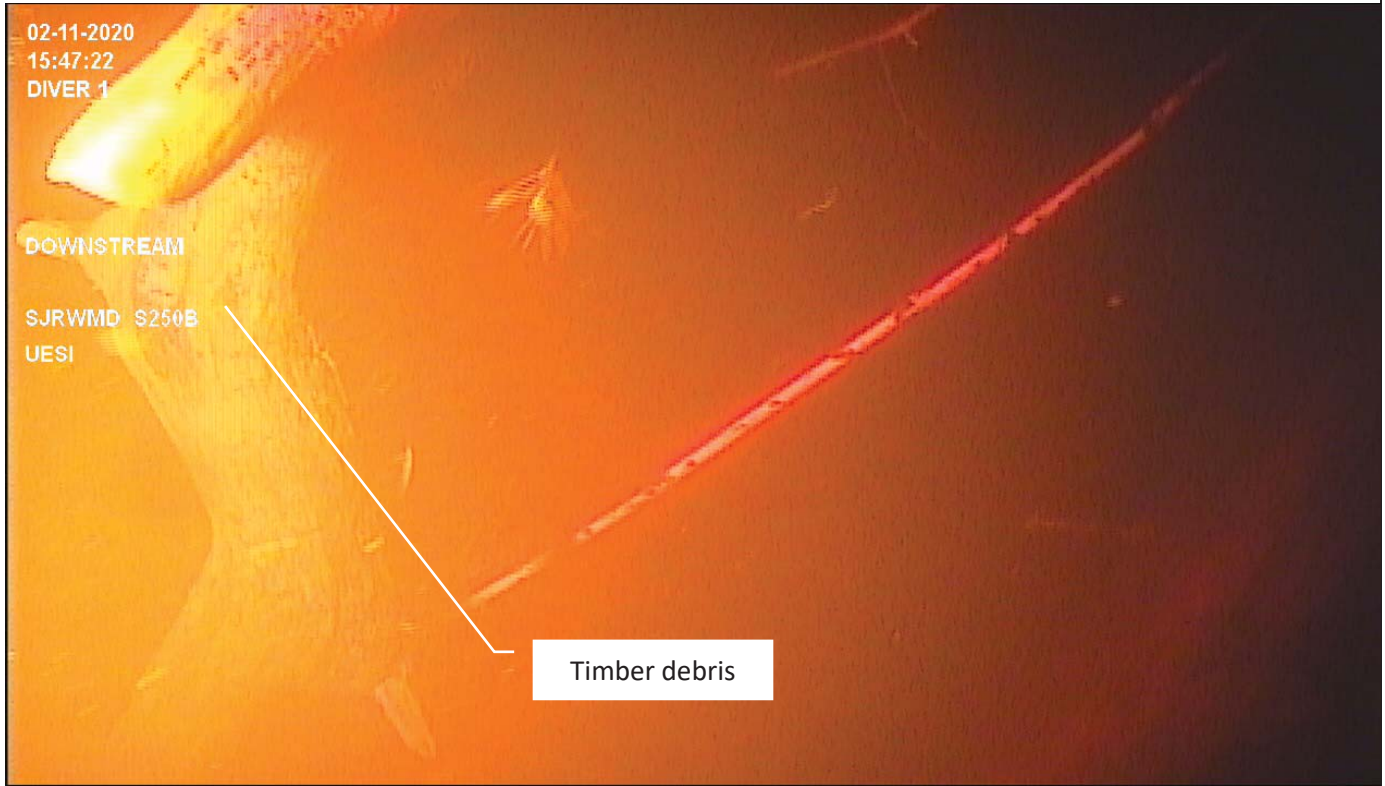
Item No.: DS115 Culvert	Rating: C-3	Photo Description: Pile of vegetation in culvert
Deficiency: The culvert has piles of twigs and logs from 25' to 38' of penetration from the downstream end. There is another collection of timber debris between 85' and 95' of penetration.		
Probable Cause: The vegetation is natural with a low flow condition.		
Recommendation: Remove the vegetation from inside of the culvert - it has the potential to clog and impact the flow capacity of the culvert.

DS115	Culverts	3	(1) C-3: The culvert has piles of twigs and logs from 25' to 38' of penetration from the downstream end [15:46]. There is another collection of timber debris between 85' and 95' of penetration [15:57]. (2) C-2: There are four drilled holes, approximately 3/4" diameter (1.5" maximum) from 5' to 6' of penetration, located at the 1:00, 2:30, 3:00 and 10:00 positions. Neither water nor soil is coming through. They appear to be drilled holes [15:40].	Remove the vegetation from the culvert - it has the potential to clog and impact the flow capacity of the culvert. Monitor the drilled holes and patch if flow or soil infiltrates.	The vegetation is natural with a low flow condition. The drilled holes were most likely planned for some type of splice.
-------	----------	---	---	---	--

- Recommended Action: Remove the vegetation from inside of the culvert - it has the potential to clog and impact the flow capacity of the culvert.
- Item DS1000: The downstream staff gauge has minor to moderate corrosion on the metal gauge board above and below water
  - Replace the downstream metal staff gauge board.

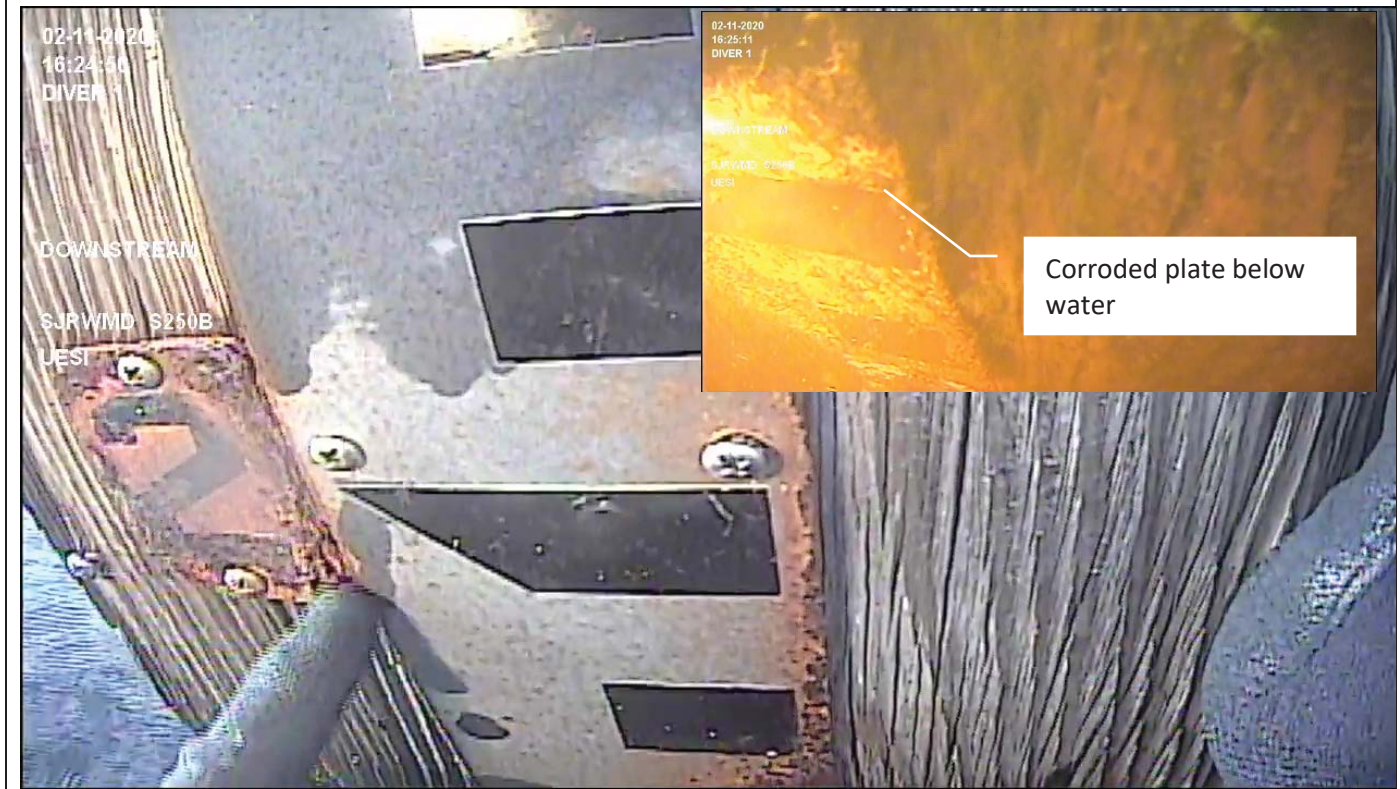
Item No.: DS1000 Additional Items	Rating: C-3	Photo Description: D/S staff gauge has corrosion
Deficiency: The downstream staff gauge has minor to moderate corrosion on the metal gauge board above and below water.		
Probable Cause: The corrosion is due to chemical attack from the water.		
Recommendation: Replace the downstream staff gauge board.
