**STRUCTURE S-250C**  
**INSPECTION DATE: 3/30/2020**

Single Barrel, 72" Diameter x 111' Long

Location:	Jane Green South
	Levee L-74W
Latitude:	27.8233 N
Longitude:	80.7548 W
Type:	Gated Culvert
No. Barrels:	One
Inspection	
Start Date:	3/30/2020
End Date:	3/30/2020

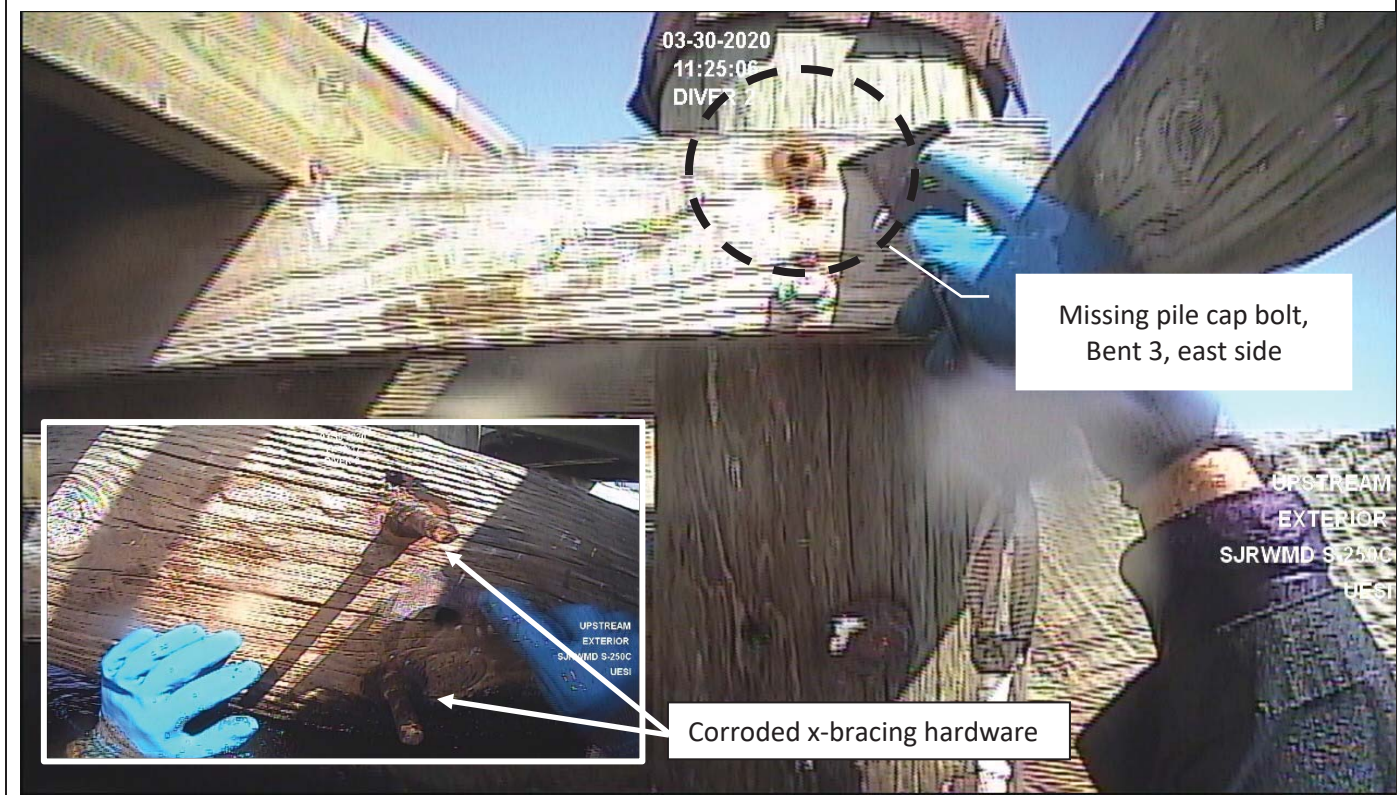
- Item US114: All the cross bracing hardware for the access pier has moderate to heavy corrosion with the washers having greater than 50% loss of section and the nuts having 30 to 50% loss of section. The cap beam at the 3rd bent from shore, east side, is missing one of two bolts. The timber members have minor to moderate checking.
  - Recommended Action: Replace the access pier cross bracing hardware and the missing bolt on the 3<sup>rd</sup> bent cap, east side. Monitor the timber for advanced decay or damage.
- Item DS115: A pile of twigs and branches, with some up to 4" diameter x 6' long, is present at 92' of penetration from the downstream end and extending to the gate [10:30]. The debris is on the bottom and floating on the top. There is a vertical angle and a diagonal brace bolted to the 3:00 side of the culvert

Item No.: US114 Structural Support	Rating: C-3	Photo Description: Access pier with corroded hardware
Deficiency: All the cross bracing hardware for the access pier has moderate to heavy corrosion with the washers having greater than 50% loss of section and the nuts having 30 to 50% loss of section.		
Probable Cause: The corrosion on the hardware is due to chemical attack from the water. The missing bolt may not have been installed.		
Recommendation: Replace all the hardware for the access pier with stainless steel hardware. Install a new cap beam bolt where missing.

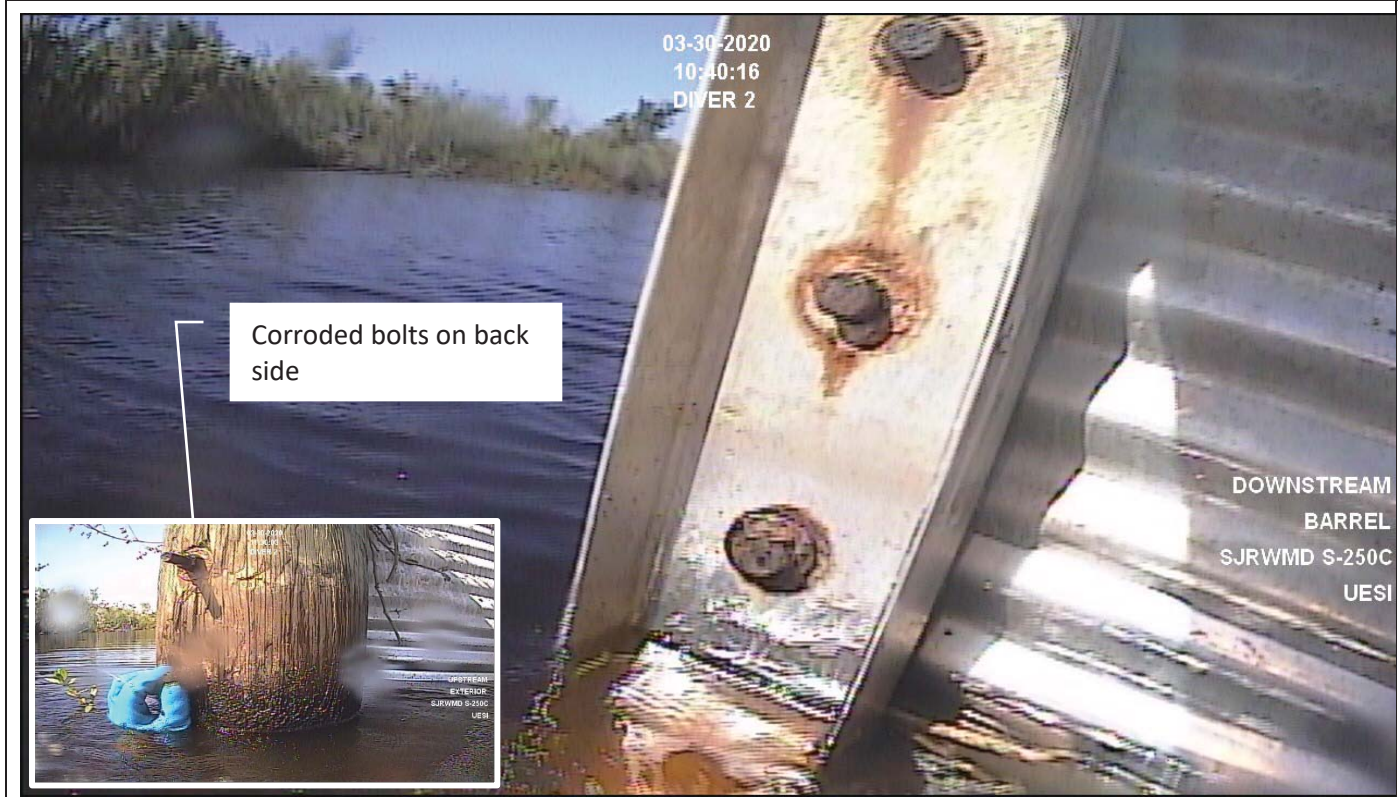
Item No.: DS152 Gate Guides	Rating: C-3	Photo Description: Corroded hardware
Deficiency: The hardware between the gate frame and the riser (and through the pier piles) is carbon steel. The washers have corroded 100% and are missing. The bolt heads have moderate corrosion. The connected parts are aluminum		
Probable Cause: The corrosion was due to chemical attack from the water and galvanic corrosion due to contact of dissimilar metals.		
Recommendation: Replace the hardware connecting the gate frame to the riser with stainless steel hardware.

Finding #	Inspection Item	Rating	Comments	Recommended action	Probable cause
DS151	Structure Gate(s)	1	No deficiencies noted		
DS152	Gate Guides and Gate Control	3	The hardware between the gate frame and the riser (and through the pier piles) is carbon steel. The washers have corroded 100% and are missing. The bolt heads have moderate corrosion. The connected parts are aluminum [10:40].	Replace the hardware connecting the gate frame to the riser with stainless steel hardware.	The corrosion was due to chemical attack from the water and galvanic corrosion due to contact of dissimilar metals.
DS153	Gate Seals & Mating Surface	1	No deficiencies noted		
DS154	Cathodic Protection (entire structure)	NA	Item not present		
DS155	Operator/Actuator Components	NA	Item not present		
DS156	Emergency Closure Gates	NA	Item not present		
DS157	Navigation Lock Miter Gates	NA	Item not present		
DS1000	Additional Items and Comments	3	(1) C-3: The downstream staff gauge has missing numbers at the 23 foot mark and below water. (2) C-2: The timber board has minor to moderate checking. [10:54 - 10:59].	Replace the numbers on the gauge board or replace the gauge board. Monitor the timber for advanced checking or damage.	The corrosion was due to chemical attack from the water and possible galvanic corrosion due to contact of dissimilar metals. The timber checking is natural for a structure of this age and in its environment.

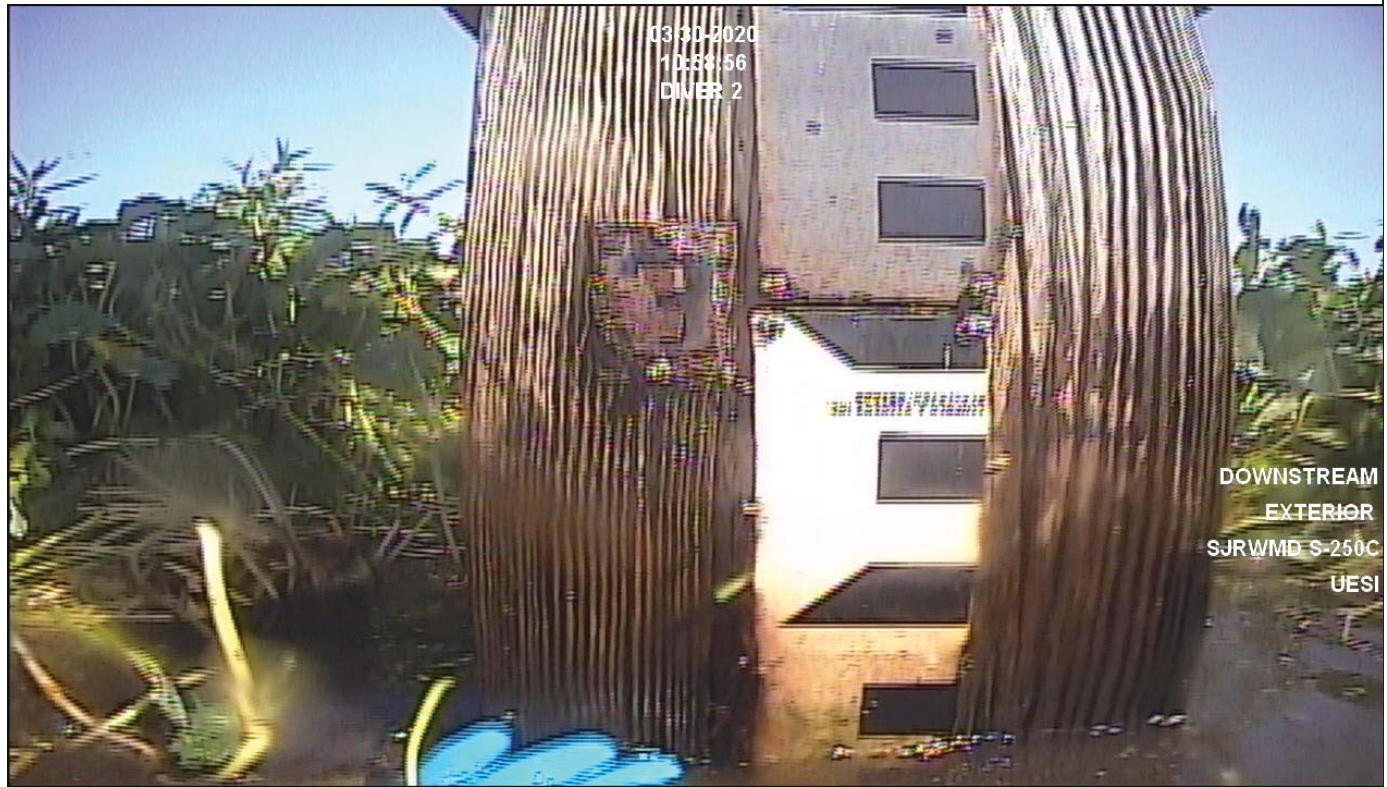
Item No.: DS1000  Additional Items	Rating: C-3	Photo Description: D/S staff gauge has corrosion
Deficiency: The downstream staff gauge has missing numbers at the 23 foot mark and below water.		
Probable Cause: The corrosion was due to chemical attack from the water and possible galvanic corrosion due to contact of dissimilar metals.		
Recommendation: Replace the numbers on the gauge board or replace the gauge board.
