STRUCTURE S-258
INSPECTION DATE: 4/1/2020

Location:	USJRB North
	Levee L-74E
Latitude:	27.8253 N
Longitude:	80.7115 W
Type:	Gated Culvert
No. Barrels:	Four
Inspection	
Start Date:	4/1/2020
End Date:	4/1/2020

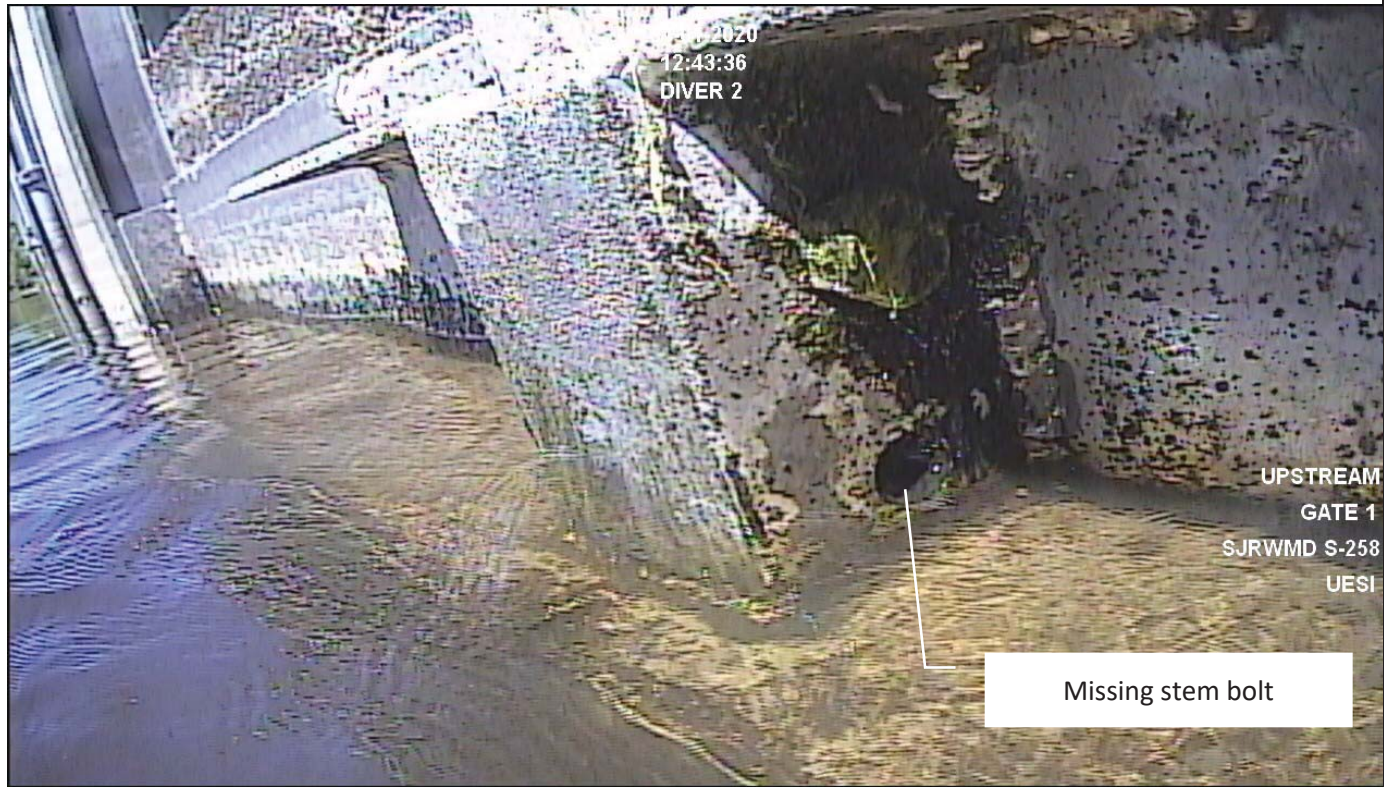
Item No.: US155 Operator/Actuator Components	Rating: C-3	Photo Description: Gate 1 stem block missing one bolt.
Deficiency: The Gate 1 stem connection block is missing one of two bolts.		
Probable Cause: The missing bolt was left out during construction.		
Recommendation: Install a new bolt for the Gate 1 stem at the block connection to the gate.

(1) C-3: The Gate #1 stem connection block is missing one of two bolts [12:44]. (2) C-2: Gate #1, #2 and #4 stem stop block bolts have minor corrosion on the bolts [12:44, 12:52, 13:05].		The missing bolt was left out during construction. The corrosion was due to chemical attack from the water and possible galvanic corrosion from contact of dissimilar metals.
US155	Operator/Actuator Components	3		Install a new bolt for the Gate #1 stem at the block connection to the gate. Monitor the bolts for the stem stop blocks for advanced corrosion.	
US156	Emergency Closure Gates	NA	Item not present		
US306	Navigation Lock Miter Gates	NA	Item not present
