STRUCTURE S-6B
INSPECTION DATE: 2/19/2020

Three Barrels, 60" x 64' Long

Location:	USJRB South
	Levee L-75
Latitude:	27.6996 N
Longitude:	80.6753 W
Type:	Gated Culvert
No. Barrels:	Three
Inspection	
Start Date:	2/19/2020
End Date:	2/19/2020

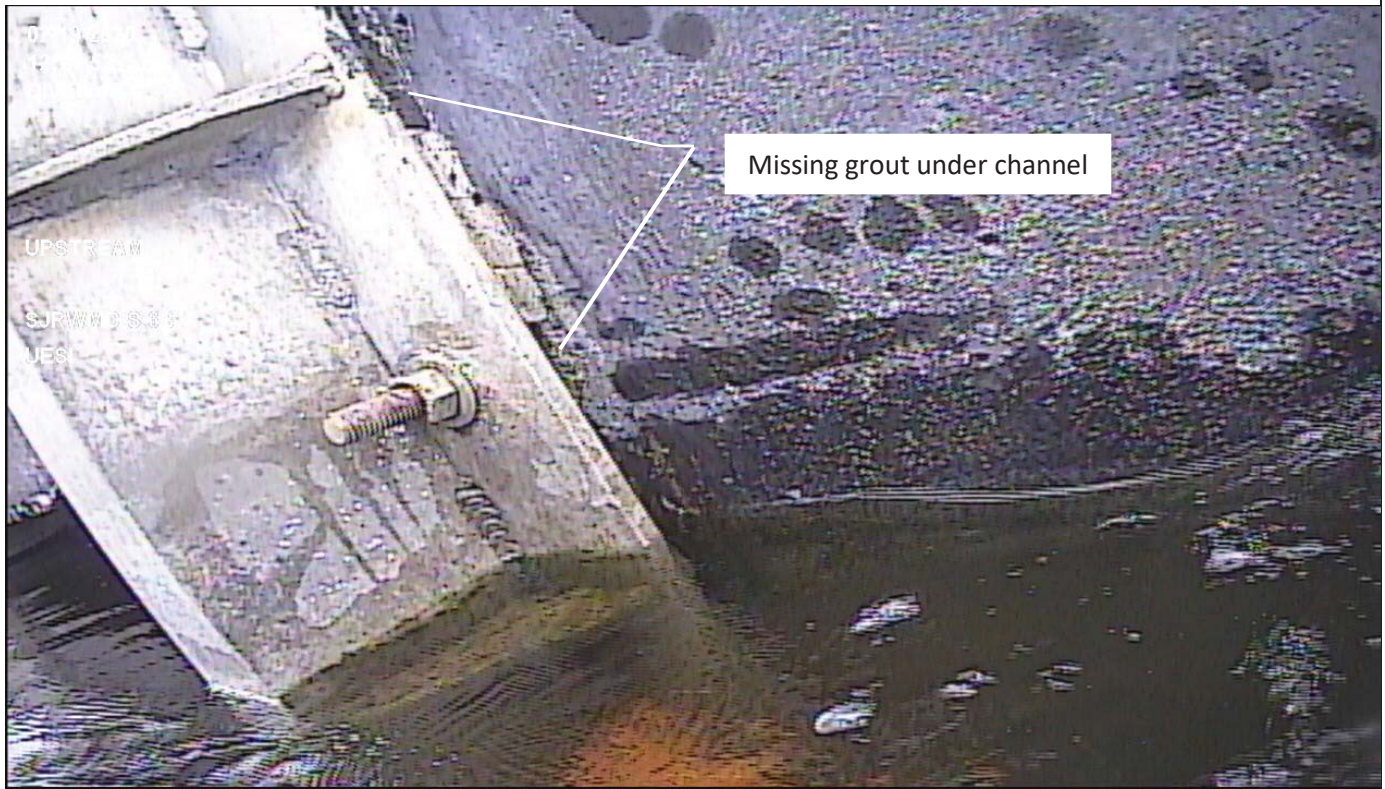
Item No.: US54 Channel Stoplogs	Rating: C-3	Photo Description: Missing grout under channel.
Deficiency: Gate #3 stoplog channel on east side has missing grout up to 3.5" deep maximum over a 9" vertical height at the waterline.		
Probable Cause: The missing grout is most likely due to poor construction.		
Recommendation: Install new grout where missing on Gate #3 east side stoplog channel.

- Item US54: Gate #3 stoplog channel on east side has missing grout up to 3.5" deep maximum over a 9" vertical height at the waterline.
 - Recommended Action: Install new grout where missing on Gate #3 east side stoplog channel.
- Item US105: Box #1 has a 1" wide construction joint from the west frame to the southwest corner with soft sealant material. The flexible sealant could be pushed into the joint.
 - Recommended Action: Remove and install new construction joint flex sealant in Box #1 from the southwest corner to the gate.

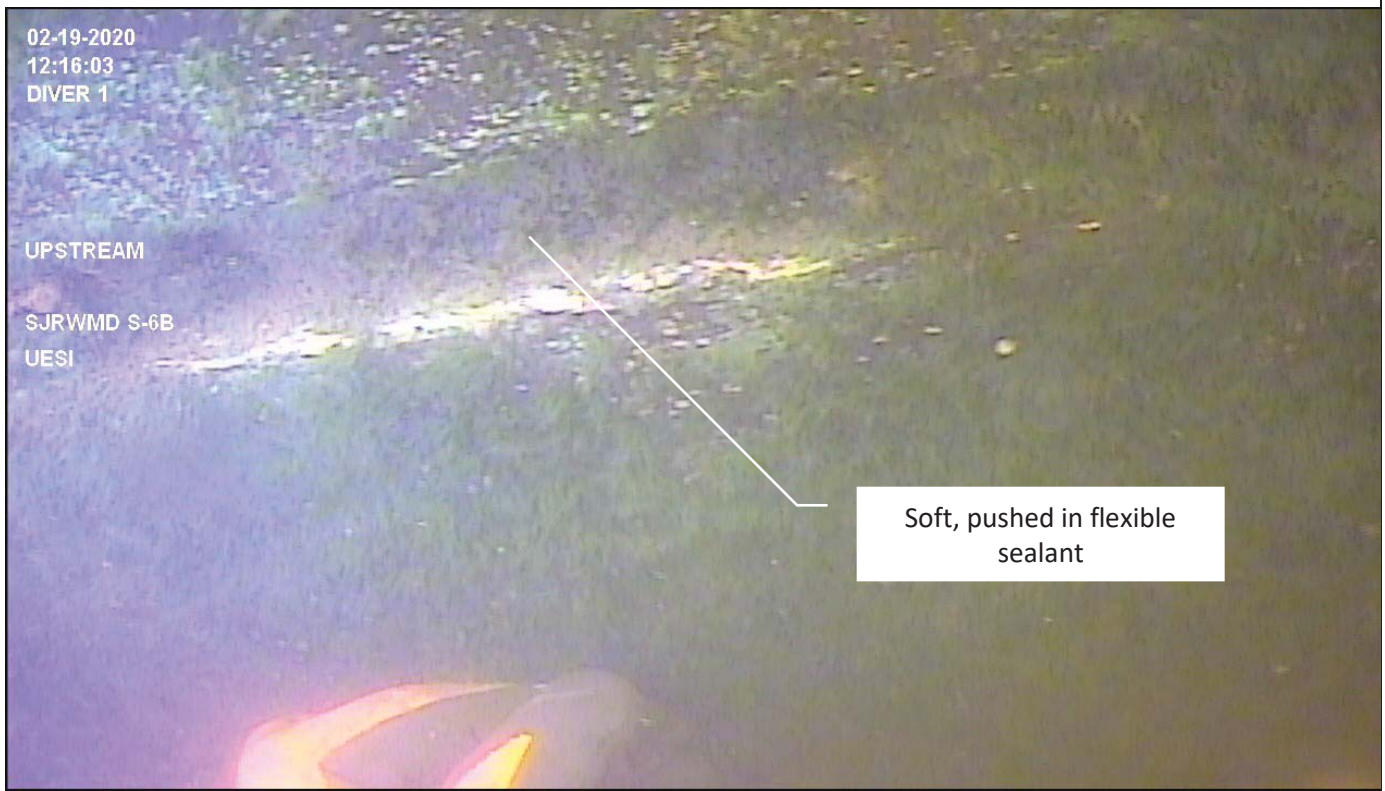
Item No.: US105 Expansion/Construction Joints	Rating: C-3	Photo Description: Soft, movable joint sealant.
Deficiency: Box #1 has a 1" wide construction joint from the west frame to the southwest corner with soft sealant material. The flexible sealant could be pushed into the joint.		
Probable Cause: Joint flex sealant most likely damaged during install or degrading due to chemicals in the water and age.		
Recommendation: Remove and install new construction joint flex sealant in Box #1 from the southwest corner to the gate.

Finding #	Inspection Item	Rating	Comments	Recommended action	Probable cause
US100	Wingwalls	NA	Item not present		
US101	Buttresses (support arms for wall)	NA	Item not present		
US102	Abutments	NA	Item not present		
US103	Retention Walls	NA	Item not present		
US104	Headwall	2	Box # 1 has a diagonal hairline crack on the west face from the upper west opening extending 18" up and east [12:58].	Monitor hairline crack for worsening conditions.	Crack is most likely due to concrete shrinkage.
US105	Expansion/Construction Joints	3	Box #1 has a 1" wide construction joint from the west frame to the southwest corner with soft sealant material. The flexible sealant could be pushed into the joint [12:16].	Remove and install new construction joint flex sealant in Box #1 from the southwest corner to the gate (exterior side).	Joint flex sealant most likely damaged during install or degrading due to chemicals in the water and age.
