STRUCTURE S-77
INSPECTION DATE: 4/9/2020

One Barrel, 40" x 352' Long

Location:	USJRB South
	Levee L-77E
Latitude:	27.6474 N
Longitude:	80.6441 W
Type:	Pump Station
No. Barrels:	One
Inspection	
Start Date:	4/9/2020
End Date:	4/9/2020

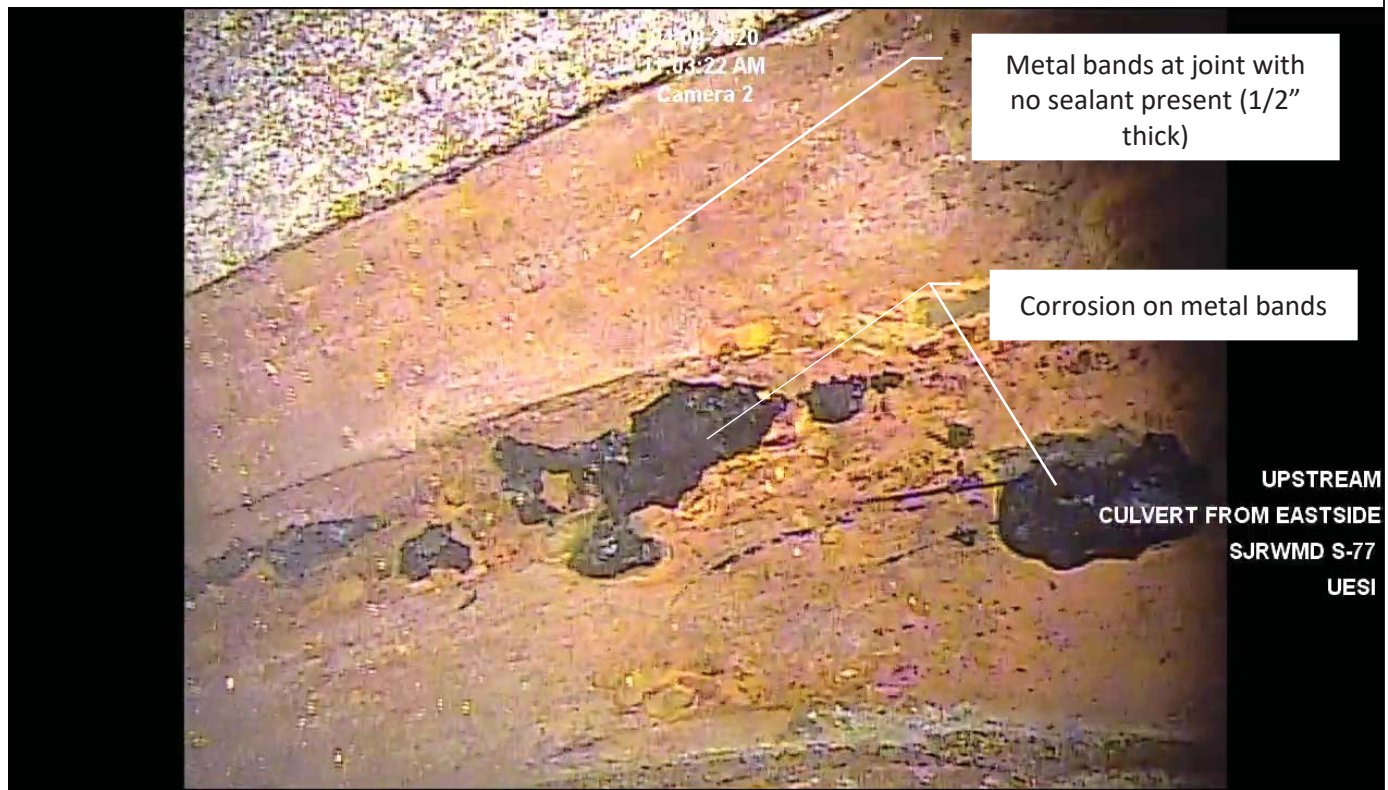
- Item PS200: The joints at 215' and 265' in from the east end are missing grout for the full circumference, but with no evidence of soil intrusion. The joints appear to be approximately 10" wide with metal bands with minor corrosion.
 - Recommended Action: Clean the corrosion and install joint sealant at the Joints at 215' and 265' that were missing grout.
- Item PS206: The flap gate seal has lost adhesion to the metal flap gate over 1/4 of the circumference.
 - Recommended Action: Install new adhesive material for the flap gate seal.

Item No.: PS200 Discharge pipe	Rating: C-3	Photo Description: Missing grout sealant.
Deficiency: The joints at 215' and 265' in from the east end are missing grout for the full circumference, but with no evidence of soil intrusion. The metal bands have minor corrosion.		
Probable Cause: The missing joint material may not have been installed.		
Recommendation: Install joint sealant at the Joints at 215' and 265' that were missing grout.

Finding #	Inspection Item	Rating	Comments	Recommended action	Probable cause
PS14	Engine Cooling System (Underwater)	NA	Item not present		
PS100	Screens and Trash Racks	NA	Item not present		
PS102	Intake Bell and Impellor #1	NA	Item not present		
PS103	Intake Bell and Impellor #2	NA	Item not present		
PS104	Intake Bell and Impellor #3	NA	Item not present		
PS105	Intake Bell and Impellor #4	NA	Item not present		
PS106	Intake Bell and Impellor #5	NA	Item not present		
PS107	Intake Bell and Impellor #6	NA	Item not present		
PS108	Bypass Gates (e.g. Slide Gates)	NA	Item not present		
PS200	Discharge Pipe #1	3	(1) C-3: The joints at 215' and 265' in from the east end are missing grout for the full circumference, but with no evidence of soil intrusion [10:57, 11:01]. The joints appear to be approximately 10" wide with metal bands with minor corrosion. (2) C-2: The discharge pipe has areas of overpour ranging in size from 1 sf to 6 sf and from 0.5" to 2" thick. The areas were located at 56' [10:36], 107' [10:44], 165' [10:54], 215' [10:57] in from east end. Discharge pipe also has a spalled section at 56' in from east end at the 12:00 position, area is 3" long x 3" wide x 1" deep [10:42].	Install joint sealant at the Joints at 215' and 265' that were missing grout. Monitor the minor spalls, overpour areas and cracks in the joint material for additional damage.	The missing joint material may not have been installed. The other items can most likely be traced back to construction work.

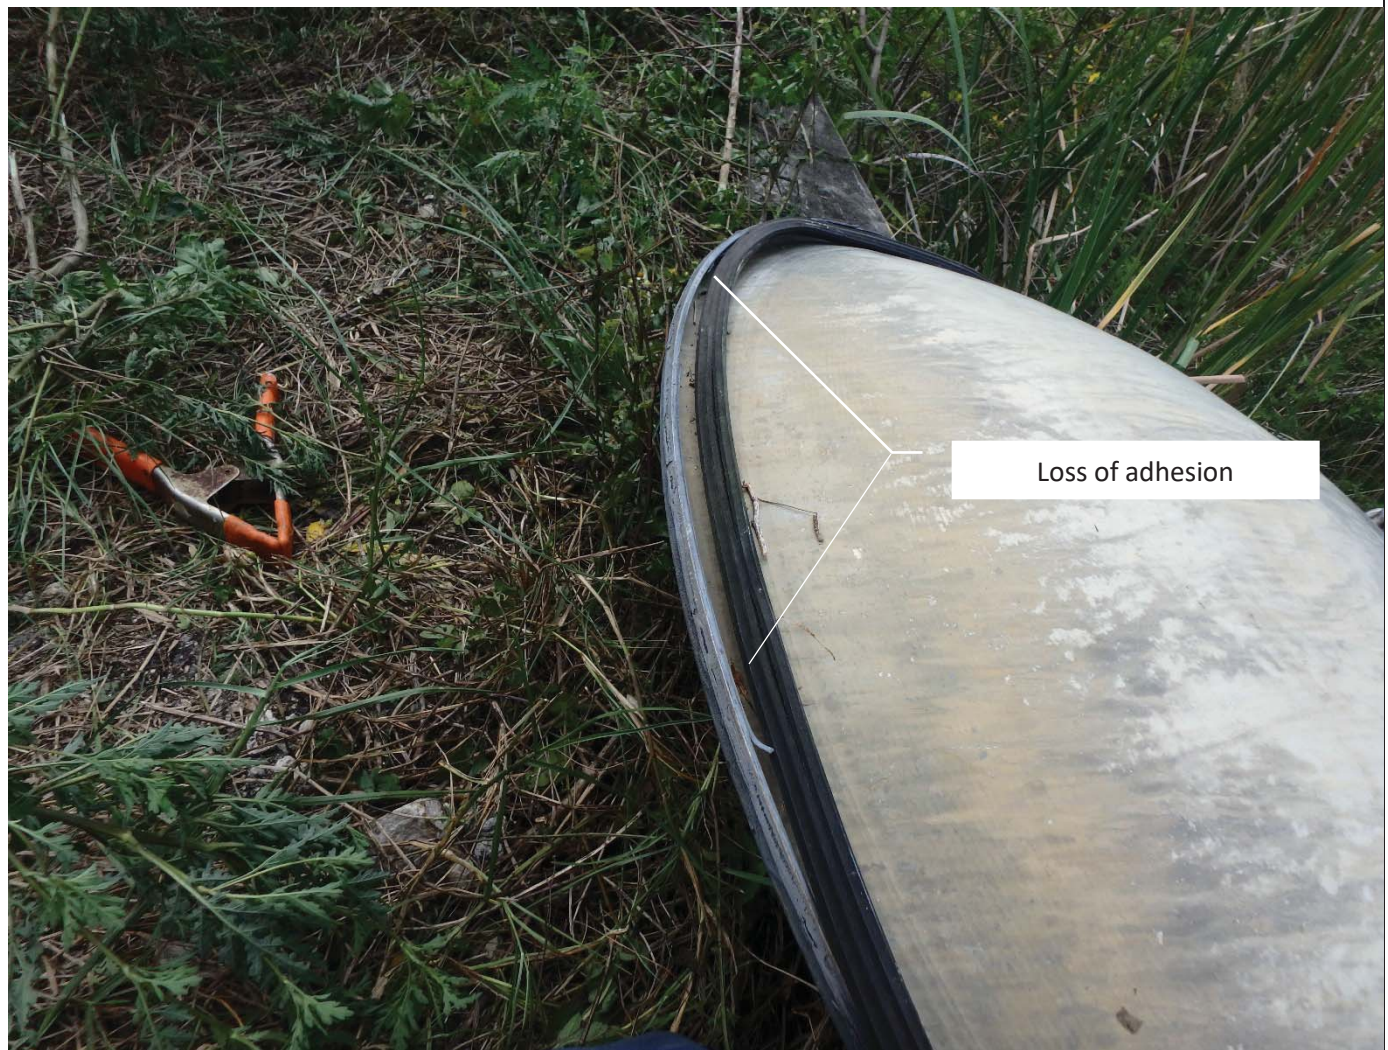
Item No.: PS206 Backflow Gate	Rating: C-3	Photo Description: Loss of seal adhesion
----------------------------------	-------------	---

Deficiency: The flap gate seal has lost adhesion to the metal flap gate over 1/4 of the circumference.

Probable Cause: The loss of adhesion may have been due to poor construction and degradation from the environment and use.

PS206	Backflow Gates	3	The flap gate seal has lost adhesion to the metal flap gate over 1/4 of the circumference.	Install new adhesive material for the flap gate seal.	The loss of adhesion may have been due to poor construction and degradation from the environment and use.
PS207	Bypass Culvert Interior	NA	Item not present

Recommendation: Install new adhesive material for the flap gate seal.
