**Engineering Evaluation of Concrete Condition
and Steel Sheet Pile Wing Wall Thickness
St. Johns River Water Control Structure S-96B
Indian River County, Florida**

Subject: Engineering Evaluation of Concrete Condition and
Steel Sheet Pile Wing Wall Thickness
St. Johns River Water Control Structure S-96B
Indian River County, Florida

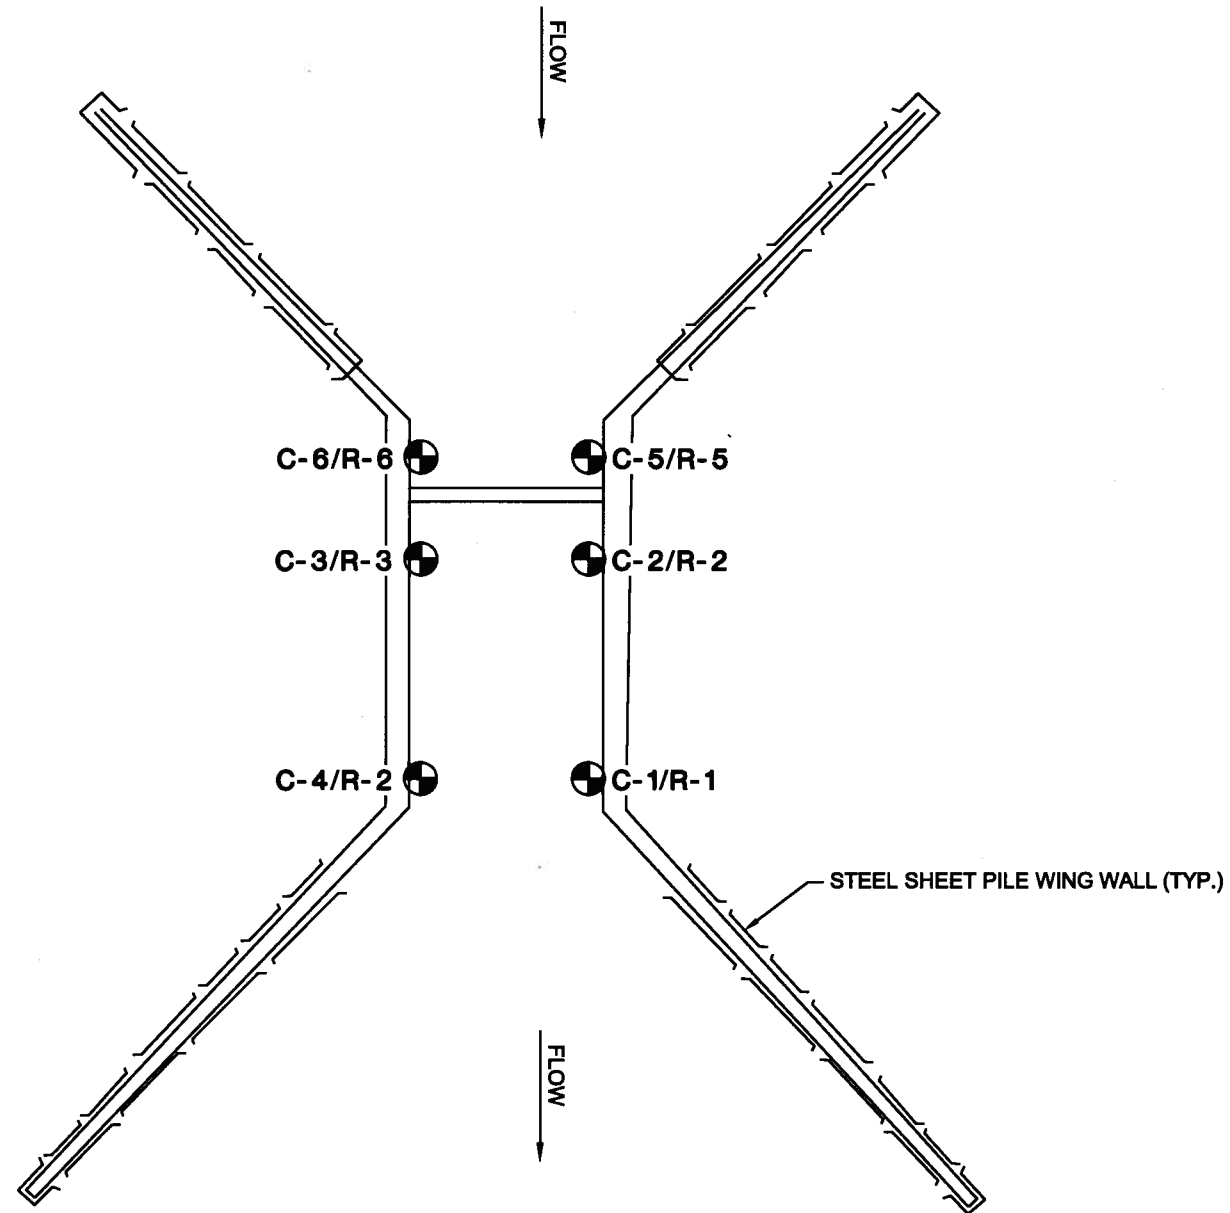
CORE LOCATION PLAN

The approximate plan view locations where the readings were obtained are shown on Figure 1.

A summary of the concrete core data including their length and general observations is presented as Table 2. The approximate core locations are schematically illustrated on a site plan shown on Figure 1. These locations were determined by estimating distances from

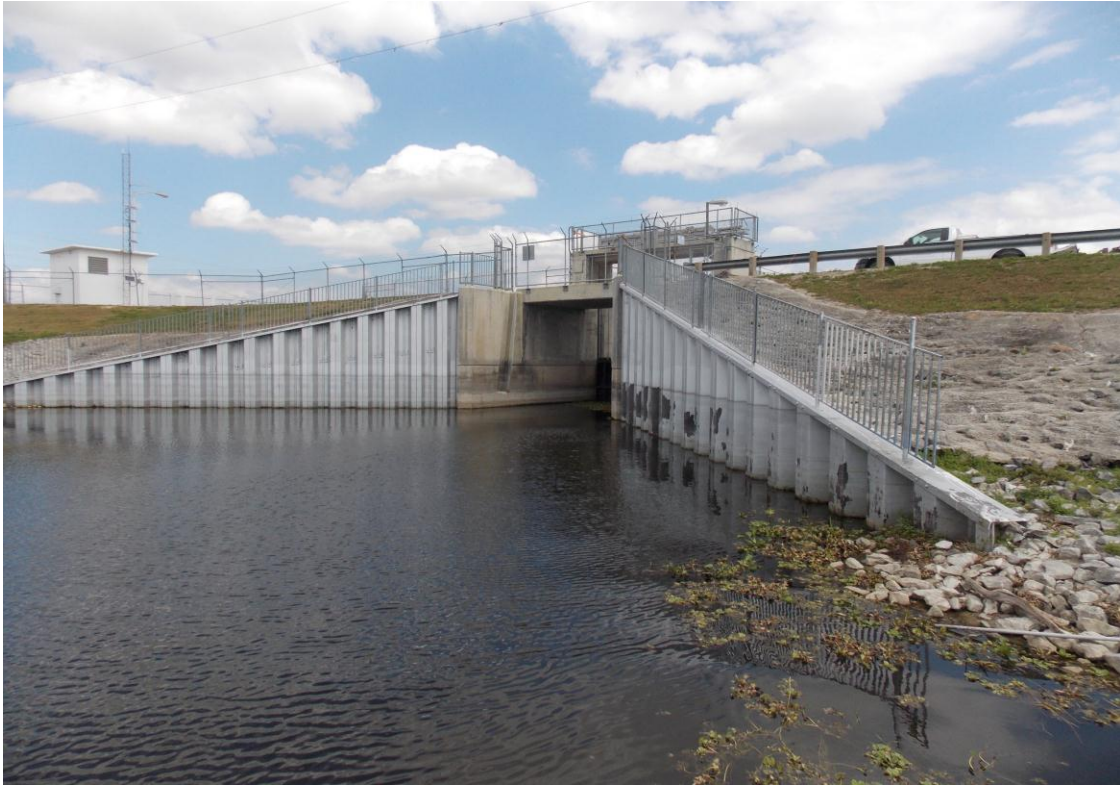
Downstream - View of Structure and Wing Walls.

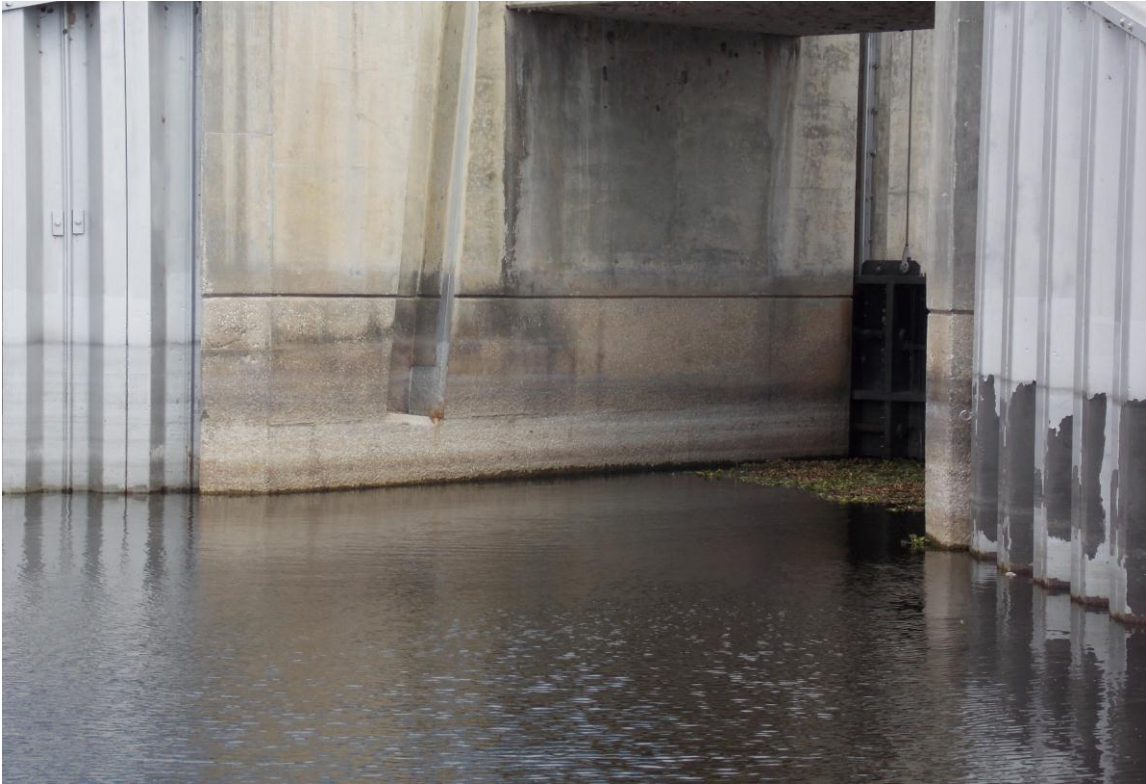
For the downstream side of the structure, our observations indicated that the concrete appeared to be in “good” condition; however, there appeared to be somewhat more advanced concrete erosion than the upstream portion of the structure. Pitting within the water floatation zone and below the water surface was observed to be $\frac{1}{4}$ to $\frac{1}{2}$ inch. We were unable to observe the concrete structure below a depth of approximately 6 inches due to water clarity. No spalling, significant cracking, rust staining or other indicators of potential structural defects or corrosion were observed.

Downstream - North Structure Wall.

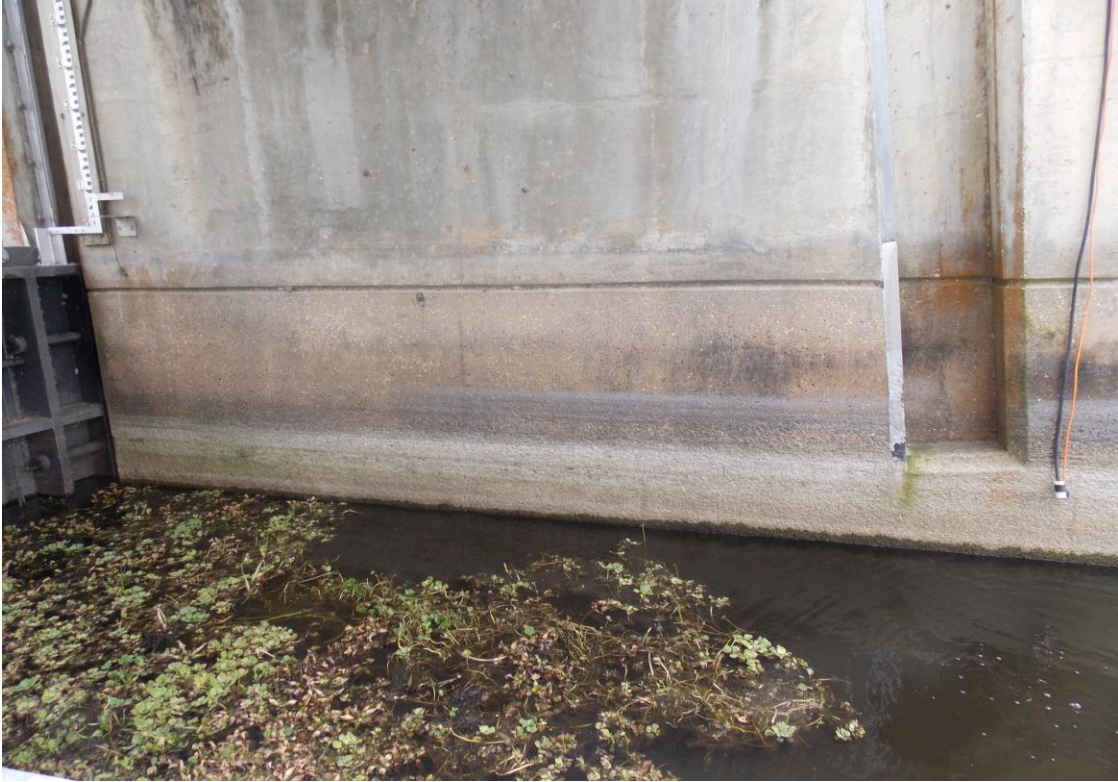
Downstream - South Structure Wall.

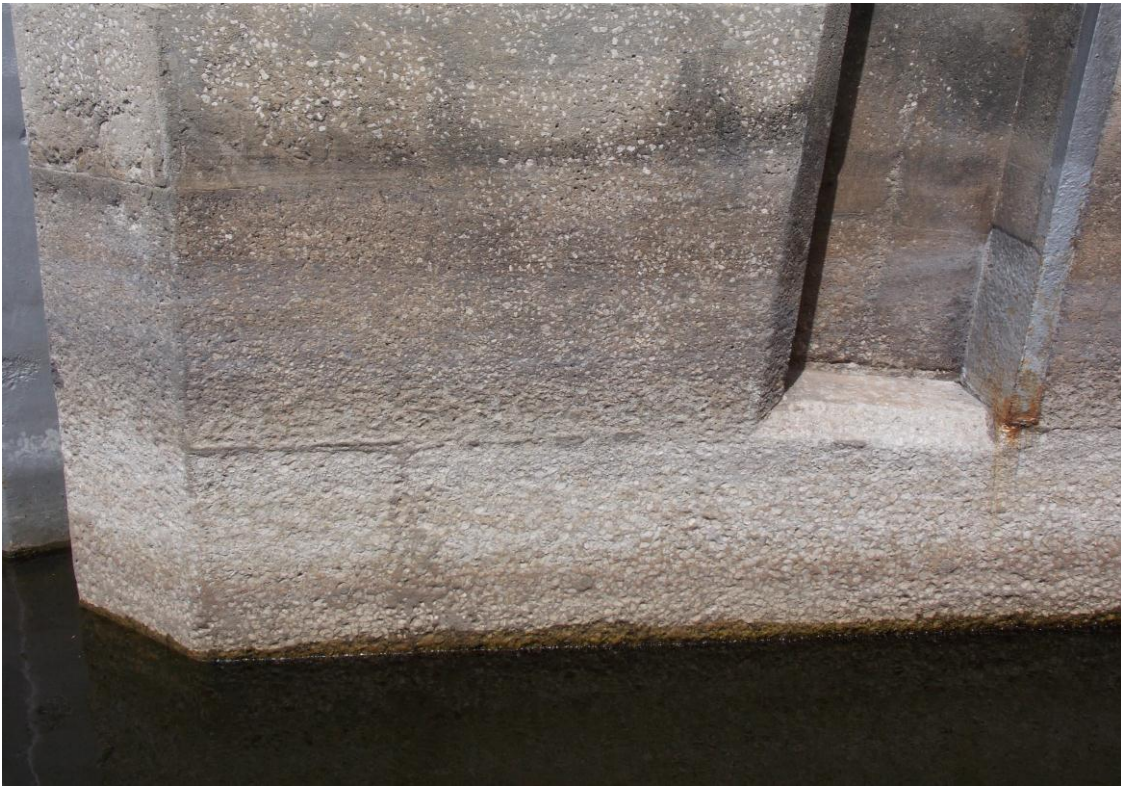
Downstream -South Structure Wall.

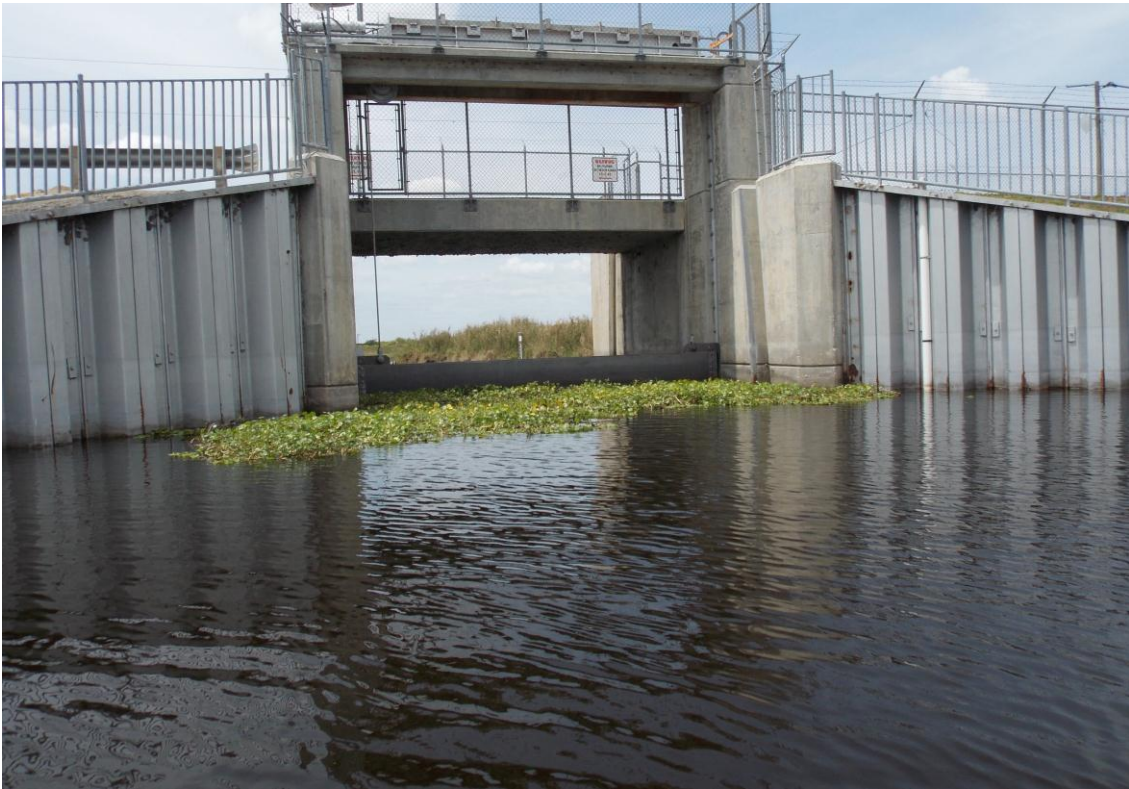
For the upstream side of the structure, our observations indicated that the concrete appeared to be in “very good” condition. Pitting within the water floatation zone and below the water surface was minimal. We were unable to observe the concrete structure below a depth of approximately 6 inches due to water clarity. No spalling, significant cracking, rust staining or other indicators of potential structural defects or corrosion were observed.

Upstream - Structure and Wing Walls.

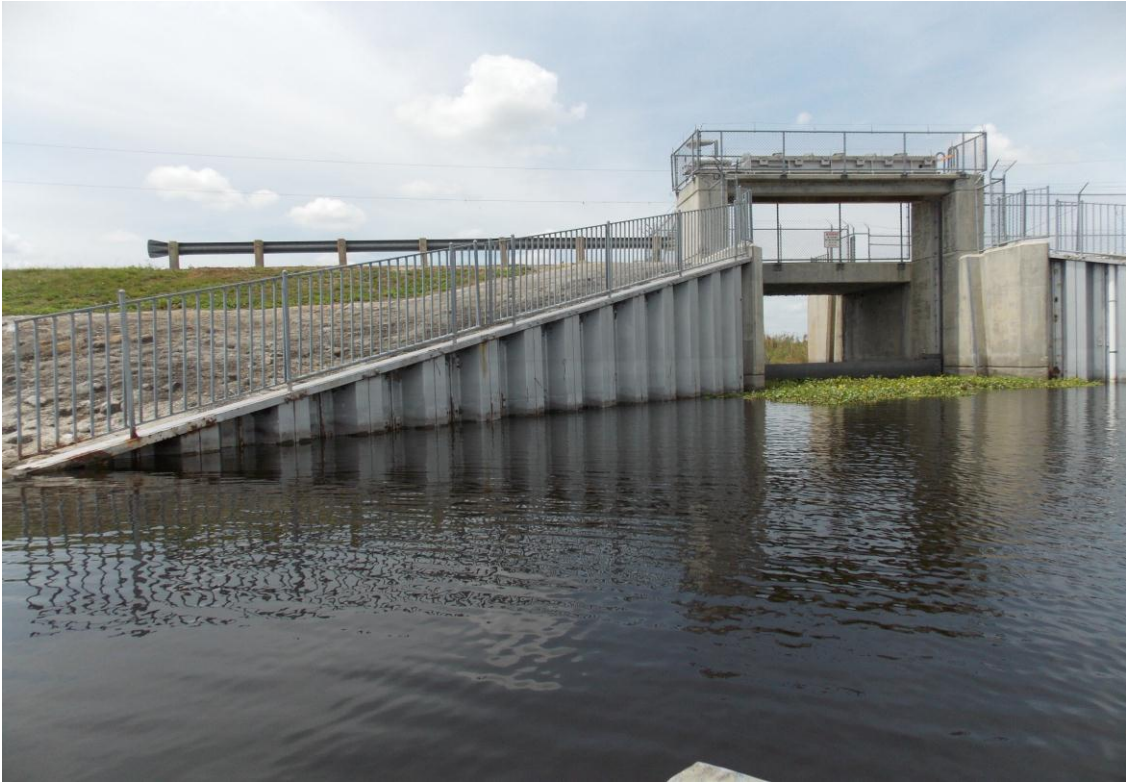
Upstream - South Wing Wall and Structure.

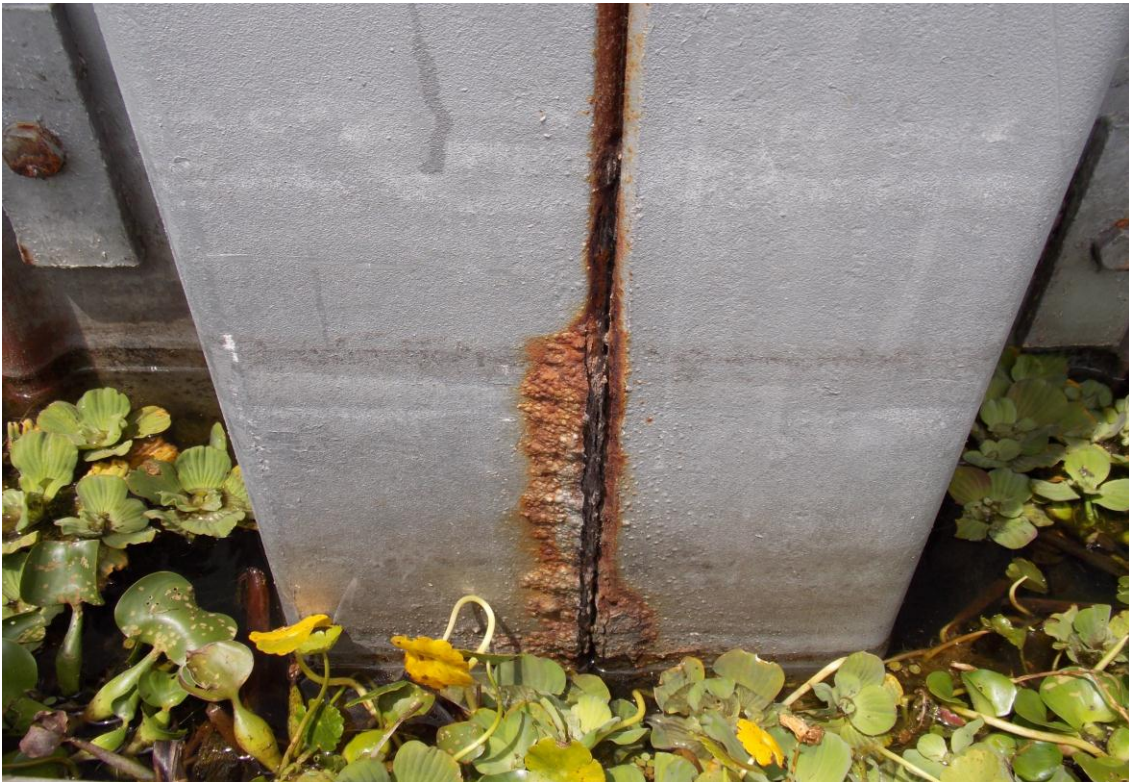
Relative to the steel sheet pile wing walls, the upstream walls appeared to be exhibiting greater corrosion than the downstream wing walls near the water line, especially the joints. The portions of the steel sheet pile walls that were below the water surface could not be observed relative to their condition.

Our observations and testing relative to the steel sheet pile wing walls indicate that there is corrosion occurring on the upstream wingwalls. Based on observations, corrosion is occurring at the section joints and at the water line. However, wall thickness readings indicate that the section thickness has not been compromised. Considering the relatively narrow water fluctuation zone on the upside portion of the structure, the concentration of the corrosion within this zone is logical.

Upstream - North Wing Wall Corrosion at Joint.

Relative to the upstream steel sheet pile wing walls, we recommend that the corrosion occurring at the joints and at the water level be pressure washed and/or sand blasted to remove the corrosion and then repaint/coat the prepared surface as needed.

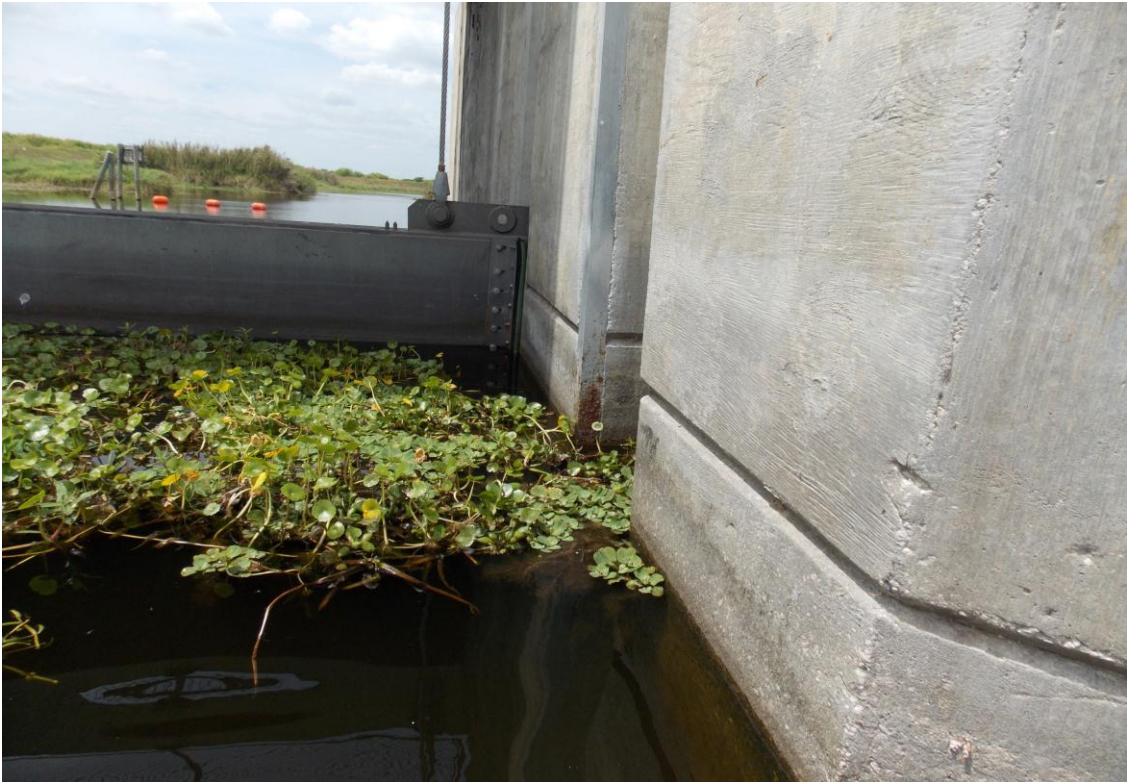
Upstream - North Structure Wall.

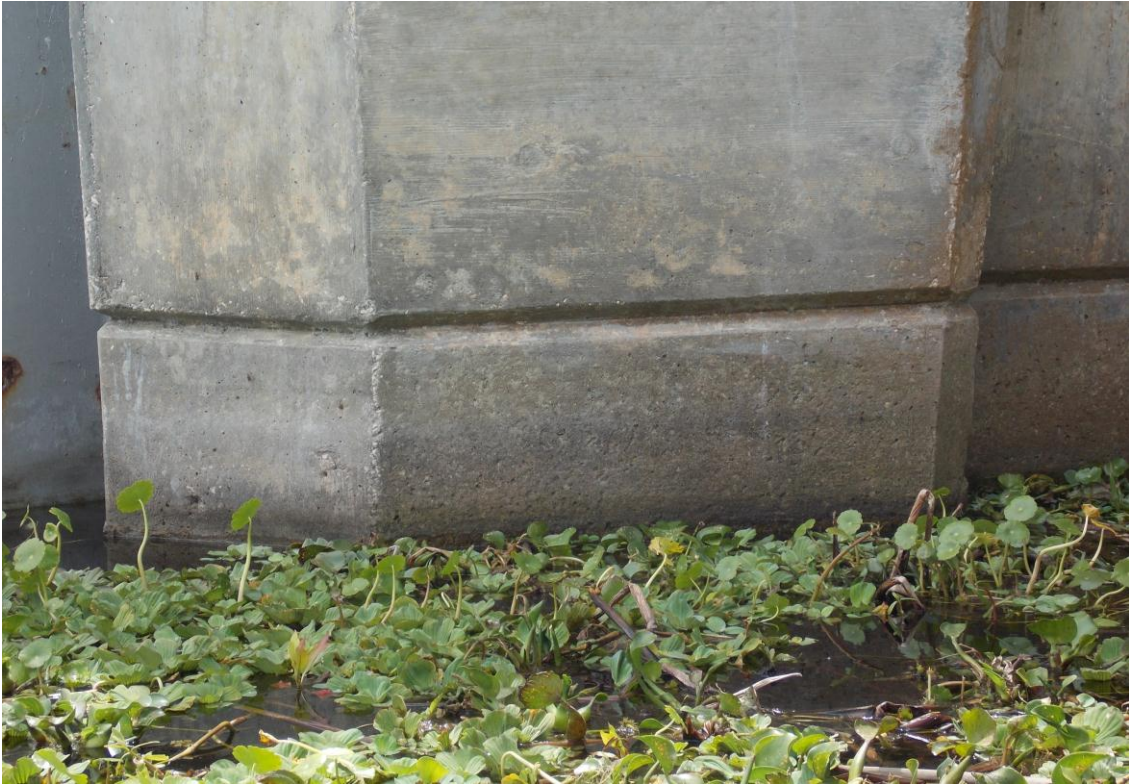
Upstream - South Structure Wall.

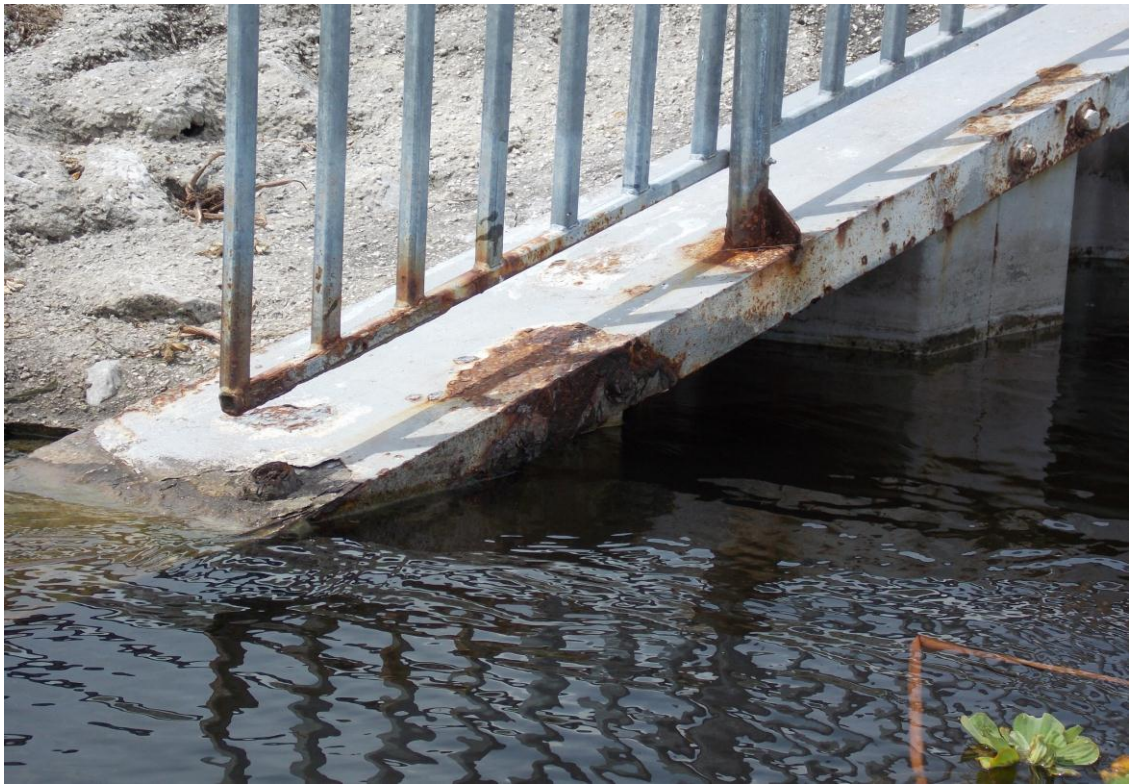
Upstream - South Wing Wall.

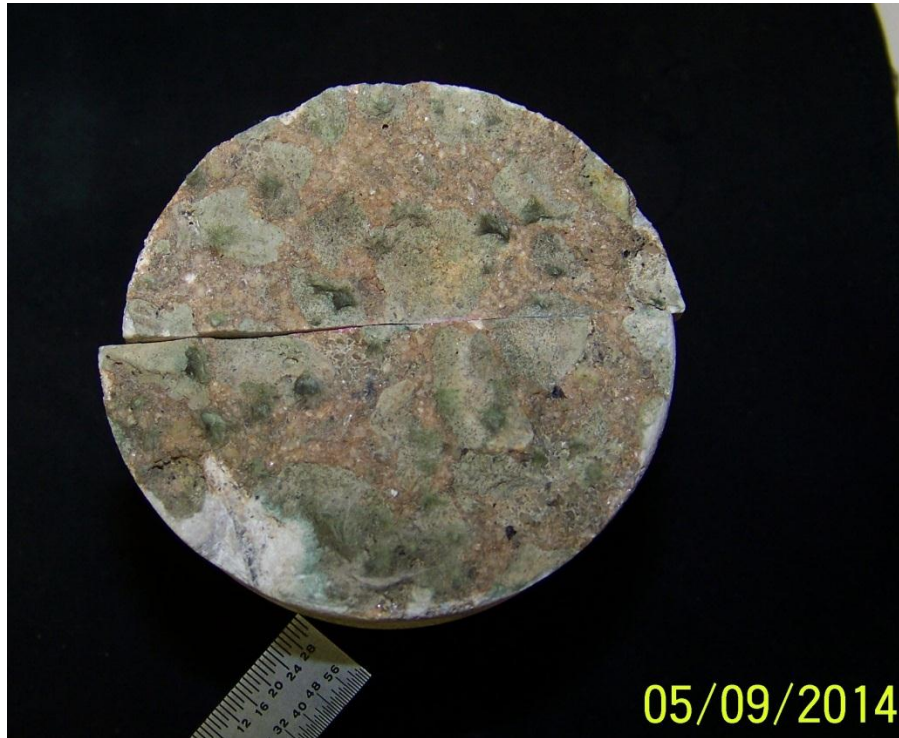
Photo 2 – Sample 1A – end view, note surface erosion.

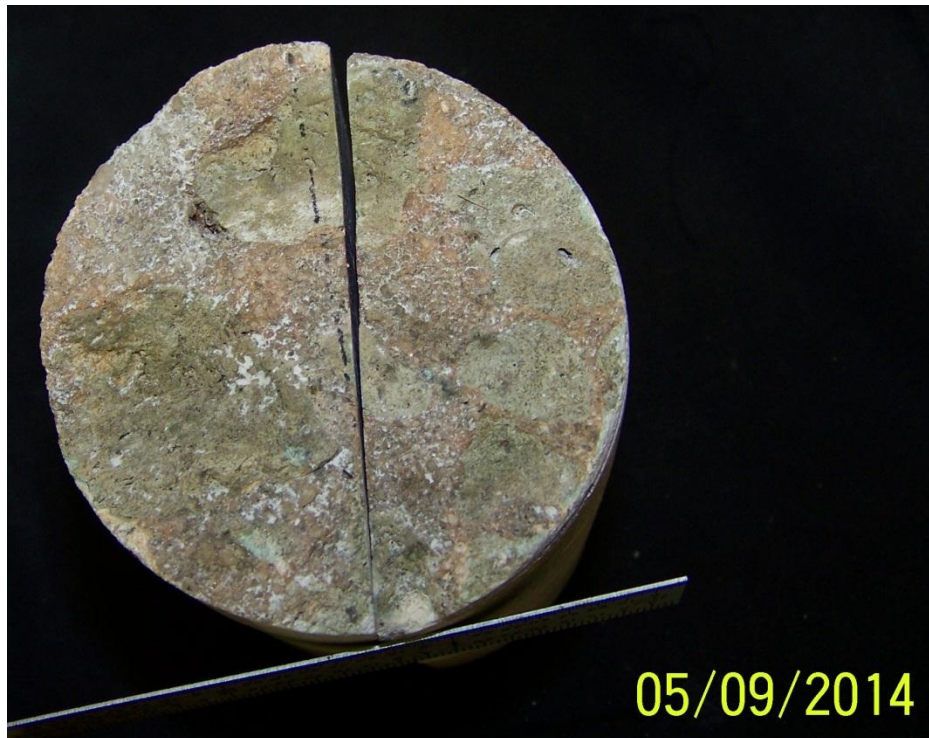
Photo 3 – Sample 3A – end view, note surface erosion.

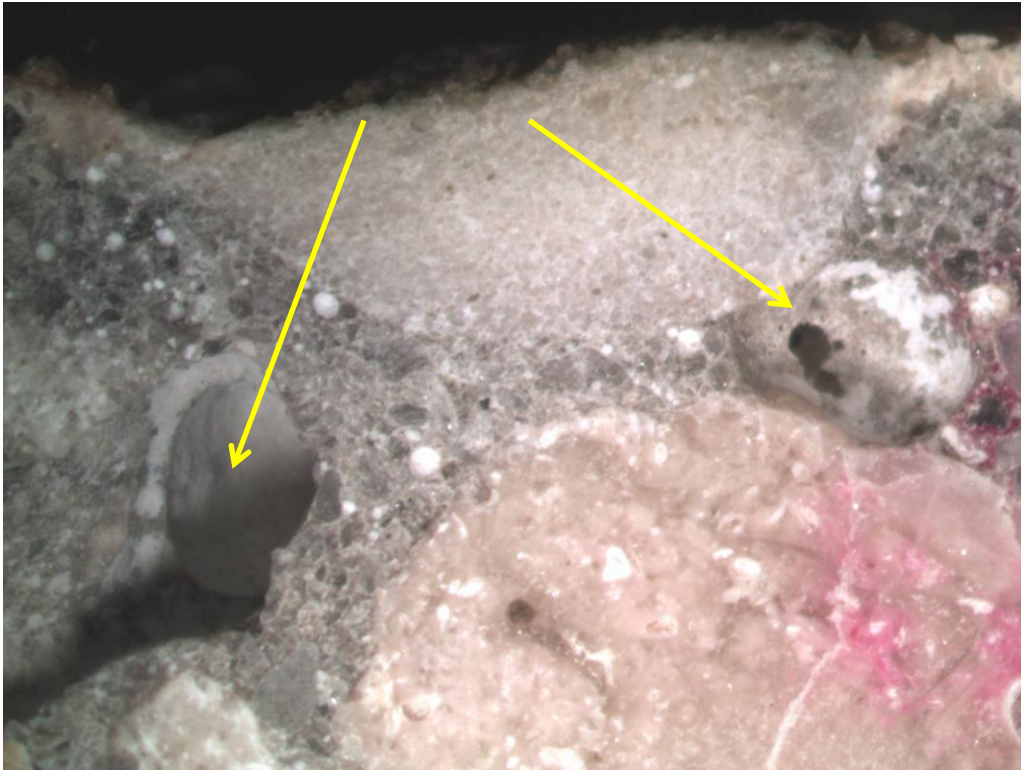
Photo 4 – Sample 1A – entrapped air voids near surface.

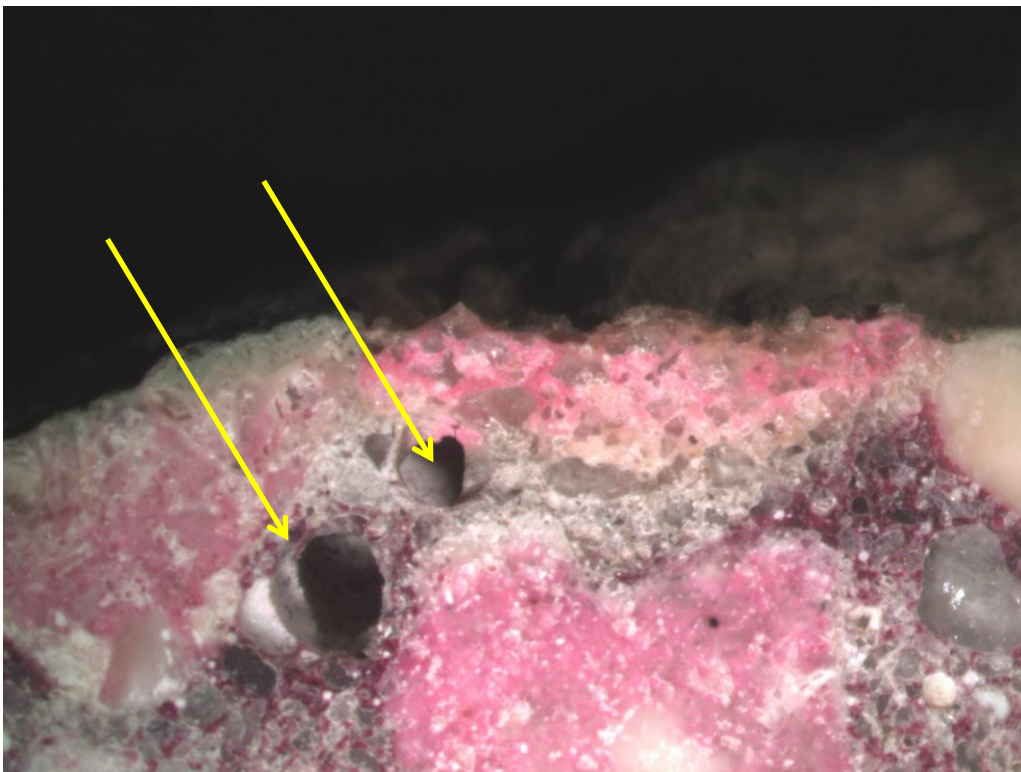
Photo 5 – Sample 1A – entrapped air voids near surface.

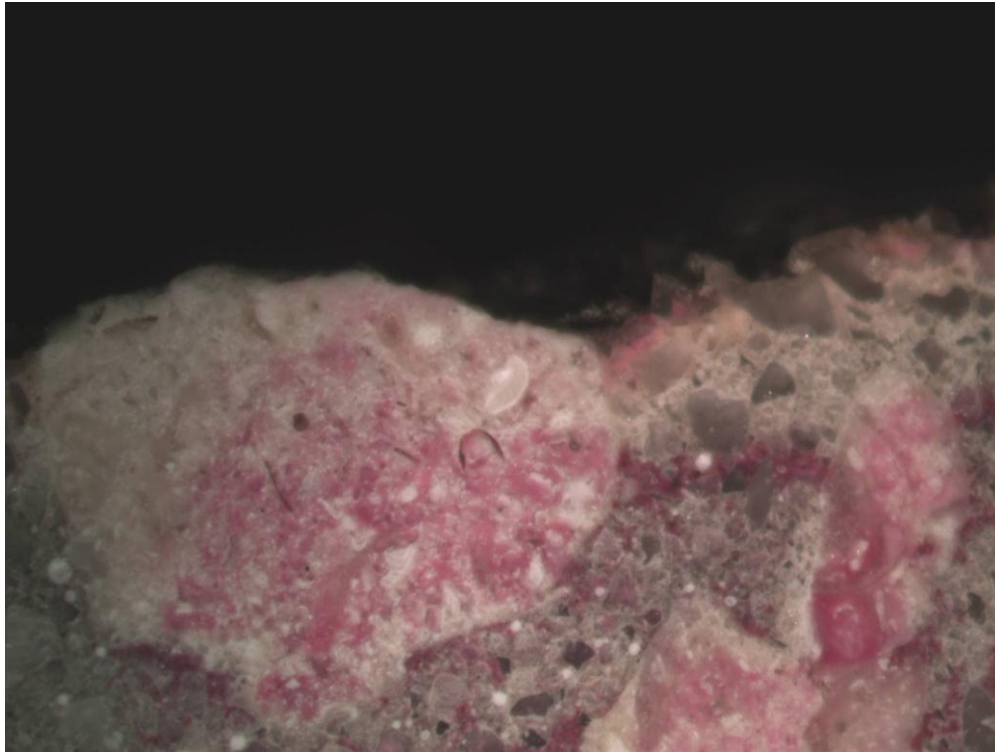
- The surface of the sample is eroded. Photo 6 shows one coarse aggregate piece becoming exposed to a point where it will mostly pop out.

Photo 6 – Sample 3A – magnified view of eroded surface

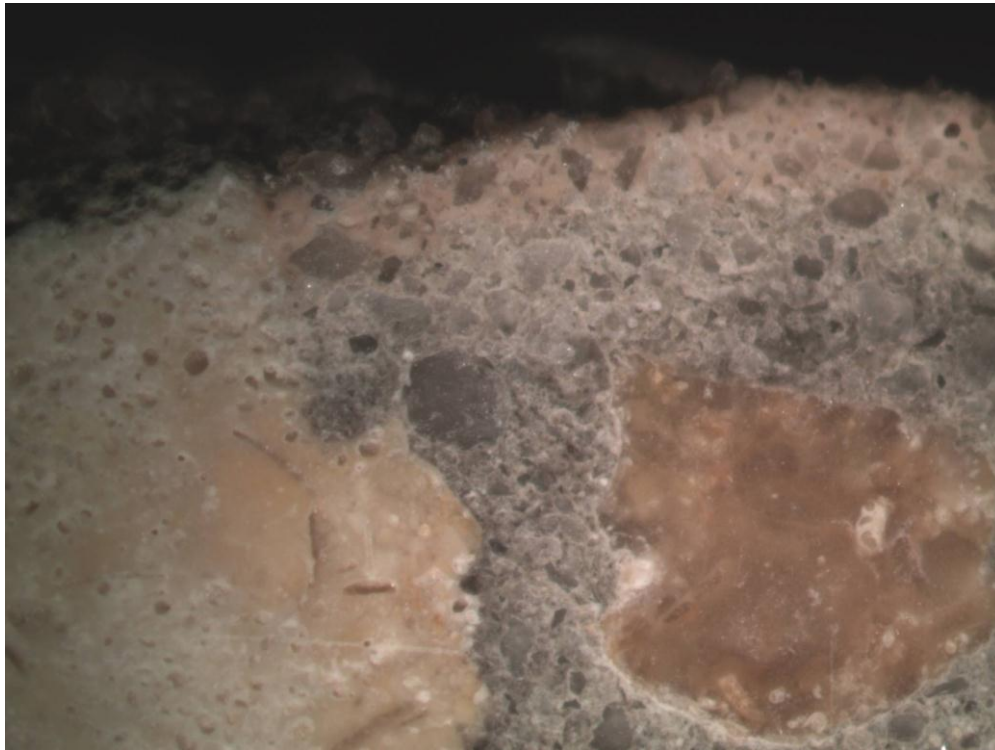
- Paste is light to medium gray with some dark gray zones through the depth of the cores. Sample 3A has a light tan layer at the surface which can be attributed to carbonation which was measured to be on the order of $\frac{1}{16}$ inch deep at the surface as determined by the application of a phenolphthalein indicator solution.
- Paste moderately hard when scratched with steel point.
- Paste to aggregate bond appears good.

Photo 7 – Sample 3A – variation in paste coloration, tan near surface to darker gray between coarse aggregate.

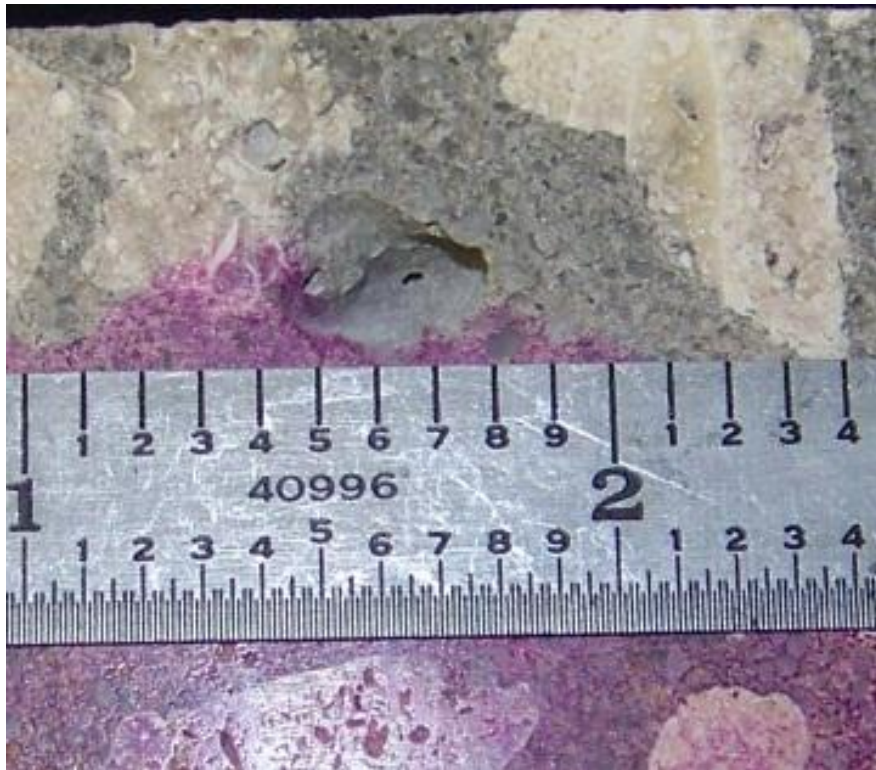
Photo 8 – Sample 3A – large entrapped air void

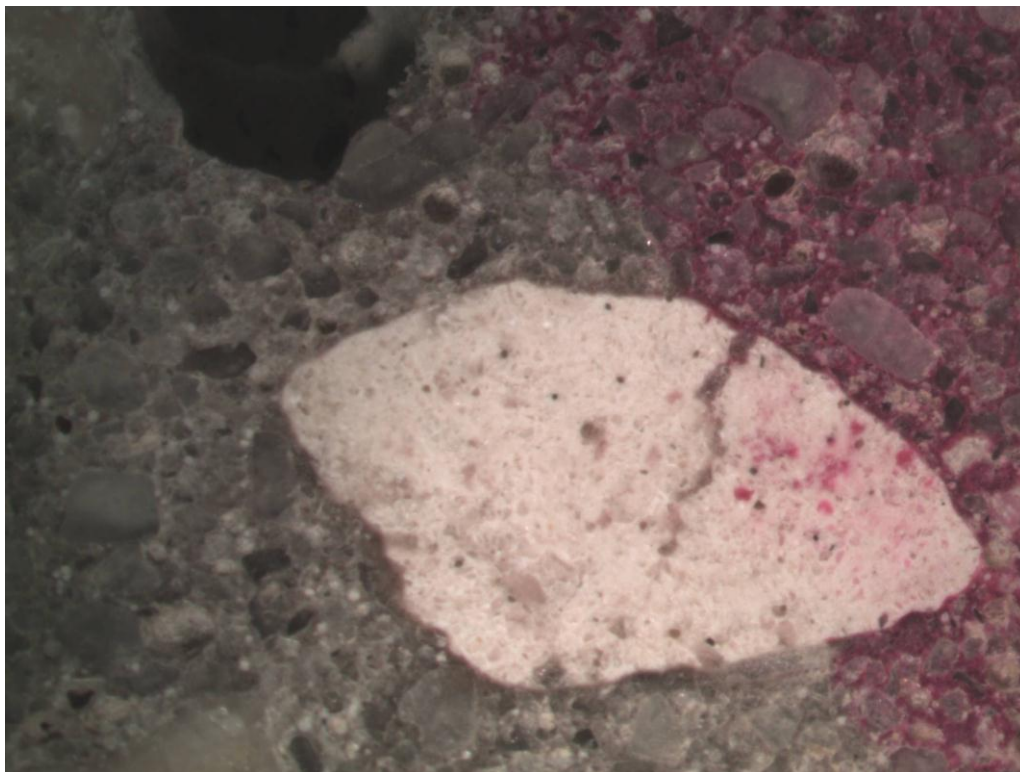
- White to tan to crushed fossiliferous limestone and siliceous limestone.
- Nominal maximum particle size is ¾ inch graded down to ⅛ inch.
- The particles are equidimensional with a sub-rounded to sub-angular texture.
- Volume of coarse aggregate appears reasonable.
- Coarse aggregate relatively well distributed.
- Aggregate paste bond is good.
- No indications of cement-aggregate reactions were noted within the coarse aggregate.
- One aggregate piece in Sample 3A was found to contain a crack partially through the piece. This does not appear to be the result of a reactive aggregate. (Photo 9)

- No cracking observed, except for the crack observed in the coarse aggregate piece. The piece of aggregate was well embedded in the concrete and is not considered to be an issue at this time.

Photo 9 – Sample 1A – crack extending partially through coarse aggregate piece.
